FACEBY LODGE FARM  
CARLTON -IN -CLEVELAND  
TS9 7DP

## Pre-Application Arboricultural Survey

8<sup>th</sup> March 2019

Prepared by  
Elisabeth Airey MSc MArborA HND(Arbor) Cert Woodland Mgt.

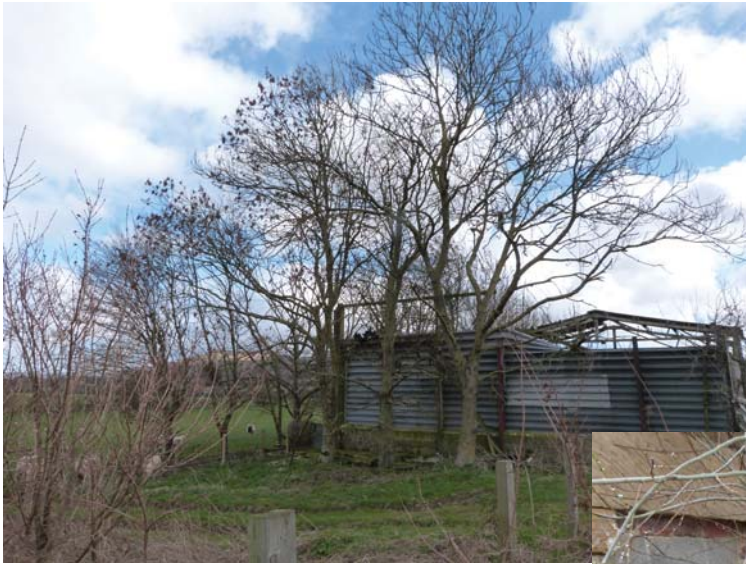
- Trees 1, 2 & 3

Trees 1, 2 & 3 are located some way from the main area of development and as such they are not directly implicated in the redevelopment of the buildings however there is the potential for them to be damaged directly by construction vehicle movements on site, or indirectly via soil compaction from vehicle movements. There is also the potential that these trees could be damaged during the demolition of the building directly south of their location. In addition, demolition of the barn has implications for third-party owned trees within the adjacent pasture.

**Mitigation:** Protective fencing should be erected north of the trees to prevent accidental damage to the stems from vehicle movement on site. To the east of the trees' location is a field gate giving access onto the adjacent pasture and any fencing will need to accommodate ongoing access requirements for the field.

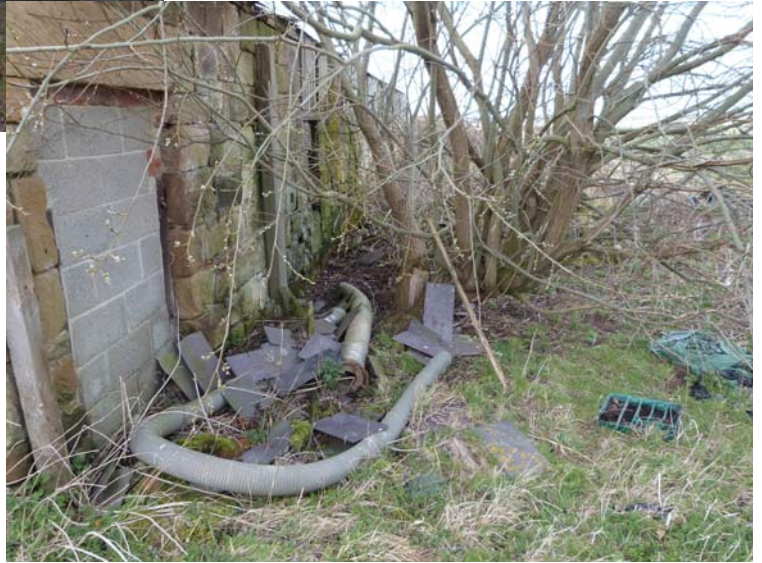
Tree 4 -

There are four significant trees within the curtilage of the proposed development area. Three mature trees are located away from the focus of redevelopment, however one tree (T4 Goat Willow) is directly affected by the proposals. T4 is a poor quality multi-stemmed self-sown Goat Willow, and has a partially collapsed canopy due to a significant tear in the main stem union at the base of the tree.

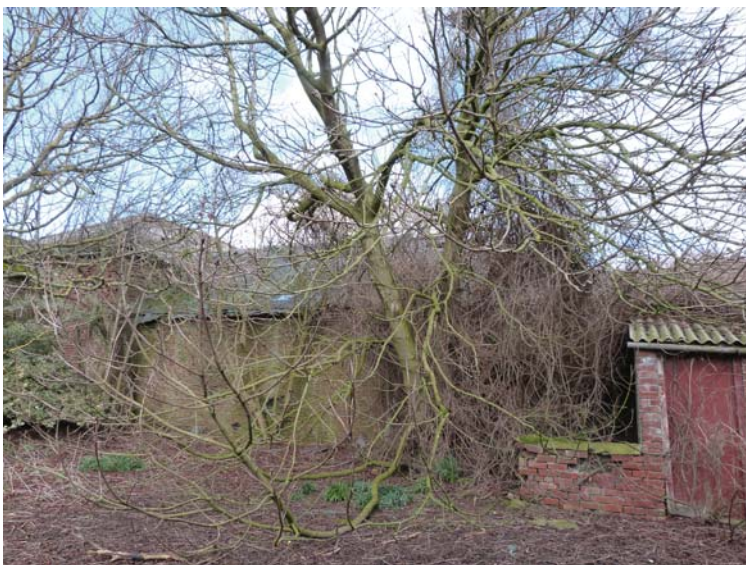
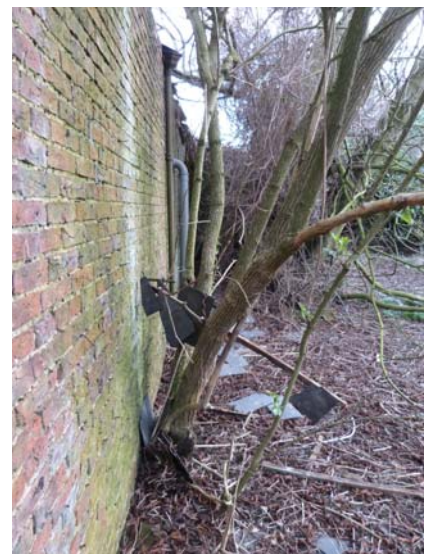
Group 3 Trees within derelict walled garden -

Adjacent to the west of the site is a derelict garden where many self-sown trees are growing adjacent to the rear walls of the subject barns. These trees are causing direct physical damage to the fabric of the farm buildings, and immediate action to resolve this is recommended.

**Group 3:** This group is a mix of mature planted stock, and semi-mature self-sown trees within a derelict garden to the west of the main buildings. A mature Horse Chestnut tree is causing direct physical damage to the roof of the building. Multiple self-sown trees are growing close to or touching the

Remedial pruning work to reduce the canopy spread of the mature Horse Chestnut is necessary to abate further damage to the building roof.

In this instance, this work will also include the felling and pruning of trees on land outside of the development site boundary, where they are causing direct damage to the buildings. Stumps should be ground out where possible, or poisoned to avoid potentially damaging regrowth.

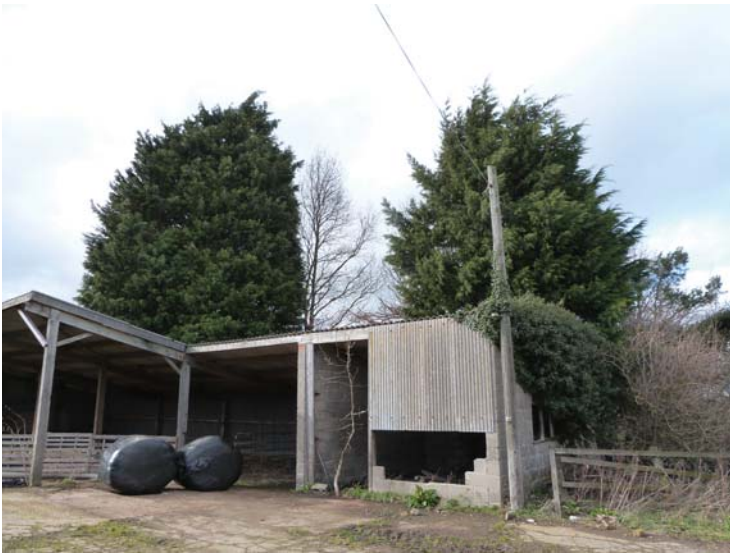
**- Group 1 trees adjacent to storage sheds**

**Group 1:** A mature, mixed specie group of trees is located on third party land adjacent to the farm track and a range of derelict storage sheds (Nos. 4 & 6 / BIP). The redevelopment of the site proposes the removal of these buildings and replacement with a parking area. The ground treatment within the parking area is not identified on the supplied plans, but any ground disturbance may affect the established rooting zone of these trees. ( A concrete pad may exist).

**Mitigation:** The sheds should be demolished inwards onto the footprint of the existing building. It is recommended that the surface finish for the parking area is non-invasive (no-dig construction) and porous eg. Cellweb or Geogrid with stone chips/gravel onto a porous geotextile membrane if a concrete pad is not extant.

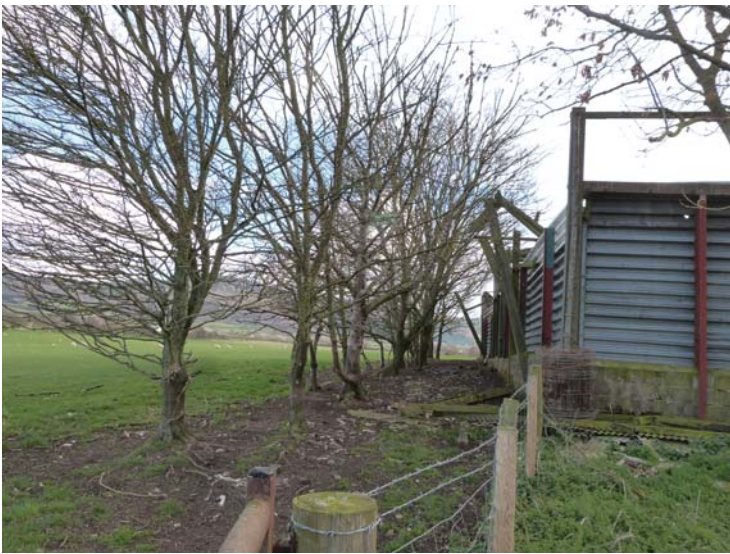
**- Group 2 trees adjacent to derelict steel-framed barn and Trees 1,2 & 3**

The redevelopment of the site has the potential to cause minor detriment to trees in Group 1, without undertaking suitable mitigation. Trees within Group 2 are not directly affected by the redevelopment, but could be damaged during the demolition of derelict barns if this were done without due care. Trees within Group 3 are implicated in serious structural damage to the property that requires immediate attention, and includes tree felling and remedial pruning, however this matter is outside the scope of this report.
