Report on Reinstated Roof

Farm Building Conversion
Thirley Cote Farm
Harwood Dale
YO13 ODR

Report 11523 NID 06/02/2019

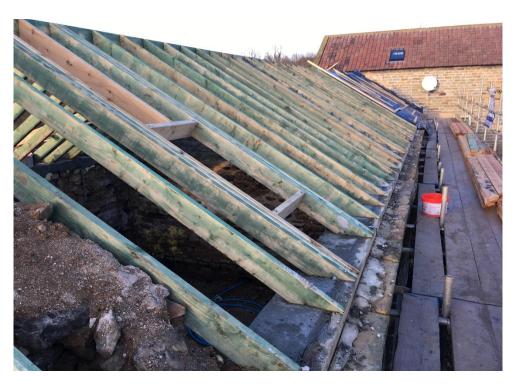
Photo 1
Roof over Bedroom 1, Hornbeam Cottage

3.1 Roof over the reception area of Mulberry Cottage to the end of the building (Bedroom 3 Hornbeam Cottage) is where only rafters have been positioned with insufficient restraint to prevent 'spread' or lateral movement.

The preference is to use the solution described in Section B. This ensures only timber is used in the proposed roof structure which, we believe, is preferred for planning reasons. It will also allow the client some flexibility when agreeing a final ceiling height.

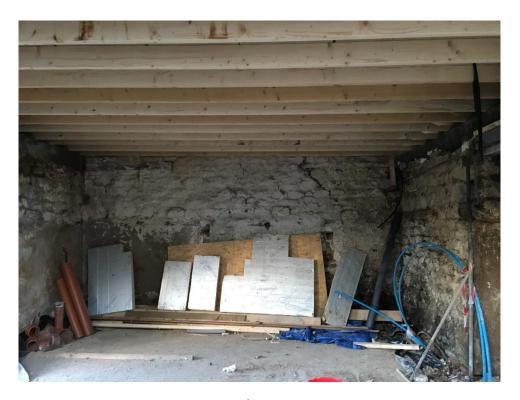
The new structure over Bedrooms 1 and 2 of Mulberry Cottage also has ceiling joists positioned at wall plat level connecting the rafter feet.

Photo 2
Roof/ceiling over Beds 1 and 2, Mulberry Cottage

3.2 The roof over Bed 1 and Bed 2 of Mulberry Cottage already has ceiling ties incorporated within the new works.

To ensure protection from lateral movement and to comply with Building Regulations, these ceiling ties need to be bolted to rafters with M12 bolts and sized at $47 \times 220 \text{ c}24 \text{ timber}$.

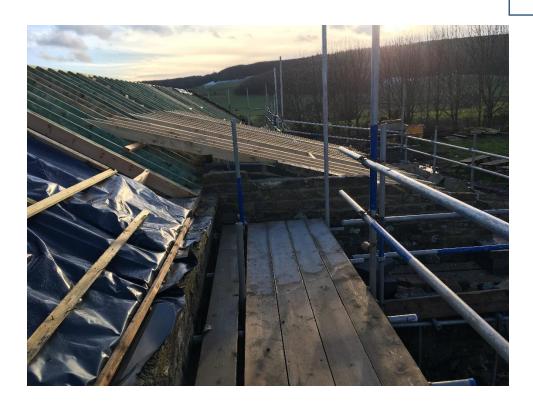
A lean-to roof has been set out with rafters over the rear offshoot, which will become the Dining/Kitchen area of Mulberry Cottage.

Photo 3
Lean-to roof over Kitchen/Dining, Mulberry Cottage

- 3.3 The roof formed over the rear offshoot is self-supporting and spans between 2 wall plates. The rafters for this roof which span approx. 3.3m need to be 47 x 170 c24.
- 3.4 The lean-to roof rafters connect to a series of the main roof rafters. The final design of these rafters will require this load to be taken into account.
