TREE REPORT

Altered access at Sunny Bank Barn Broxa Lane Hackness

**LAWSON HARPER
Amended 18 May 2015**

SUPPLEMENTRY TREE REPORT

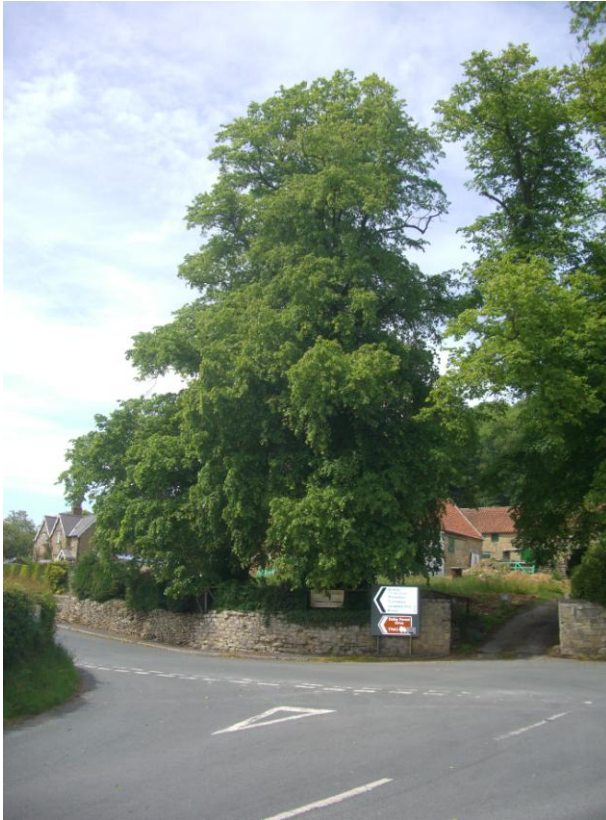
Fig 3 Tree T1 and T2

A pair of mature Limes (T1 and T2) growing approximately five meters apart and having integrated crown. In terms of visual impact the trees are considered as a group along with a third mature lime (T3) on the opposite side of the entrance within the adjacent property.

The overlapping crown of T1 and T2 has resulted in reduced spread for both trees which would be left with unbalanced and poorly shaped crow should either one be removed.

T1 appears to have grown from two leaders which have conjoined . there is a distinct joint ridge on the east and west side of the tree. The dominant lead to the north has a distinct lean to the north. The southern branch has been previously cut back due to overhanging of the highway, this has left a stub with much suckering and several pegs.

There are several short pegs left from previous pruning, most showing dieback, numerous minor healed and healing lesions from minor limb removal.

The tree in tandem with T2 has light, balanced crown but is now growing out from previous thinning, spread has been restricted by previous tree work.

The trees are located within 2 m to 3m of a retaining wall which forms a sharp change of level of some 1.3m. There is no sign of heave or root damage to this wall and the roots appear to have established to accommodate the level change.

The surface around the trees is covered in stones which are thought to have historically migrated from the barn or been used to make up the ground. Some originate from the wall which appears to have been higher as some point in its history.

There was slight late leafing out towards the top of the tree on the northern side but other than this no major issues observed there is moderate to light suckering at the base. Aphid residue is present as expected for the species but there are no signs of gall might or fungal disease
Trees 1 and 2 are in good to excellent condition.

The cutting back of the retaining wall to the extent of the sight line would sever the entire southern rooting plate to within 0.75m of the bowl of both trees T1 and T2 removing both the feeding and anchorage roots of both trees over approximately 30% of the rooting area. Despite the roots to the south being restricted by the retaining wall and cutting back of the crown to prevent overhang to the highway, this is highly likely to result in stability issues particularly when the northward lean of T1 is taken into account. It would also potentially affect the long term viability of the both trees.

Localised stress and die back is likely to result with the trees drying after a number of years. Whilst this would offer an opportunity for replacement with the mature T3 remaining.

The potential instability could reduce the longevity of the trees and overturning would be likely to damage any adjacent replacement. The condition of T3 suggests the tree is in decline and so can not be relied upon to retain the visual impact. It is therefore considered that realignment of the line of the retaining wall is not an option unless the trees were felled and replaced.

Action Required

Minor works to T1 to remove or balance the reduced limb to the south
reduction in the height of the wall and rebuilding to ensure retention capability and stability

Recommendation

Sightlines be accommodates by changes to ground profile

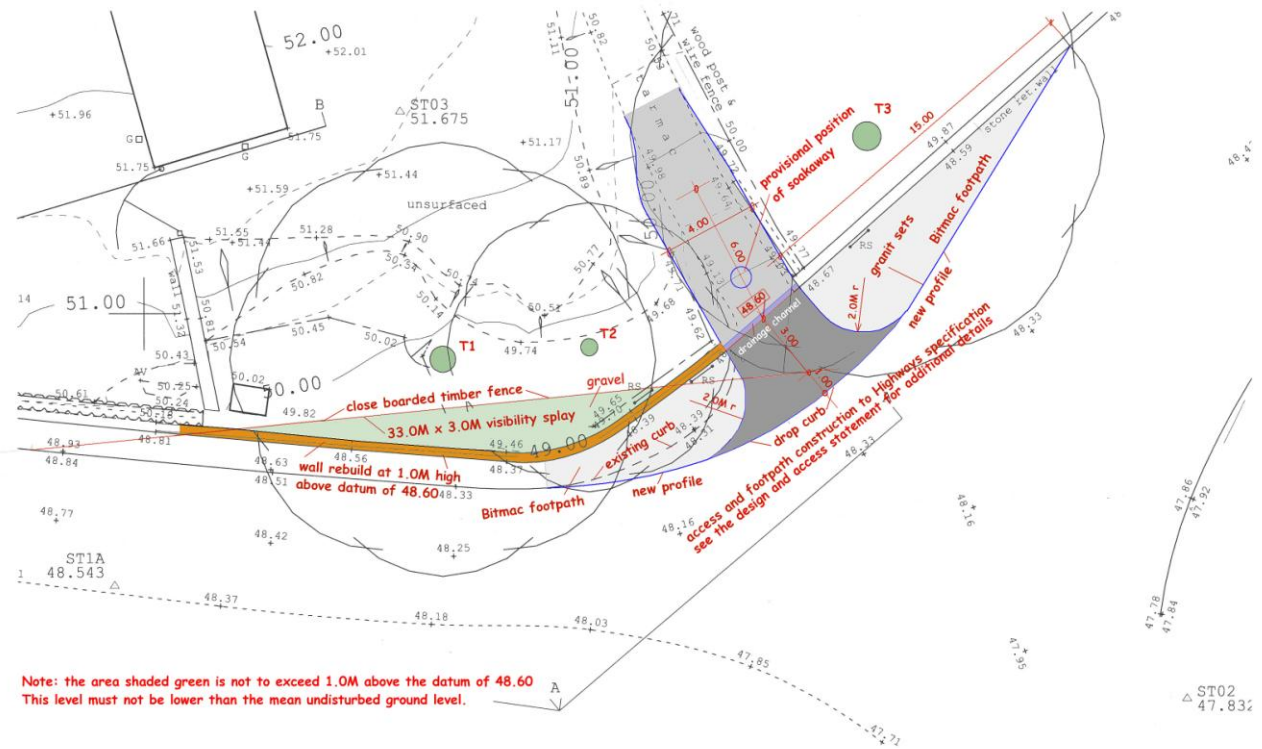
Fig 4: Extent of the proposed works

Cutting back of the retaining wall to to ground level to accommodate the sightline would result in the loss of the trees and is considered unacceptable.

However, the sightline can be accommodated by careful hand grading of the ground profile to reduce the level of deposited stones to accommodate a sightline at 1.0m above datum.

The works can be successfully accommodated without detrimental effect to the trees surveyed by reducing the height of the wall and the ground level in a small section of the land to the south of the trees. as indicated in Fig 4 - The extent of the proposed works

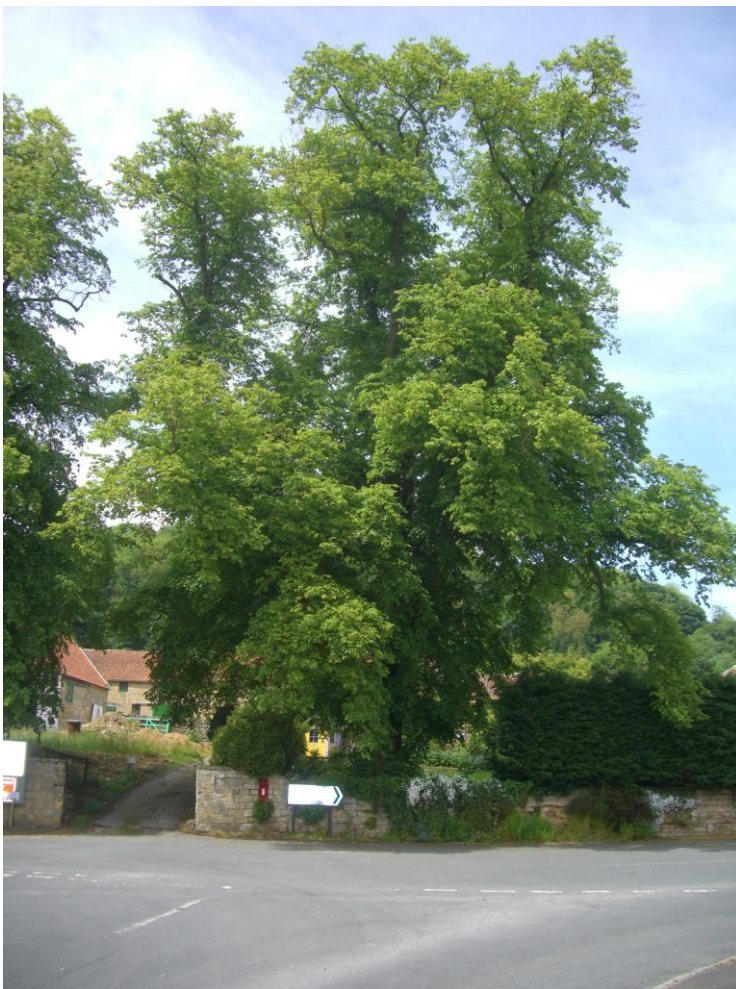
Fig 5: T3

T3	
Species	<i>Tilia x europaea</i>
Common Name	Common or European Lime
Height	IRO 40 M
Approximate Age	100+ Years
Girth at 1.5 M	1.5 M
Crown Spread North	6.0 M
Crown Spread to East	5.0 M
Crown Spread to South	8.0 M
Crown Spread to West	7.0. M
Overall Condition	Fair

The tree is the largest of the group and appears to have been established prior to those at Sunny Bank. It is not affected by the development and is not subject to the emergency TPO

The tree has an unbalanced crown with a large limb extending almost right-angled to the south, and three distinct leaders.

The tree showed signs of late leafing and early leaf drop. There was also minor crown dieback on all three stems. The tree is showing signs of stress but as no obvious cause can be found and the stress response is general and uniform it is likely to be from age or water table or climatic issues rather than mechanical root damage. The lack of corresponding stress in the trees at Sunny Bank makes environmental factors unlikely. The tree is currently in fair condition but this condition can be expected to deteriorate in the near the medium future.

This tree is not affected by the works

Its condition rules out any proposal that the loss of the trees at Sunny Bank would be mitigated by the retention of this tree.

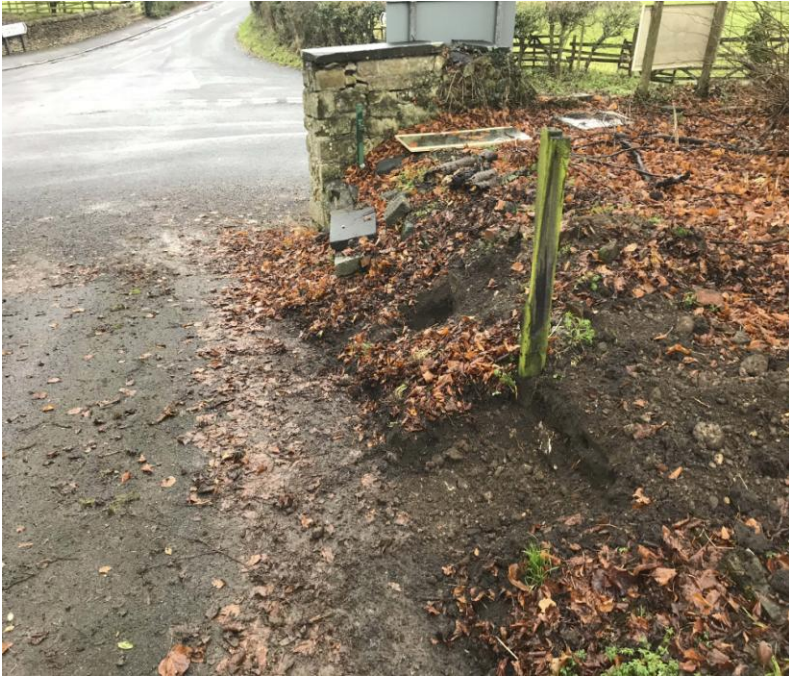
Photo 2 - General view of access driveway

This will require the removal of approx 400mm deep x 400mm wide of spoil from the area shown in pictures two and three and extending 6.0M, from the front boundary wall, up the driveway.

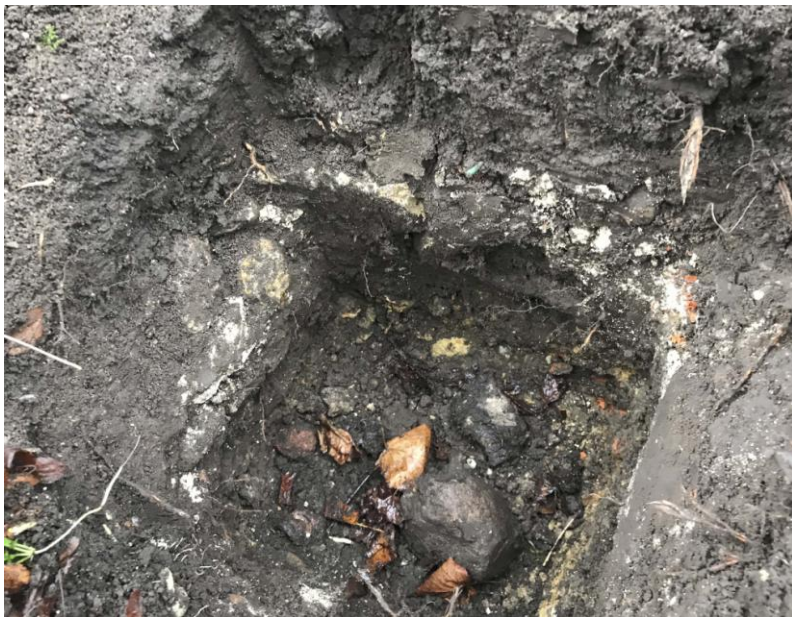
Photo 4 - Test excavation hole on access driveway

The driveway itself is tarmac and has been in situ for many years. There is evidence of some basic arrangement of stones to fashion a retaining wall.

Two 300mm square test holes were excavated to a depth of 600mm along the proposed excavation area to assess the founding material and the presence of any root material from the trees.

The ground in the area for excavation has approximately 100mm of top soil which reduces where abutting the existing tarmac surface. It appears to have been carried down the sloping ground by the action of the weather and the ground beneath is stone and rubble which continues to the mean level of the tarmac drive. There is evidence of historical and a rudimentary attempt to retain the ground around tree (T1) when the access driveway was originally constructed. During the test dig, there was little evidence of rooting material.

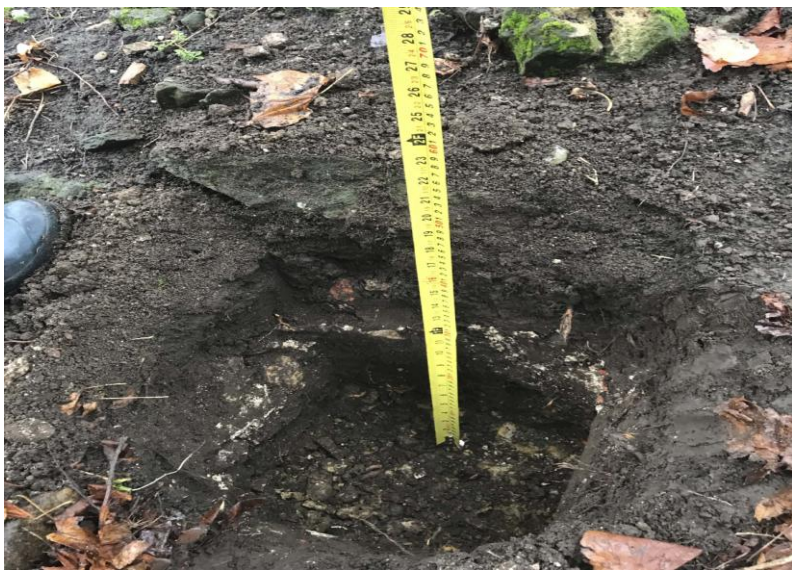
Photo 5 - Test excavation with tape for reference

From the investigation carried out on site, the proposed excavation to increase the access to 4.0M wide x 6.0M would not adversely effect the root structure of tree T1. All other matters are addressed in Lawson Harper's report.
