## 6.0 PHASING AND DISCUSSION

### **West range (1000)**

### **South range (2000)**

### **Cart shed (3000)**

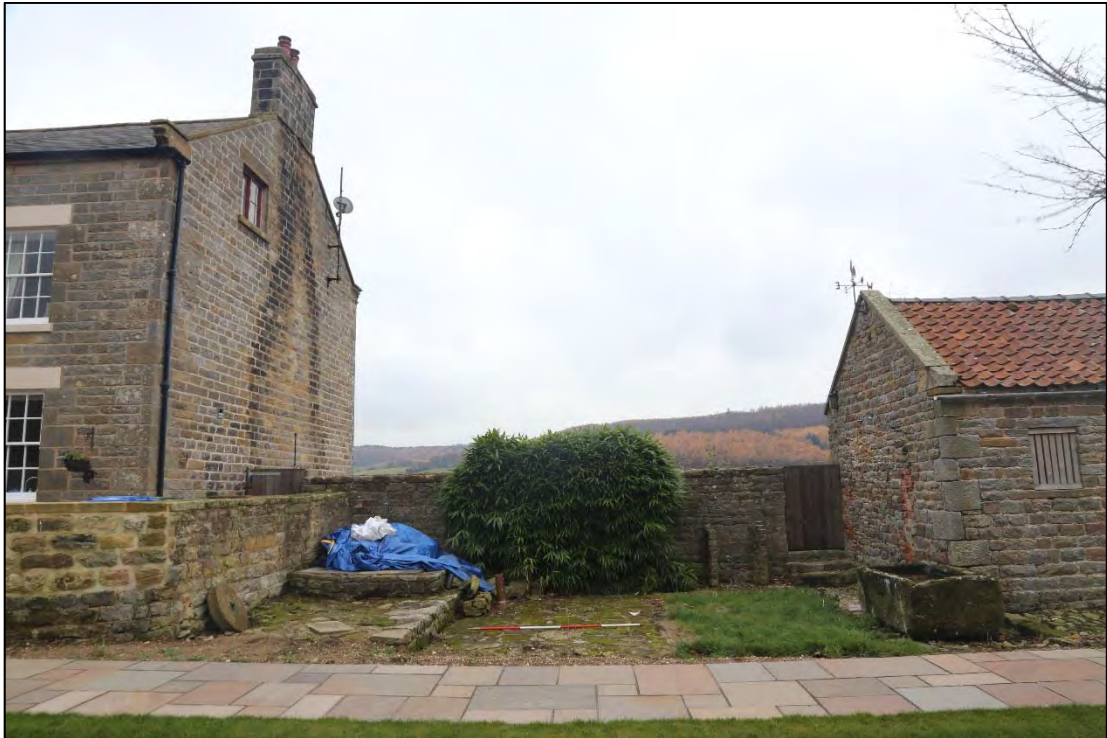
pier (2401) visible in the east elevation (Plate 61) would indicate another implement store, which might be anticipated in such close proximity to the stable. Alternatively, the CS Archaeology report suggests this may have been a pigsty, with waste from the farmhouse being fed direct to the pigs.

*Plate 61: building footings between the south range and farmhouse associated with the south range extension. This building may have originally served as an implement shed or pigsty.*

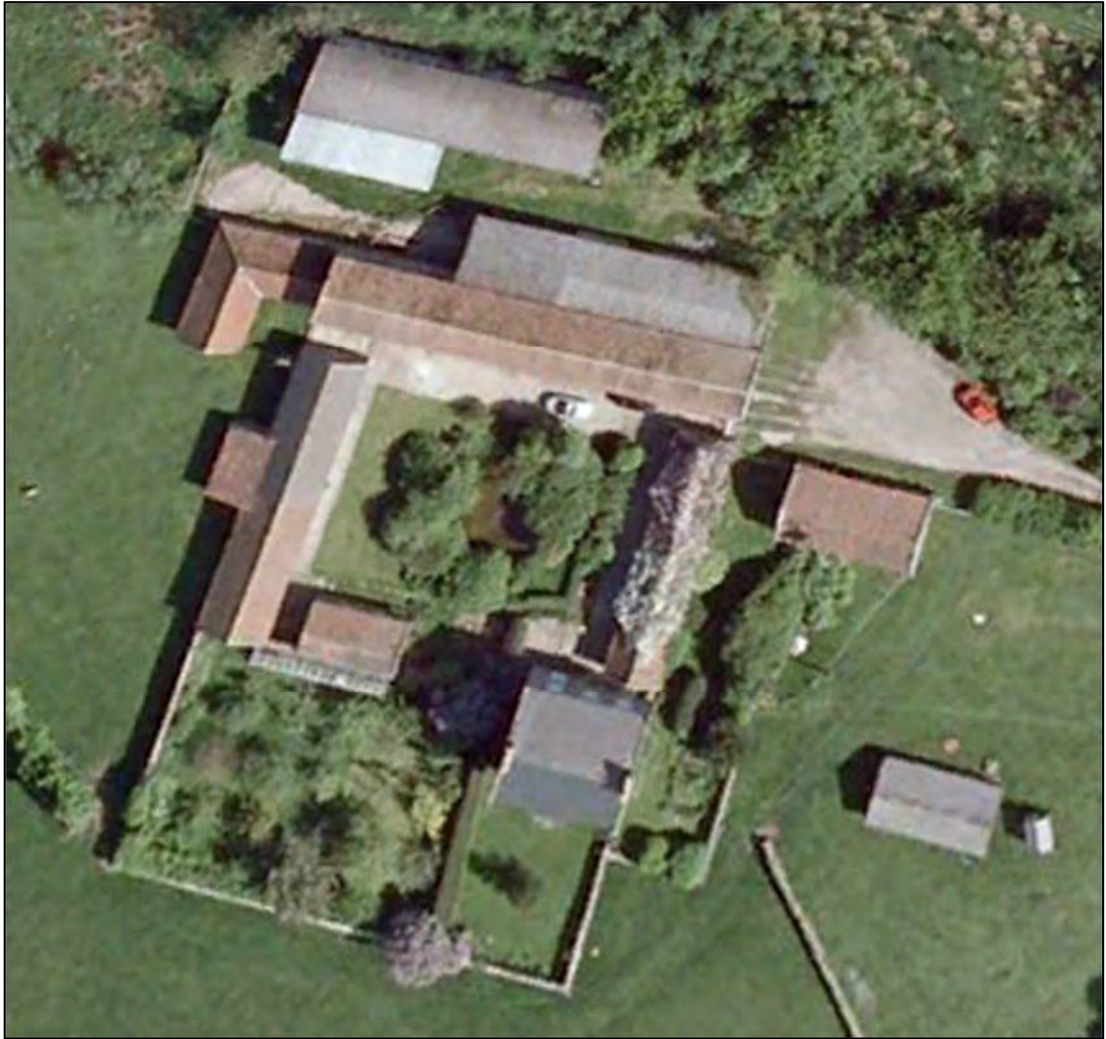
*Figure 9: historic Google Earth imagery (2009) of Thirley Cotes farm prior to its development as holiday accommodation. The demolished 'greenhouse' building is visible extending to the rear of the south range. Also visible are a series of modern agricultural building with corrugated roofs, all of which have since been demolished.*

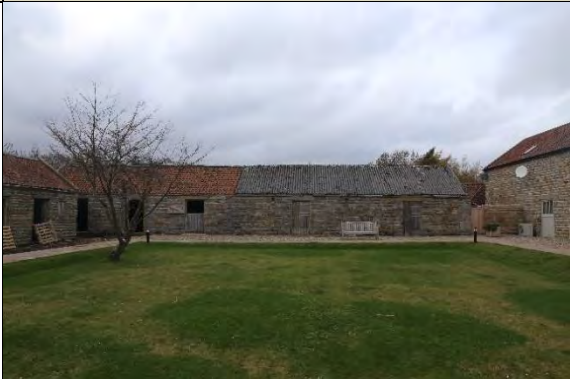
No.	Name	Description	Related Feature	Date	Significance	Photo
1000	West range byer and stable	Western most building of the farmstead. It forms the western edge of the foldyard. Evidence of a cattle byre at the northern end and stabling at the south end of the building.	100 north room 200 central room 300 south room 400 north loosebox 500 south loosebox	Early 19 <sup>th</sup> century	High evidential and historic value. Served as cattle byre and stable with access from fold yard and fields.

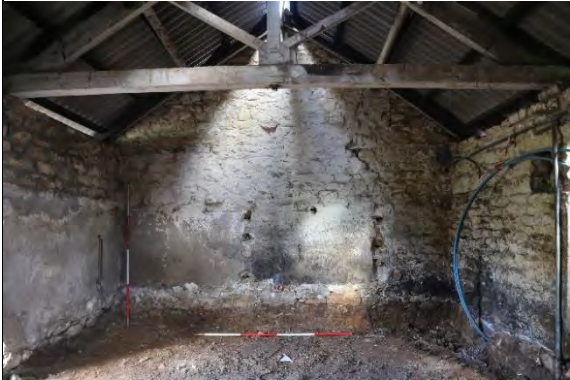
100	North room	Accessed both from the east and west, this latterly served as a byre evidenced by the joist holes (111) which indicate the presence of stalls along the north wall. On the west wall is a tethering bar (109) and there are two keep holes or lamp niches.	101 west door 102 east door 103 west niche 104 east niche 105 horizontal timber 106 horizontal timber 107 horizontal timber 108 king post trusses 109 tethering post - runner 110 north wall containing horizontal timbers 111 joist holes 112 stall partitions 113 trough 114 trough 115 manure / access passage 120 east wall 130 south wall 140 west wall	Early 19 <sup>th</sup> century	High-moderate evidential value as the archaeological features are indicative of the use but extensively modified.

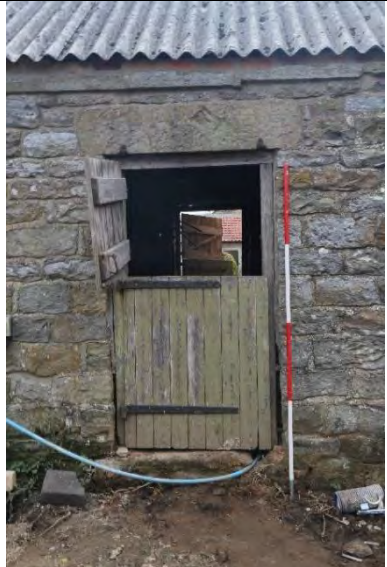
No.	Name	Description	Related Feature	Date	Significance	Photo
101	West door	One of only two access points into the west range from this side of the building, providing direct access from the west field. The lintel of this door is more roughly hewn than any others and is held in place by two metal brackets.	102 east door 201 west door 202 east door 301 west door 302 east door 401 north loosebox door 501 south loosebox door	Early 19 <sup>th</sup> century	High evidential value as an original feature.

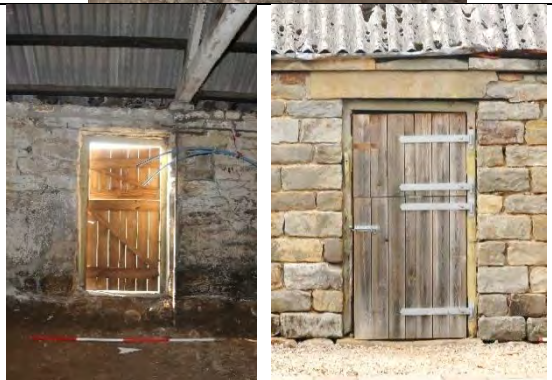
102	East door	Access door from the foldyard. Has a broken stone lintel.	101 west door 201 west door 202 east door 301 west door 302 east door 401 north loosebox door 501 south loosebox door	Early 19 <sup>th</sup> century	High evidential value as an original feature.

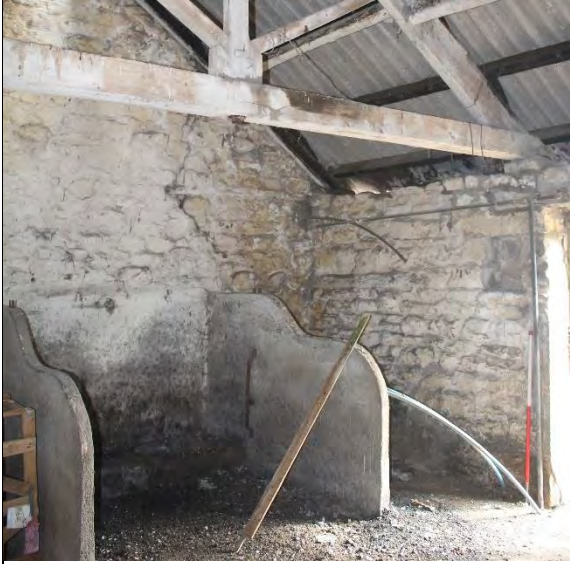
No.	Name	Description	Related Feature	Date	Significance	Photo
112	Stall Partitions	<p>Recorded by CS Archaeology, but no longer present during NAA survey.</p> <p>Photo by CS Archaeology 2018.</p> <p>Two modern concrete stall partitions with tethering bars on either side. Thus, creating three stalls which could of housed two animals each.</p> <p>There is a corresponding tethering bar (109) on the west wall and it is assumed that there would have been a similar one on the east wall.</p>	<p>109 tethering bar 111 joist holes 113 trough 204 joist holes 206 stall partition scar 207 trough</p>	19th –20th century	Moderate–low value as evidence for the use of the space but relate to final use of building.

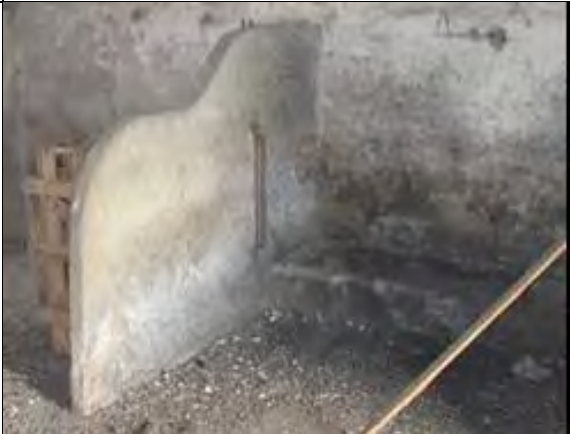
113	Trough	<p>Recorded by CS Archaeology, but no longer present during NAA survey.</p> <p>Photo by CS Archaeology 2018.</p> <p>Each stall had a twin brick, concrete rendered trough. Allowing for 6 animals to be fed individually.</p>	<p>109 tethering bar 111 joist holes 112 stall partitions 204 joist holes 206 stall partition scar 207 trough</p>	19th -20th century	Moderate–low value as evidence for the use of the space but relate to final use of building.

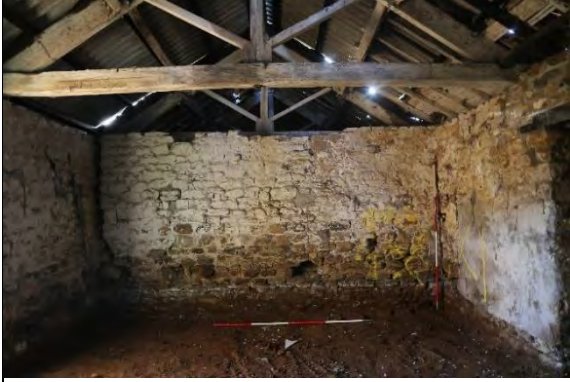
No.	Name	Description	Related Feature	Date	Significance	Photo
200	North-central room	This room was also a cattle byre in its final phase of use. Parts of the room have been rendered in concrete .	201 west door 202 east door 203 east niche 204 joist holes 205 timber upright 206 partition scar 207 north trough 208 south trough scar 209 manure / access passage 210 north wall 220 west wall 230 south wall 240 east wall	Early 19th century	Moderate evidential value. This room provides some important clues as to the last phase of use as a byre.

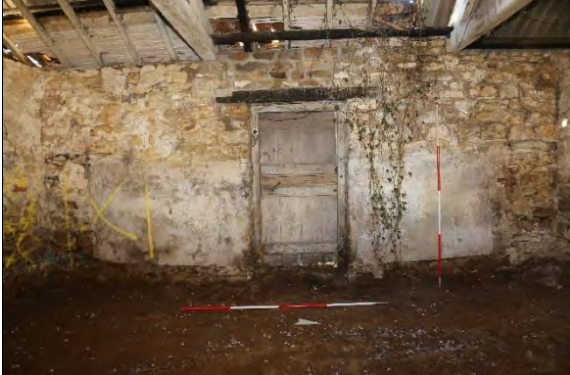
201	West door	The west door has a large, dark wooden lintel in the interior with a stone lintel outside. It opens into the outshot and has a stone threshold.	101 west door 102 east door 202 east door 301 west door 302 east door 401 north loosebox door 501 south loosebox door	Early 19th century	High evidential value as an original feature of the building.

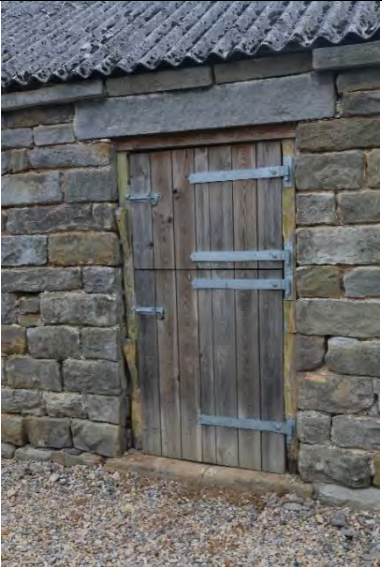
No.	Name	Description	Related Feature	Date	Significance	Photo
202	East door	This door opens onto the foldyard and has a large stone lintel and threshold stone.	101 west door 102 east door 201 west door 301 west door 302 east door 401 north loosebox door 501 south loosebox door	Early 19th century	High evidential value as an original feature of the building.

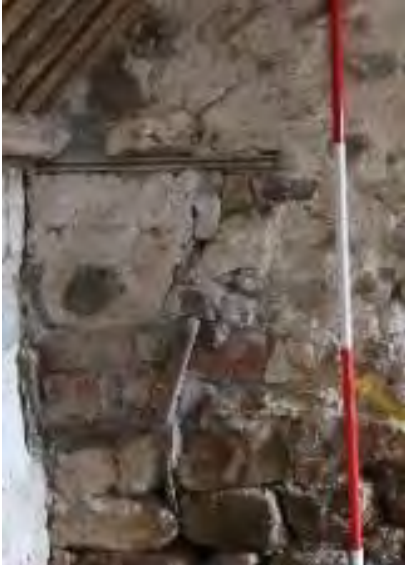
403	Trough remains	An upside-down semi-trapezoid of wood on the west corner of both the north and south wall indicating the location of the trough. The trough has been walled in with brick. Above the wooden trough remains is a wooden tie. It is unknown what purpose it served.	304 trough remains 503 trough remains 2103 trough remains 2203 trough remains	19th century	High-moderate: provides evidence for the use of this room.

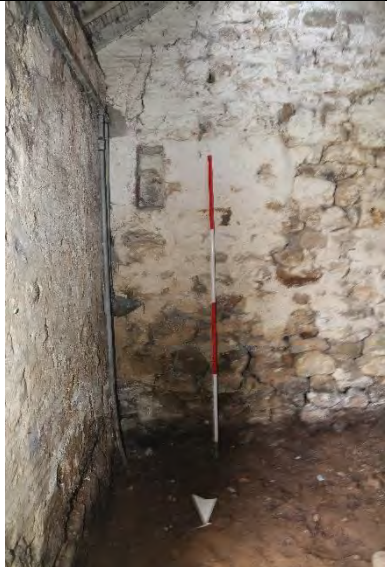
No.	Name	Description	Related Feature	Date	Significance	Photo
404	Niche	A small rectangular niche in the south-east corner. This niche has been partially filled by brick. It may originally have served for storage.	505 niche	Early 19th century later blocked	High evidential value as part of the original fabric of the building. It has since been modified.

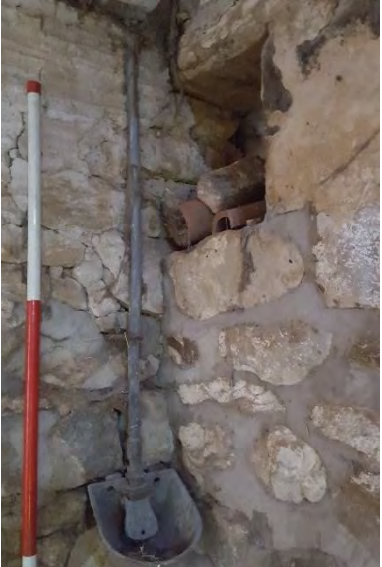
No.	Name	Description	Related Feature	Date	Significance	Photo
505	Niche	Niche partially filled with clay tiles, bricks, and pipe.	404 niche	19th century	Moderate evidential value as part of the original building fabric but poor condition.
