**STRUCTURAL ADVICE IN
RESPECT OF A
PLANNING APPLICATION
FOR CONVERSION OF
THE BARNs TO LIVING
ACCOMMODATION
NEWGATE ESTATE
HIGHDALES
HACKNESS
YO13 0JU**

**PROJECT NO.
MCB/PS/JC/43078 Rpt001**

Date: 22nd October 2019

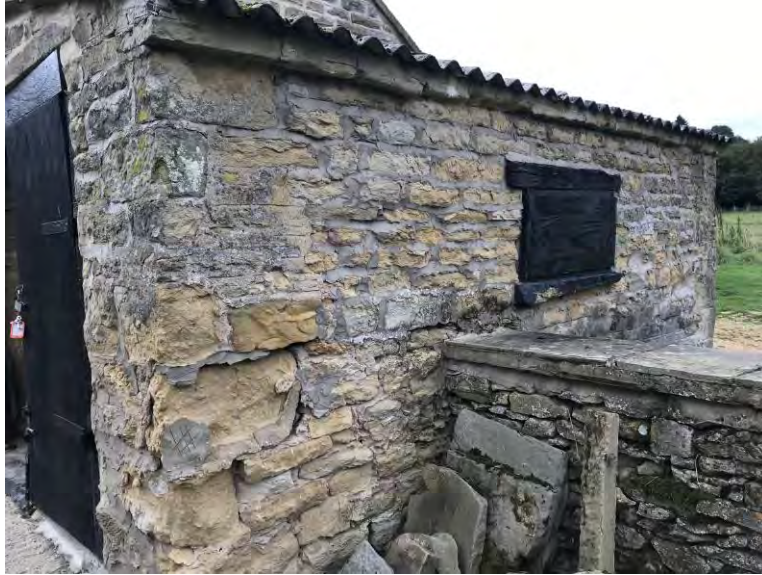
Photograph No. 1

- 3.4 The masonry has suffered erosion and has been poorly pointed in the past. There is possible asbestos sheeting to the roof. (See photo 1)
- 3.5 Drive iron corroded within masonry joint and spalled masonry evident. (See photo 2)

-
- 4.19 The potential asbestos sheeting should be tested accordingly and any recommendations from the specialist should be reviewed and acted upon.
- 4.20 Where cement based pointing has been used, this should be carefully removed and a lime mortar based system should be used.

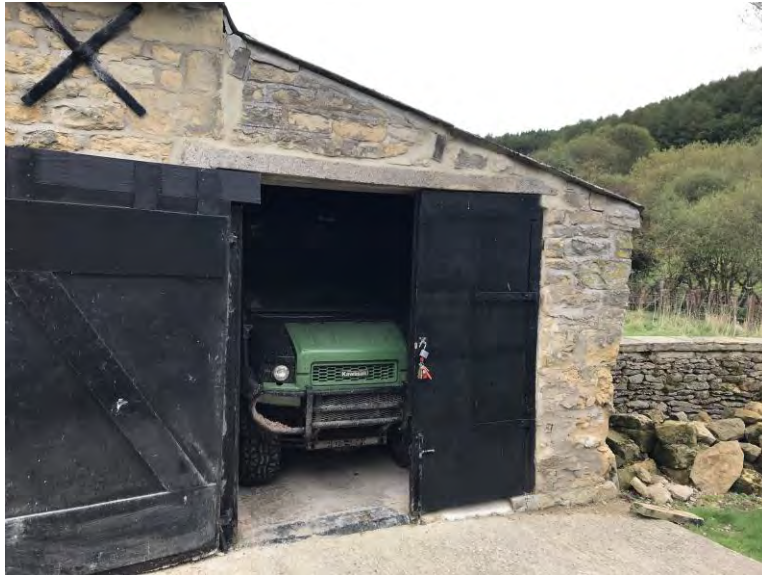
Photograph No. 3

-
- 3.6 The lintel has deflected, there are pointing failures throughout and the flashing is incorrect. (See photo 3)
 - 3.7 The wall is out of plumb and there is evidence of crack repairs and cracking is evident. No positive surface water drainage. (See photo 4)
 - 3.8 Timbers show sign of woodworm and rot. There is poor bonding to the wall and the lintel bearing is of concern. (See photo 5)
 - 3.9 There is cracking to the gable wall of Room B which is evident in a number locations. (See photo 6)

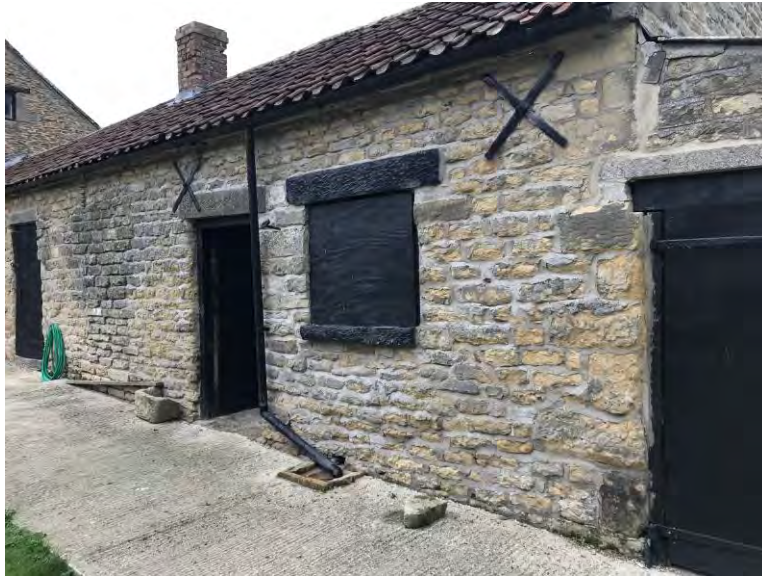
Photograph No. 7

- 3.10 There is poor pointing and minor stone erosion with pattress plates evident. (See photo 7)
- 3.11 There is stone erosion and pointing issues. Existing openings have been infilled and roofing failures are evident. This also is typical for Rooms C and D. (See photo 8)
- 3.12 The chimney brickwork has spalled and the pointing and flashings are damaged. (See photo 9)
- 3.13 The lintels are in poor condition with woodworm and rot visible. Cracking is evident to the walls. (See photo 10)
- 3.14 There is cracking to the gable, fireplace and external wall. Roof spread is evident. (See photos 11 and 12)
- 3.15 Bulging to the wall is evident along with multiple cracks. (See photo 13)
- 3.16 The WC room has been decorated recently possibly covering damage. Mould spores are evident. (See photo 14)
- 3.17 The Bitumen felt roof is showing signs of degradation.

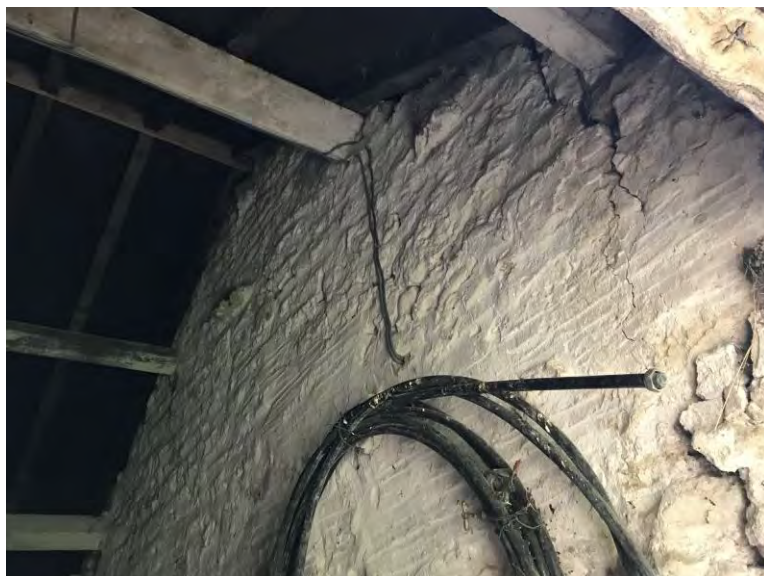
Photograph No. 15

- 3.18 Cracking noted to gable walls. (See photo 15)
- 3.19 Cracking to walls generally. Woodworm and rot are evident to the lintels. (See photo 16)
- 3.20 The Bitumen felt roof is showing signs of degradation.

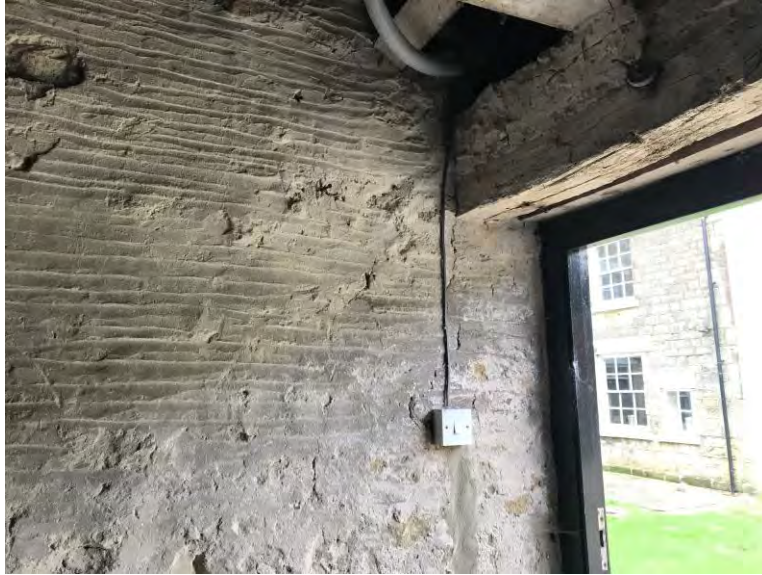
Photograph No. 17

- 3.21 The lintel shows signs of infestation and there is cracking to the wall. (See photo 17)
- 3.22 The kingpost truss is in reasonable condition.
- 3.23 The Bitumen felt roof is showing signs of degradation. (See photo 18)
- 3.24 There is cracking to the wall and roof movement is evident. (See photo 19)
- 3.25 The wall has had previous poor repairs undertaken and the purlins have a distinct 'bow'. (See photo 20)
- 3.26 Cracking is evident to the existing gable but note previous 'repair'. Pointing and mortar joint washout is evident. (See photos 21 and 22)

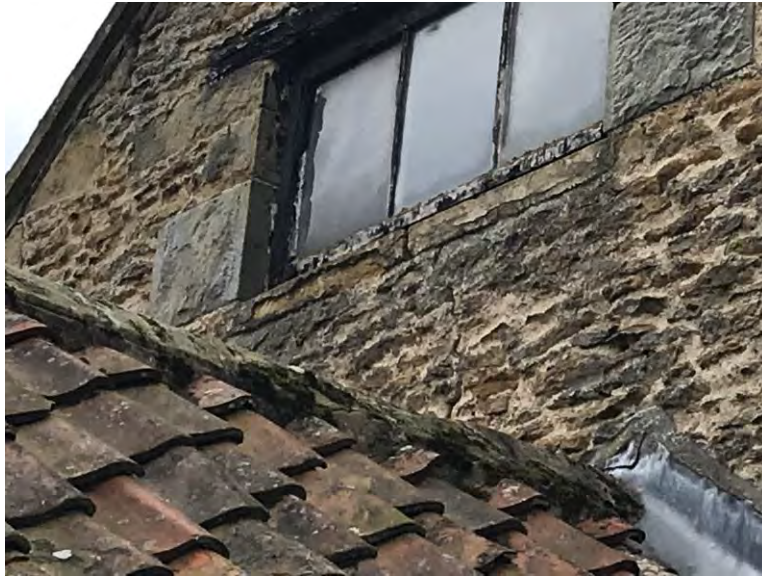
Photograph No. 23

- 3.27 There is a crack evident to the gable, note also masonry erosion. (Lintel and cill issues evident). (See photo 23)
- 3.28 There is masonry and pointing erosion along with masonry spalling and cracking generally evident. (See photo 24)
- 3.29 There is lintel failure to the window. (See photo 25)
- 3.30 Cracking of masonry joints typical to this elevation. (See photo 26)

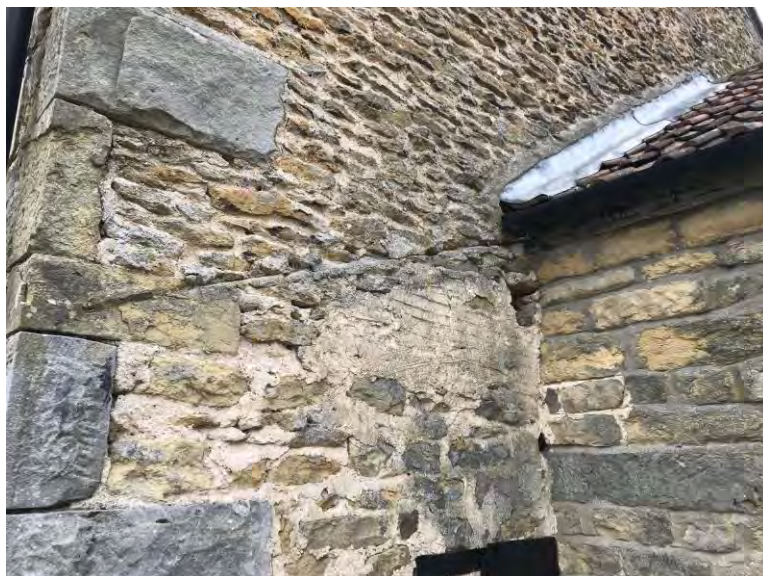
Photograph No. 29

-
- 3.31 Further typical cracking is noted near the doors. (See photos 27 and 28)
 - 3.32 Pointing and render repairs are evident though spalling and cracking are still evident to the top side wall and gable. Previous lean-to roof noted. (See photo 29)
 - 3.33 The internal aspects to the ground floor have been recently refurbished. (See photo 30)
 - 3.34 The floor edge to the first floor is not supported or tied to the external wall. (See photo 31)
 - 3.35 First floor floor joists have been excessively notched. (See photo 32)
 - 3.36 Walls are typically cracked but have received some minor 'repairs'. (See photos 33 and 34)
 - 3.37 The trusses are in good order but some infestation is noted. Note gap around the floor. (See photo 35)
 - 3.38 The truss bearing location is poor and a crack is evident. (See photo 36)
 - 3.39 The Bitumen type felt to the roof shows signs of degradation.

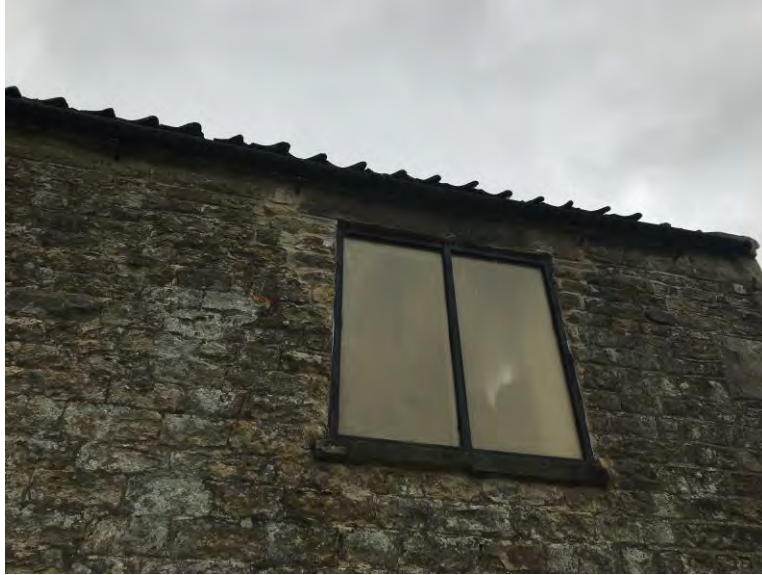
Photograph No. 37

- 3.40 The lintel to the first floor has been replaced recently. (See photo 37)
- 3.41 There is stone failure to the water table. (See photo 38)
- 3.42 The gable has been partially repointed and the door has been replaced recently. (See photo 38)
- 3.43 The timber lintel has shrunk and there is multiple cracking evident to the gable. (See photo 39)
- 3.44 The pointing has eroded or is missing and there is cracking evident. This is typical throughout. (See photo 40)

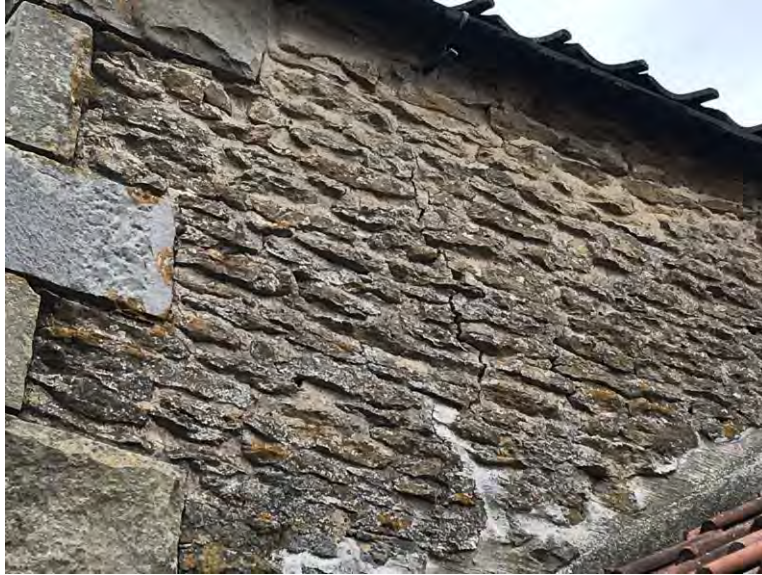
Photograph No. 41

-
- 3.45 Mortar fillet flashing has been used and there is a crack to the wall. (See photo 41)
- 3.46 There is cracking to the lintel jamb. (See photo 42)

- 4.15 Mortar based flashings have typically been undertaken with cement based mortar, these should be carefully replaced with lead flashings.
- 4.16 Window and door frames need to be sealed accordingly to prevent ingress.

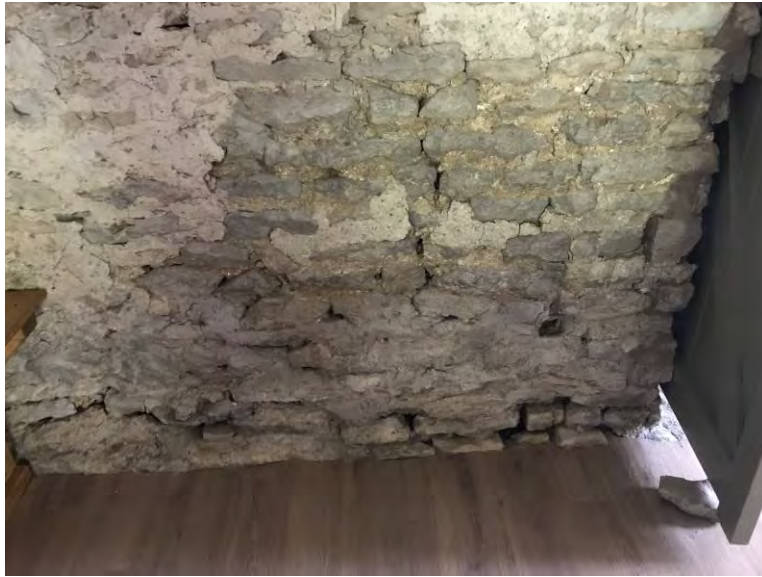
Photograph No. 43

- 3.47 Internally the ground floor has been refurbished although the walls have been left un-pointed and with poor mortar joints. (See photos 43 and 44)

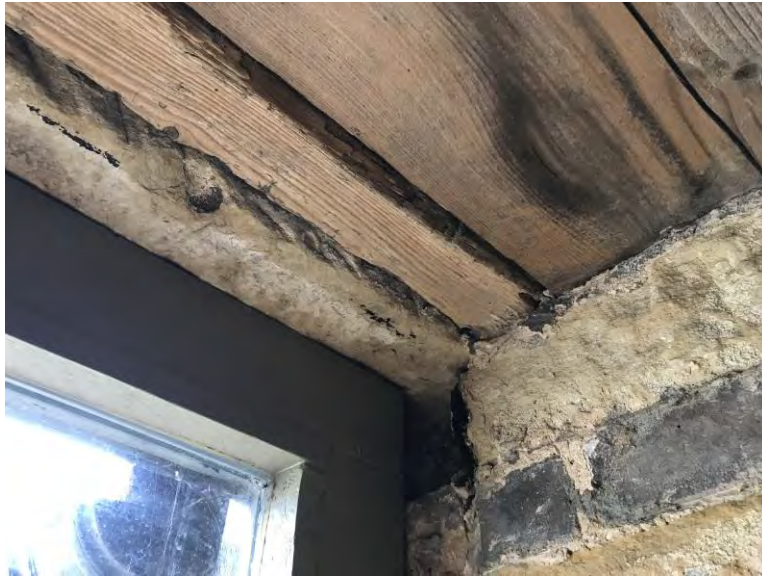
Photograph No. 45

- 3.48 The window frame has not been sealed in fully. Rot and infestation are noted to the lintels. The flooring is 'floating' and there is a membrane present. (See photo 45)

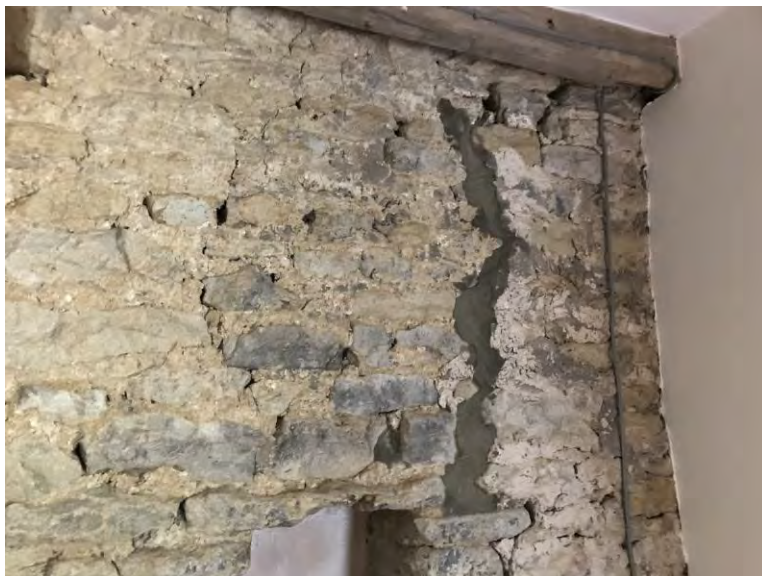
Photograph No. 46

- 3.49 Previous poorly repaired cracks and other minor cracks are evident. (See photo 46)
- 3.50 The redundant window cill shows signs of infestation and rot. Mould is also noted to the furniture. There is a crack to the wall. (See photo 47)

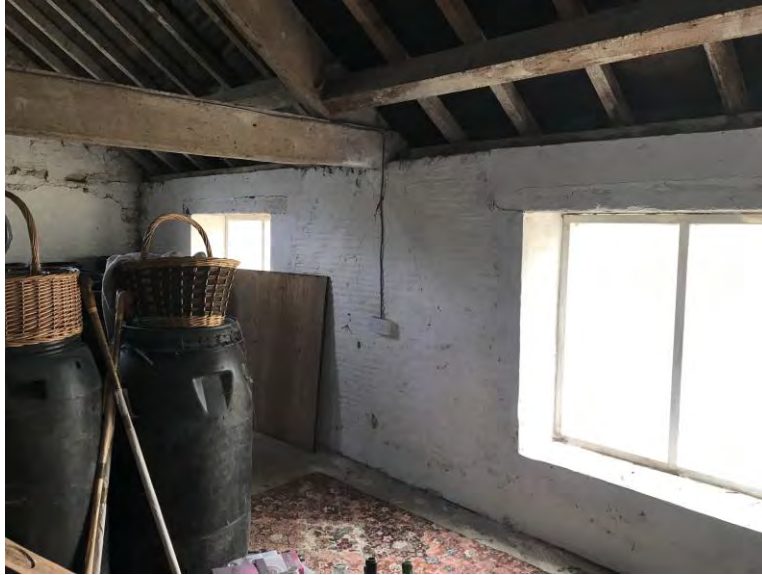
Photograph No. 49

- 3.51 The trusses appear to be in good order but the Bitumen felt is showing signs of degradation. (See photo 48)
- 3.52 The walls are lime rendered but cracking is noted over the windows. Timber infestation is noted generally. (See photos 49, 50 and 51)

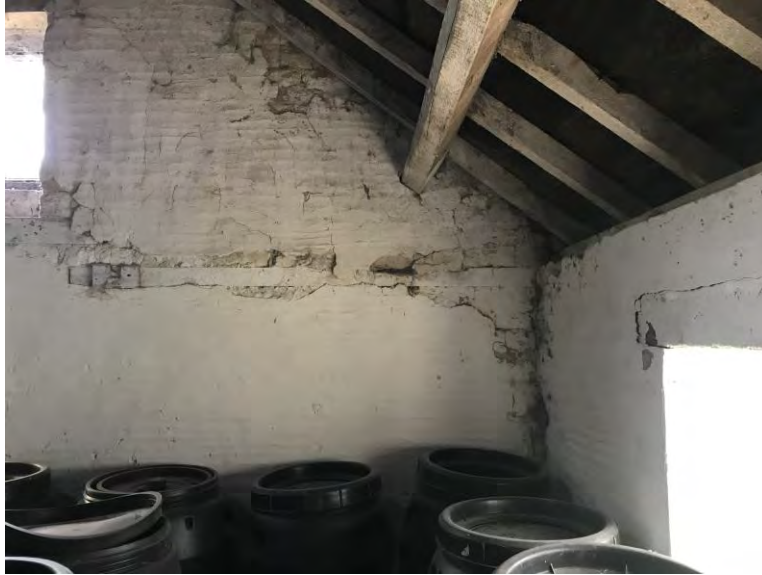
Photograph No. 53

- 3.53 Truss bearing failure is noted. (See photo 52)
- 3.54 Cracking to the render and wall are evident to the north gable, with a possible lack of restraint. (See photo 53)

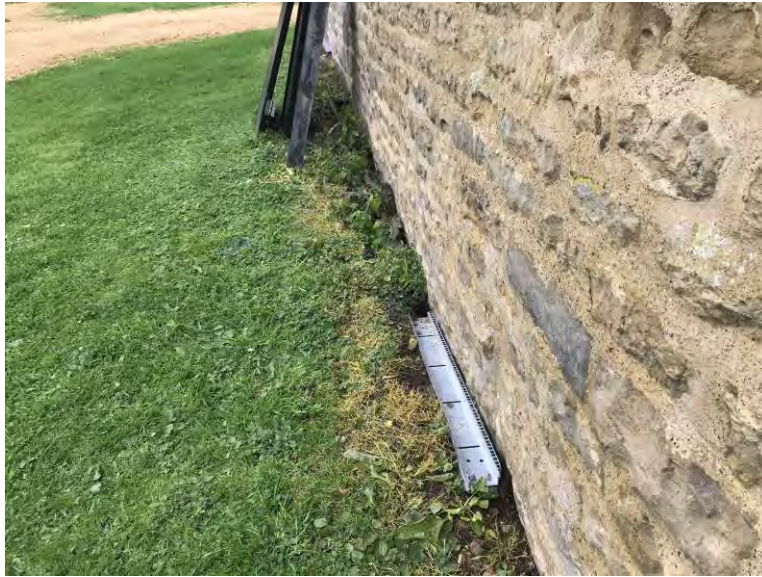
Photograph No. 55

- 3.55 Recent roof works and pointing are evident to rooms I and J. (See photo 54)
- 3.56 Erosion is noted at the base of the wall. (See photo 55)
- 3.57 The wall appears to have been re-built along with re-roofing. (See photo 56)
- 3.58 There is cracking at the lintel jamb. (See photo 57)

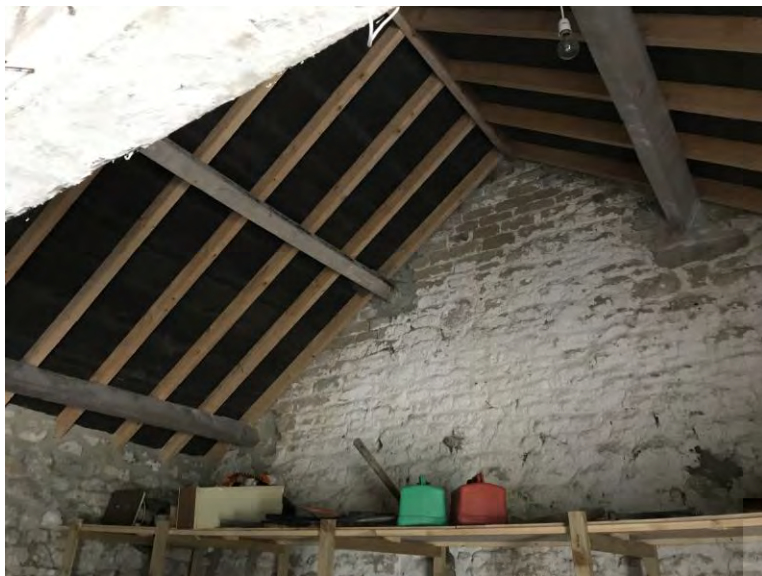
Photograph No. 58

-
- 3.59 The room has been repointed internally locally. Note purlin sag. (See photo 58)
- 3.60 The wall has been rebuilt up to the underside of the felt. Note previous crack repair at purlin to the wall. (See photo 59)
- 3.61 The truss bearing has been rebuilt but a new crack is evident. (See photo 60)
- 3.62 The walls are typically repointed/rebuilt locally but cracking and mortar wash-out is evident. (See photo 61)
- 3.63 Cracking to western gable noted. (See photo 62)
- 3.64 Timber infestation and rot noted. Localised masonry has been rebuilt. (See photo 63)
- 3.65 Cracking is noted to the new wall at truss bearing. (See photo 64)
- 3.66 The Bitumen type felt which is laid on new rafters is showing signs of degradation.

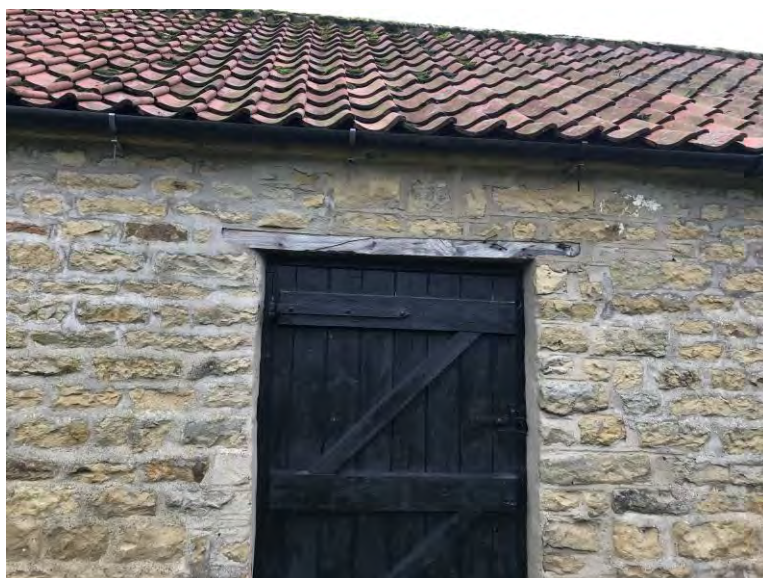
Photograph No. 65

- 3.67 The pointing is poorly executed typically.
- 3.68 The lintel has bowed and shrunk. (See photo 65)
- 3.69 The wall appears to have been rebuilt along with reroofing. (See photo 66)
- 3.70 There is cracking at the lintel jamb. (See photo 67)
- 3.71 Existing trusses are generally in reasonable condition. The rafters and purlins typically have been replaced. (See photo 68)
- 3.72 The main truss shows signs of minor damp and infestation. (See photo 69)
- 3.73 There is cracking near to the lintel to the rebuilt wall. (See photo 70)

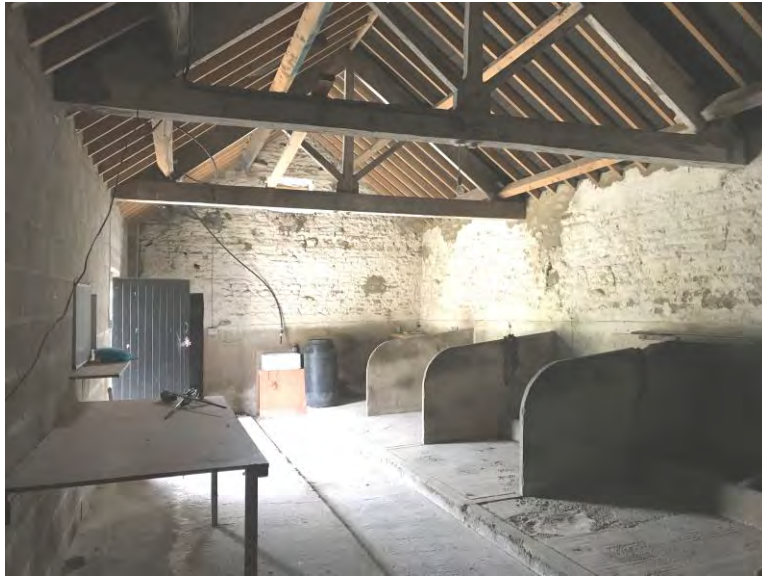
Photograph No. 71

-
- 3.74 Cracking is evident to the walls and the masonry has been rebuilt locally up to the felt. (See photo 71)
- 3.75 The Bitumen felt is showing signs of degradation.
- 3.76 The truss bears onto the opening and there is cracking evident. (See photo 72)
- 3.77 Cracking is noted to the concrete floor. (See photo 73)
- 3.78 There is typical cracking to the byre, through render and to the wall. (See photo 74)
- 3.79 The gable walls have cracks evident, emanating from the purlin positions. (See photo 75)

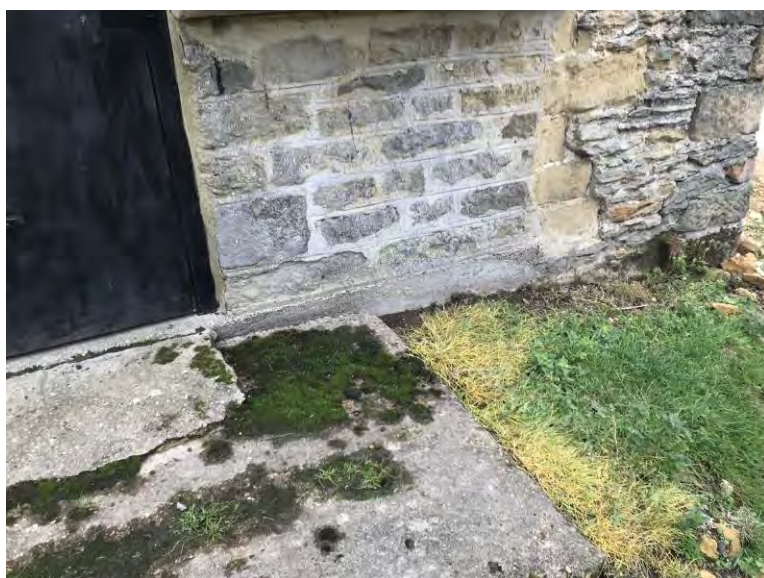
Photograph No. 76

- 3.80 The pointing is poorly executed. Some areas have been rebuilt. Note exposed concrete slab and eroded masonry. (See photo 76)
- 3.81 There is oil staining evident to the floor. (See photo 77)
- 3.82 Cracking to the walls is evident. (See photos 78 and 79)
- 3.83 The generator exhaust is not terminating properly. (See photo 80)
- 3.84 The water table flashing is not long enough. There is pointing missing and the masonry is cracked and eroded. (See photo 81)
- 3.85 Cracking to the wall is evident to the gable. (See photo 82)
- 3.86 There is a straight joint crack between the two buildings. (See photo 83)
