Outbuildings at Egton Manor,  
Barnard Road  
Egton Bridge  
North Yorkshire

Historic Building Recording Level II

Report No. Y440/19

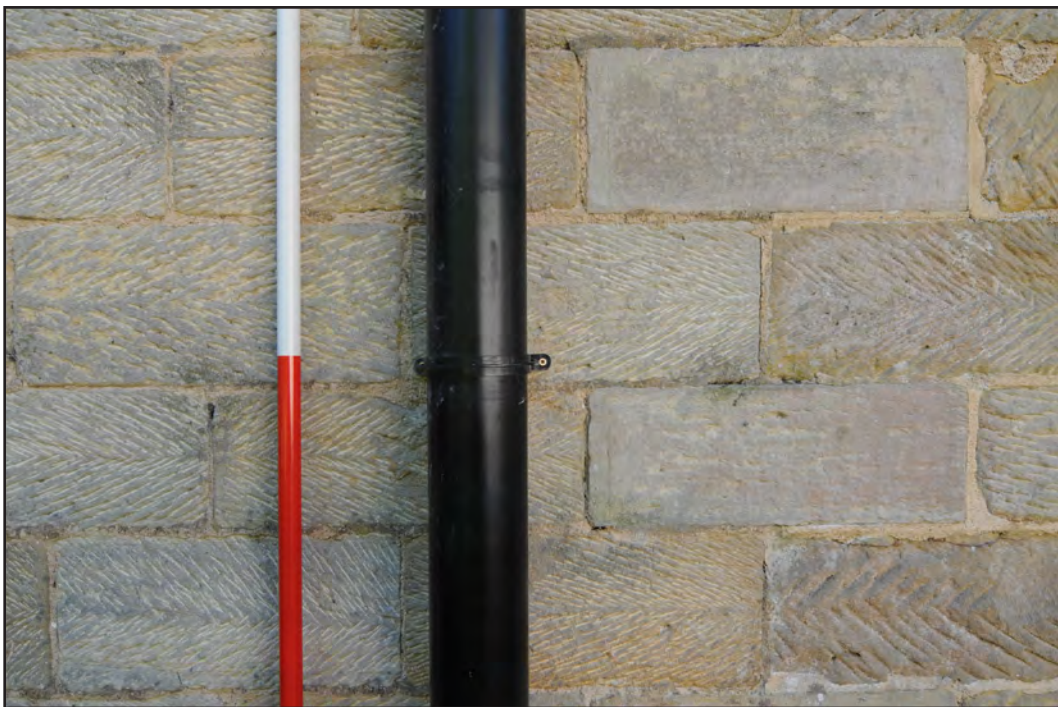
Photograph: 16

Description: Detail showing the change in stone work in the north elevation of the former stable block

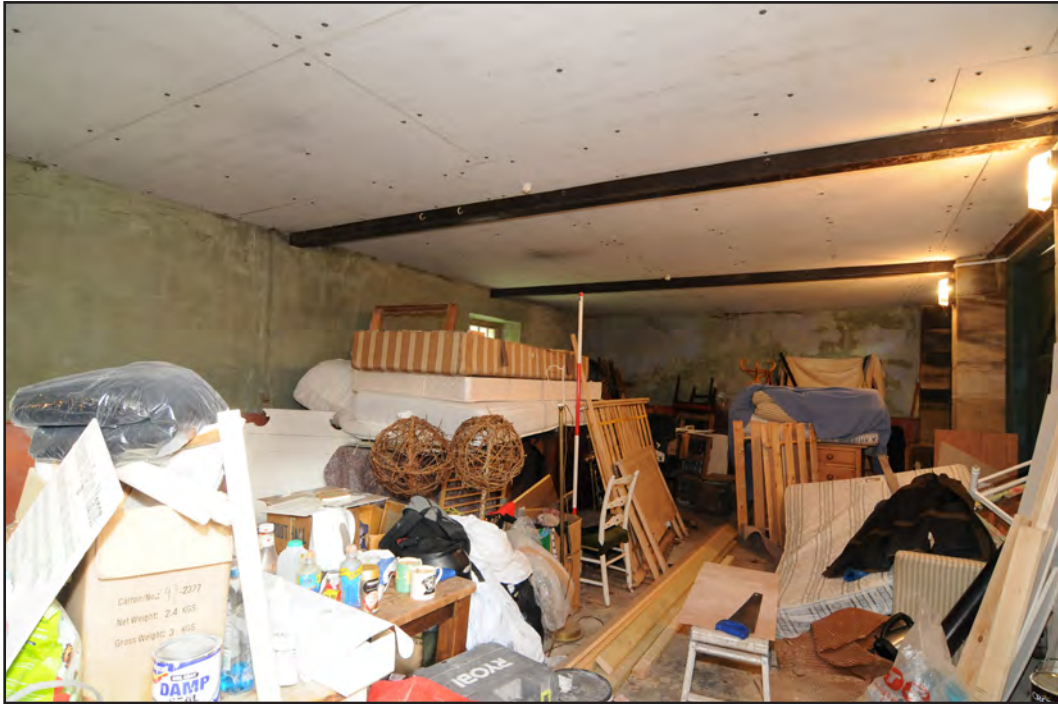
Photograph: 21  
Digital Reference: EMBR\_068  
Description: View inside the garage showing modern plasterboard on the ceiling  
Direction: E

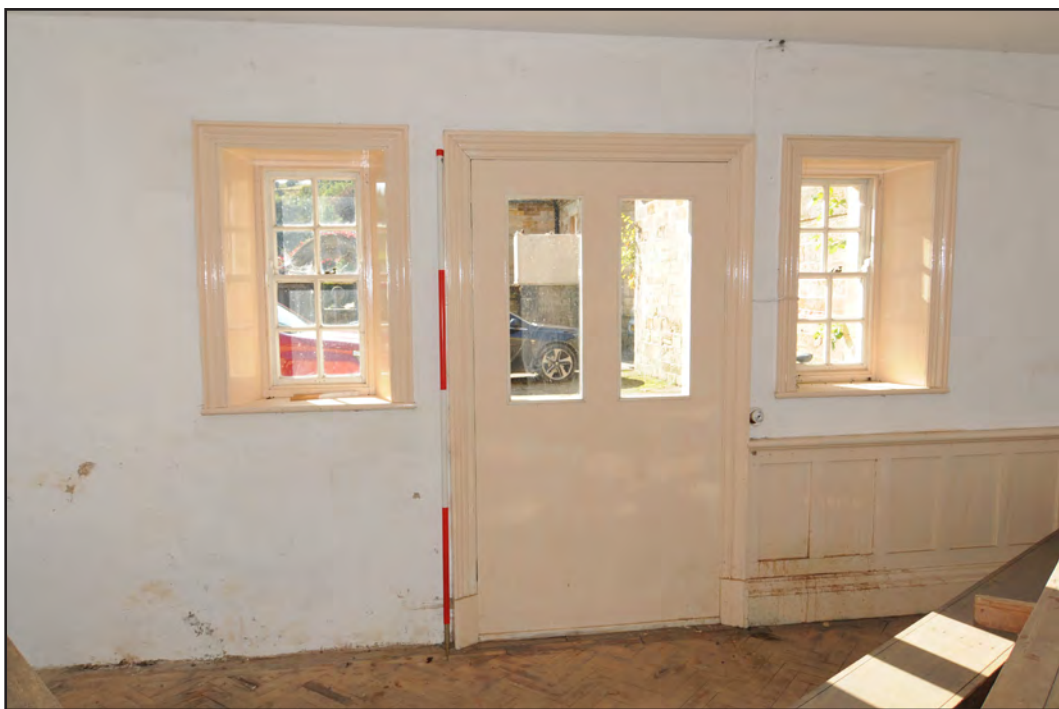
Photograph: 26

wooden panelling below the dado rail (Photograph 25), but this is missing to the east side of the entrance door in the south wall (Photograph 26) some of the panelling has also been reused to create a storage area to the north of the fireplace.

Description: Keepers shoot room door and windows in the south wall with missing panelling to the east

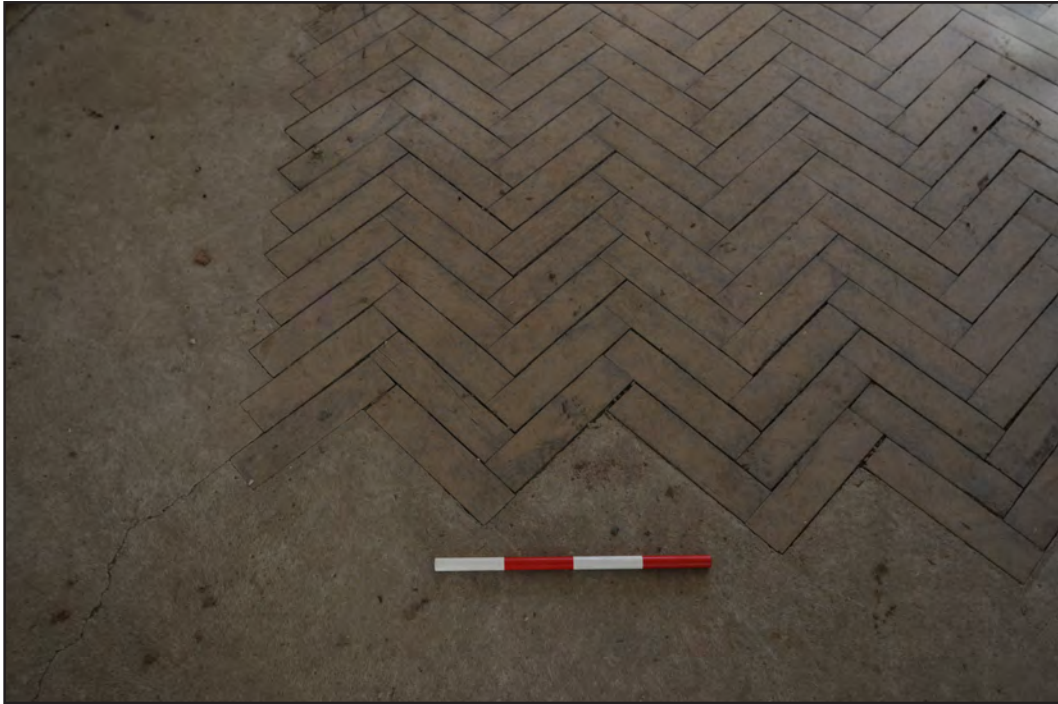
Photograph: 27  
Digital Reference: EMBR\_010  
Description: Remains of the parquet floor surface in the Keepers shoot room  
Direction: S

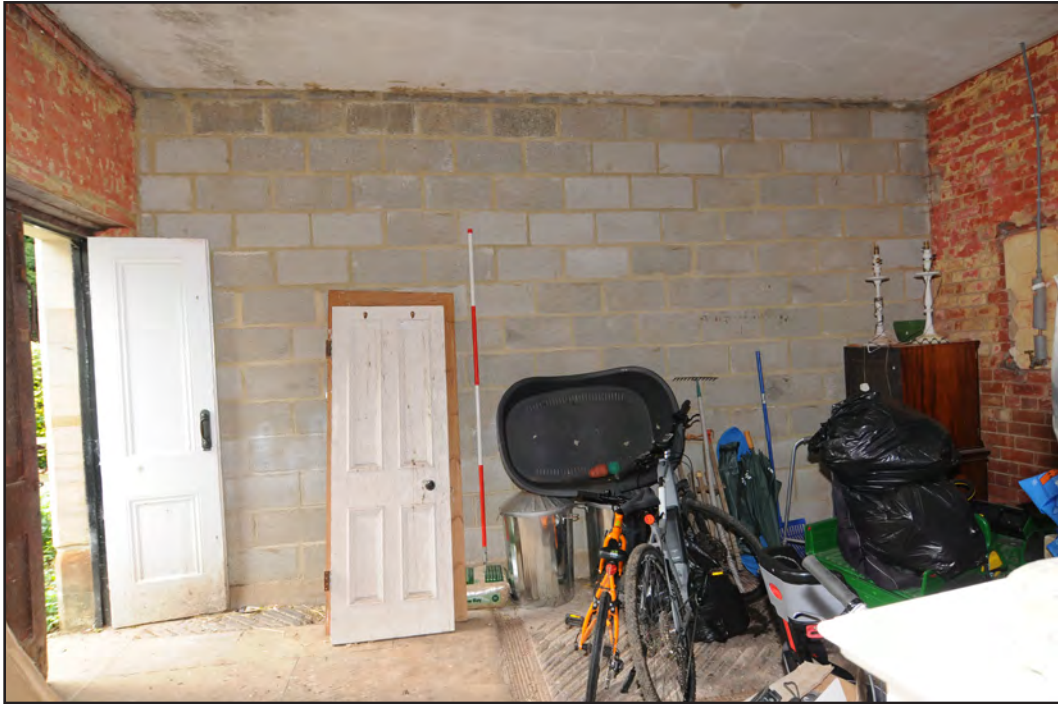
Photograph: 37

Description: Modern breeze block wall separating the stables from the game larder

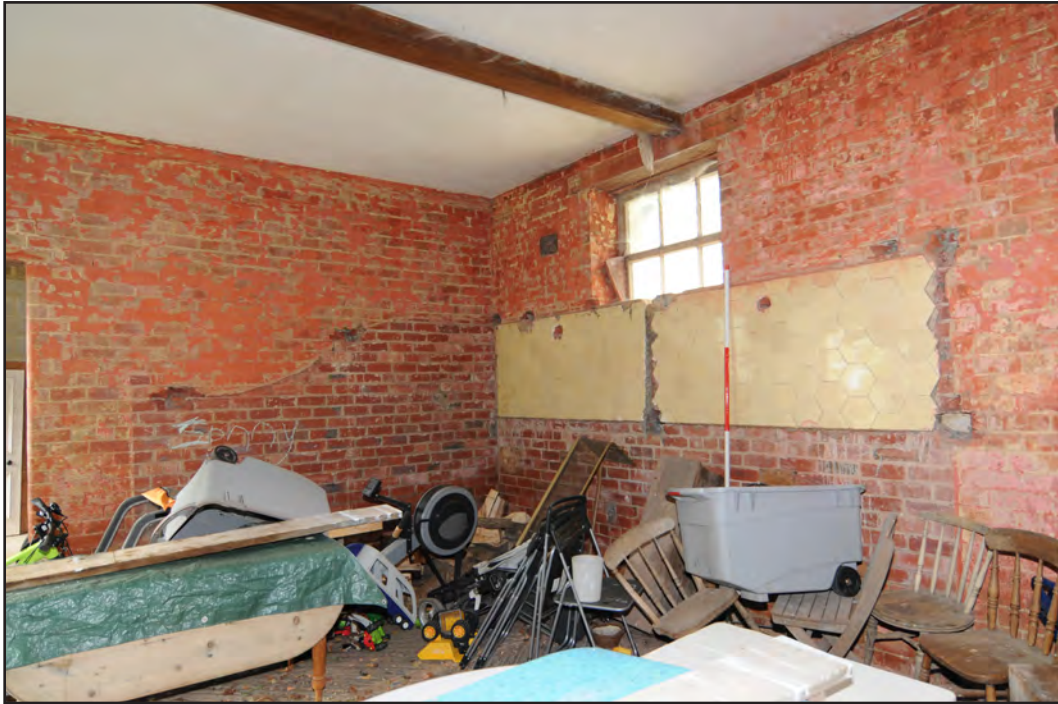
Photograph: 39

Description: Tiled wall surfaces and scarring showing the shape of the stall dividers
