## **Proposed Sustainable re-development at Meadowcroft, Raw, Whitby, YO22 4PP.**

**Meadow Croft  
Dark Lane  
Raw, Robin Hoods Bay  
Whitby  
YO22 4PP**

**Meadowcroft, Raw**  
**Bat and Bird Survey Report**  
**16<sup>th</sup> December 2020**

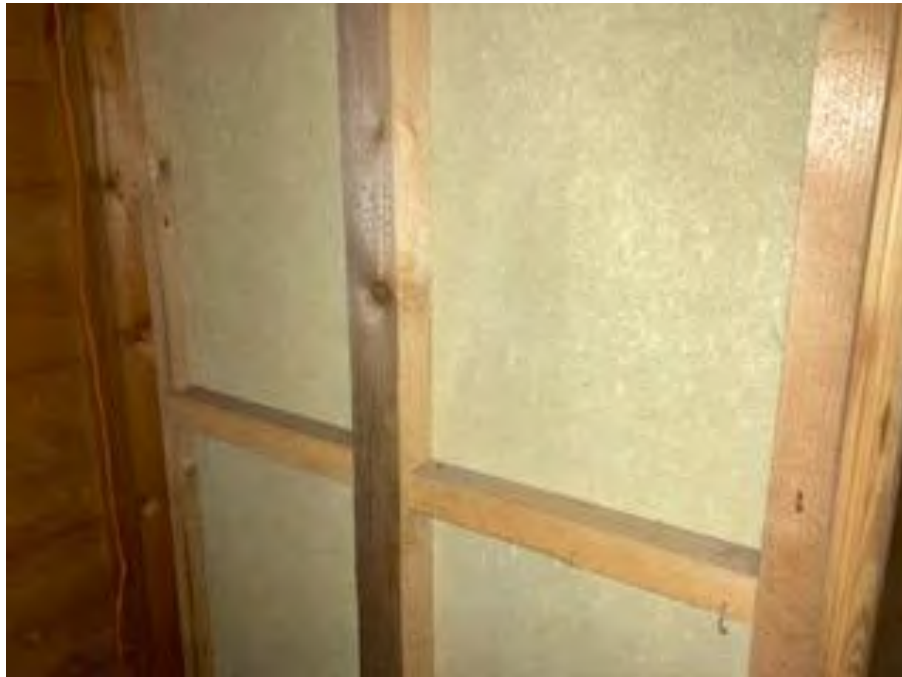
<b>Building:</b>	Main
<b>Floor:</b>	First Floor
<b>Room:</b>	Landing cupboard
<b>Insp. Ref:</b>	MC/1
<b>Sample No:</b>	01

**Item:** composite cement board

<b>Product Type:</b>	Asbestos cement
<b>Extent of Damage:</b>	Good Condition
<b>Surface Treatment:</b>	Asbestos cement
<b>Asbestos Type:</b>	Chrysotile

<b>RECOMMENDATION:</b>	<b>Remove</b>
------------------------	---------------

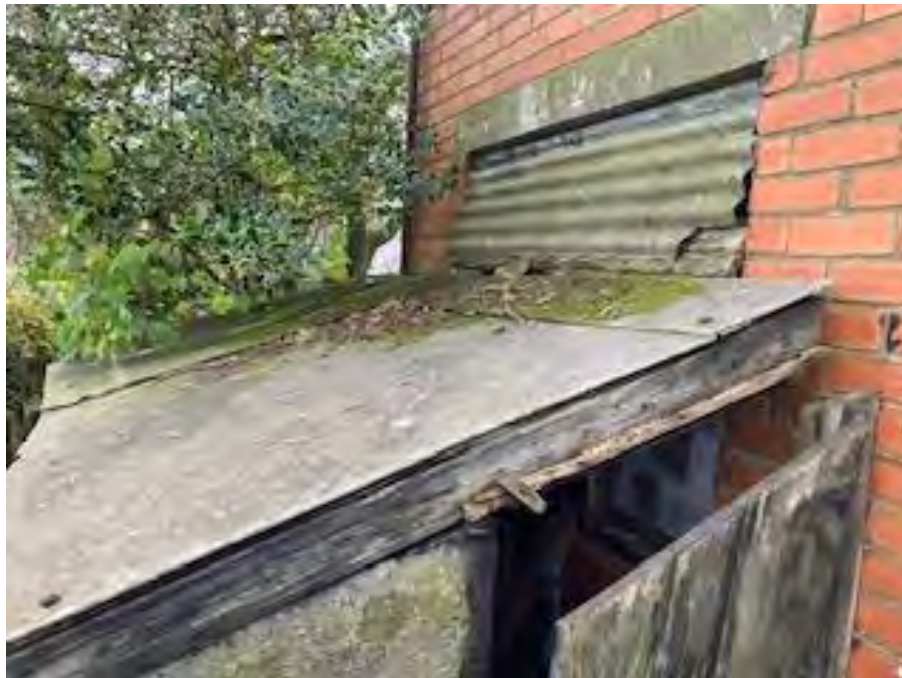
<b>Building:</b>	Workshop
<b>Floor:</b>	Ground Floor
<b>Room:</b>	N/A
<b>Insp. Ref:</b>	MC/2
<b>Sample No:</b>	02

Item: Cement sheet

<b>Product Type:</b>	Asbestos cement		
<b>Extent of Damage:</b>	Medium Damage		
<b>Surface Treatment:</b>	Asbestos cement		
<b>Asbestos Type:</b>	Chrysotile		
<b>Extent / Amount:</b>	4 m <sup>2</sup> approx.	<b>Asbestos Present:</b>	<b>Yes</b>
<b>Accessibility:</b>	Occasional disturbance		
<b>RECOMMENDATION:</b>	Remove

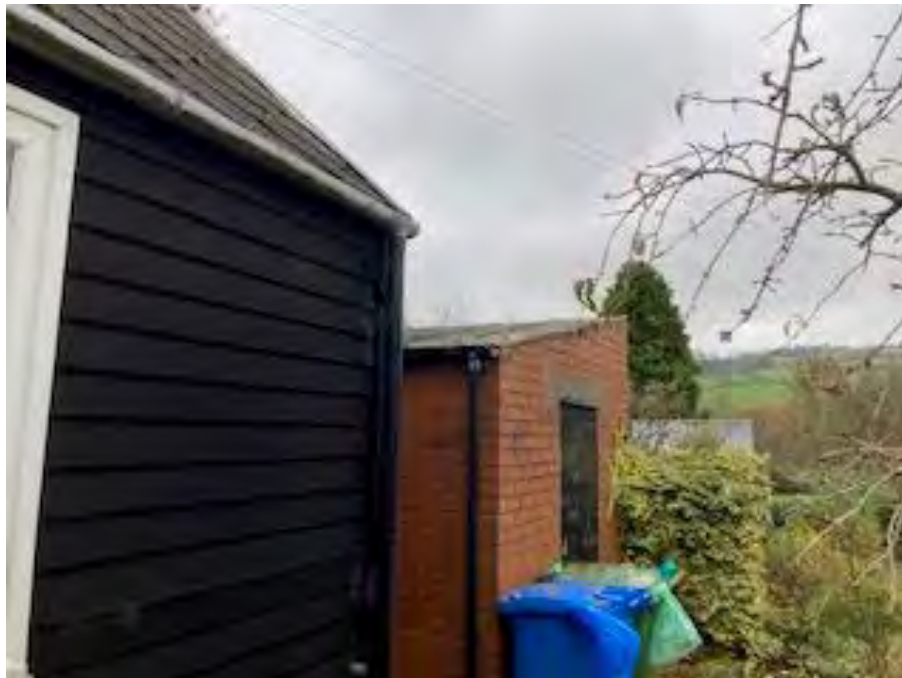
<b>Building:</b>	Workshop
<b>Floor:</b>	External
<b>Room:</b>	N/A
<b>Insp. Ref:</b>	MC/3
<b>Sample No:</b>	03

Item: Cement Roofing Sheet

<b>Product Type:</b>	Asbestos cement		
<b>Extent of Damage:</b>	Low Damage		
<b>Surface Treatment:</b>	Asbestos cement		
<b>Asbestos Type:</b>	Chrysotile		
<b>Extent / Amount:</b>	30 m <sup>2</sup> approx.	<b>Asbestos Present:</b>	Yes
<b>Accessibility:</b>	Occasional disturbance		
<b>RECOMMENDATION:</b>	Remove

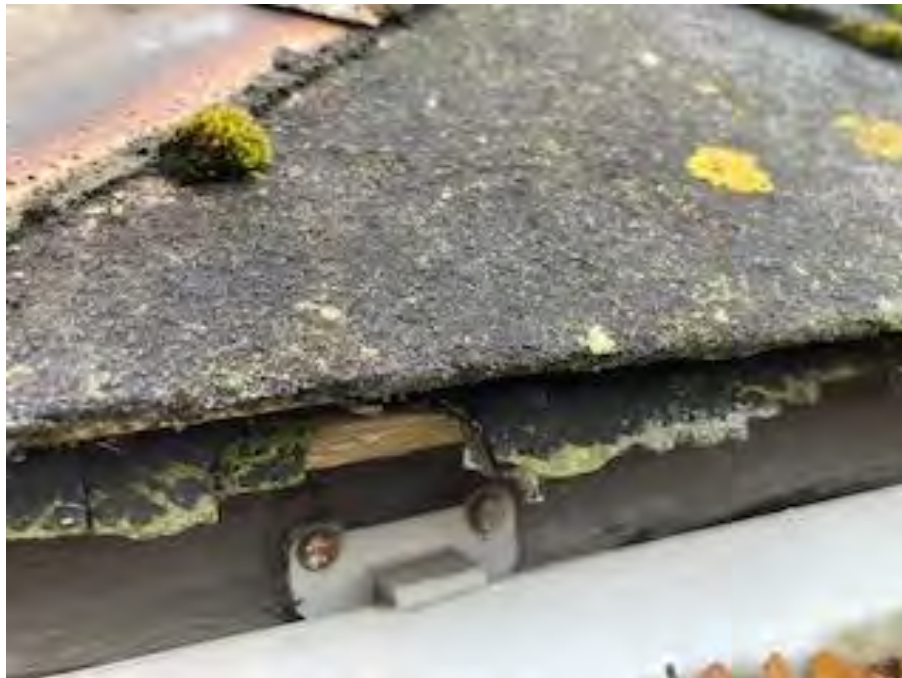
<b>Building:</b>	Main
<b>Floor:</b>	External
<b>Room:</b>	N/A
<b>Insp. Ref:</b>	MC/4
<b>Sample No:</b>	04

Item: Roof felt

<b>Product Type:</b>	
<b>Extent of Damage:</b>	
<b>Surface Treatment:</b>	
<b>Asbestos Type:</b>	No asbestos detected

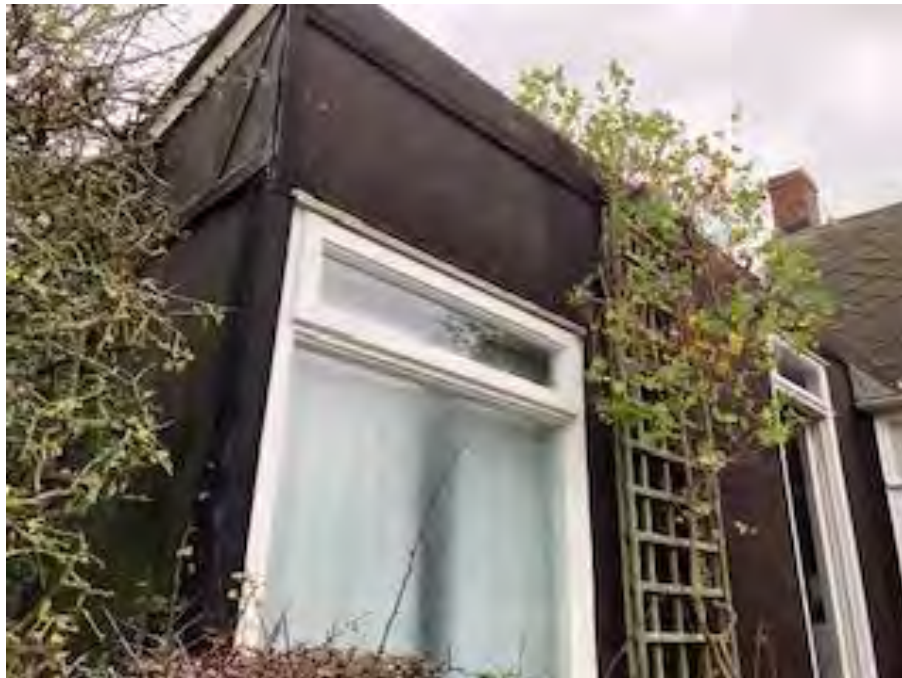
<b>Building:</b>	Main
<b>Floor:</b>	External
<b>Room:</b>	N/A
<b>Insp. Ref:</b>	MC/5
<b>Sample No:</b>	05

Item: Cement sheet

<b>Product Type:</b>	Asbestos cement		
<b>Extent of Damage:</b>	Low Damage		
<b>Surface Treatment:</b>	Asbestos cement		
<b>Asbestos Type:</b>	Chrysotile		
<b>Extent / Amount:</b>	140 m <sup>2</sup> approx.	<b>Asbestos Present:</b>	<b>Yes</b>
<b>Accessibility:</b>	Occasional disturbance		
<b>RECOMMENDATION:</b>	Remove

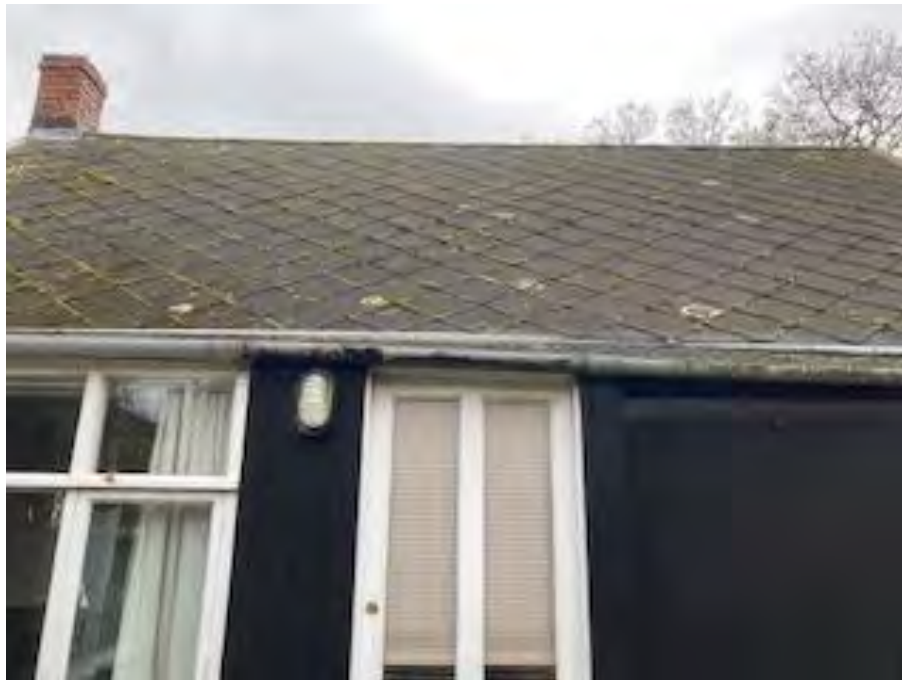
<b>Building:</b>	Main
<b>Floor:</b>	External
<b>Room:</b>	N/A
<b>Insp. Ref:</b>	MC/6
<b>Sample No:</b>	06

Item: Cement Tile

<b>Product Type:</b>	Asbestos cement		
<b>Extent of Damage:</b>	Low Damage		
<b>Surface Treatment:</b>	Asbestos cement		
<b>Asbestos Type:</b>	Chrysotile		
<b>Extent / Amount:</b>	100 m <sup>2</sup> approx.	<b>Asbestos Present:</b>	<b>Yes</b>
<b>Accessibility:</b>	Occasional disturbance		
<b>RECOMMENDATION:</b>	<b>Remove</b>

<b>Recommendation:</b>	Remove				
Main	External	N/A	Cement Tile : Asbestos cement	Chrysotile	4 (D) 7 (D)
<b>Inspection Ref:</b>	MC/6	<b>Sample:</b> 06	<b>Amount:</b> 100 m <sup>2</sup> approx.	<b>Reinspect by:</b>	Nov 2021
<b>Recommendation:</b>	Remove

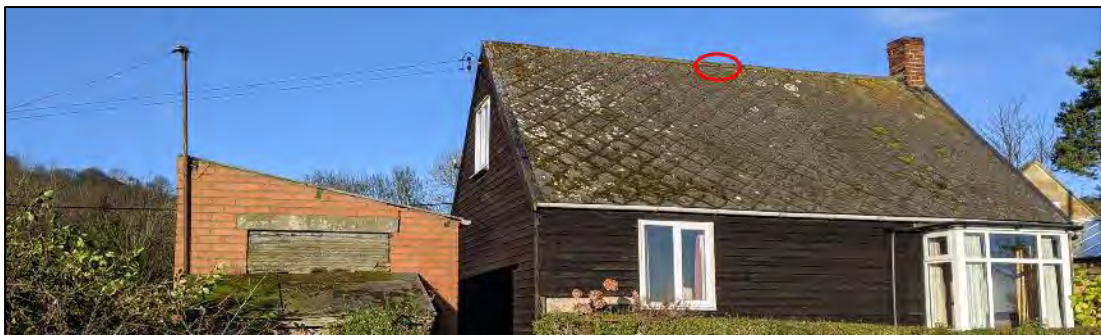
- 5.2.9 Building 1 was considered to offer a low-moderate level of bat roost potential with this potential almost exclusively limited to space beneath the ridge tiles.

**Plate 1. Southeast elevation of B1 (main dwelling), with B2 (brick outbuilding) on left. The identified bat roost location is circled in red**

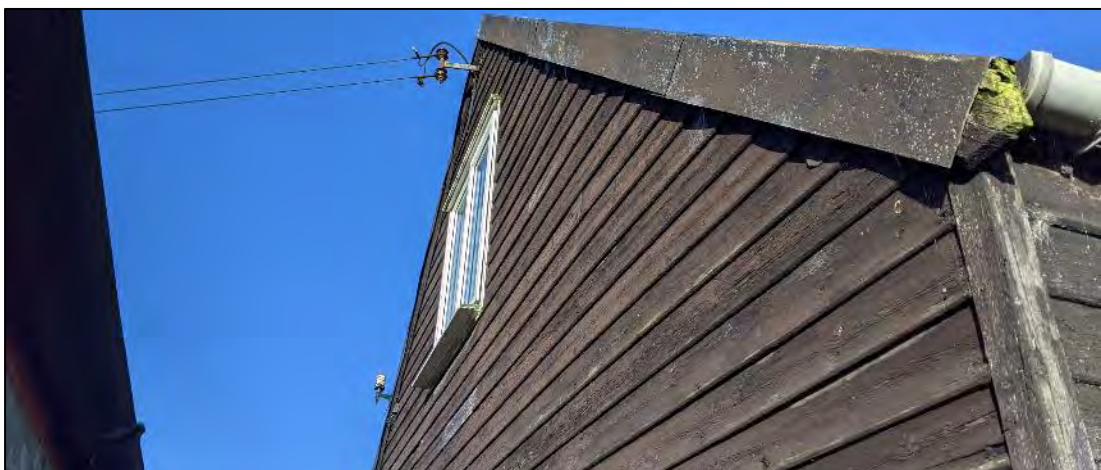
- 5.2.6 Externally the building is in quite a good state of repair with no more than superficial crevices between timber cladding panels (Plate 2), with the exception of a missing section of timber cladding low down on the wall of the southeast elevation, which was

**Plate 2. Tightly fitting cladding on southeast gable**

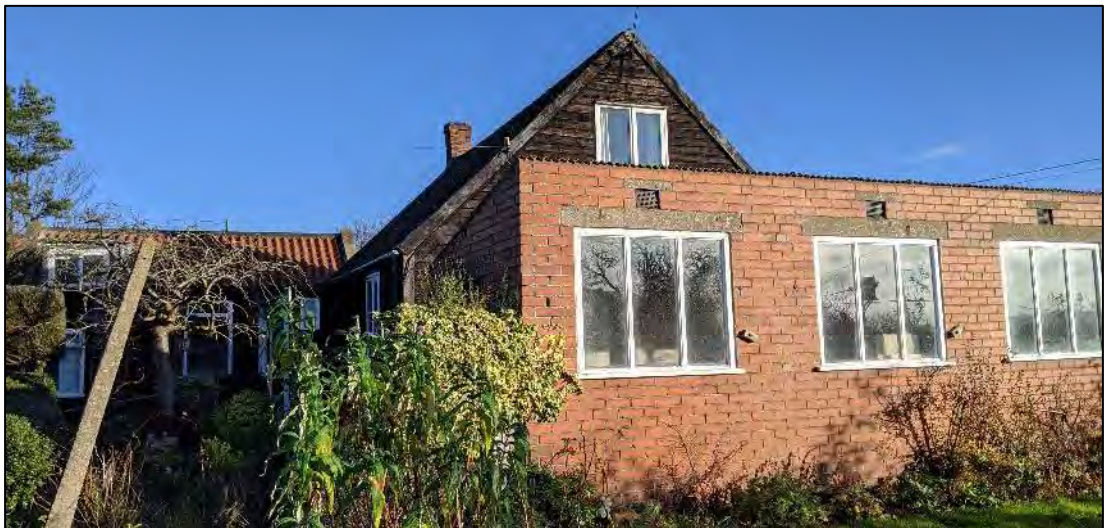
- 5.2.10 Building 2 comprises a single-storey brick outbuilding with a sloping corrugated asbestos cement sheet roof. This building has single paned wood framed windows in its southwest elevation with metal ventilation panels above.
- 5.2.11 No features offering greater than negligible bat roost potential were recorded from the exterior of this building.
- 5.2.12 Internally the roof of B2 is open to the underside of the corrugated panels and it is suspended on simple wood beams. The walls are whitewashed. No signs of bat presence were recorded from B2 and the building was considered to offer negligible bat roost potential.

**Plate 6. Southwest elevation of B2**

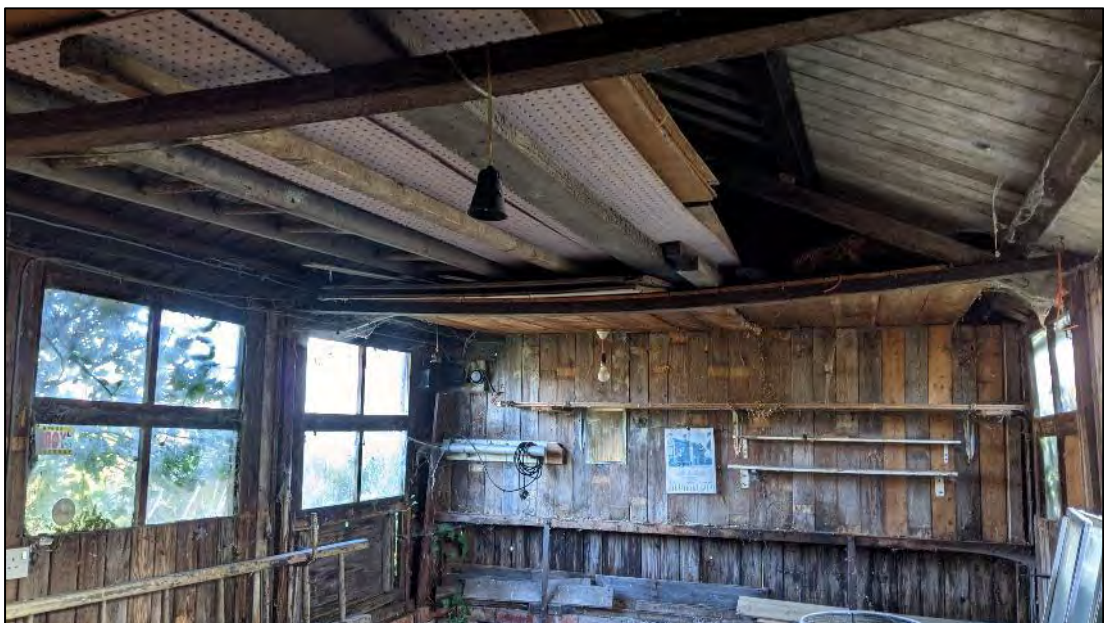
5.2.15 Internally B3 is open to the underside of the roof sheeting and wall cladding. No evidence of bats was recorded from this building and the building was considered to offer negligible bat roost potential.

**Plate 9. Interior of B3**

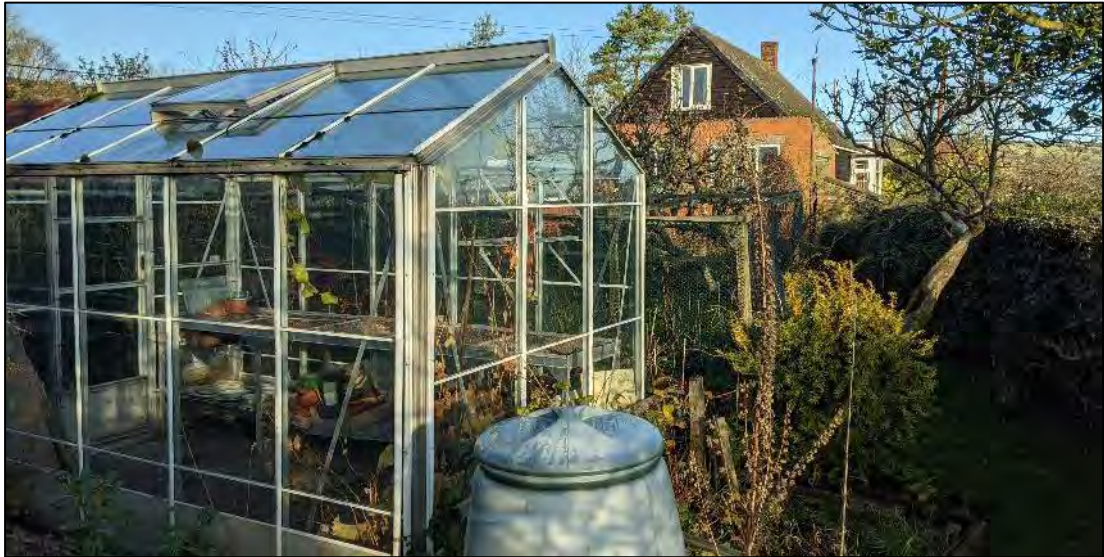
- 5.2.16 Building 4 comprises a metal framed and glazed greenhouse which is unsuitable for use by roosting bats.

**Plate 10. Building 4 (greenhouse)**

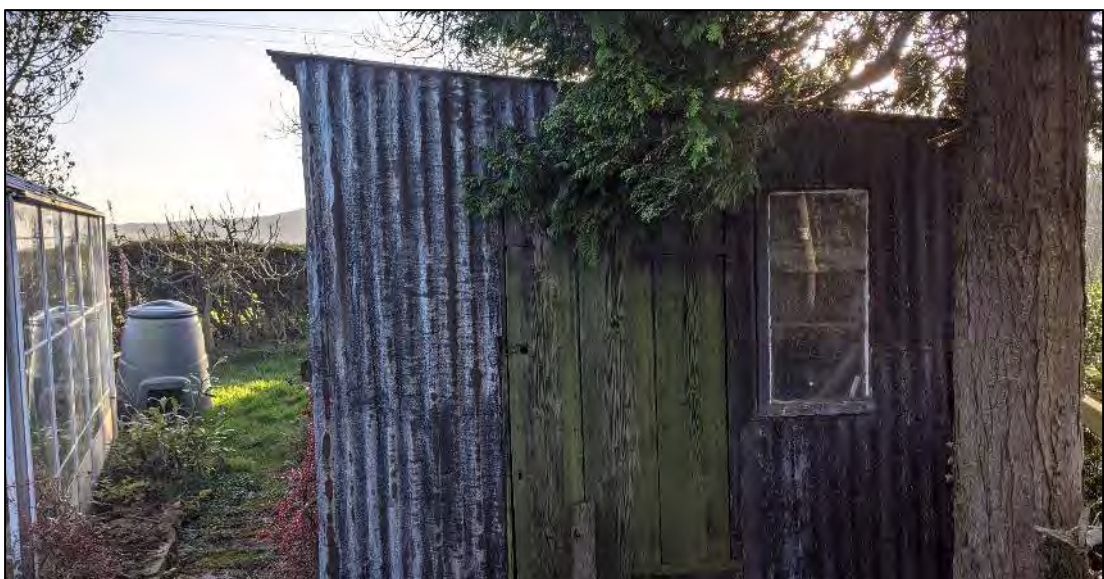
- 5.2.17 Building 5 comprises a single storey and single skin timber framed shed with the walls and the mono pitched roof clad in corrugated galvanised steel sheets. Single-paned wood-framed windows are present (Plate 11).
- 5.2.18 Internally the roof and walls are unlined, and no evidence of bats was recorded. This building was considered to offer negligible bat roost potential.

**Plate 11. Northwest elevation of B5**

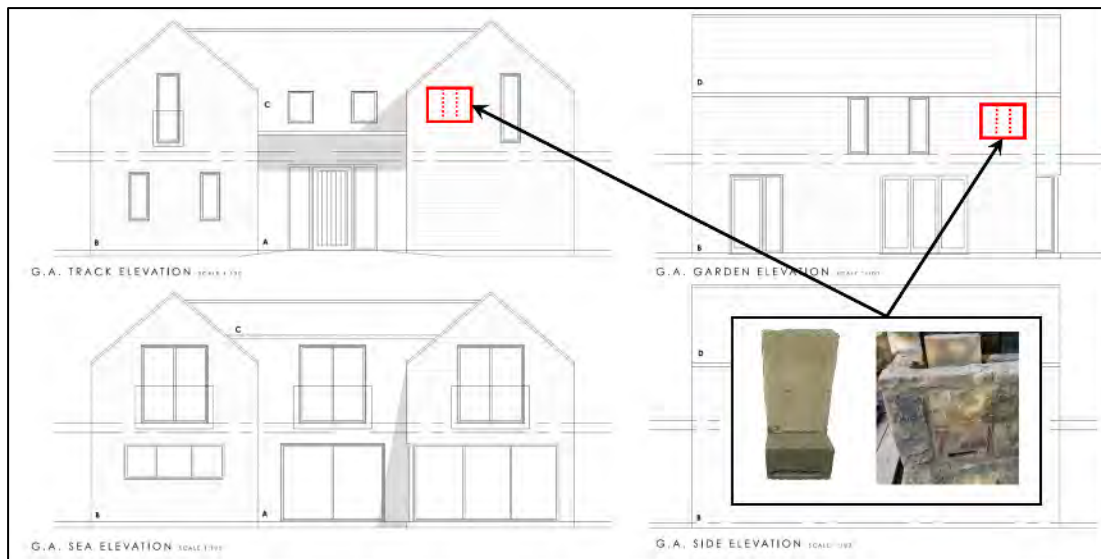
**Figure 3. Proposed compensatory roost provision plan**

- 6.3.2 The worst-case scenario in relation to roosting bats is considered to comprise the presence of a maternity roost of crevice dwellings bats. It is however considered probable that roost use is limited to day roosting by a species of pipistrelle bats beneath the ridge tiles.
- 6.3.3 It is possible to mitigate for the worst-case scenario through the provision of large crevice roosting features within the exterior of the new dwelling. Such provision could comprise two connected sets of three integrated bat boxes, with one on the southwest elevation and one on the northwest elevation (Figure 3) of the new dwelling. These boxes to be installed at wall top height and away from any external lighting.
