**Archaeological Standing Building  
Recording**

**Lodge Hill Farm**

**Egton Grange**

**July 2021**

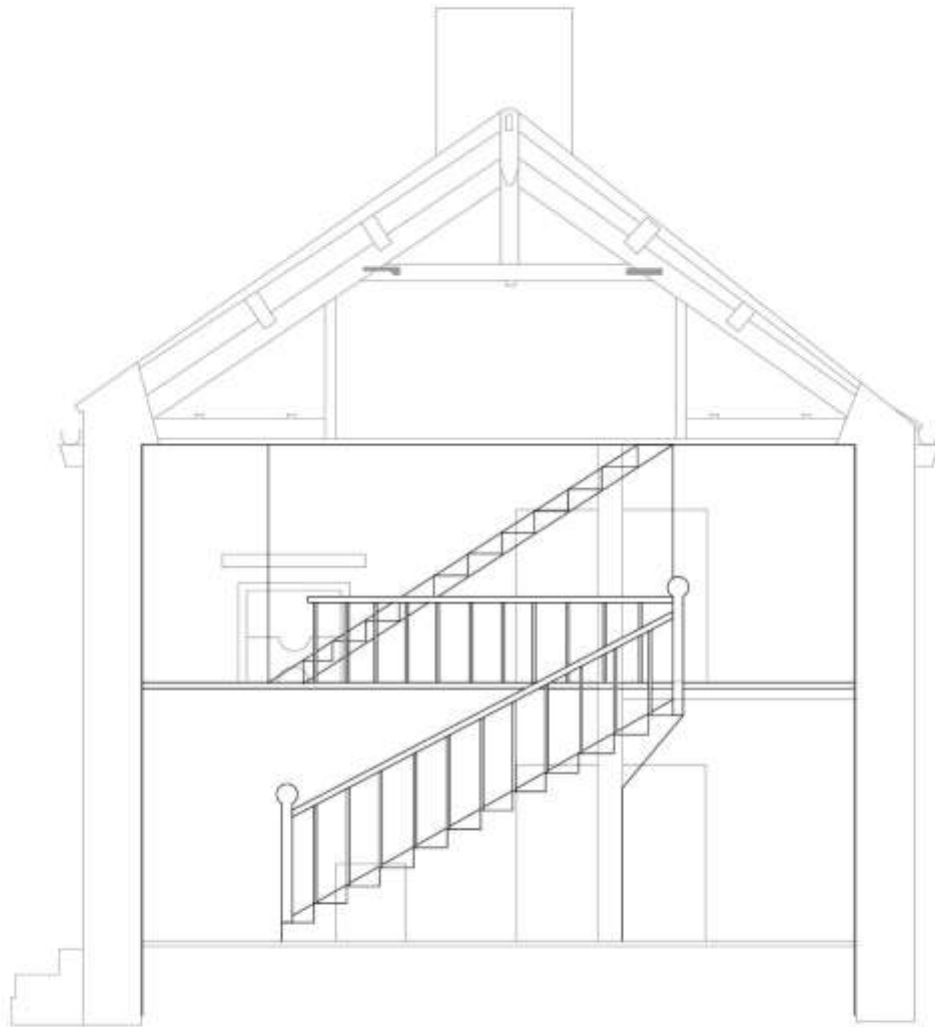
**Fig: 12**

Drawing Name:	Building 1: Cross-section showing position of stairs
Site:	Lodge Hill Farm
Project type:	Archaeological Standing Building Recording

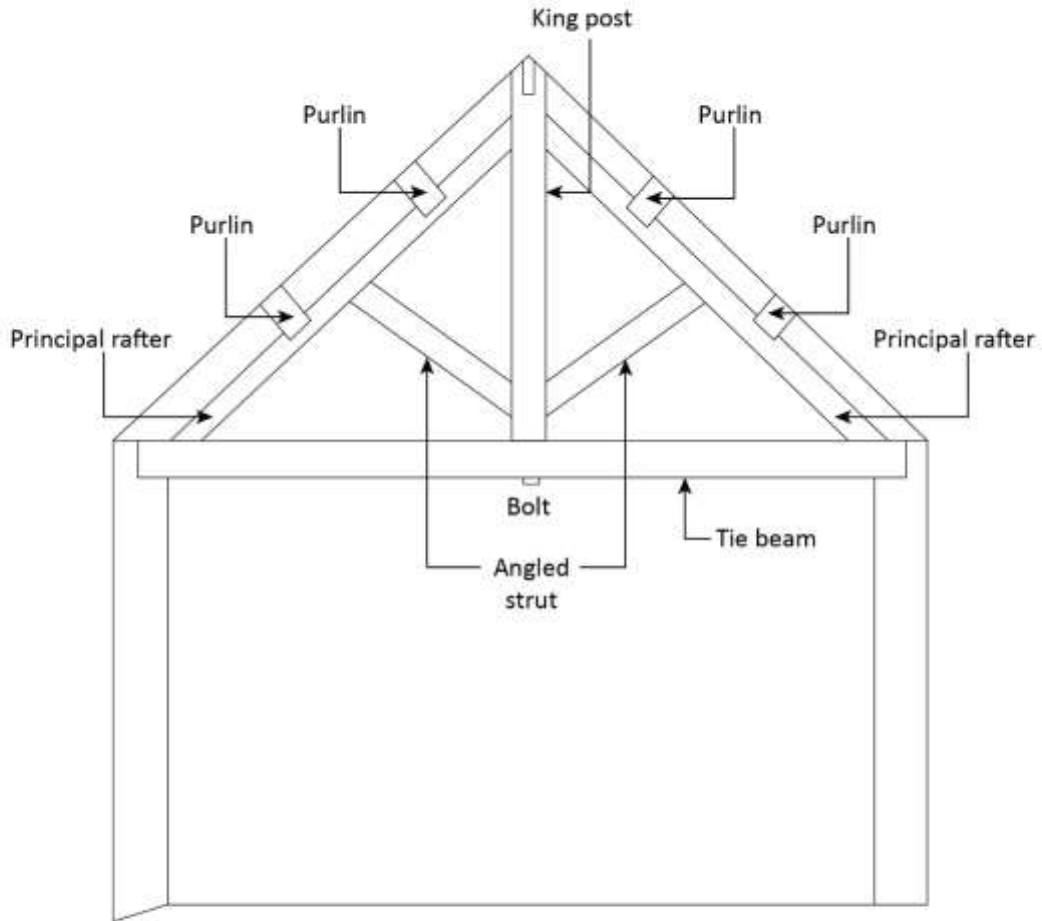
**Fig: 13**

Drawing Name:	Building 4: Cross-section showing roof structure
Site:	Lodge Hill Farm
Project type:	Archaeological Standing Building Recording
© borderarchaeology

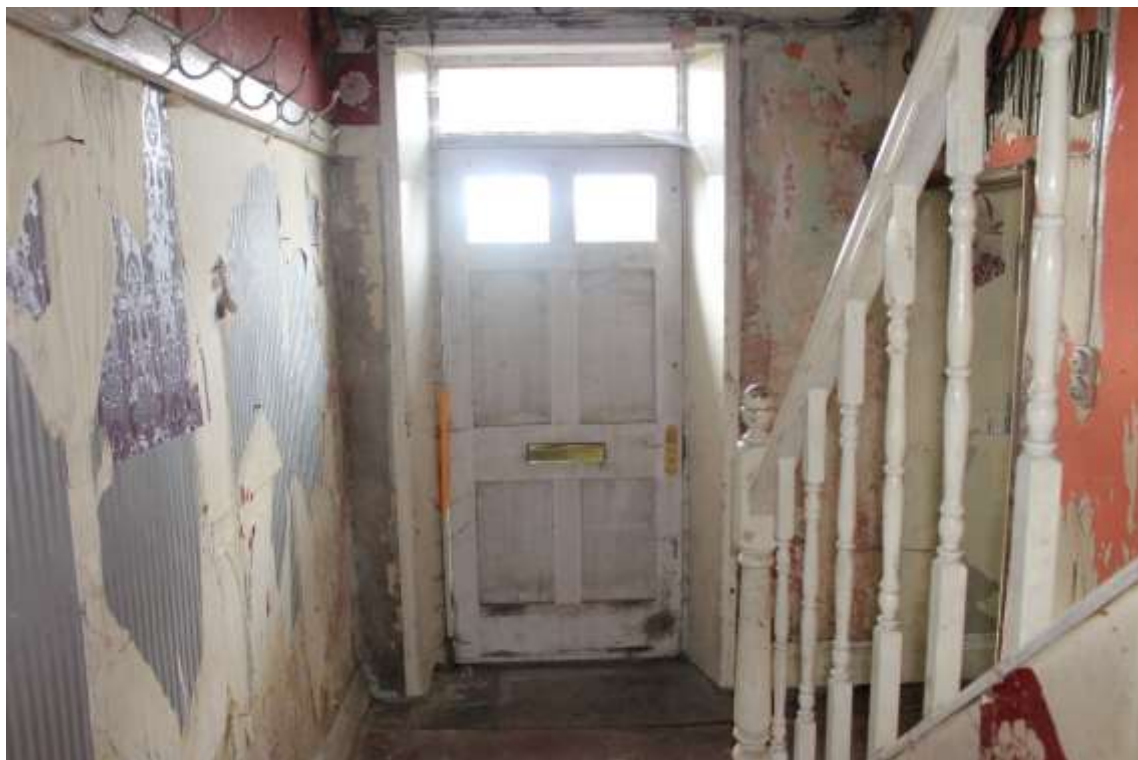
The main entrance opens onto a central hallway running NNW through the property (*Plate 13*) and lit by a partly glazed six-panel door surmounted by a transom window (*Plate 16*). The hall comprises two uneven compartments separated by a doorway with a transom window (*Plates 13 & 18*). The larger compartment opens W into a sitting room (*Plate 16*) and a straight staircase on the W wall leads up to first-floor level (*Plates 14-15*). The smaller N compartment opens onto four further rooms (*Plates 17-19*). Air bricks noted externally suggest the painted York stone (sandstone) flag floor may be suspended. Three ceiling beams with decorative beading and the underside of the first-floor floorboards are visible.

*Plate 16: Internal view SSE showing main entrance to the farmhouse within ground floor hall way – Building No. 1*

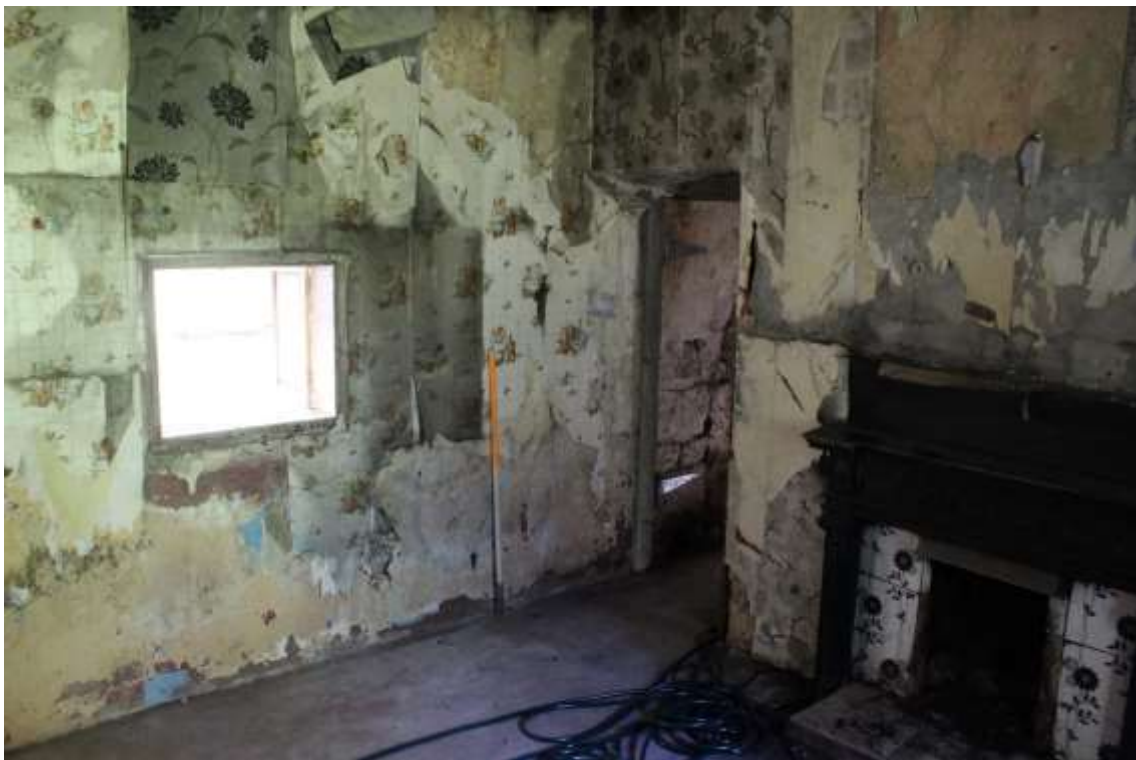
The kitchen opens W from the N end of the central hallway (*Plates 25-30*) and leads through into the single-storey outhouse (*Plate 26*). The walls appear heavily sooted but no discernible fire damage was noted. The floor is concrete and the walls plastered, with exposed chamfered ceiling beams and the underside of the first-floor floorboards again visible (*Plate 30*). The room is lit by a two-light casement in the N wall (*Plate 29*) while the W wall contains a central coal-grate with tile-and-wood surround over earlier mosaic tile (*Plate 25*). The S wall contains a service-hatch through into the first sitting room (*Plate 26*).

*Plate 26: internal view SSW within ground floor kitchen – Building No. 1*

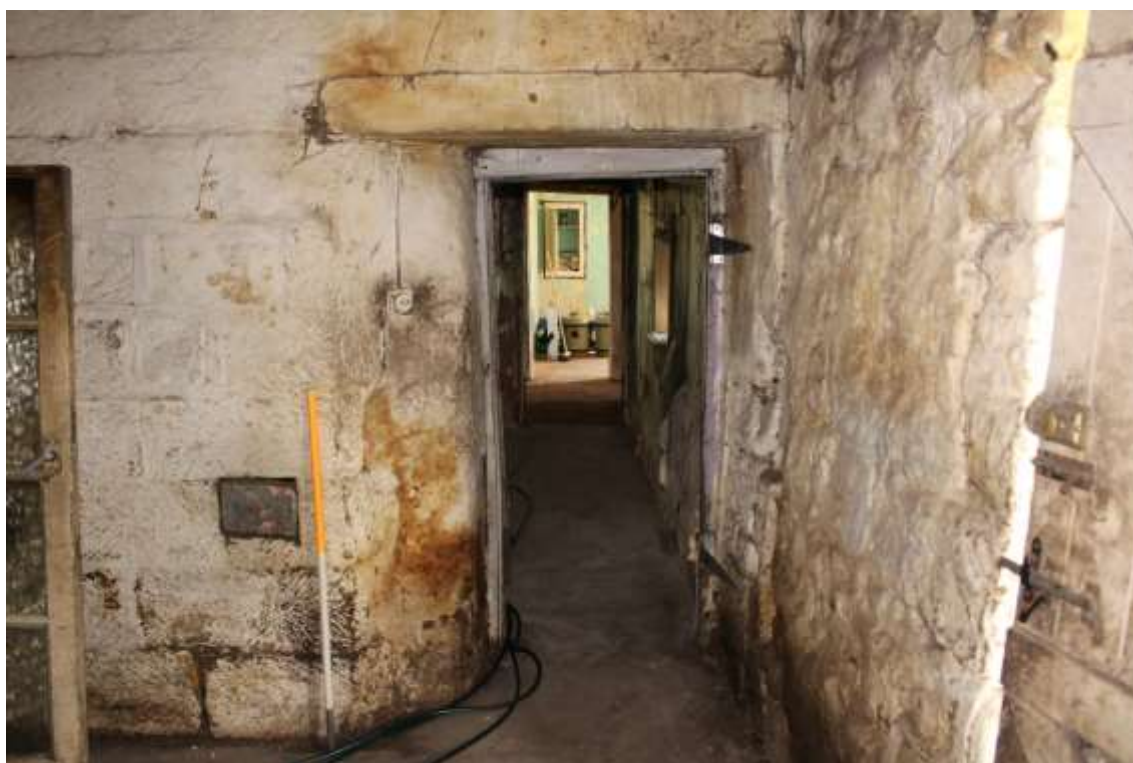
The outhouse (*Plates 44-51*) with whitewashed walls and concrete floor is accessed through either the kitchen (*Plate 50*) or external doors onto the front (S) and rear (N) of the property. The room is lit by a small single-light sash window in the N wall, to the left of which is a small alcove forming a storage space of similar proportions (*Plate 48*). The remains of a brick-and-stone stove were noted in the SW corner of the room (*Plate 49*) and a soot-box in the E wall allows access to the kitchen flue (*Plate 50*). The exposed roof-space reveals rough-hewn timber purlins with gable-end supports (*Plate 51*).

*Plate 50: internal view NW within ground floor outhouse showing entrance from kitchen and soot box – Building No. 1*

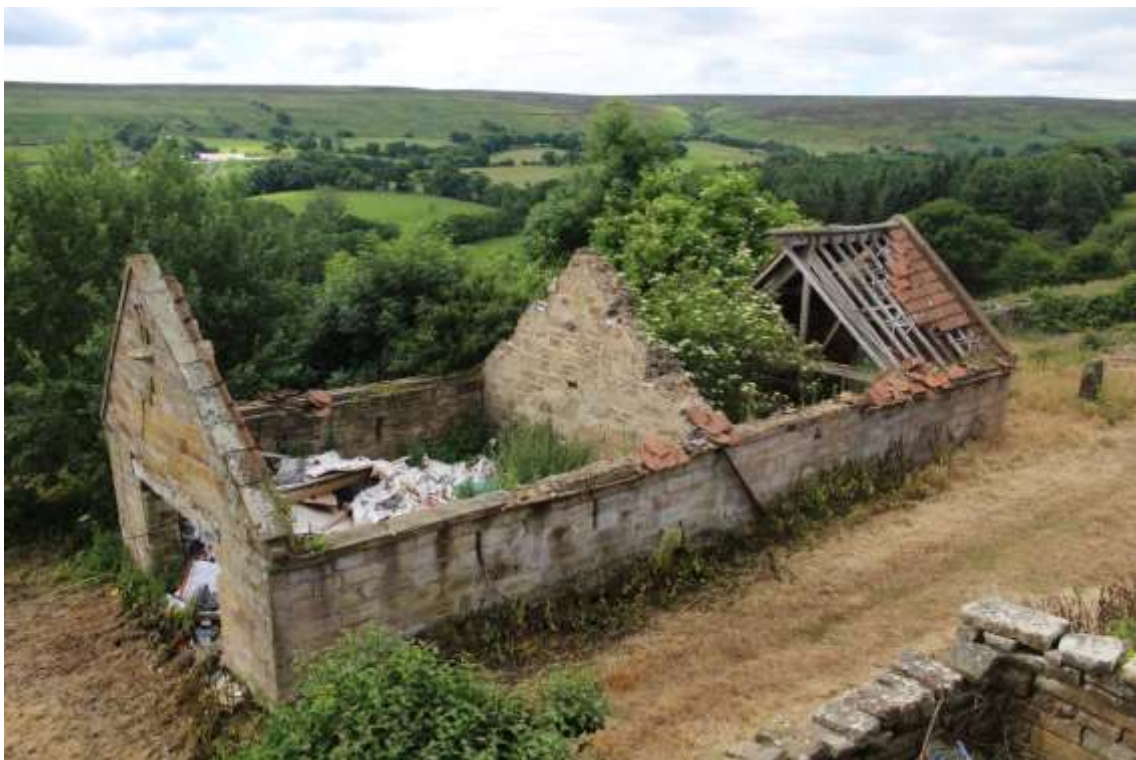
*Plate 96: Exterior view SSW of derelict barn - Building No. 2*

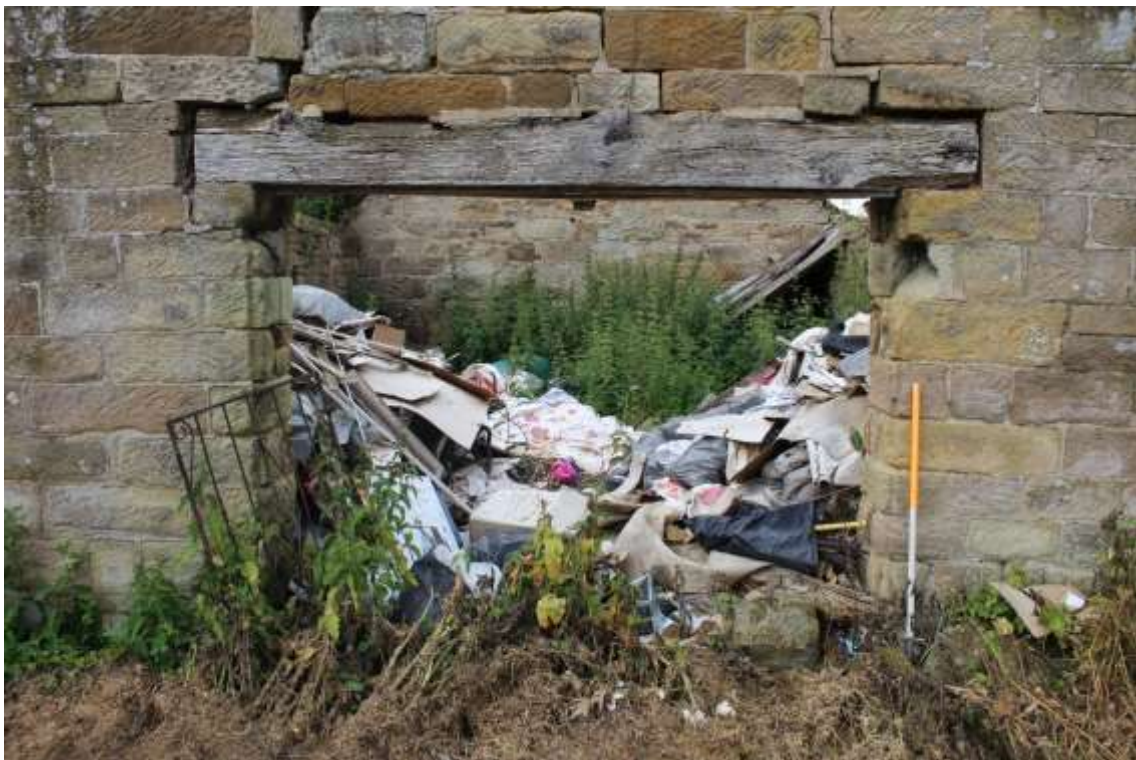
The building's condition raised health and safety concerns and a complete survey of the internal features was not possible. However, the building could clearly be seen to be comprise of two compartments. The ENE compartment is thought likely to be a cart shed, with no identifiable features seen at floor level (*Plate 100*). Views of the internal gable wall show slots for two pairs of purlin timbers (*Plate 101*).

*Plate 100: Exterior close up view E elevations of Building No. 2 and internal area*

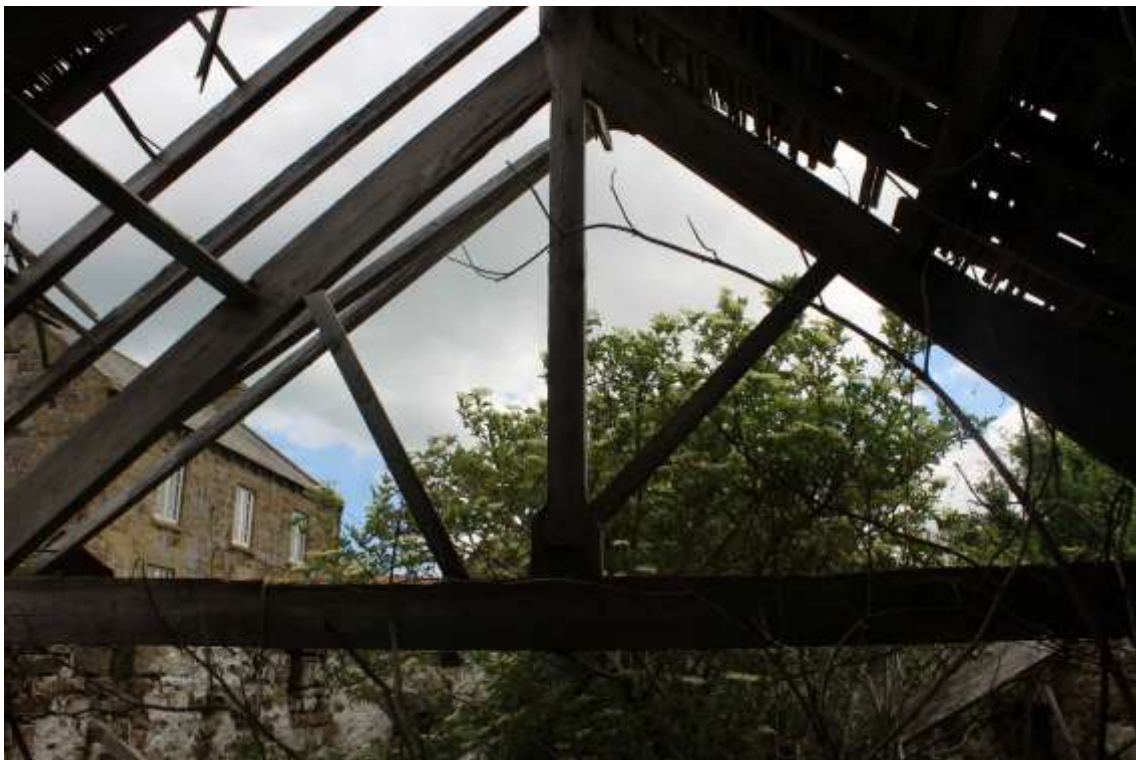
*Plate 108: Internal view ENE of surviving king post truss with W compartment of Building No. 2*

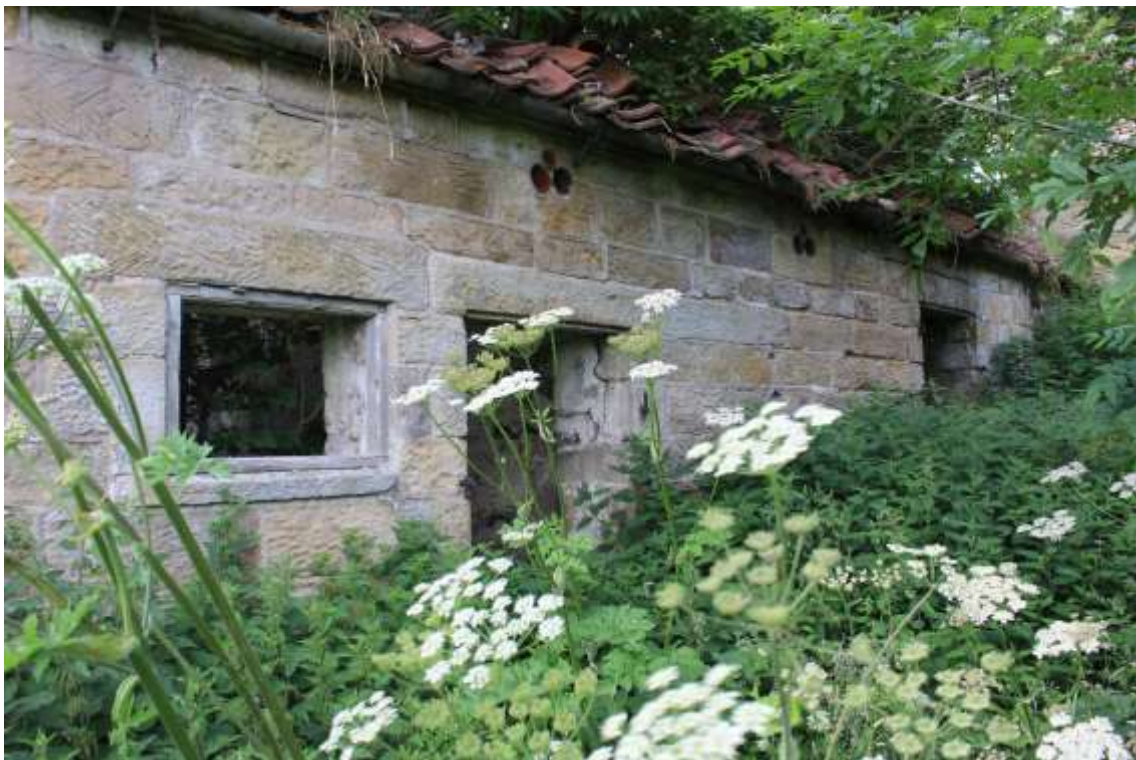
The N-facing gable end of the barn is built into the hillside, causing the exterior roofline to be at ground level (*Plates 106, 109-110*). The wall contains a single window or loading hatch. The W-facing elevation extends along the slope of the hill and has a doorway at its N end opening onto a field beyond the main farmyard (*Plates 110-113*). Iron hinge and latch brackets for a stable door survive within the doorway (*Plate 112*). A tie-pin was noted midway along the wall, with several vents spaced evenly along the roofline. No architectural features of note were observed on the S-facing gable end (*Plates 113-115*). Tree growth and waste obscured part of the E elevation (*Plate 97*) but two stable doors, a window and several vents could be discerned (*Plate 116*).

*Plate 116: External oblique view of E-facing elevation of Building No.3*

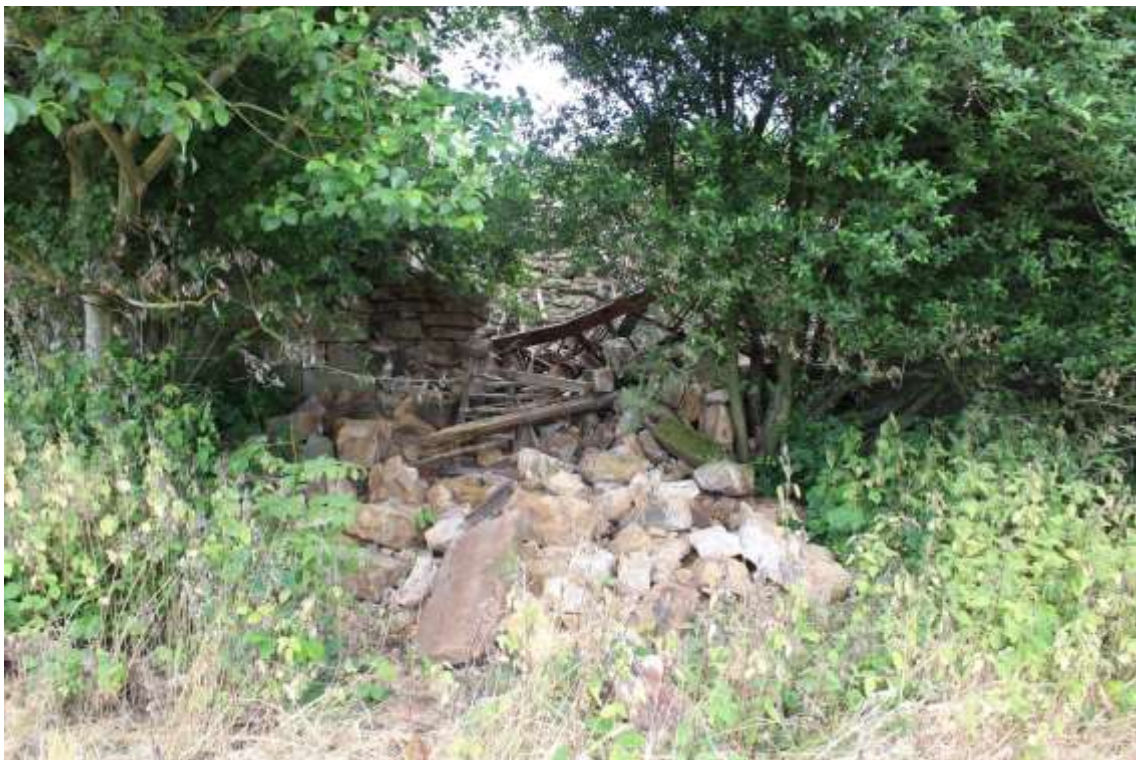
*Plate 122: External views N of the collapsed third section of the S-facing principal elevation*

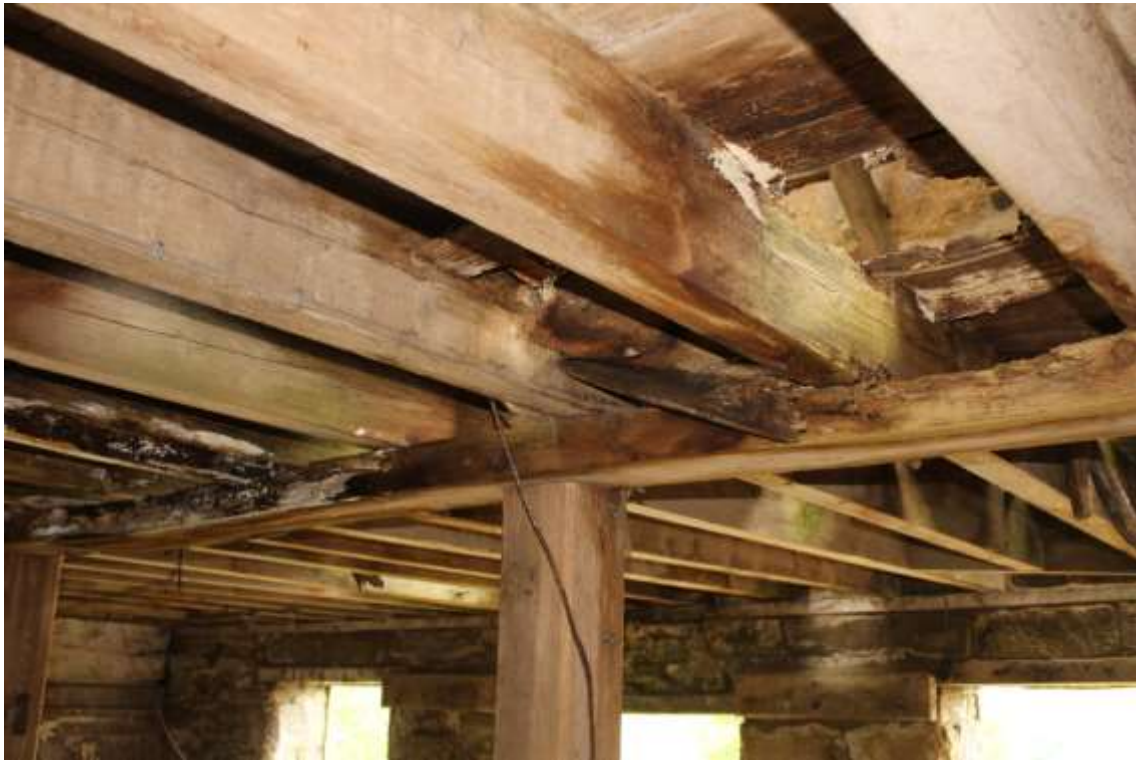
*Plate 131: Internal view ESE of rotten ceiling timbers within the first compartment of Building No.4*

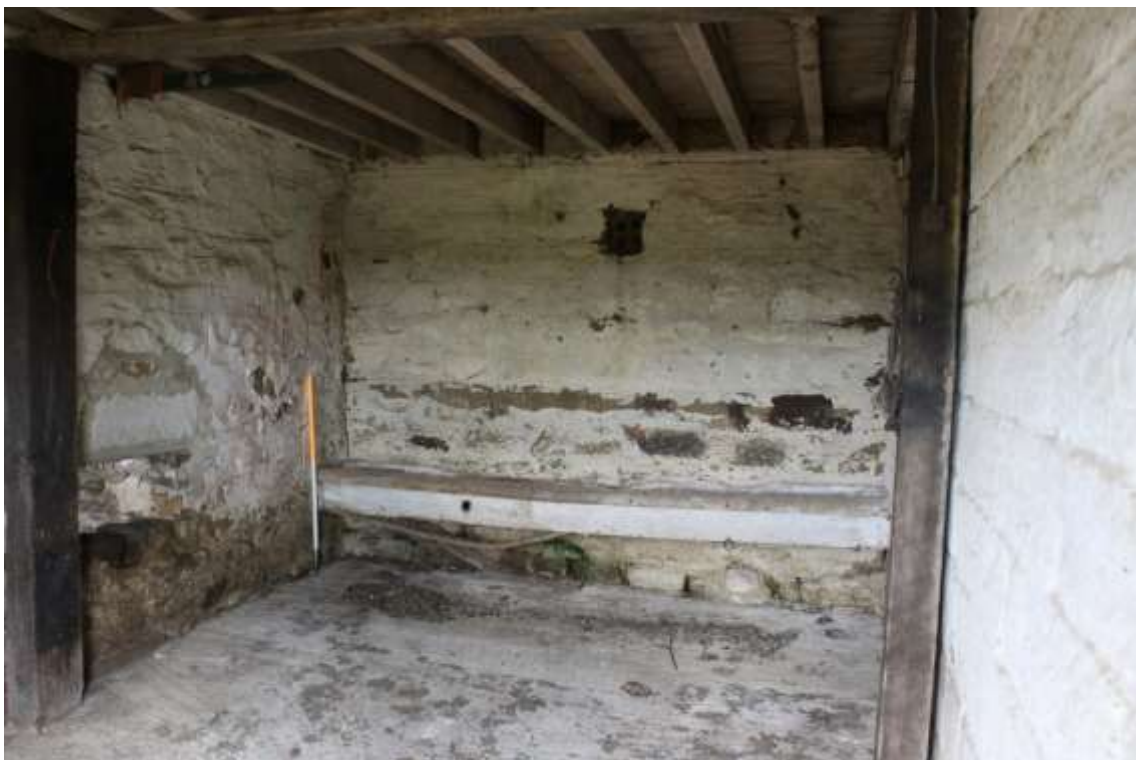
The second compartment (*Plates 136-141*) opens N from the main farmyard and connects with the adjacent compartments by means of doors in the SW and SE corners of the room. A surviving stable door and wooden trough (*Plate 137*) at the rear of the room suggest it was used as a loose box. The room has a concrete floor, whitewashed walls and two timber struts supporting an upper storage area which could not be accessed for health and safety reasons. The room is lit by a window in the S wall (*Plate 139*). An internal window looks into the adjacent compartment to the E (*Plate 140*).

*Plate 136: Internal view NNW of the second compartment of Building No.4*

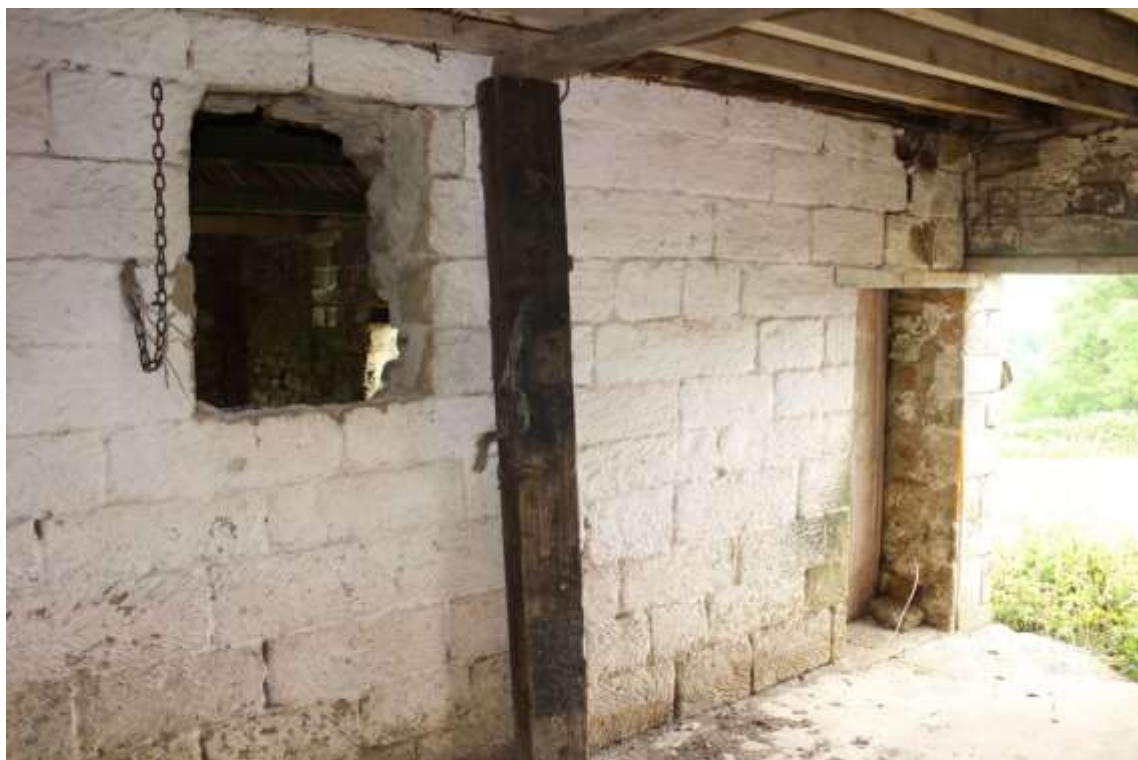
*Plate 140: Internal view SSE of the second compartment of Building No.4*

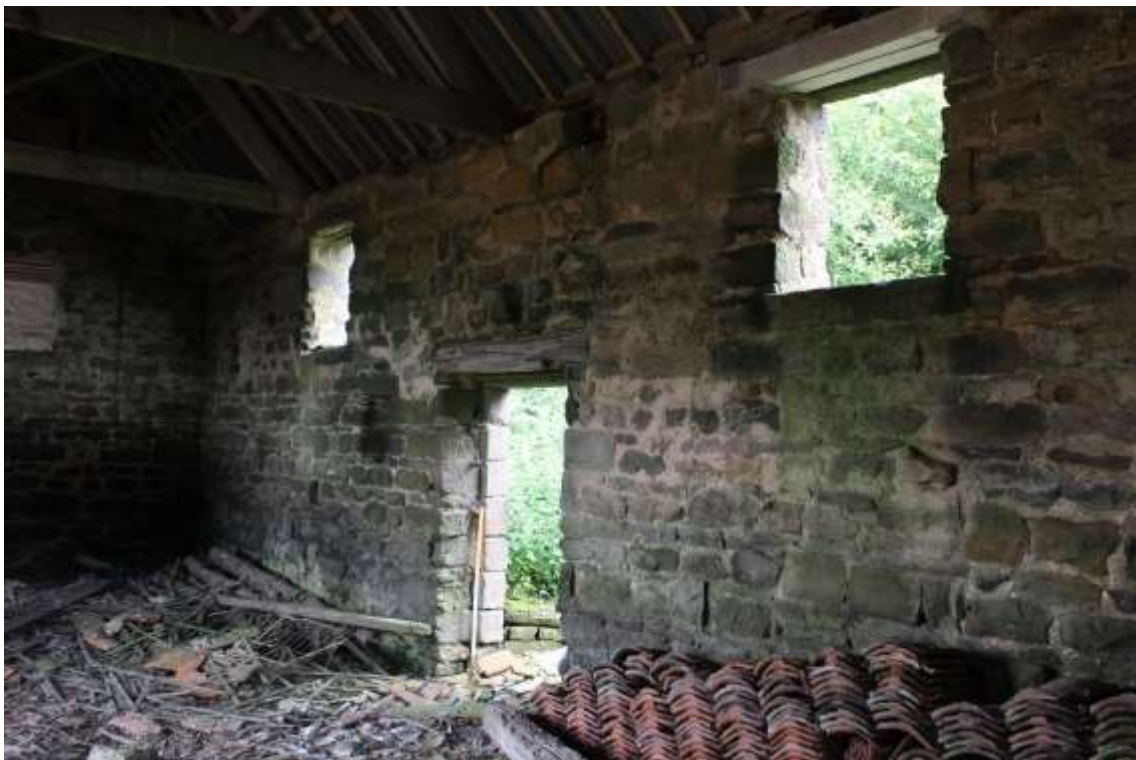
*Plate 146: Internal view NW showing rear entrance and windows within the N wall of the third compartment of Building No.4*
