North Yorkshire County Council

Beck Hole Bridge Maintenance 2021

Engineering Statement

Structure Reference Number: 392

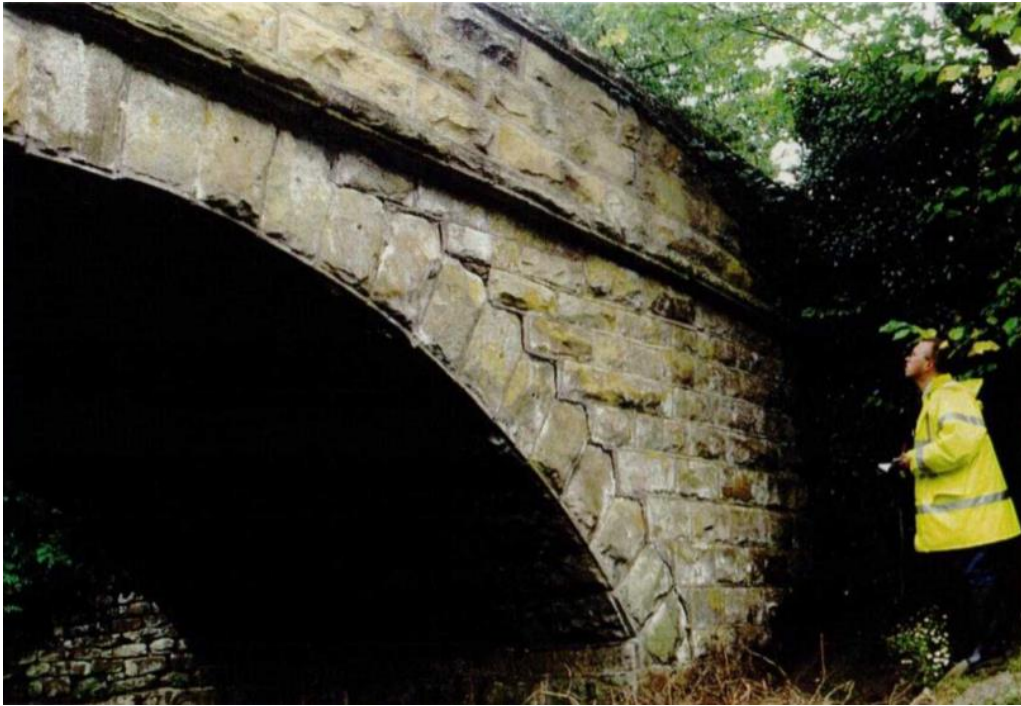
Downstream Elevation (SW Spandrel) – 1997

"Beck Hole Bridge is in good condition. No defects were found that would seriously affect the capacity of the bridge. The South West wing wall and spandrel wall should be monitored at regular intervals to assess if any further movement is taking place."

Movement has taken place on the South West side of the structure which is affecting the spandrel wall, wing wall and parapet. The spandrel wall and wing wall are bulging outward. This has caused the spandrel to separate from the edge voussoirs of the South arch by up to 25mm. No cracking or other defects have taken place."

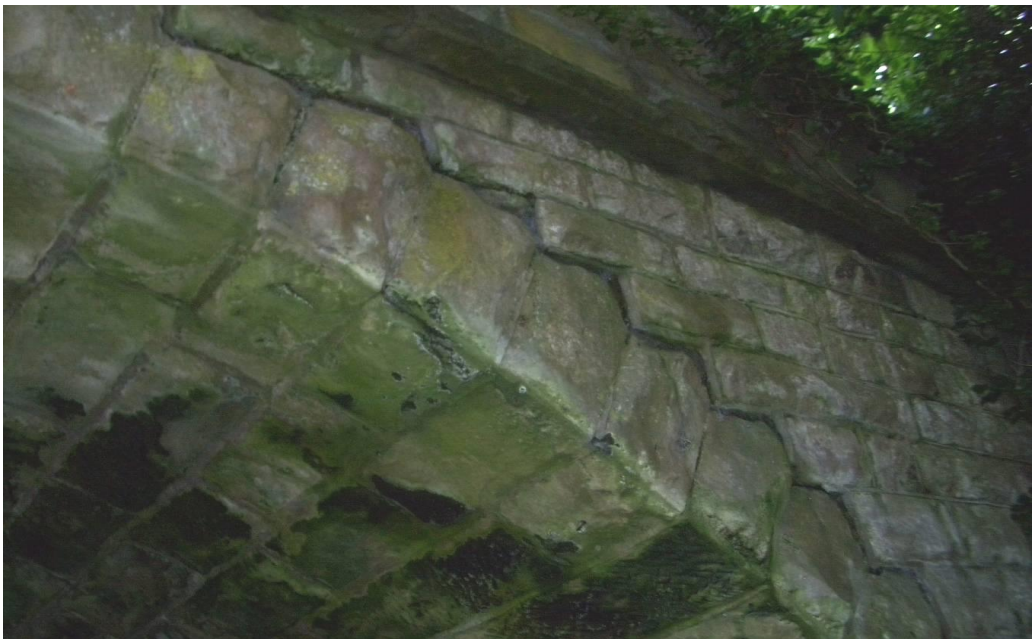
Downstream Elevation (SW Spandrel) - 2011

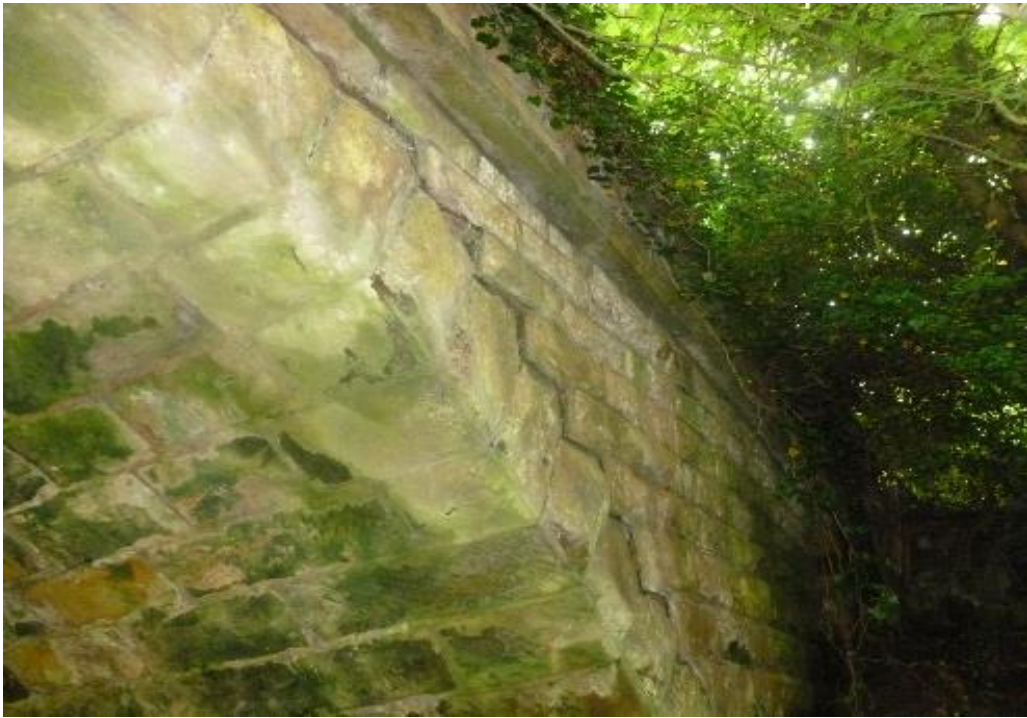
Downstream Elevation (SW Spandrel) - 2015

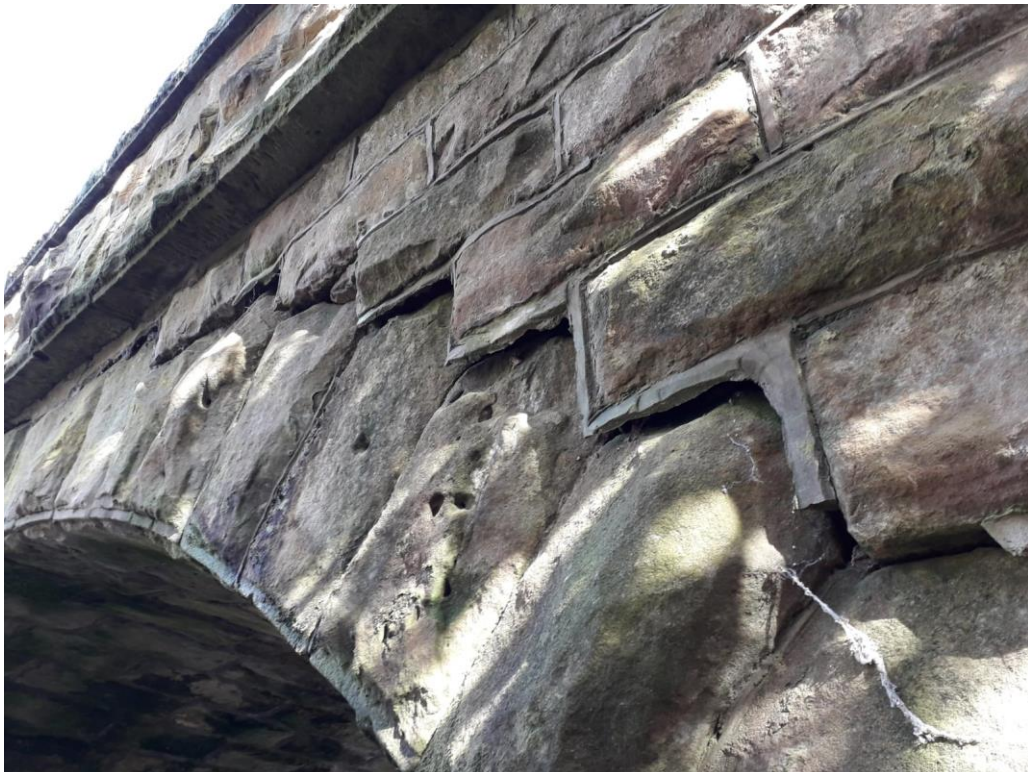
Downstream Elevation (SW Spandrel) – 2021

Beck Hole Bridge has undergone routine inspections since 1997 with all identifying movement in the south west spandrel wall for the southern span of the structure. The movement is clearly not typical of the original build and is classed as a defect. The movement has been monitored and has since continued to move and now requires remedial work to prevent further structural instability.

"The SW spandrel to the south-arch appears to have displaced outwards further since the last inspection. This should be pointed to enable any future movement to be detected more easily. Bulge appears to be increasing SW (30mm to 50mm)."

The movement can be attributed to an increase in traffic loadings from its original build. When it was built circa C19, there would have been a lot less traffic using the bridge, and of different type mainly horse and cart. The bridge is now subject to modern day to day use of public and agricultural vehicles, which can weigh up to 44t without any restriction. The increased usage can and has caused spandrel movement, which can be clearly seen

on Beck Hole Bridge. It is commonly found on masonry arch bridges particularly with a reduced road width and no verge protection. A typical repair is to take down the defected stonework to sound material and rebuild back up using the existing stone and a durable mortar, matching the existing colour. The stonework rebuild will be carried out by competent stonemasons.

A Cement: Hydrated Lime: Sand (1:1:6) mortar mix has been proposed over Lime: Sand mortar for a variety of reasons. The bridge is located on an actively used route in the middle of a village, with any works requiring as minimal impact on local residents and businesses as possible. A traditional cement based mortar will have a quick setting time, allowing for the works to be completed within a 3-5 week period. A traditional lime mortar does not have a quick setting time and needs to be carefully worked. 'Historic Scotland (TAN1): Preparation and Use of Lime Mortars' report states *"For work on ruined structures in exposed locations it may be necessary to provide a weatherproof envelope some time in advance to encourage drying out of saturated masonry fabric. The water content of the masonry should be reduced to a level at which lime mortar can dry and carbonate, which may take up to a year in some situations. Potential future sources of water ingress into the masonry fabric must also be eliminated."* According to BS8104:1992, Beck Hole Bridge is located in a 'severe' weather exposure location, resulting in an unacceptable environment for a lime based mortar to be used. It would also be impossible to keep the lime mortar dry, as water will be present in the ground it is retaining, even with concrete backing there will still be water and salt penetration. If a lime mortar was to be considered it would involve an extended amount of time repairing the bridge, potentially up to a year. This would close an important highways route, resulting in a significant impact on local residents and businesses as well as increasing the cost on public spending.
