**From:** Maria Calderon  
**Sent:** 20 September 2021 09:53  
**To:** Megan O'Mara  
**Subject:** Beck Hole Bridge

**BECK HOLE BRIDGE, GOATHLAND, SCARBOROUGH, NORTH YORKSHIRE  
Application No. NYM/2021/0263/LB**

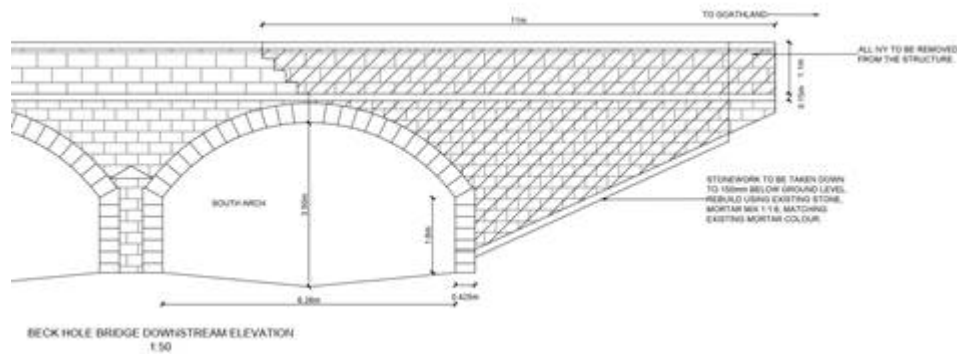
- However, the supporting drawing conflicts with the DAS/HS in scope: the extent of the proposed dountaking is about double that which is actually suffering from structural

activity (see below).

- The photographic evidence suggests the lateral translation of the spandrel relative to the barrel peters out and terminates around springing level at the lower end, and does not reach the crown at the higher level. For practical stability reasons, the masonry will need to be opened up to a splayed / corbelled profile to access the affected area, but even accounting for this the scope in my view is about twice that which seems to be required. I can see no justification for the rebuilding of the upper part of the end pilaster. Further, taking down the masonry beneath springer block will open up a can of temporary support worms which should be borne in mind, I wouldn't do this unless expressly required.

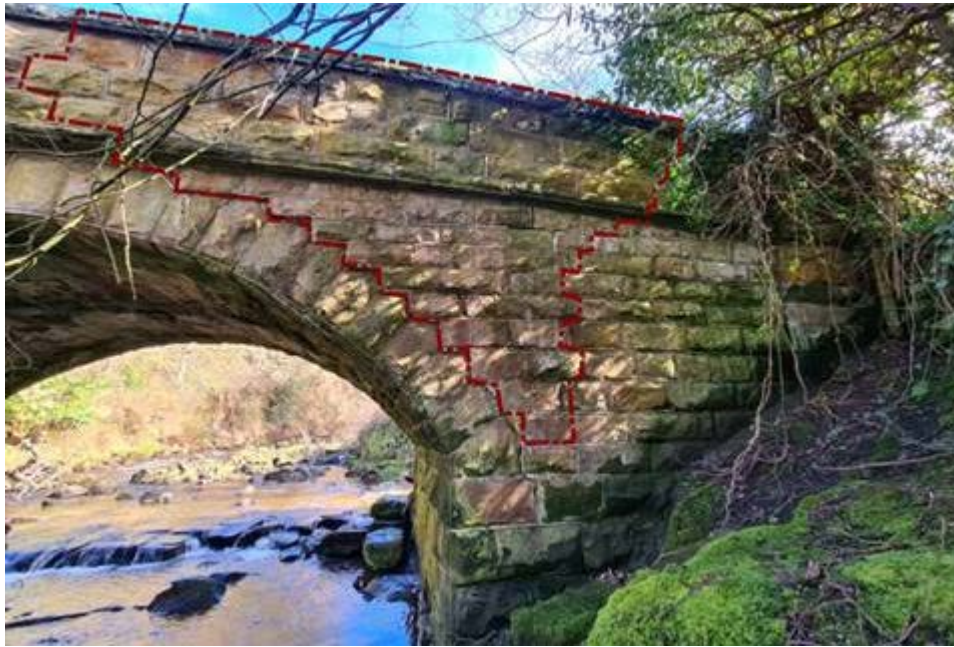
- A more focused scope of repairs based on the photos is outlined below, which I think the project should be tapered back to. The proposed intervention doesn't in my view actually deal with the problem: if the spandrel is too thin to resist the lateral earth pressure, then it should be thickened to the rear (i.e. dig down the back of it and substantially increase its thickness – possibly combined with some fixing into the extrados if this is not toothed).
