Fox and Rabbit Farm,
Pickering,
YO18 7NQ

Arboricultural Report

April 2022

Report reference	1701
Revision	1
Prepared by	James Blades
Approved by	James Stacey
Issue date	11/04/2022

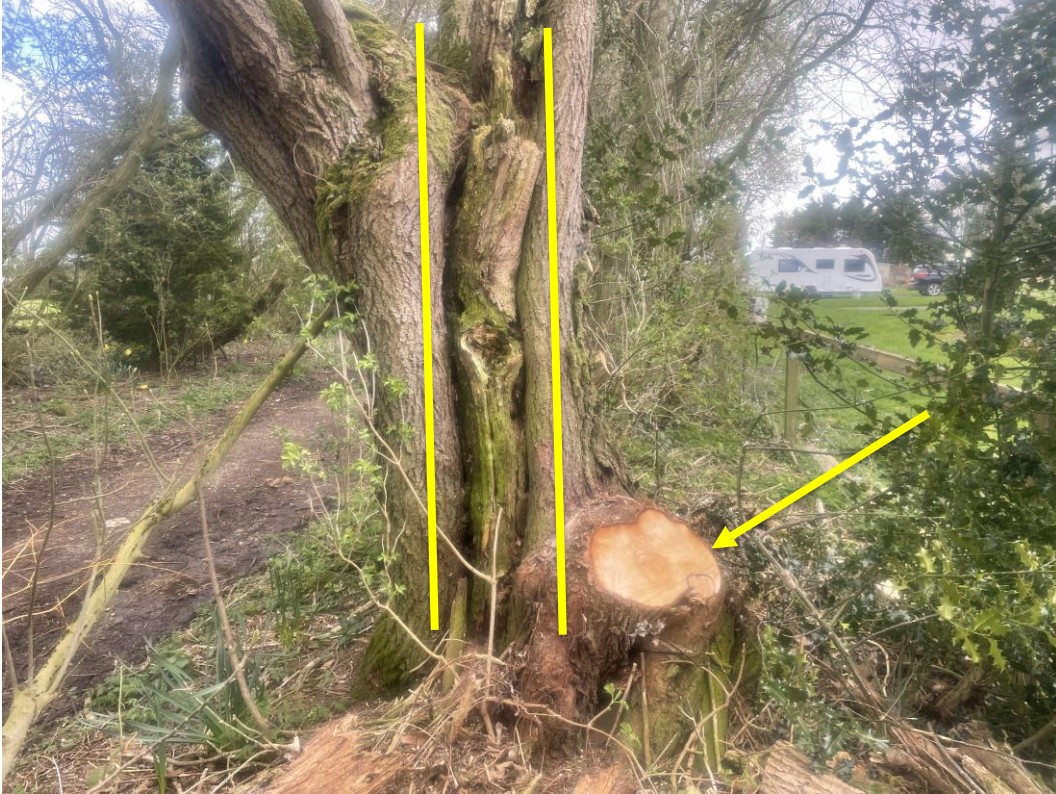
- 3.1.1.5 T1-T5 are the principal trees in relation to the site and proposed development.
- 3.1.1.6 T1 and T2 are both willow trees in a compromised condition. T1 has suffered from several past limb failures and has a significant decay column running along the west side of the largest remaining central limb. T2 appears to have significant dieback within the crown and is considered to be standing deadwood. The trees are considered to be BS5837:2012 Category U.

Image 1 – Looking east to T1, coulmn of decay and previous limb failures indicated (since pruned back).

- 4.3.1.1 It is considered that T1 and T2 will require removal prior to any development. The trees are in a severely compromised structural condition. The proposed development will also likely impact upon the trees beyond any damage that has already occurred from the previous excavations and installation of hard standing in this area.
- 4.3.1.2 It is recommended that where possible the trees are removed and replaced on a 1:1 basis to prevent the future fragmentation of the tree line here.

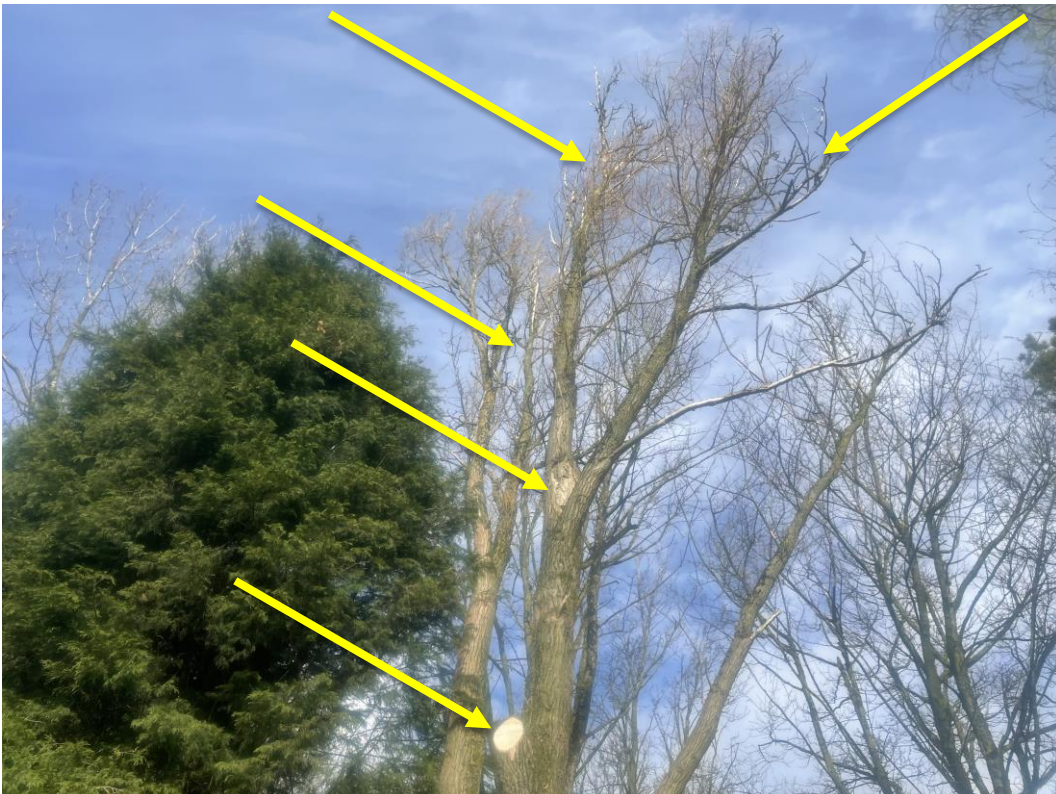
Image 2 – Looking north to T2, heavy deadwood+previous limb failures (since pruned back) indicated.

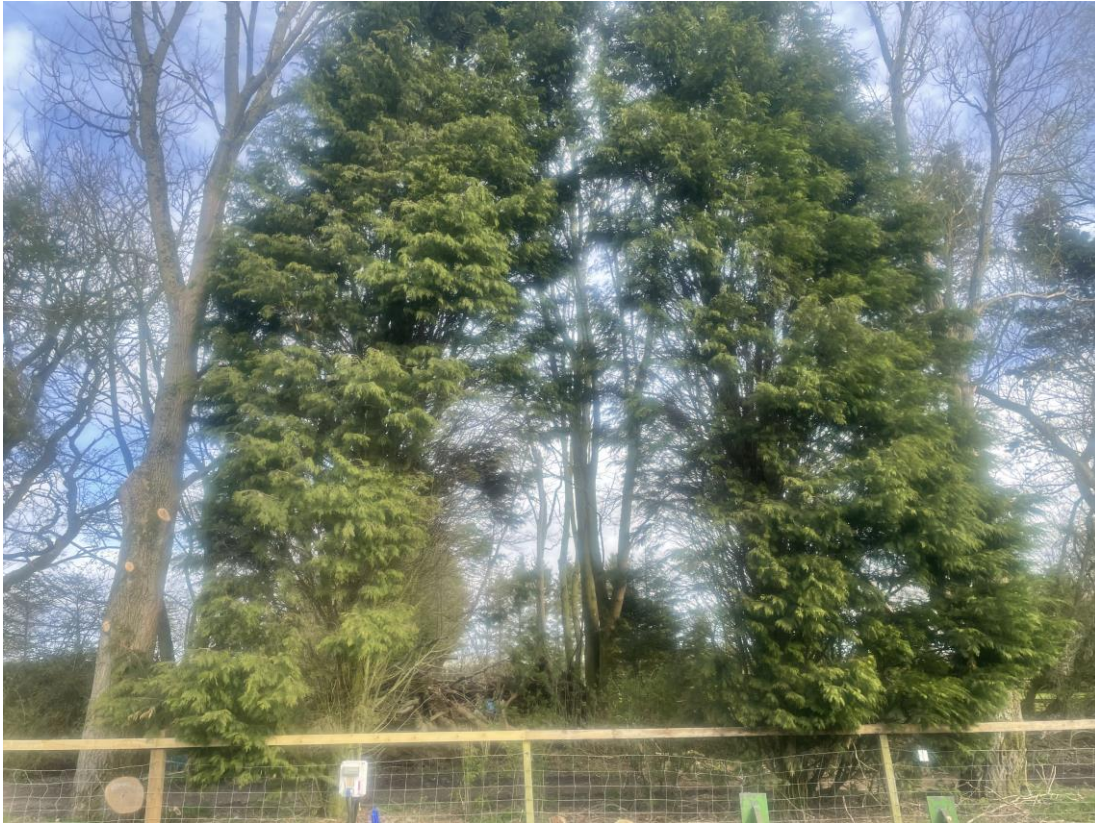
- 3.1.1.7 T3 and T4 are both maturing leylandii trees with to significant defects, both have some minor included unions throughout the crown typical of the species, the trees may have suffered from some root disturbance/destruction to the southern outer root protection area's (RPA) due to the previous excavations here. Both trees are considered to be BS 5837:2012 Category C1.

Image 3 – Looking north to T3 and T4 (right to left).

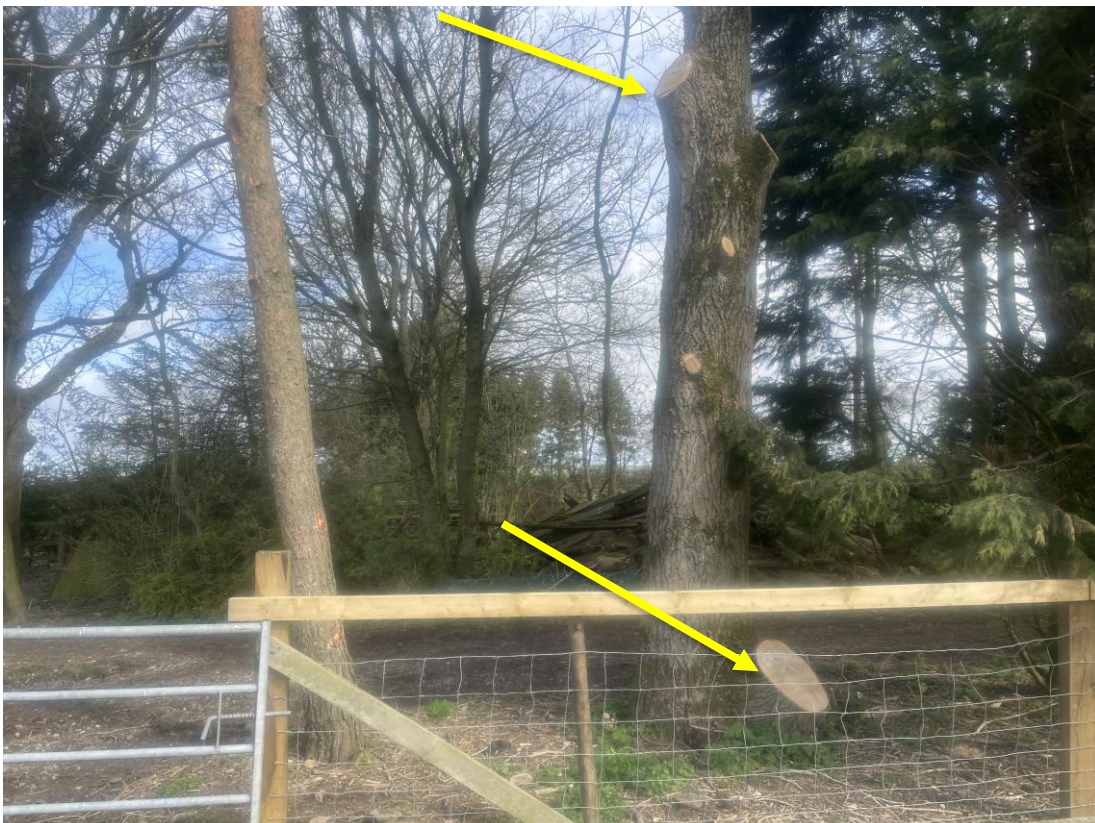
- 3.1.1.8 T5 is a large poplar tree, the tree has suffered from some past limb failures which have since been pruned back. It is estimated that the tree has lost up to 40% of its total canopy due to these recent failures. Similar to T3 and T4 the tree has likely suffered from root destruction/disturbance to the outer southern RPA due to past installation of an area of hardcore (see Appendix 2, Image 5-6). It appears that the area outlined has been excavated to a depth of approximately 300-400 mm and infilled with a layer of hardcore in order to create a storage area for farm machinery and hay bales. The remaining crown does not yet appear to have suffered from any die back due to previous damage. The tree is considered to be BS5837:2012 Category C1.

Image 4 – Looking north to T5 and T6 (right to left), large limb failure on T5 indicated (since pruned back).

4.9.1.3 Due to the current condition of T5 it is recommended that the trees physiological and structural condition is monitored moving forward in light of both the loss of canopy and potential root removal/disturbance.

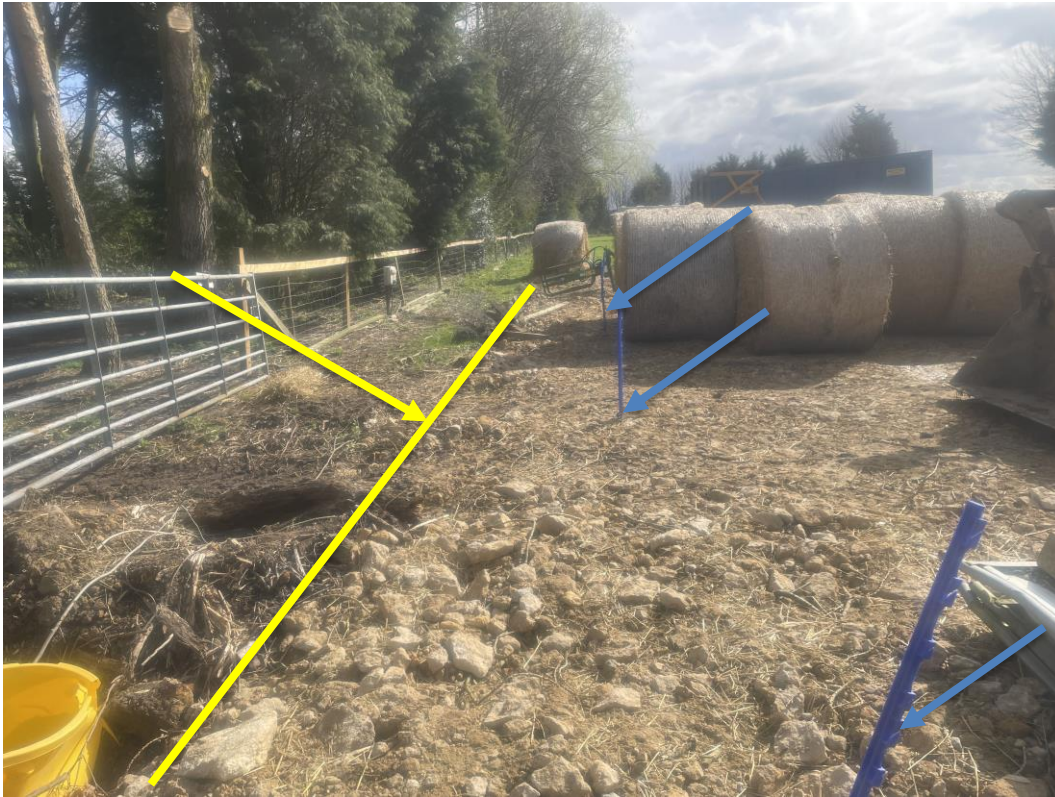
- 4.5.1.1 Previous excavation to an approximate depth of 300-400 mm has taken place within the RPA of T3, T4 and T5 (see Appendix 2, Image 5, 6, 7 and 8 and Appendix 4). Where previous excavations (for the purpose of creating an area of hard standing) have taken place it is highly likely that rooting has been destroyed/removed.

Image 5 – Looking east along tree line, area of previous excavation can clearly be seen. Blue poles show the approximate proposed north wall of the barn (indicated).

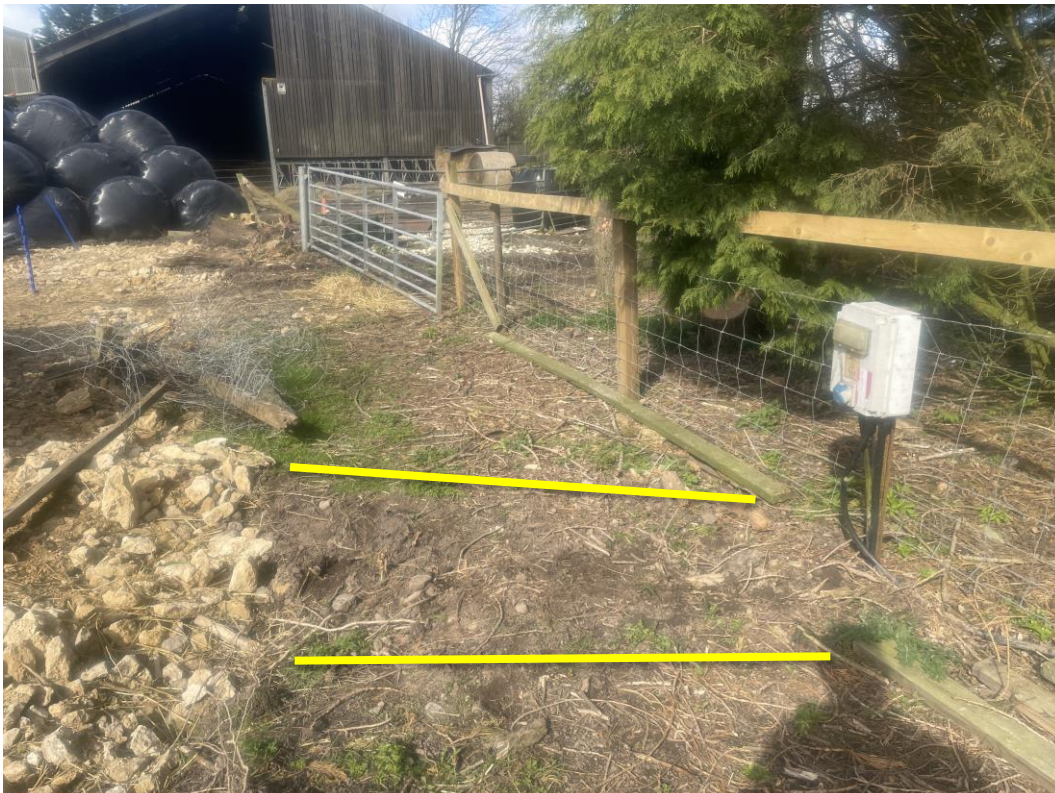
Image 6 – Previous power utilities for caravan bay also likley to have contributed to historic root removal in this area (indicated).

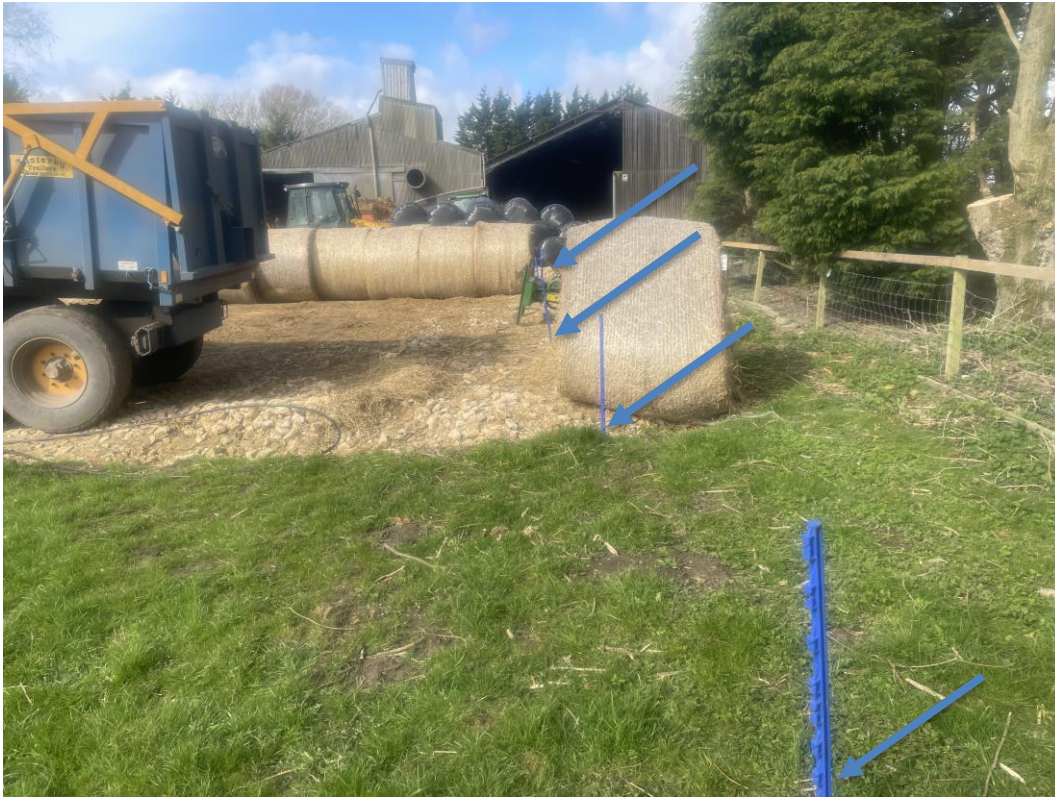
Image 7 – Looking west along the tree line, again blue poles indicate approximate position of proposed barn.

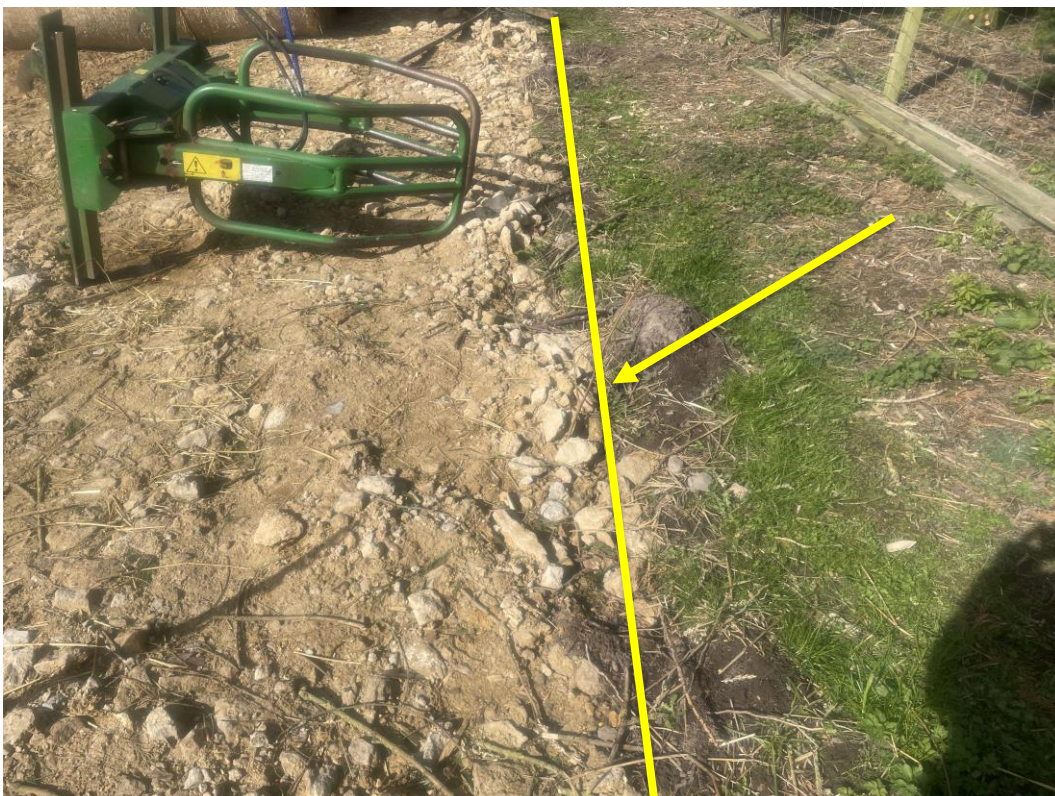
Image 8 – Depth of excavation is between 300-400 mm below the existing ground level, back fill with hardcore and subsequent compaction of the area will have removed the majority of rooting here.

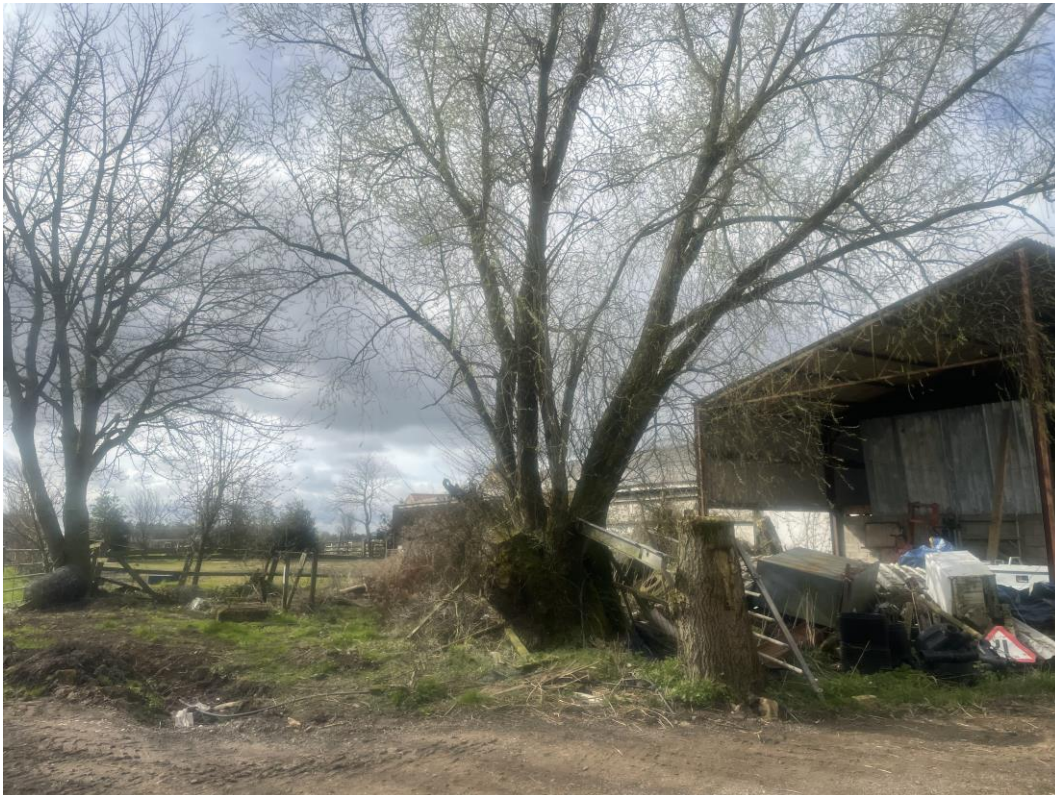
- 3.1.1.9 T6 is a small scots pine tree heavily suppressed by T5. The tree is considered to be BS5837:2012 Category C2.
- 3.1.1.10 T7 is a large spreading willow tree to the south of the proposed development. The tree has had several large limbs removed in the past and also may have been historically pollarded to 1.5 m due to the multi-stemmed nature of the tree. The tree appears to be in a fair condition and is considered to be BS5837:2012 Category C1.

Image 9 – Looking south to T7.

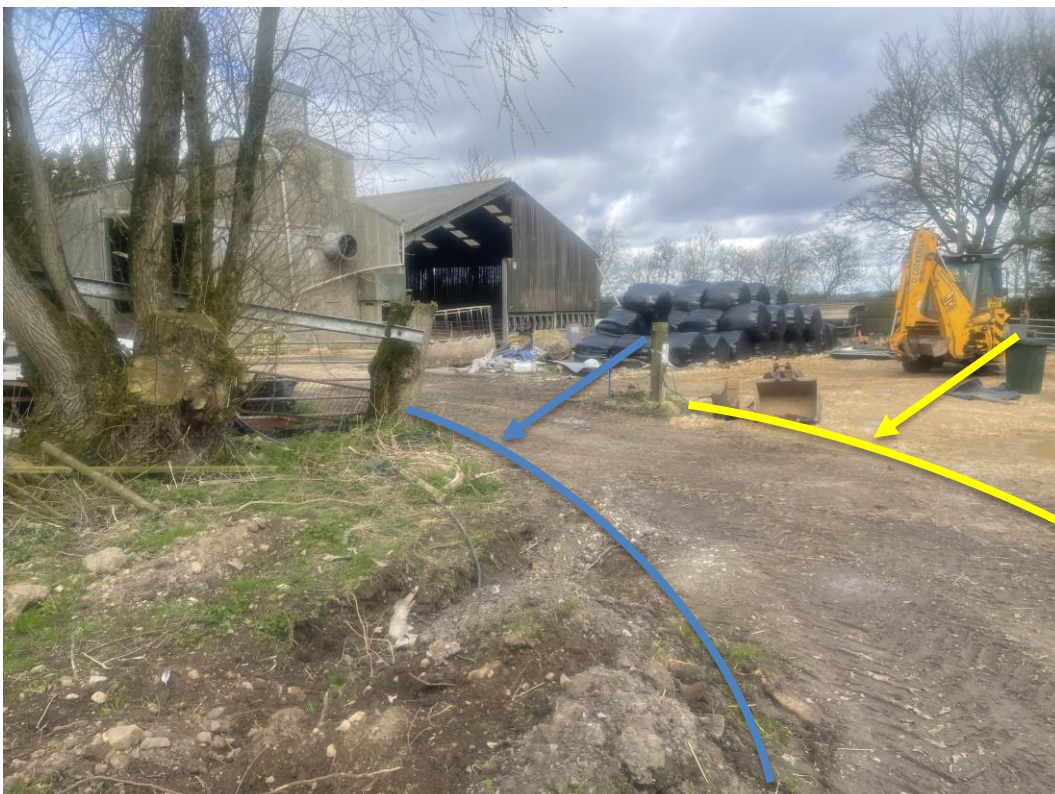
- 4.5.1.4 Similar to T5 it appears that the area of impact has previously been excavated and filled with hardcore. Further to this, there is a heavily trafficked farm access track along the north and north eastern RPA of T7. This will likely mean that rooting in the outer northern RPA of T7 is severely limited with significant rooting here unlikely due to the heavy compaction by large agricultural vehicles.

Image 10 – Heavily compacted access track (blue) and south extent of previous excavations is indicated (yellow).
