North Yorkshire County Council

Beck Hole Bridge Maintenance 2022

Engineering Statement

Structure Reference Number: 392

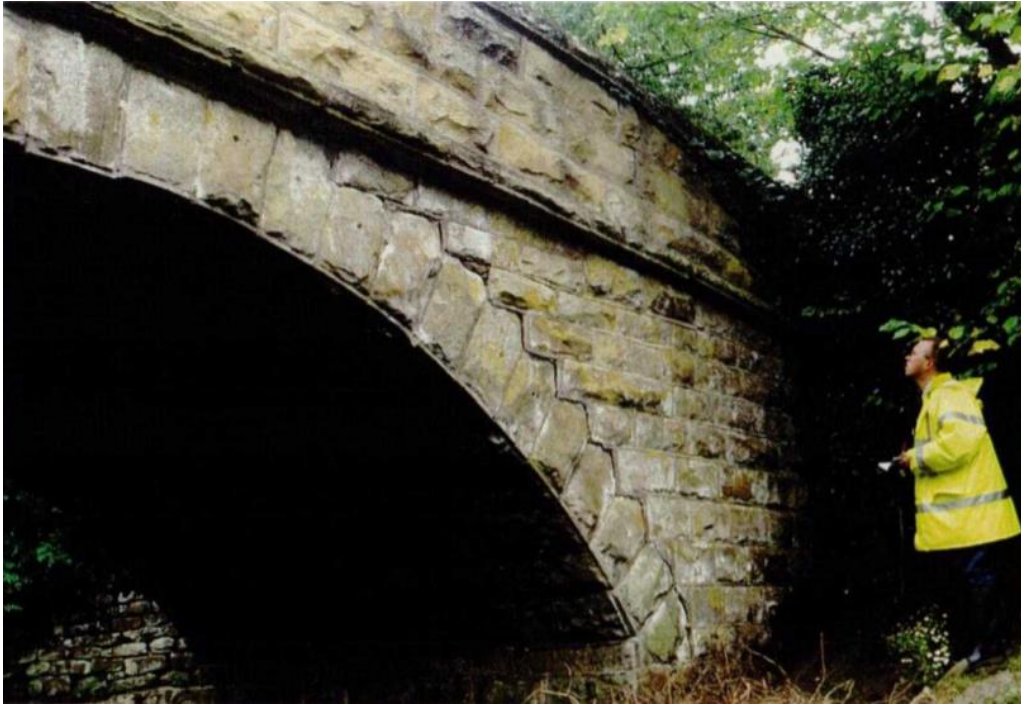
Downstream Elevation (SW Spandrel) – 1997

Movement has taken place on the South West side of the structure which is affecting the spandrel wall, wing wall and parapet. The spandrel wall and wing wall are bulging outward. This has caused the spandrel to separate from the edge voussoirs of the South arch by up to 25mm. No cracking or other defects have taken place."

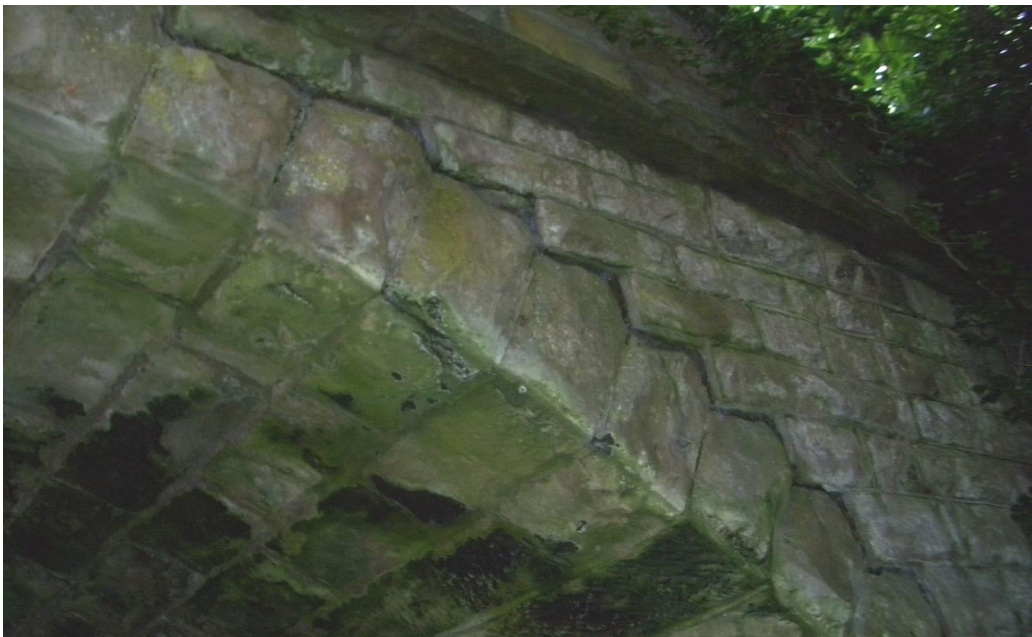
Downstream Elevation (SW Spandrel) - 2011

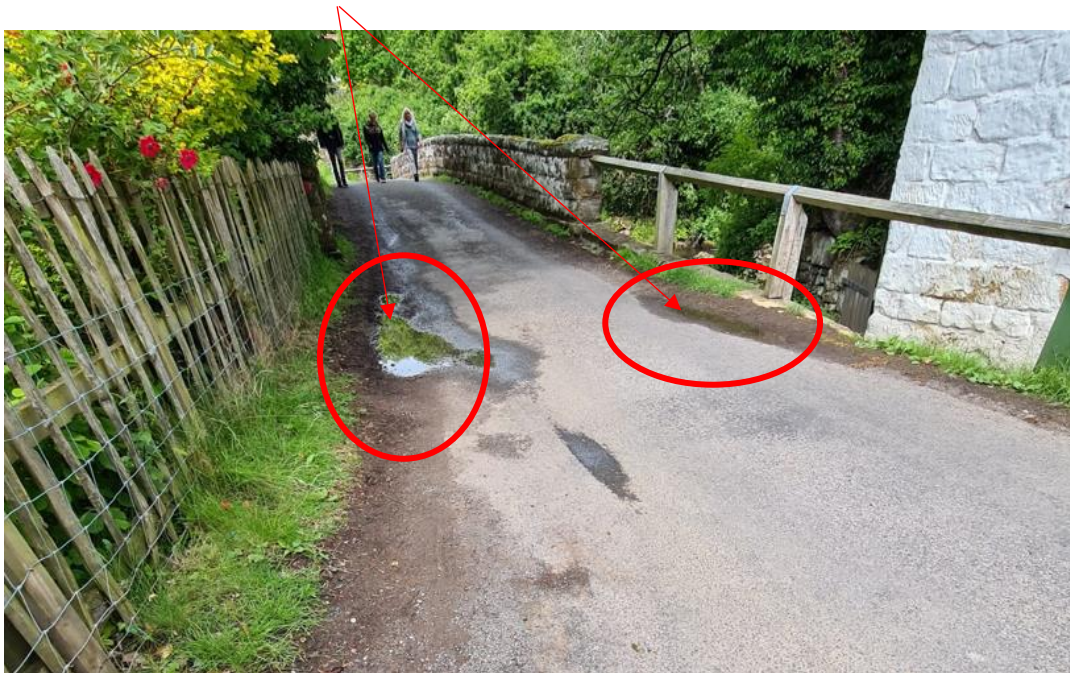
To discover the route of the spandrel wall movement, the structure has undergone random inspections, on days of wet and dry weather. On days after heavy rain it can be seen that water is pooling on the bridge approach/grass verge.

It is assumed that the pooling water is penetrating through the grass verge into the bridge fill, causing the existing fill to be saturated. As the bridge is now subject to modern day to day use of public and agricultural vehicles, which can weigh up to 44t without any restriction. The increased usage and saturated fill can cause the spandrel to push outwards. It is commonly found defect on masonry arch bridges particularly with a reduced road width and no verge protection. A typical repair is to take down the defected stonework to sound material and rebuild back up using the existing stone and introducing a structural backfill with the addition of drainage gully's to prevent any pooling from occurring. Back of wall drainage and weep holes will be added to elevate any pressure from within the structure.
