BS 5837:2012 ARBORICULTURAL SURVEY

15/11/2022

Re: Stray Head Farm, Little Beck Lane, Littlebeck, Whitby

ARBORICULTURAL SURVEY

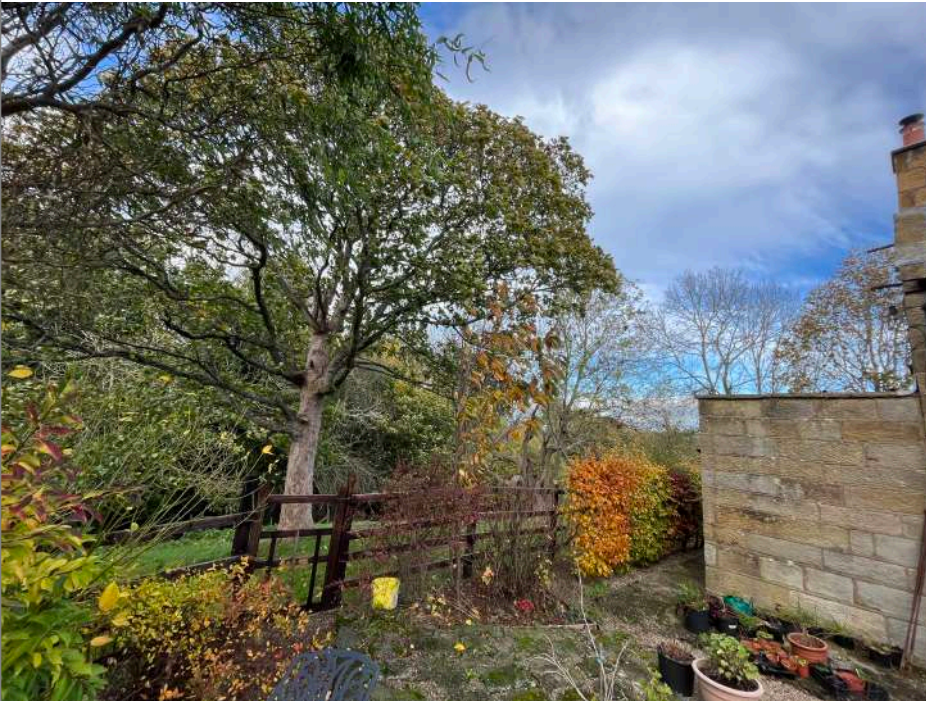
Pic 1

ID	Common Botanical	Structure	Num. Stems	Height (m)	DBH (cm)	Crown Spread	Life Stage	Life Expect	Proposed RPA (m)	Survey Notes	Physiological Condition	Structural Condition	Cat	Recommendations
T001	Sycamore <i>Acer pseudoplatanus</i>	Tree	1	13	55	N4.5 E5.5 W5.5 S5	Mature	40	6.5	Slight buttressing on the root stock. Height of first branch; 2m. Previous crown lifting work with some exposed cuts previous pruning stumps. Previous tear out higher in canopy leading to weak centre. Telephone line attached at 3.5 m and included.	Good	Good	B1	
T002	Common Ash <i>Fraxinus excelsior</i>	Tree	1	13.5	33	N1 E1.5 W1 S1.5	Early Mature	<10	4	Slight lean SE. Girdling possibly from previous fence wire. Crown lifted to 3.5 m. First branch at 3 m. Bird box present at 3.5 m. Some minor deadwood but fairly full canopy. Some slight signs of ash die back (week curled up tips and loss of leaf from ends during normal leaf drop in autumn)	Fair	Good	U

Showing T001, location and proximity to existing building and concrete pad.
Also shown is the garden fence currently installed creating a barrier to the trees in question

- Material storage and site offices must be confined to areas outside root protection areas.
- Retain the current garden fence to prevent heavy machinery inadvertently straying onto the root protected areas and prevents accidental damage to branches

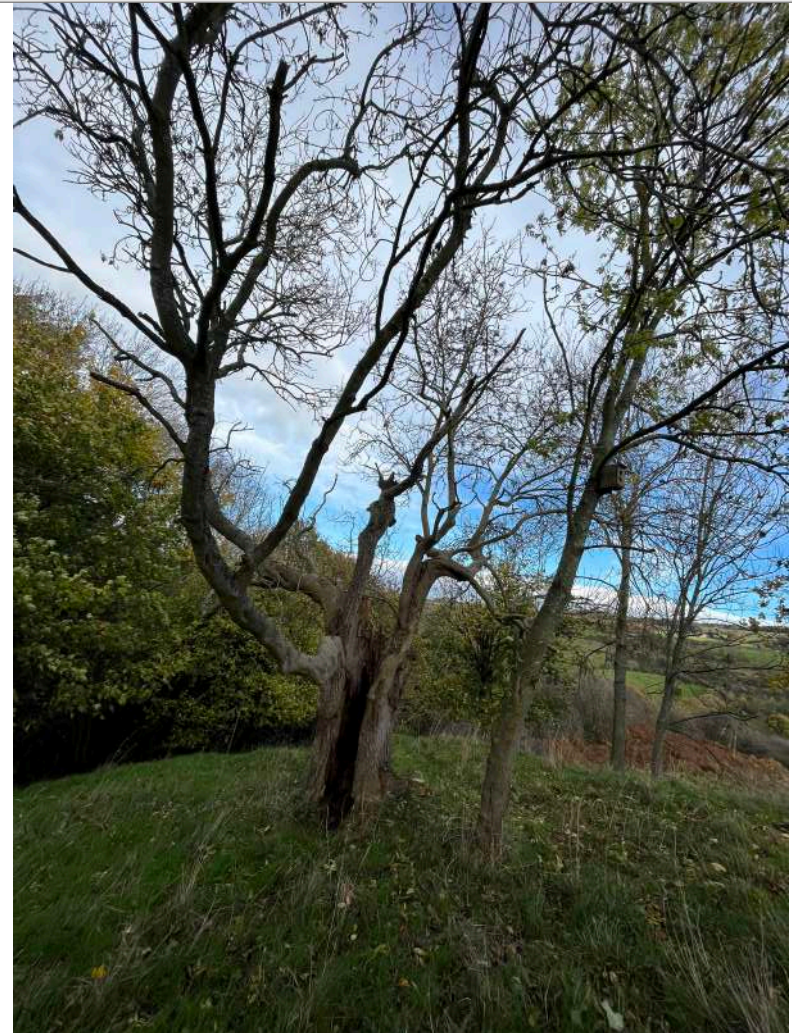
Pic 2

T003	Common Ash <i>Fraxinus excelsior</i>	Tree	1	10	107	N3 E5 W5 S5.5	Early Mature	10	6*	Butteress roots. Hollow stem from major historic failure leaving a tree growing from snapped stem (leading to adjusted RPA measurement) Previous failure at top leading to low squat form. Height to first branch 1.5m Some epicormic stress growth noted. Excellent habitat for roasting birds. Bird box on NE limb at 3 m. Slightly weakened canopy noted from pictures taken early in season.	Fair	Poor	B3	
------	---	------	---	----	-----	---------------------	-----------------	----	----	--	------	------	----	--

Showing T002 (R) and T003

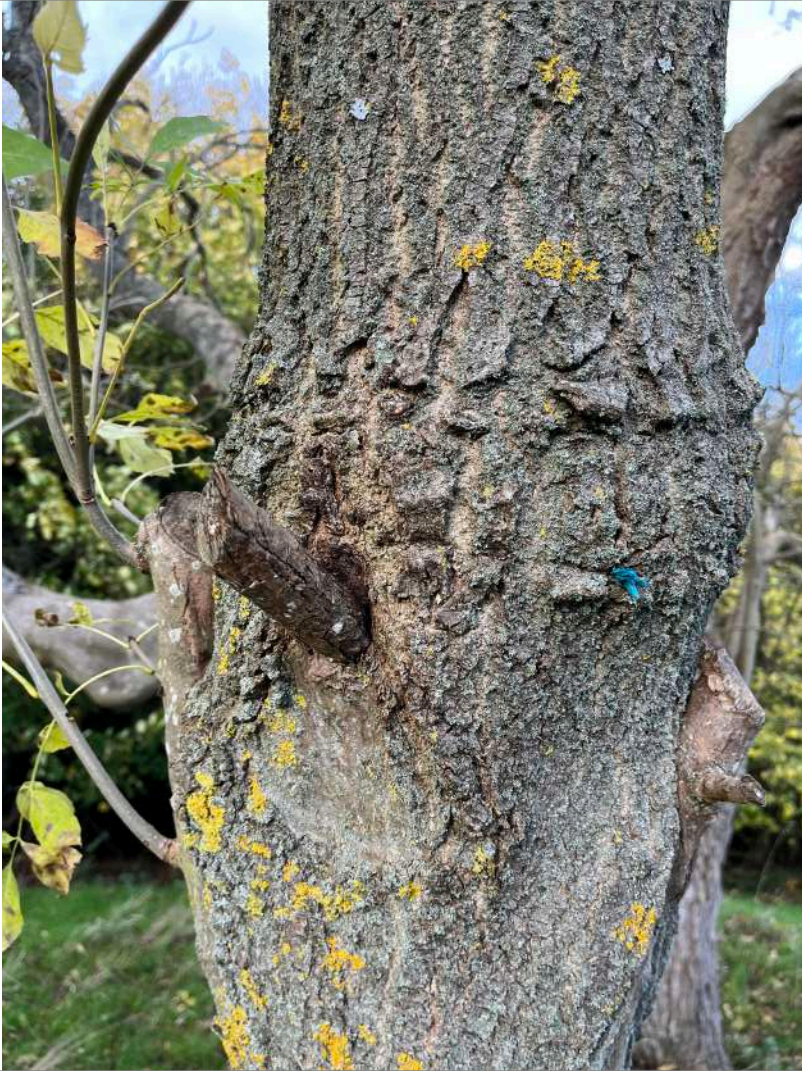
Pic 3

Showing girdling on T002
