# Arboricultural Report

Mill Inn,

Harwood Dale

## **ARBORICULTURAL REPORT AND SURVEY FOR MILL INN, HARWOOD DALE, N YORKSHIRE**

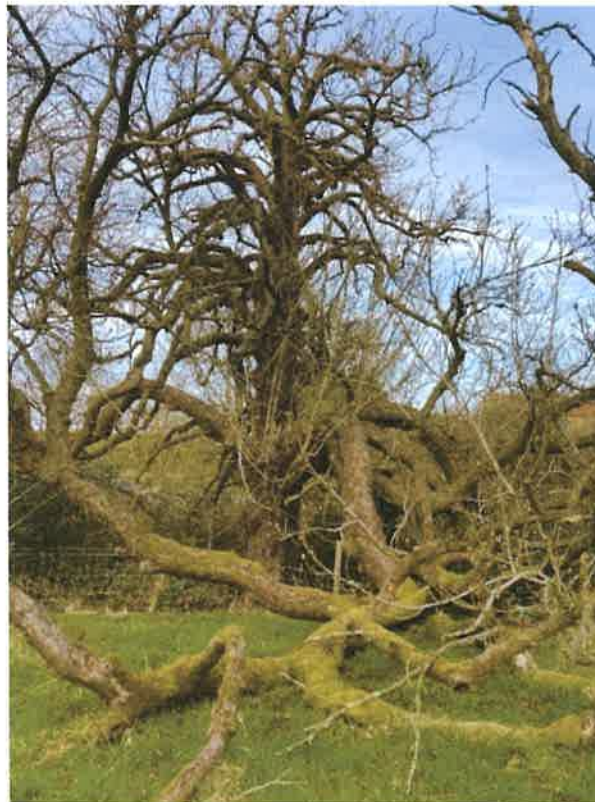
**T4 Chestnut (*aesculus hippocastanum*) shown in photograph below**

HEIGHT	CONDITION	AGE	SAFE USEFUL LIFE EXPECTANCY	LANDSCAPE RETENTION VALUE	COMMENTS	RECOMMENDATION
18 metres	Satisfactory; has large branch crack	Veteran	Approx 30 + yrs.	Good	This is a very large specimen. Has a large cracked branch laying across the floor	Pruning as required, to crown clean the canopy.

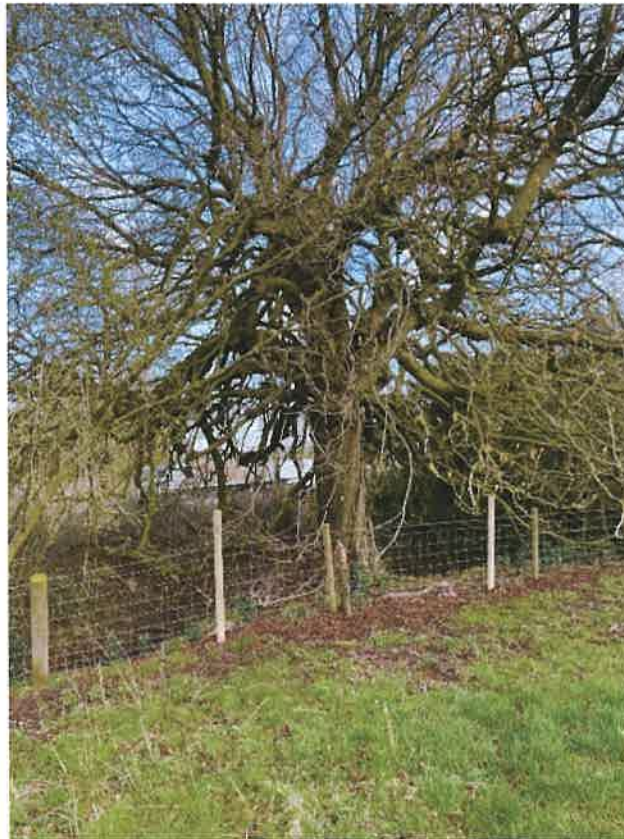
**T6 Chestnut (*aesculus hippocastanum*) shown in photograph below**

HEIGHT	CONDITION	AGE	SAFE USEFUL LIFE EXPECTANCY	LANDSCAPE RETENTION VALUE	COMMENTS	RECOMMENDATION
19 metres	Satisfactory	Mature	Approx 50 + yrs.	Good but requires crown cleaning work	A mature specimen but with dead wood throughout crown.	Pruning to crown clean the canopy, has possible chestnut canker disease.  Reassess in summer when this tree is in leaf and monitor.  Pruning may be required to crown lift and reduce over the field.

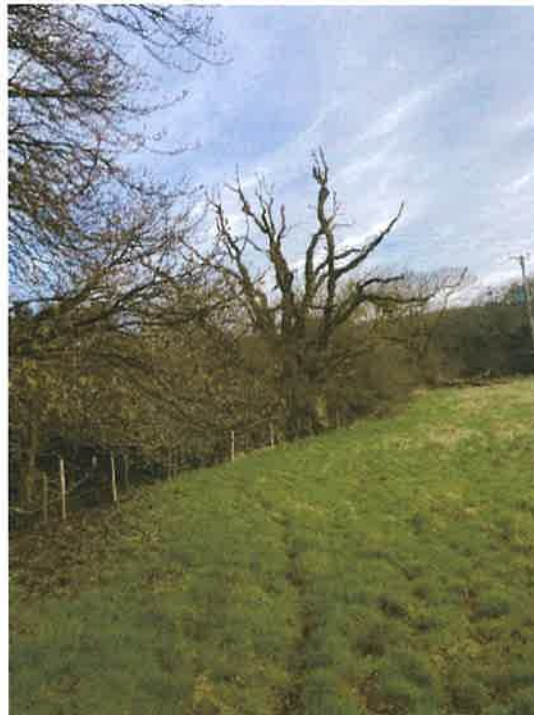
**T7 Chestnut (*aesculus hippocastanum*) in photograph below**

HEIGHT	CONDITION	AGE	SAFE USEFUL LIFE EXPECTANCY	LANDSCAPE RETENTION VALUE	COMMENTS	RECOMMENDATION
14 metres	Dead	n/a	0 – tree appears to be fully dead	Could be retained but is very close to power line	Dead once mature tree	Removal is likely to be required due to proximity of the power line, possibility of failure of branches striking the line.

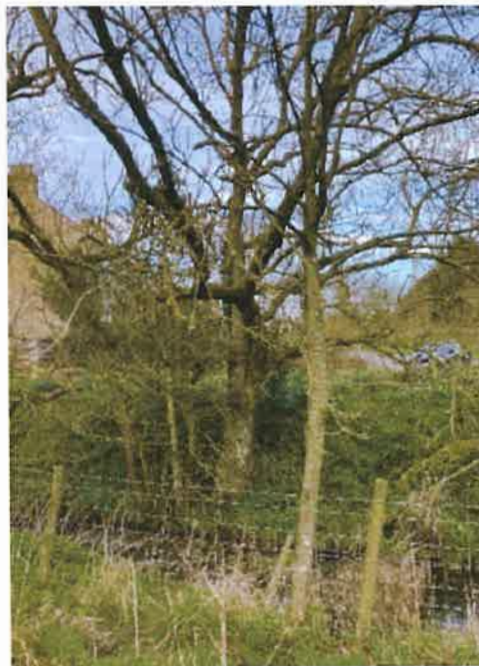
**T8 Ash (*fraxinus excelsior*) shown in photograph below**

HEIGHT	CONDITION	AGE	SAFE USEFUL LIFE EXPECTANCY	LANDSCAPE RETENTION VALUE	COMMENTS	RECOMMENDATION
14 metres	Satisfactory		30 + years	Good for retention	Self seeded tree within tree group, dead wood present.	Possible branch pruning to clear beck area / for access - removal of significant dead wood and crown cleaning recommended

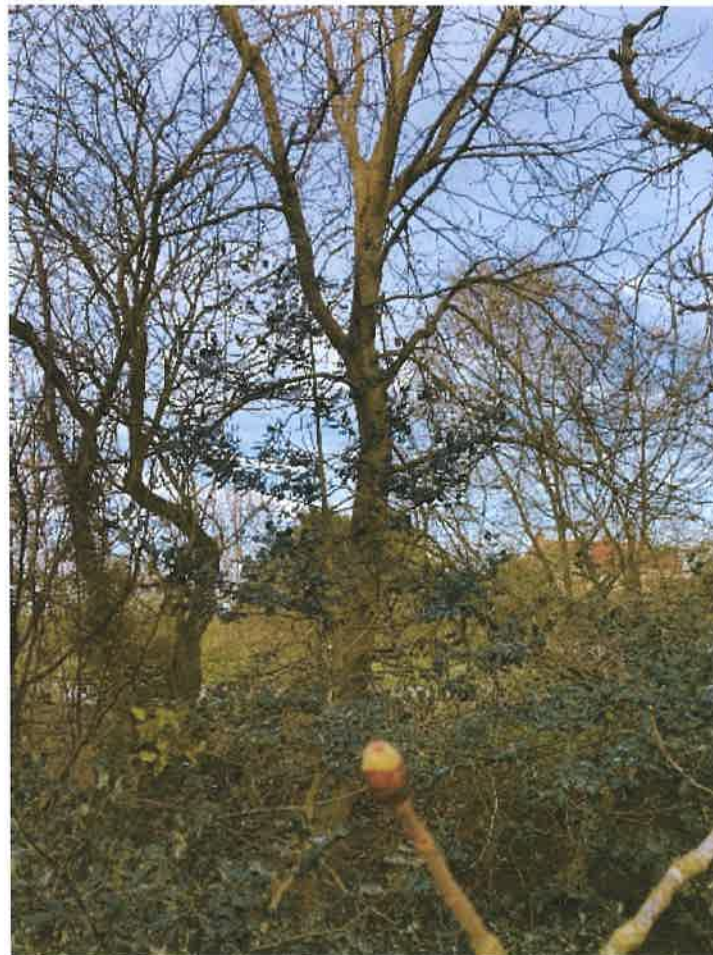
**T11 Ash (*fraxinus excelsior*) shown in photograph below**

HEIGHT	CONDITION	AGE	SAFE USEFUL LIFE EXPECTANCY	LANDSCAPE RETENTION VALUE	COMMENTS	RECOMMENDATION
12 metres	Poor – structural defect	Semi mature	n/a	Low due to structural fault in tree	Tree has a vertical crack in the stem at the top	Fell tree due to structural fault central crack in stem / lack of long term viability

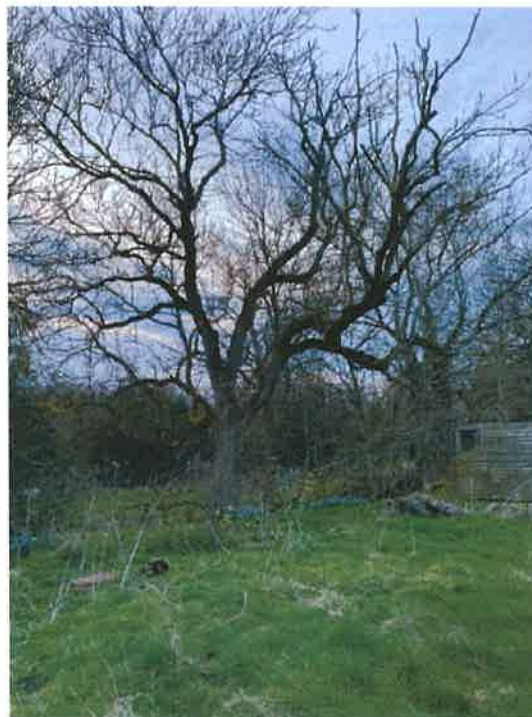
**T13 Ash (*fraxinus excelsior*) shown in photograph below**

HEIGHT	CONDITION	AGE	SAFE USEFUL LIFE EXPECTANCY	LANDSCAPE RETENTION VALUE	COMMENTS	RECOMMENDATION
14 metres	Good / dead wood present	Mature	Average	Low due to structural fault in tree	Low co dominant branch overhanging beck, but this is mostly dead. Significant dead wood, reshoots and suckers forming at base.	Crown clean recommended. This would involved removal of large dead branch across the beck. No further work required unless pruning to clear the beck.

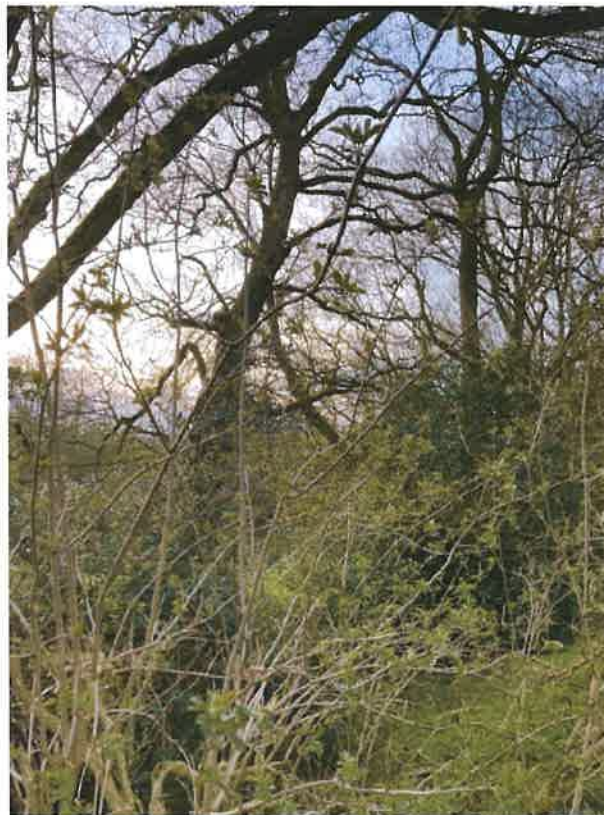
**T16 Sycamore (*acer pseudoplatanus*)**

HEIGHT	CONDITION	AGE	SAFE USEFUL LIFE EXPECTANCY	LANDSCAPE RETENTION VALUE	COMMENTS	RECOMMENDATION
4 metres	diseased	Semi mature	Low	Low	Growing centrally in beck.	Fell tree as it is suppressed by larger T15

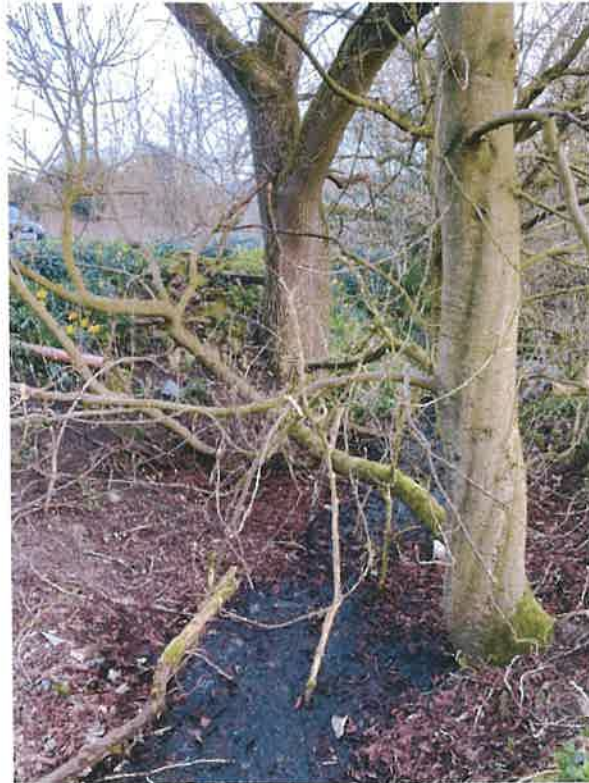
**T17 Chestnut (*aesculus hippocastanum*) shown in photograph below**

HEIGHT	CONDITION	AGE	SAFE USEFUL LIFE EXPECTANCY	LANDSCAPE RETENTION VALUE	COMMENTS	RECOMMENDATION
19 metres	Satisfactory	Mature	Approx 30 + yrs.	Good but requires crown cleaning work	A mature specimen but with dead wood	Retain tree but pruning to crown clean the canopy, Low branch crossing the beck, possibly to remove

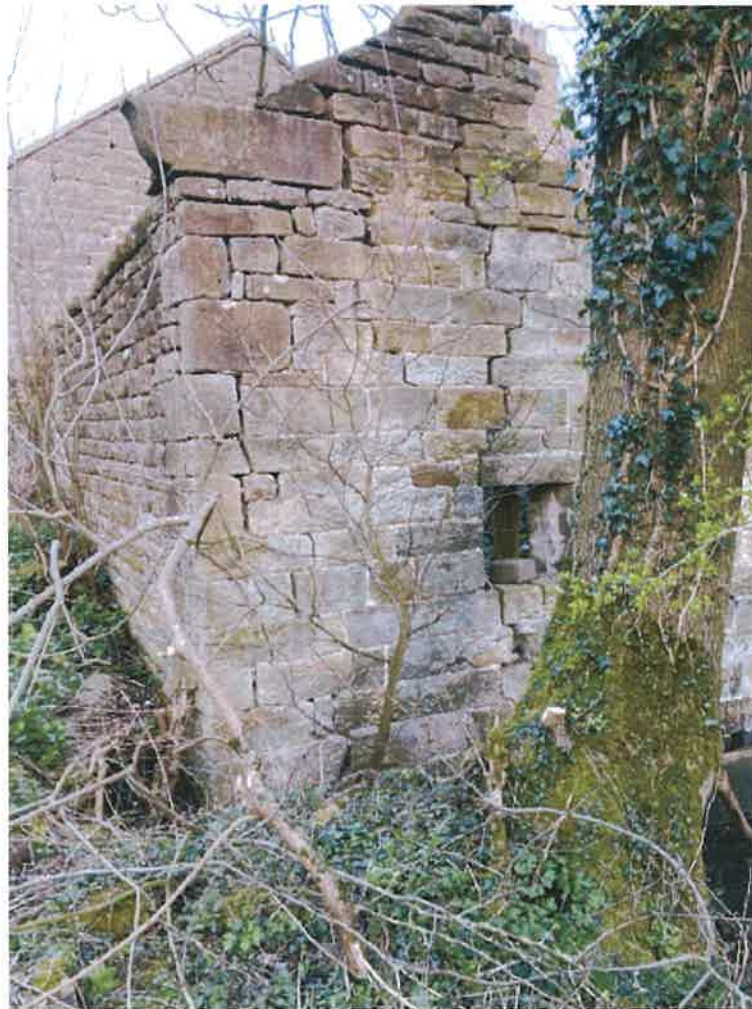
**T18 Ash (*fraxinus excelsior*) shown in photograph below**

It was noted that part of the original building where there was a former mill wheel has become overgrown with self seeded, unmaintained trees and these appear to have created tree related subsidence to the property (this can be noted due to the presence of large cracks in that part of the building). Where trees that have been left unmaintained after self seeding close to the property, the recommendation is for those trees to be felled to allow the building to be repaired and that tree related subsidence does not progress further.

HEIGHT	CONDITION	AGE	SAFE USEFUL LIFE EXPECTANCY	LANDSCAPE RETENTION VALUE	COMMENTS	RECOMMENDATION
19 metres	Satisfactory but damaging the building	Mature	Low	None	Close to the original wheel / mill area. Damaging building	Fell tree as it is creating conditions of structural damage to the property, not suitable for retention.

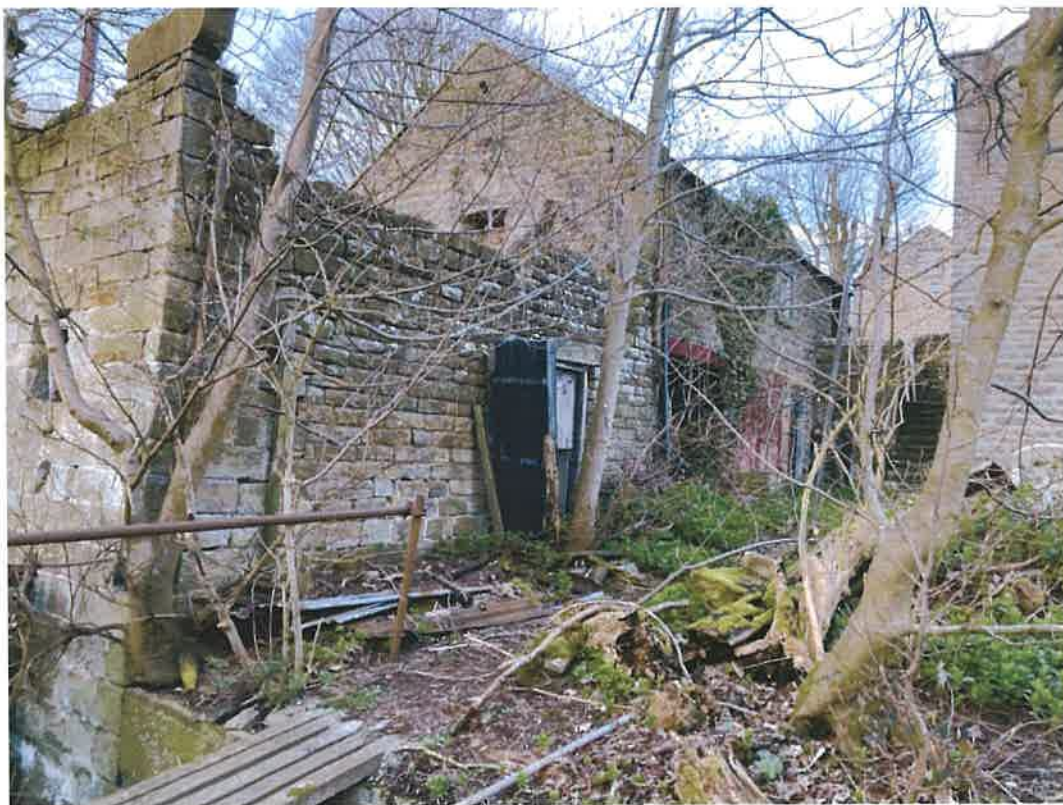
**T19, 20, 21, 23 Sycamore (*acer pseudoplatanus*) shown in photograph below**

HEIGHT	CONDITION	AGE	SAFE USEFUL LIFE EXPECTANCY	LANDSCAPE RETENTION VALUE	COMMENTS	RECOMMENDATION
12 metres	Satisfactory	Mature	Average	None	Close to the small wooden access bridge and outhouse area designated as Tea Room in future proposals.	Fell trees – these are self seeded / close to bridge and building, causing structural damage – unsustainable and not suitable for retention in this location
