31ST MAY 2023

**STRUCTURAL SURVEY ON
BARNs ADJACENT NORTH
MOOR COTTAGE EAST,
WYKEHAM, SCARBOROUGH,
NORTH YORKSHIRE, YO13 9QH**

**PROJECT NO.
MGC/PAA/JC/49160 RPT-001
REVISION A**

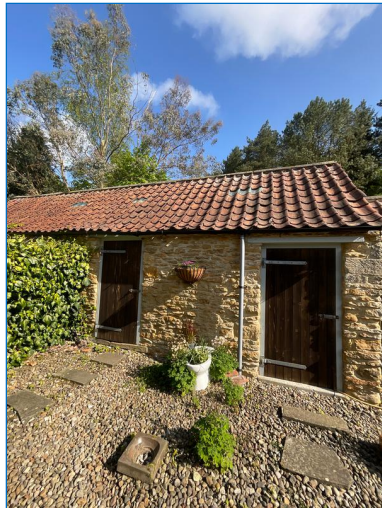
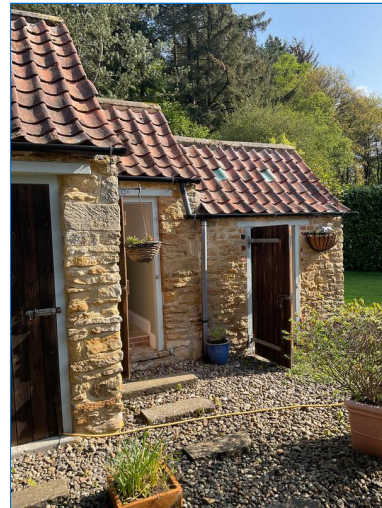
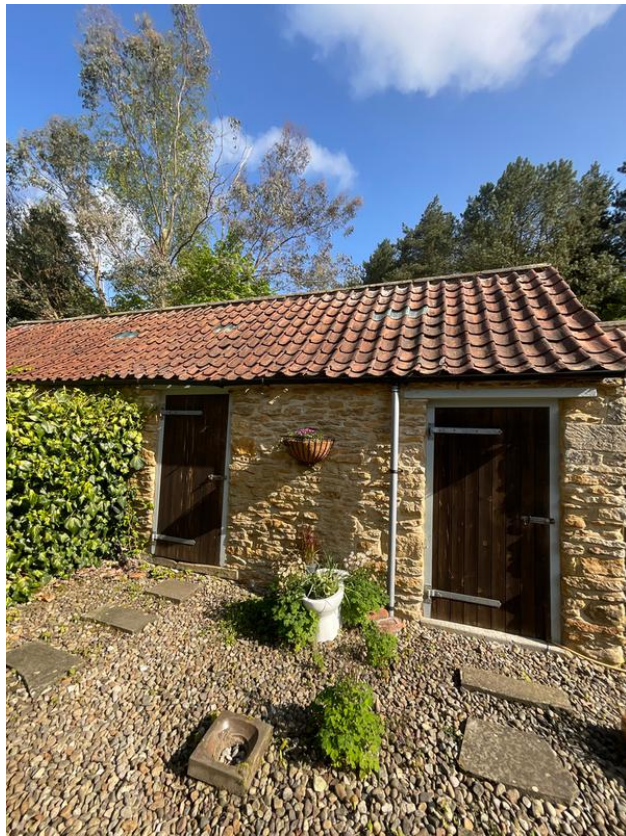
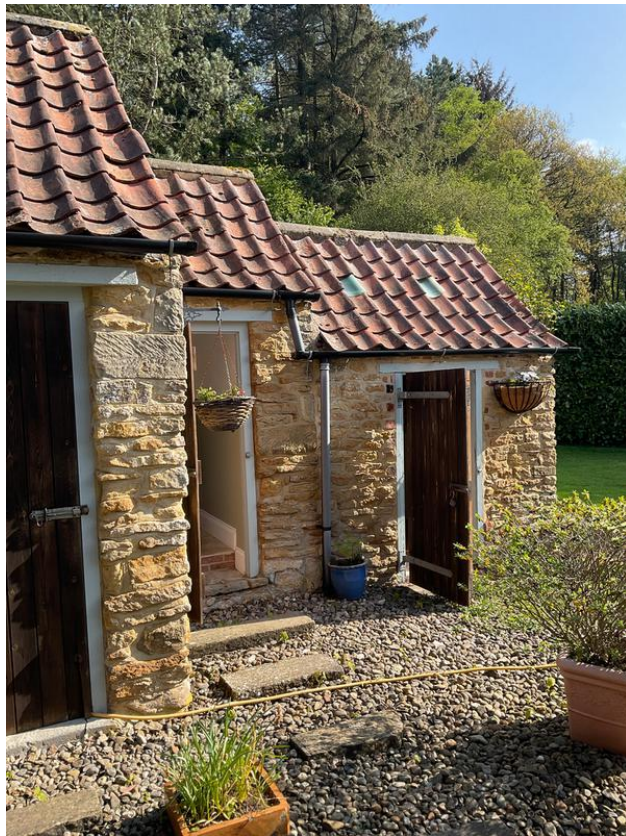
The aged roof covering to the front pitch has distortion evident throughout its length to all aspects.

It is noted, however, that the ridge line is relatively even.

The staining to the ceiling of the dairy indicates failure of the pantile roof covering. This was confirmed from external inspection, where the clay tiles are noted to have reached the end of their useful life.

The clay tile roof covering requires complete replacement as it has reached the end of its useful life. During this work the verge pointing will be reinstated.

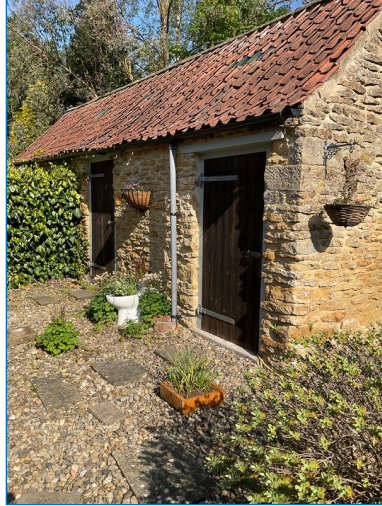
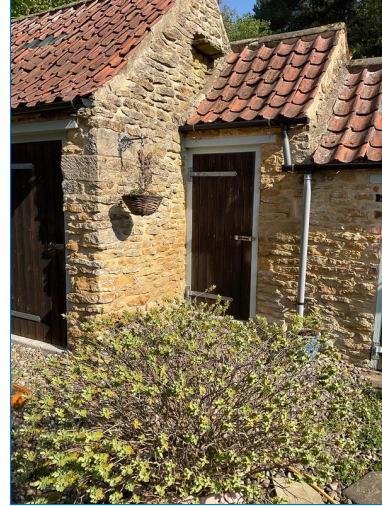
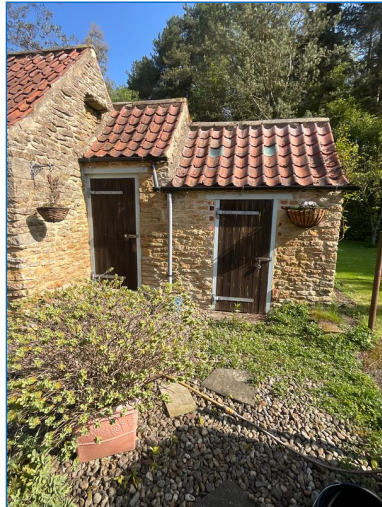
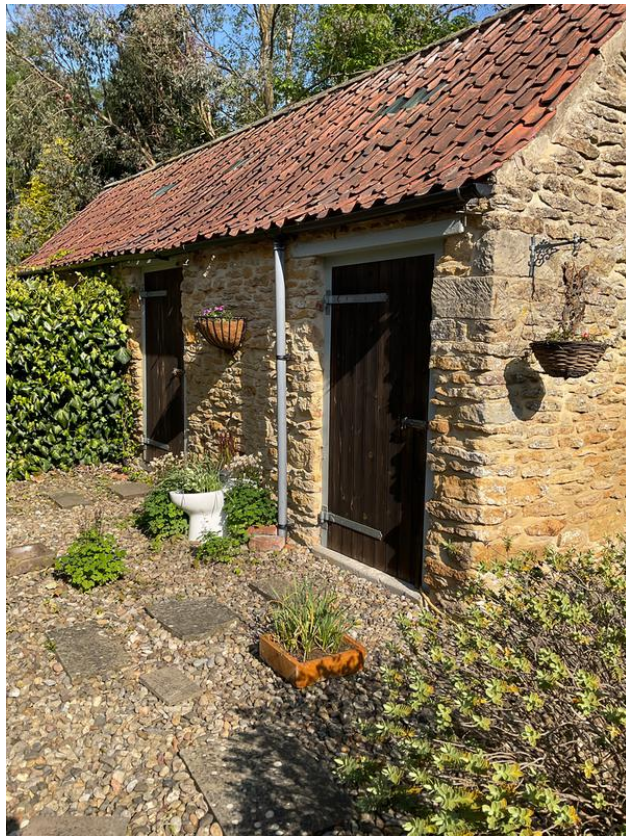
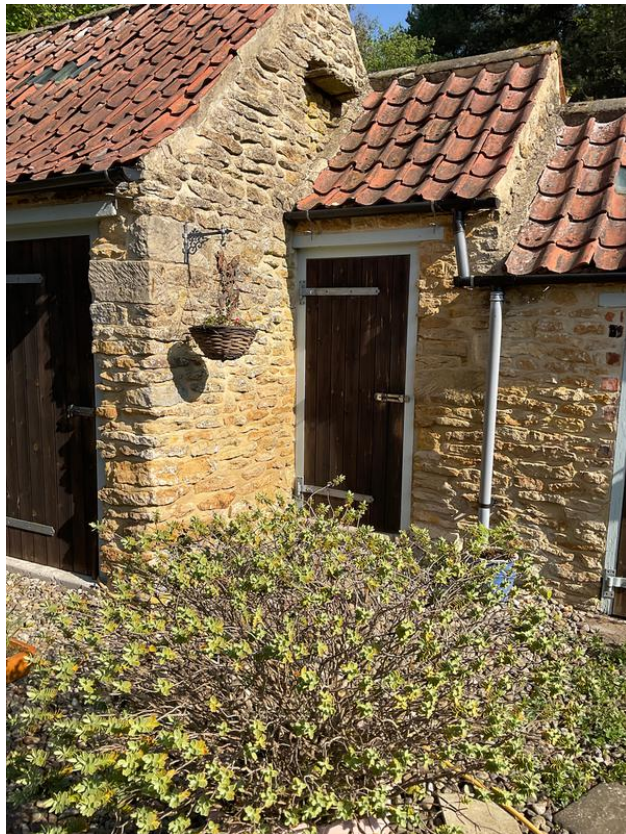
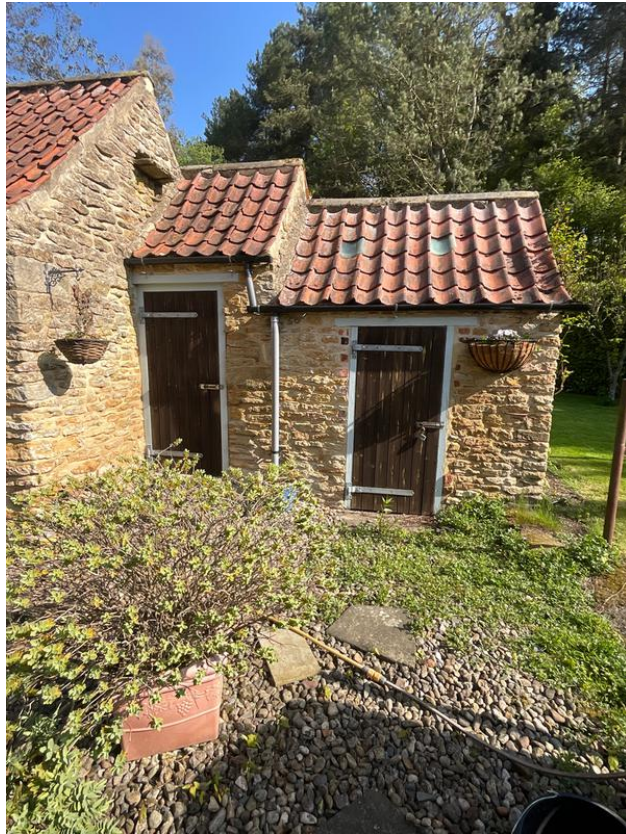
The external walls to all aspects of these barns are relatively plumb and distortion free.

There is evidence of repointing throughout the front elevation and partially to the exposed gable of the larger barn.

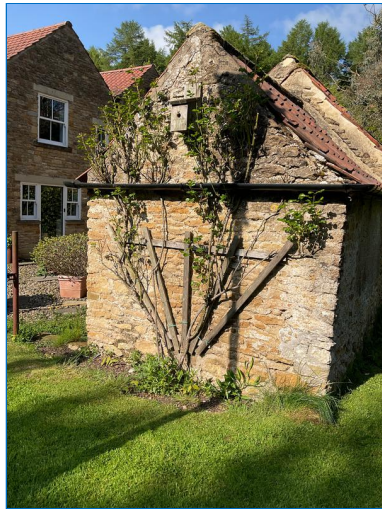
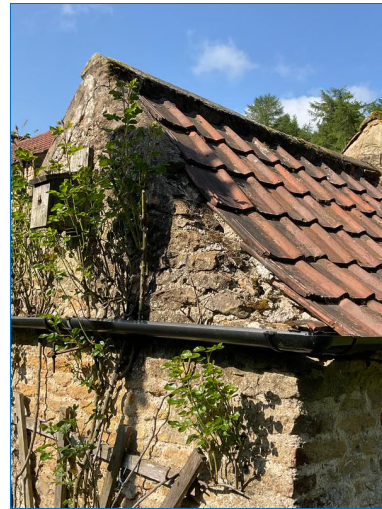
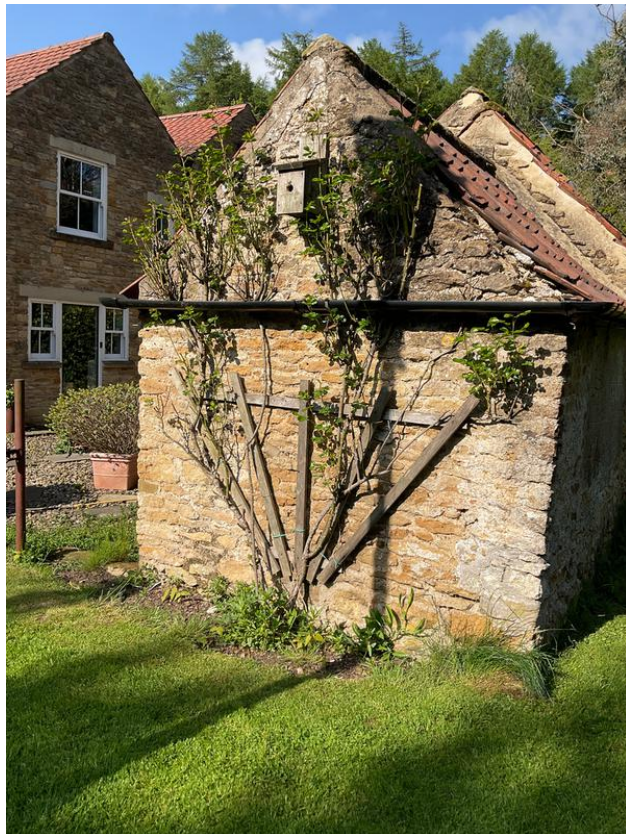
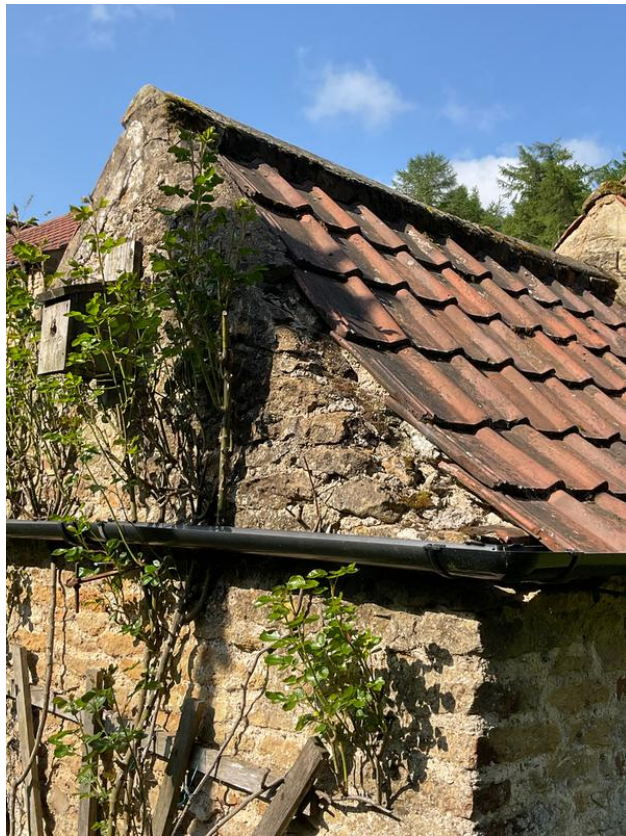
This elevation is of stone construction and has climbing vegetation evident throughout the elevation.

This wall also retains land to a height of approximately 200mm to the gable and rear elevation.

There is missing verge pointing to the rear of this gable.

The missing verge pointing to the gable elevation is due to weathering of this area.

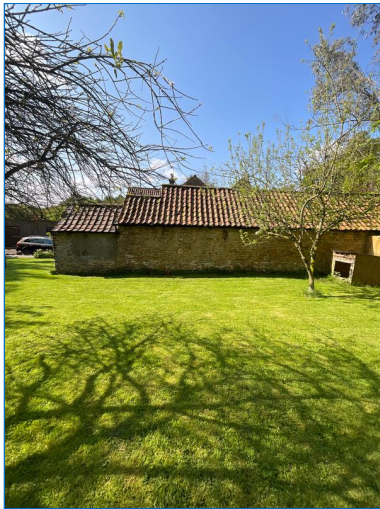
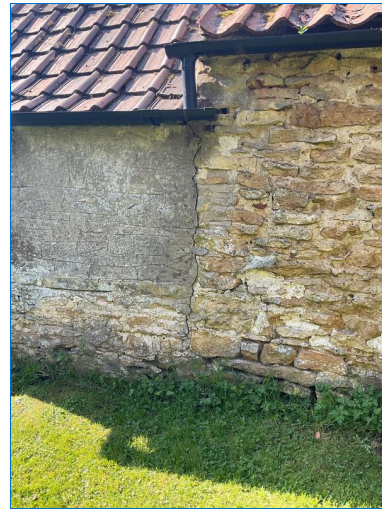
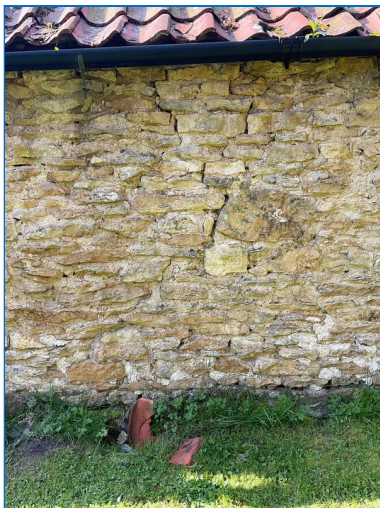
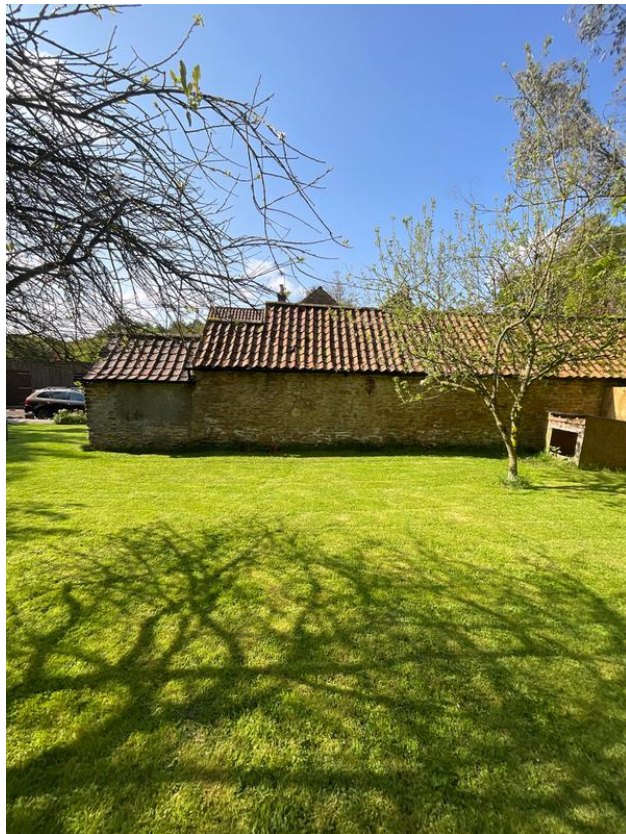
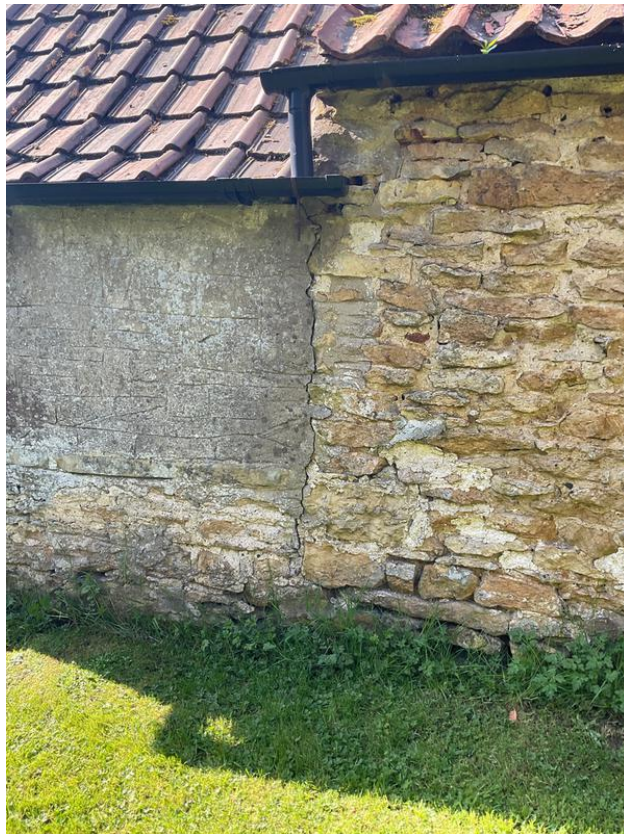
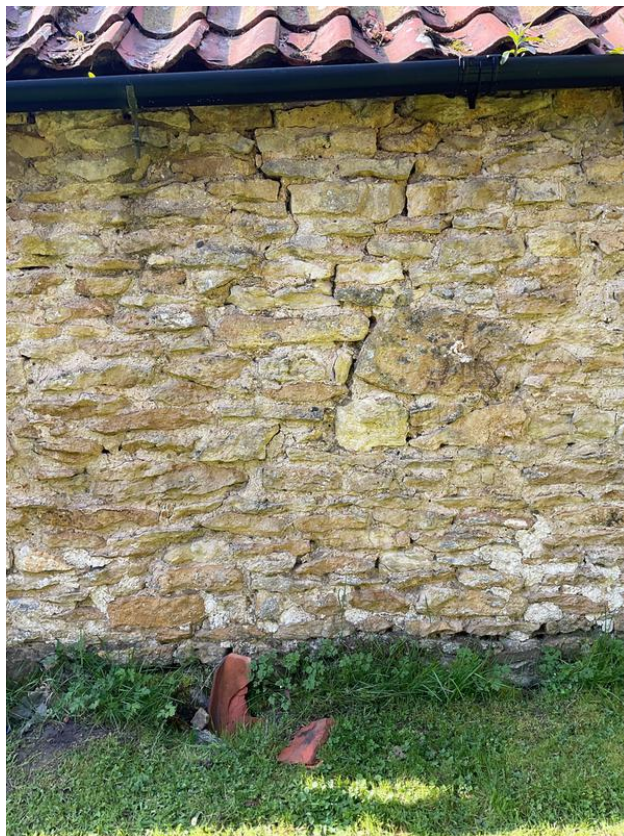
The rear elevation of this barn is of stone construction and has a straight joint evident where the lower level barn to the right is attached.

There is some hairline cracking to the rear elevation wall, approximately one third of the way along its length.

This cracking is at a point where a relatively weak, almost vertical, joint is present.

The external cracking to the rear elevation is typical of historic movement having taken place to this agricultural building. The cracking has occurred on a line of weakness where a near straight joint is evident to the stonework.

The open joints to the stonework within the barn and the straight joint to the rear elevation are a feature of construction.

The external cracking to the rear elevation should be subject to stitch repair by inserting bedjoint reinforcement across the cracking where possible.

In order to aid restraint to the rear elevation, sock anchors or similar should be installed through the rear elevation into the dividing wall between barn and store. This will restore a tie at this location.

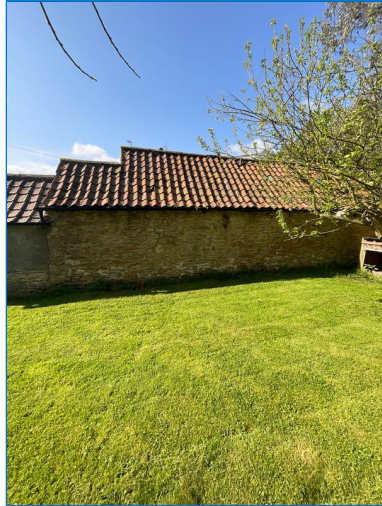
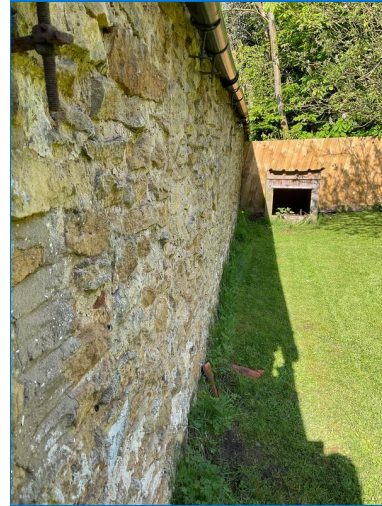
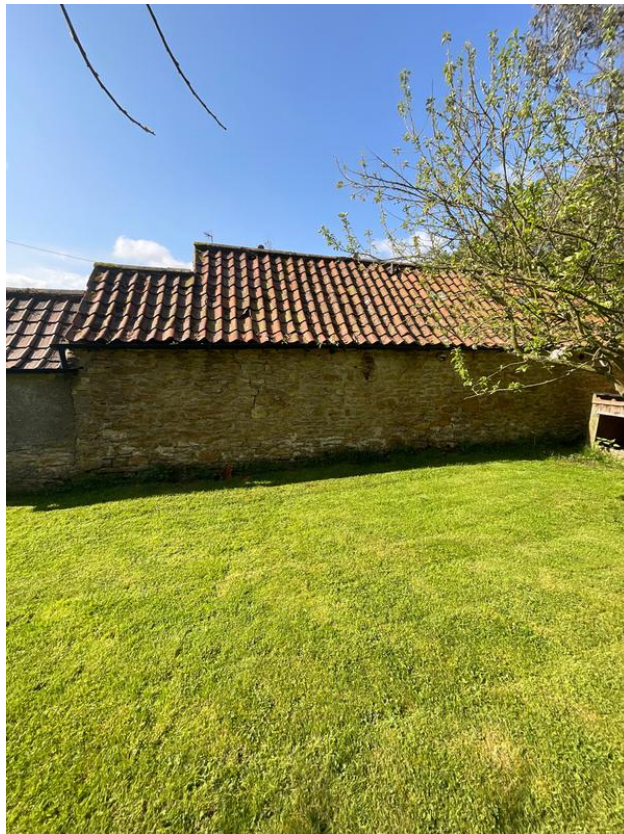
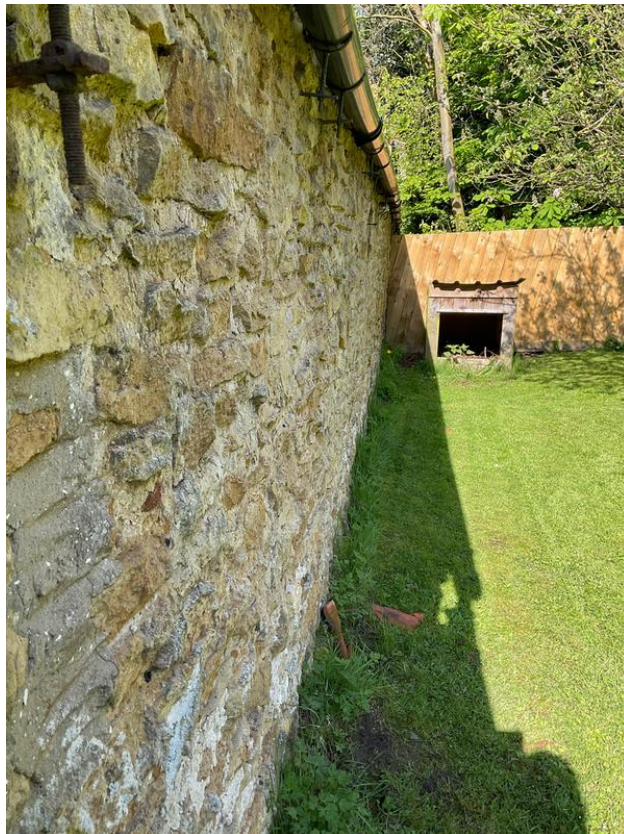
The rear roof pitch dips slightly.

It is noted that the clay tiles to the roof are spalling and have damage evident.

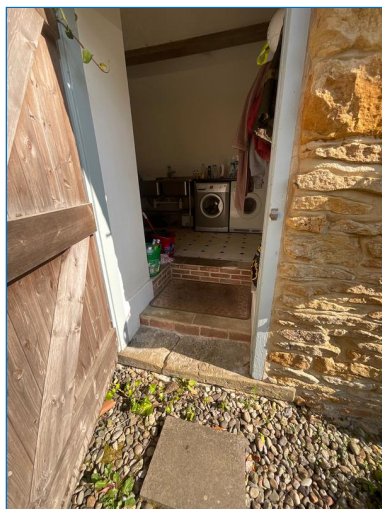
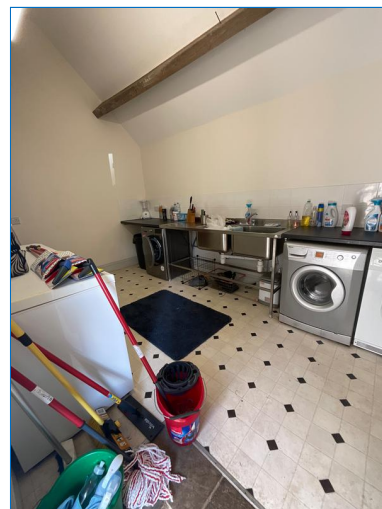
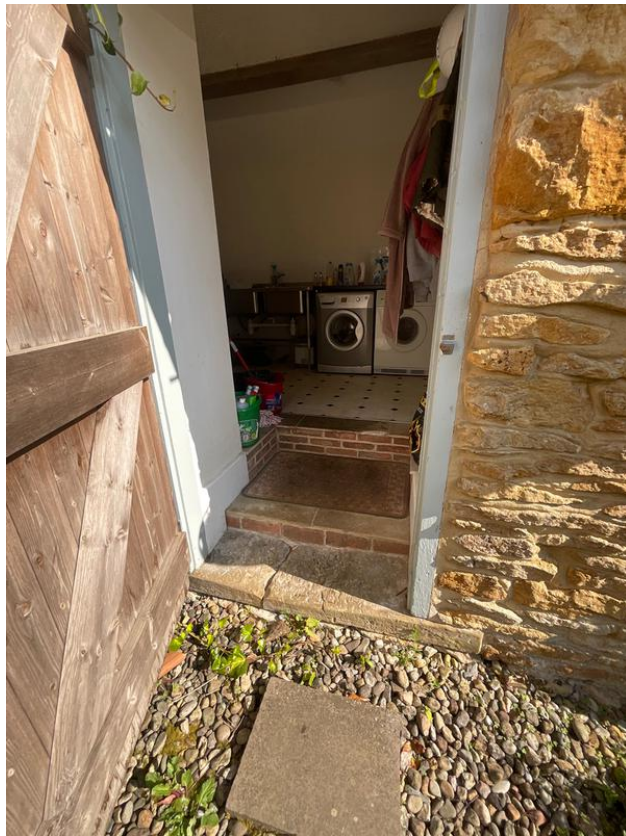
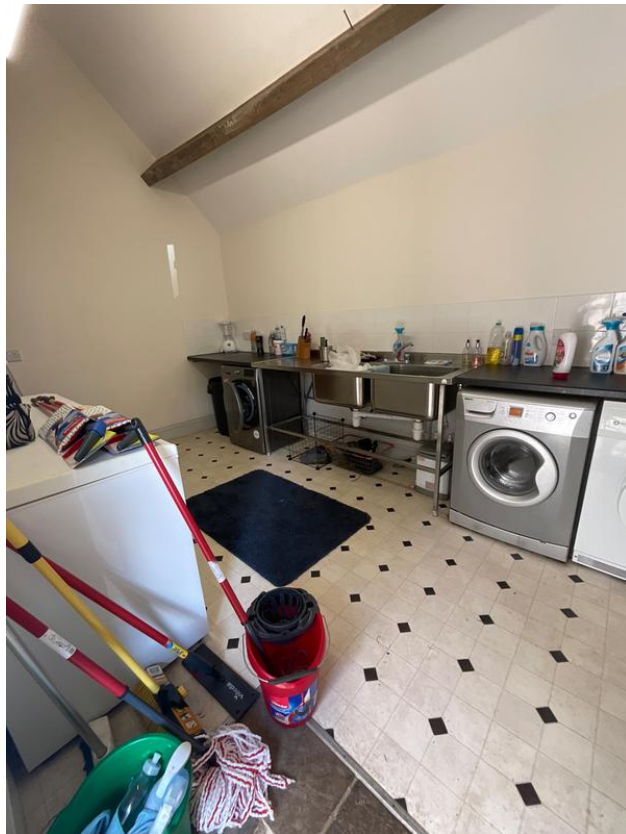
Floor level within this dairy has been raised by approximately 300 millimetres above ground level and is of suspended timber construction.

The internal walls have been dry lined and the purlins are exposed within this room.

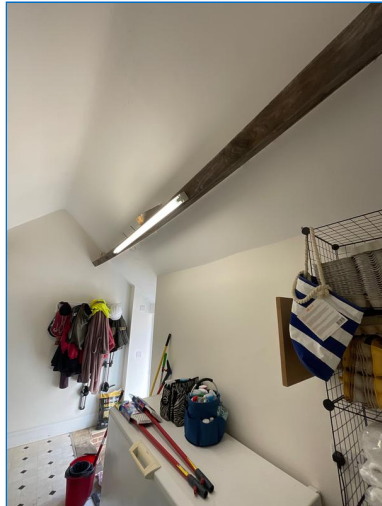
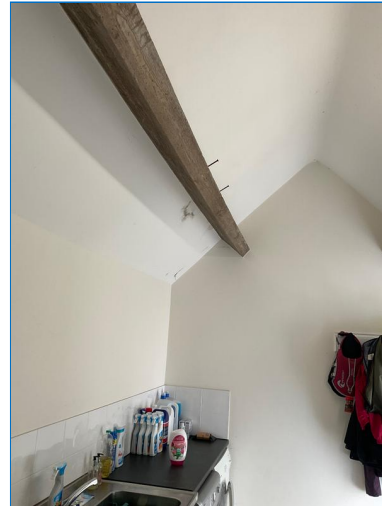
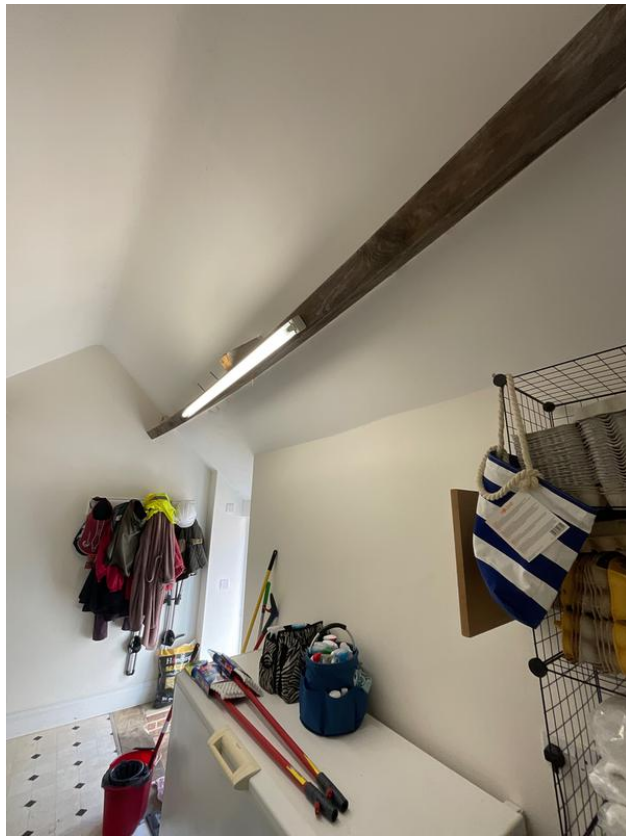
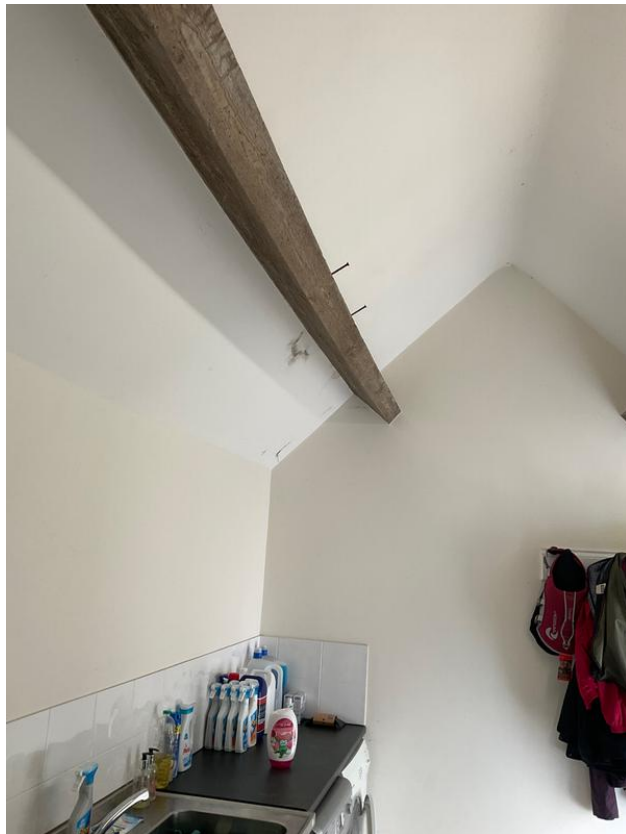
There is deflection evident to the purlin particularly to the front elevation roof slope.

There is some staining to the rear roof pitch below purlin level, indicative of water ingress.

The slight deflection to the purlins of the dairy is due to their inadequate design.

The purlins to the dairy should be subject to design check and strengthened as required.

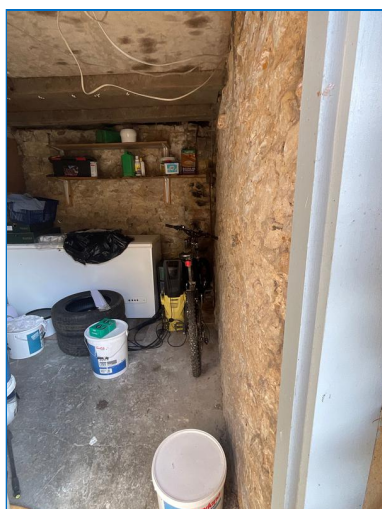
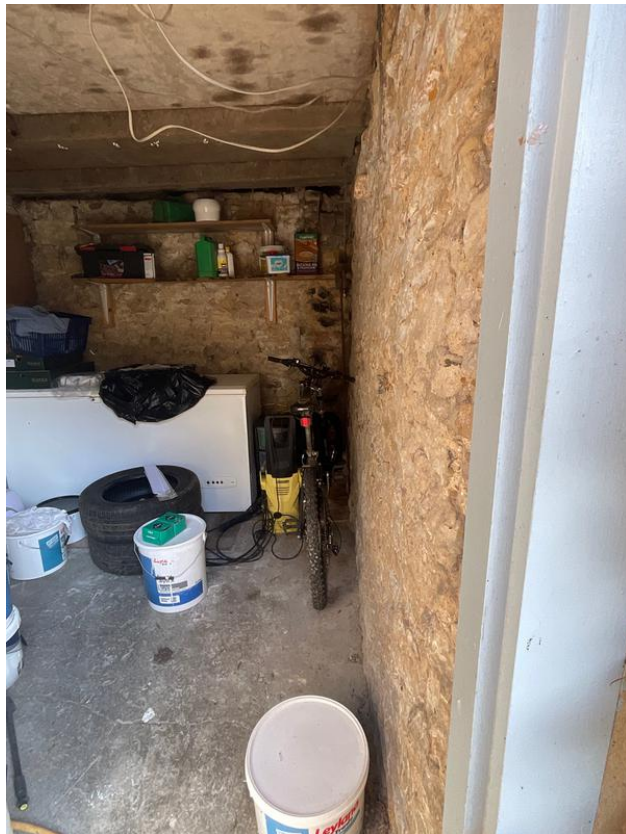
Photo - 17

There is slight distortion to the right hand elevation wall internally.

The minor distortion noted to the internal dividing wall between store and WC is a result of consolidation of the rubble fill material within the wall. It is noted that this movement is minimal.

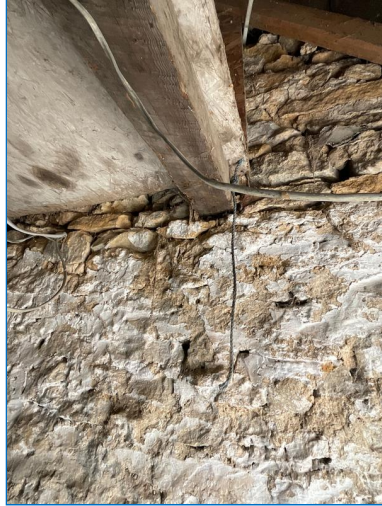
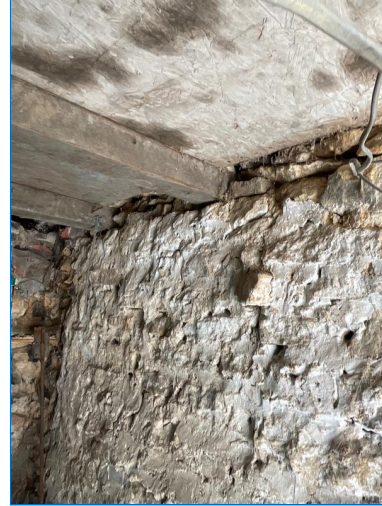
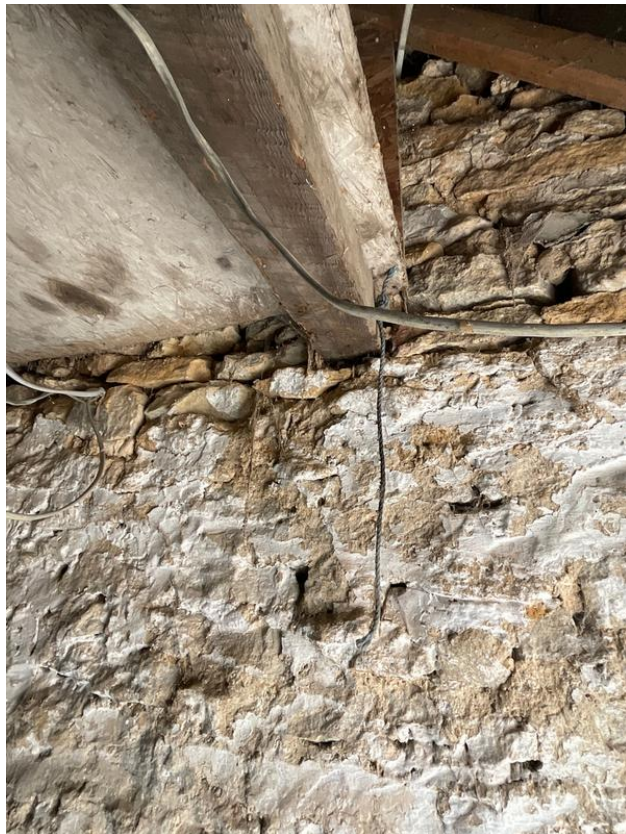
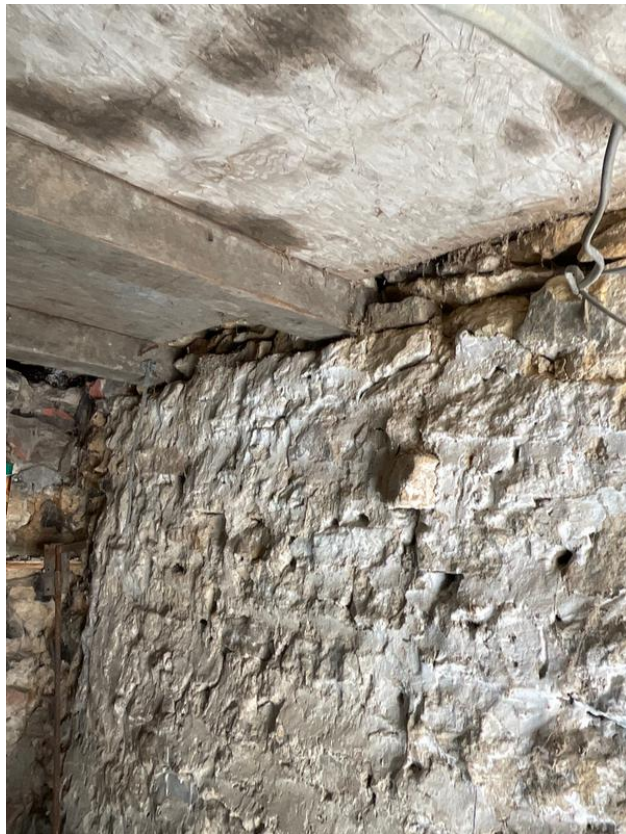
To the gable elevation wall, at mezzanine support level, there are open joints to the stone work.

The open joints where mortar is missing should be raked out and repointed in a suitable lime mortar.

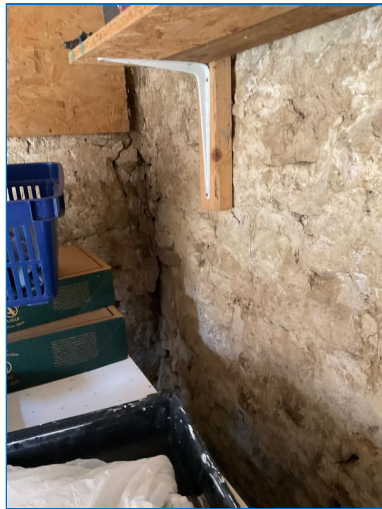
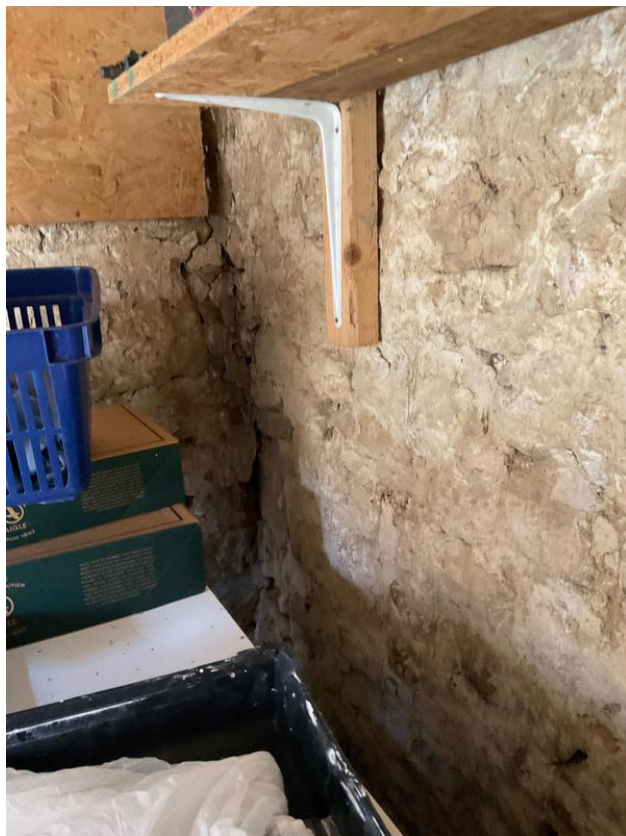
Photo - 20

At the junction of the rear elevation and the dividing wall to the dairy there is a straight joint evident which has opened very slightly.

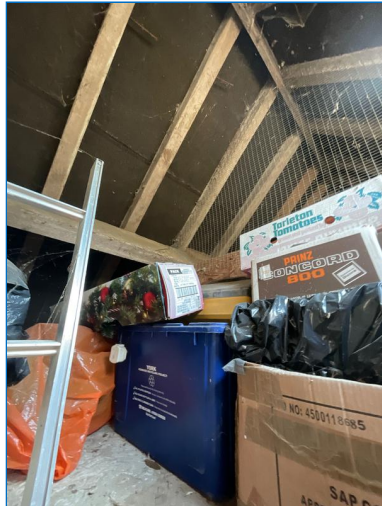
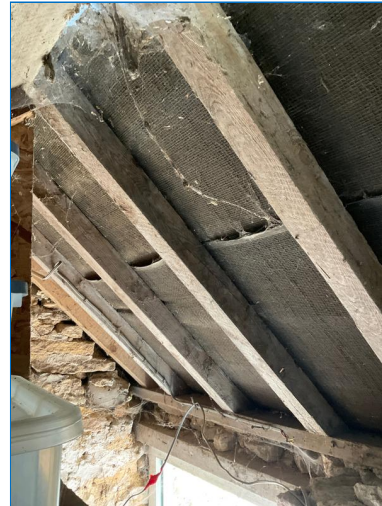
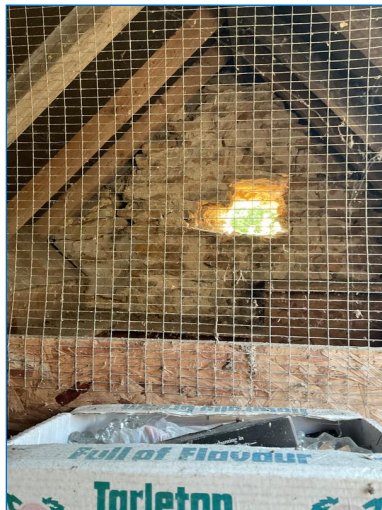
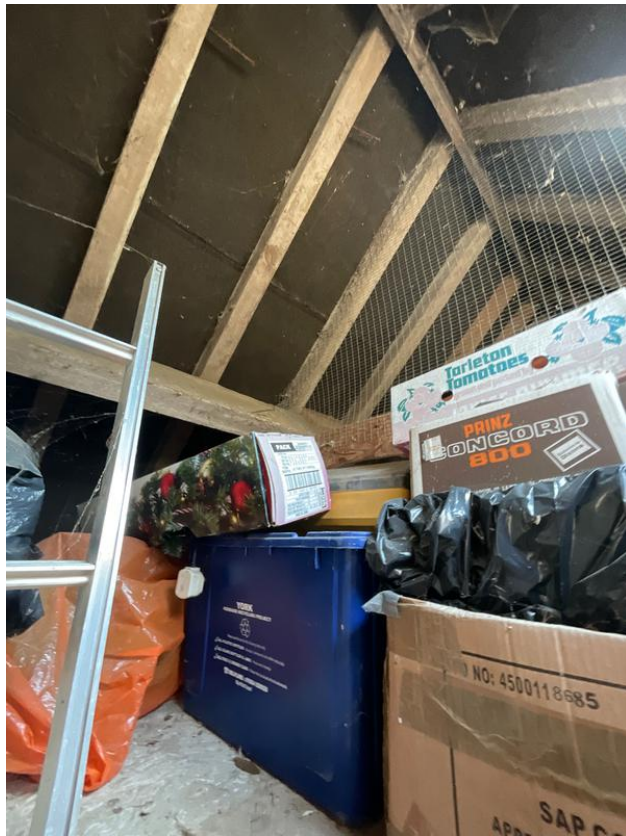
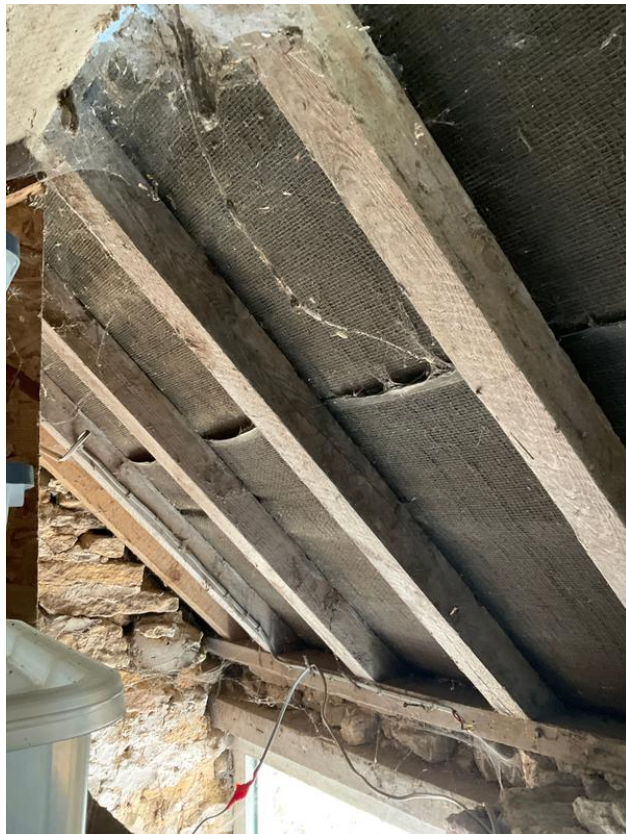
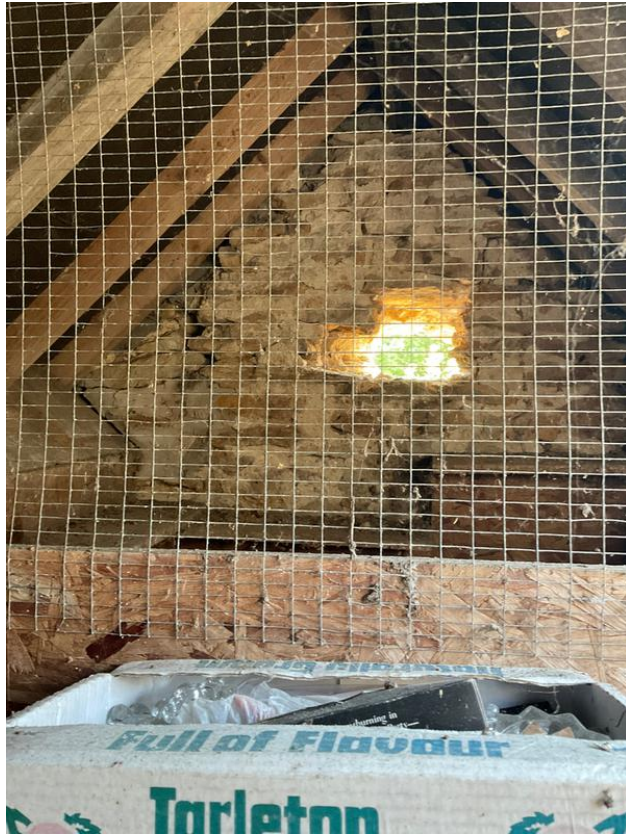
At mezzanine level the roof structure is clearly visible, comprising rafters onto purlins of similar size and location to those within the dairy.

There is evidence of defect to the roof covering externally, though no broken felt is evident internally.

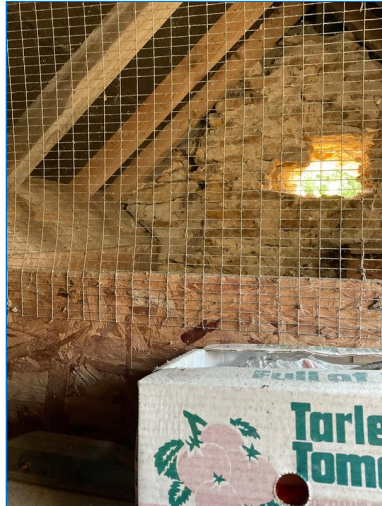
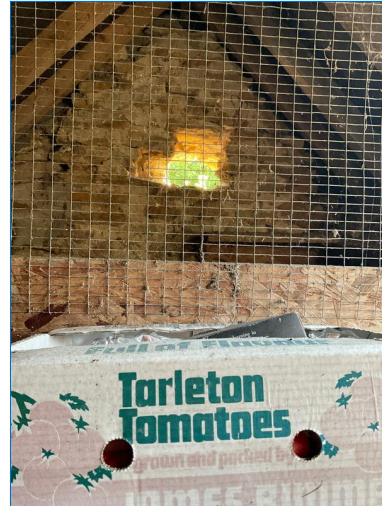
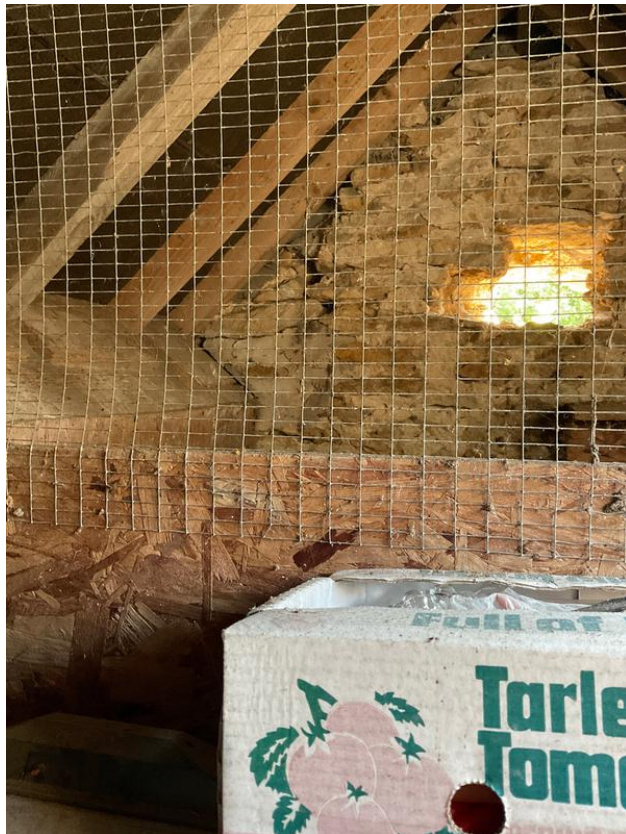
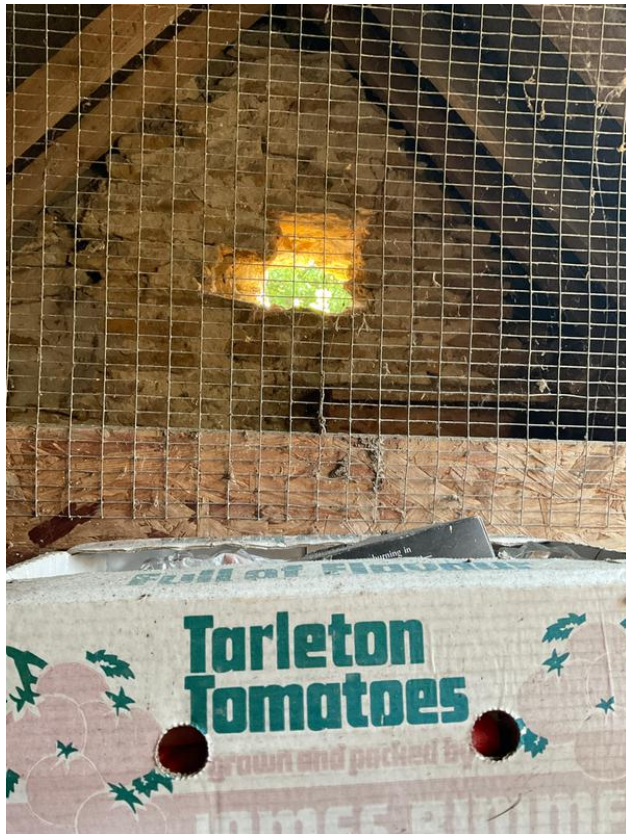
The exposed stonework to the gable elevation has an opening formed in it and there are open joints adjacent in this area.

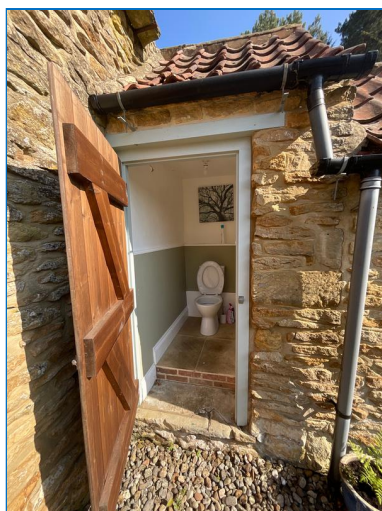
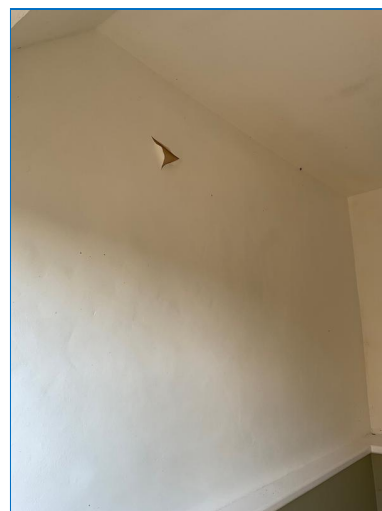
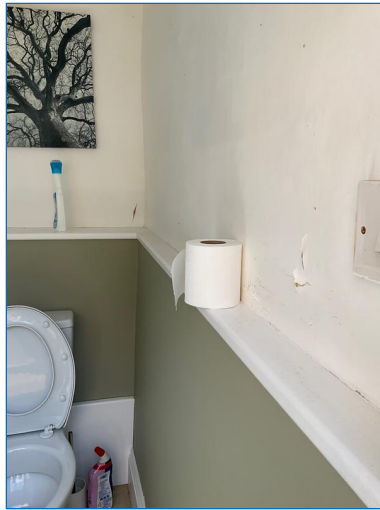
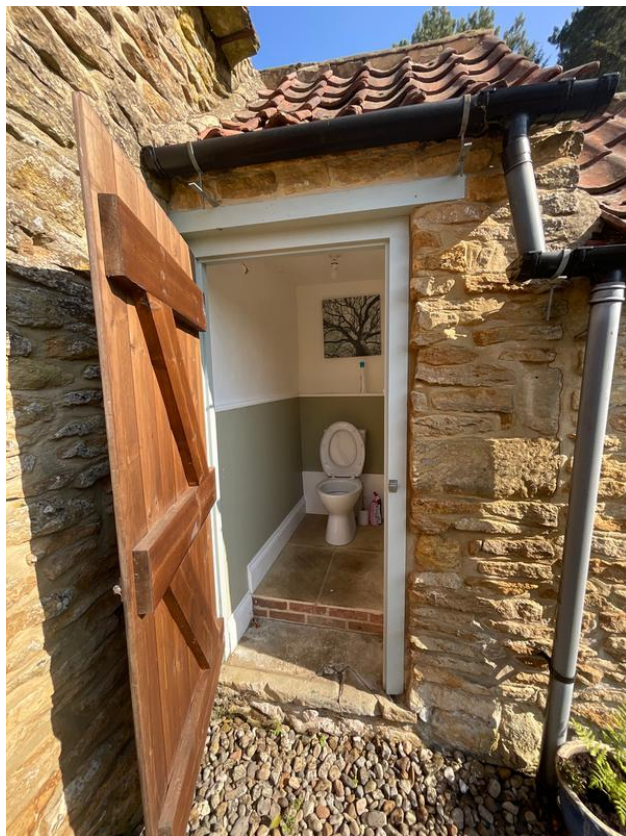
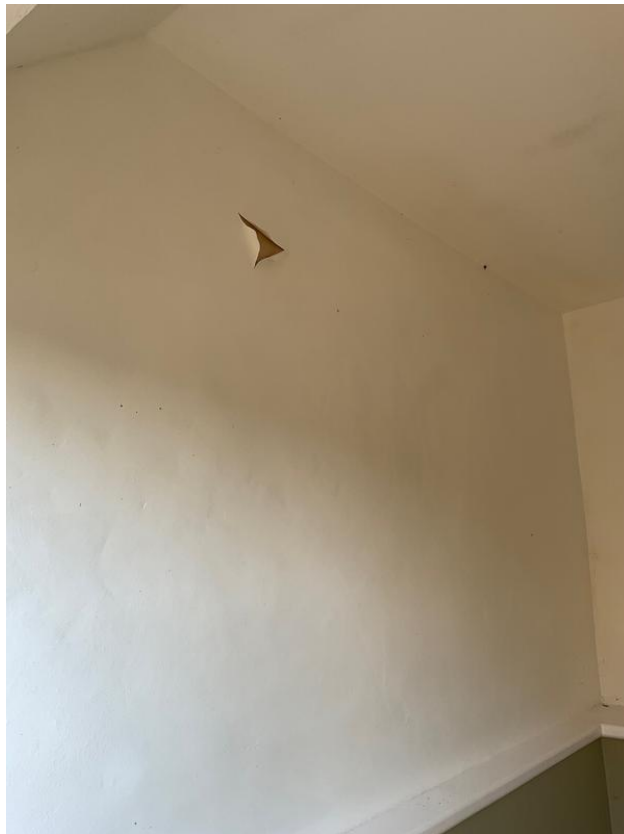
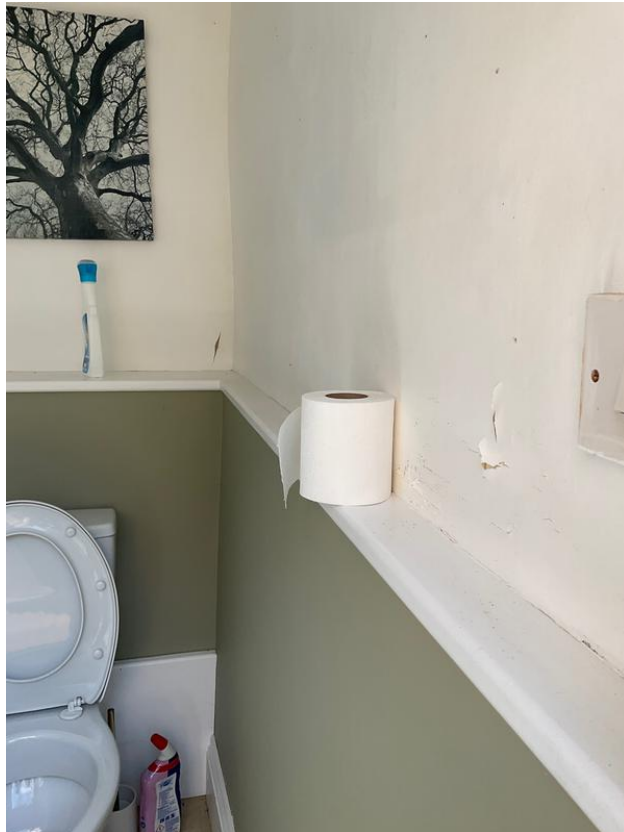
The floor within this WC is raised above ground level by approximately 300mm.

The room is dry lined and there is evidence of peeling paint to the plasterboard finish adjacent to the gable elevation wall to the adjoining barn.

Peeling paint is also noted to the dividing wall to the right of this room.

The peeling paint to the WC is likely due to large changes in temperature and moisture content within this room.

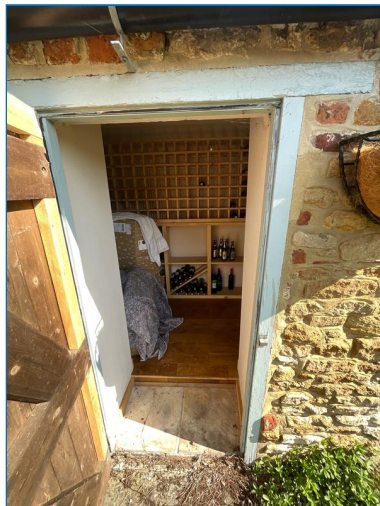
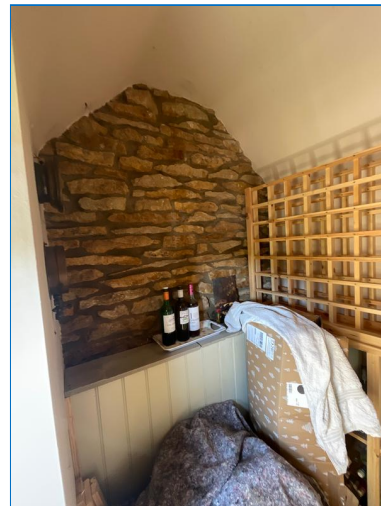
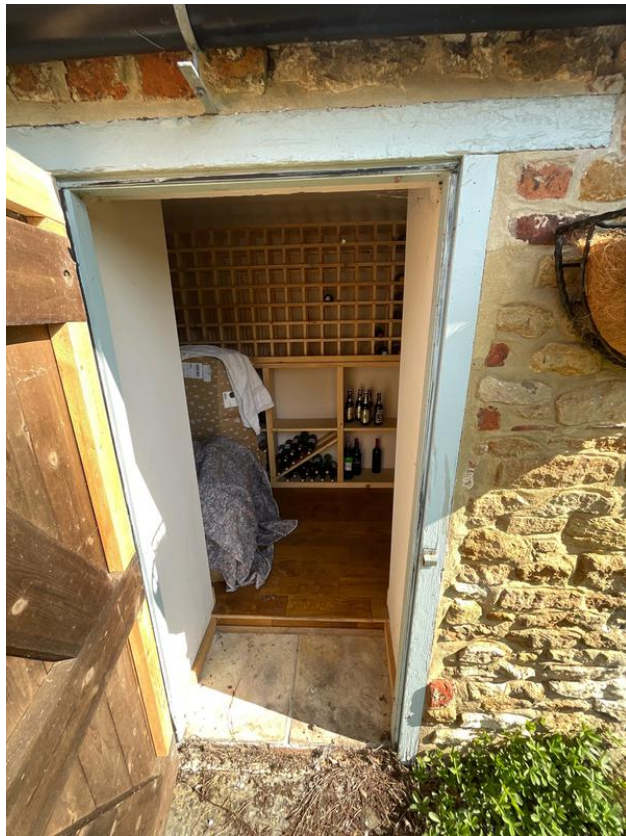
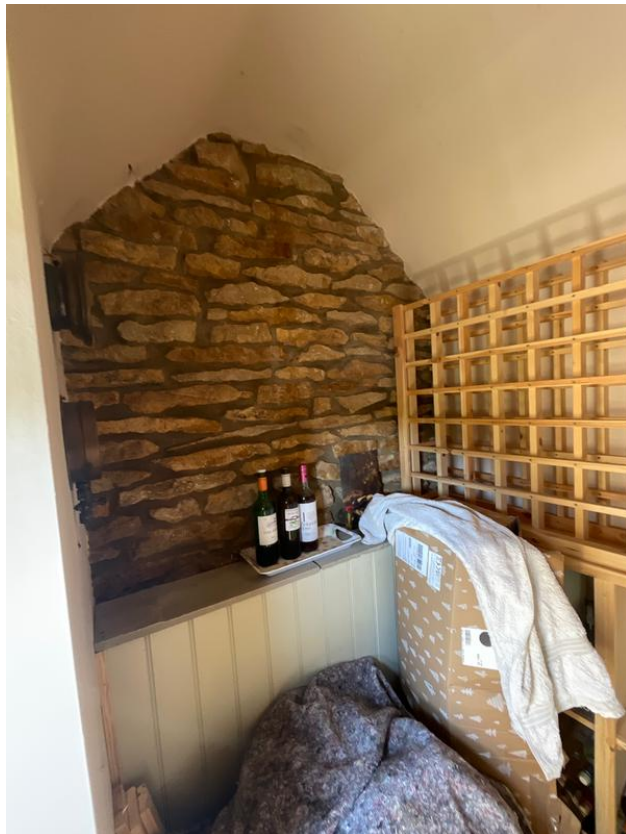
The floor to this room is raised above ground level by approximately 150mm and is of suspended timber construction.

The walls and ceiling within this room have a plasterboard finish to front and rear elevations with exposed stonework to the internal dividing wall and the external gable elevation.

There are no significant defects evident structurally within this room.
