# BS 5837: 2012 Arboricultural Impact Assessment & Method Statement

Site Address:	Prospect House Farm, Suffield, Scarborough, YO13 0BH	Client:	Mr. Joe Marshall
Report Ref:	PHFS01-23	Report Date & Revision:	29th of August 23 Revision: I
Author:	Laurence Smith BSc (Hons) Arb, M Arbor A	Signed:

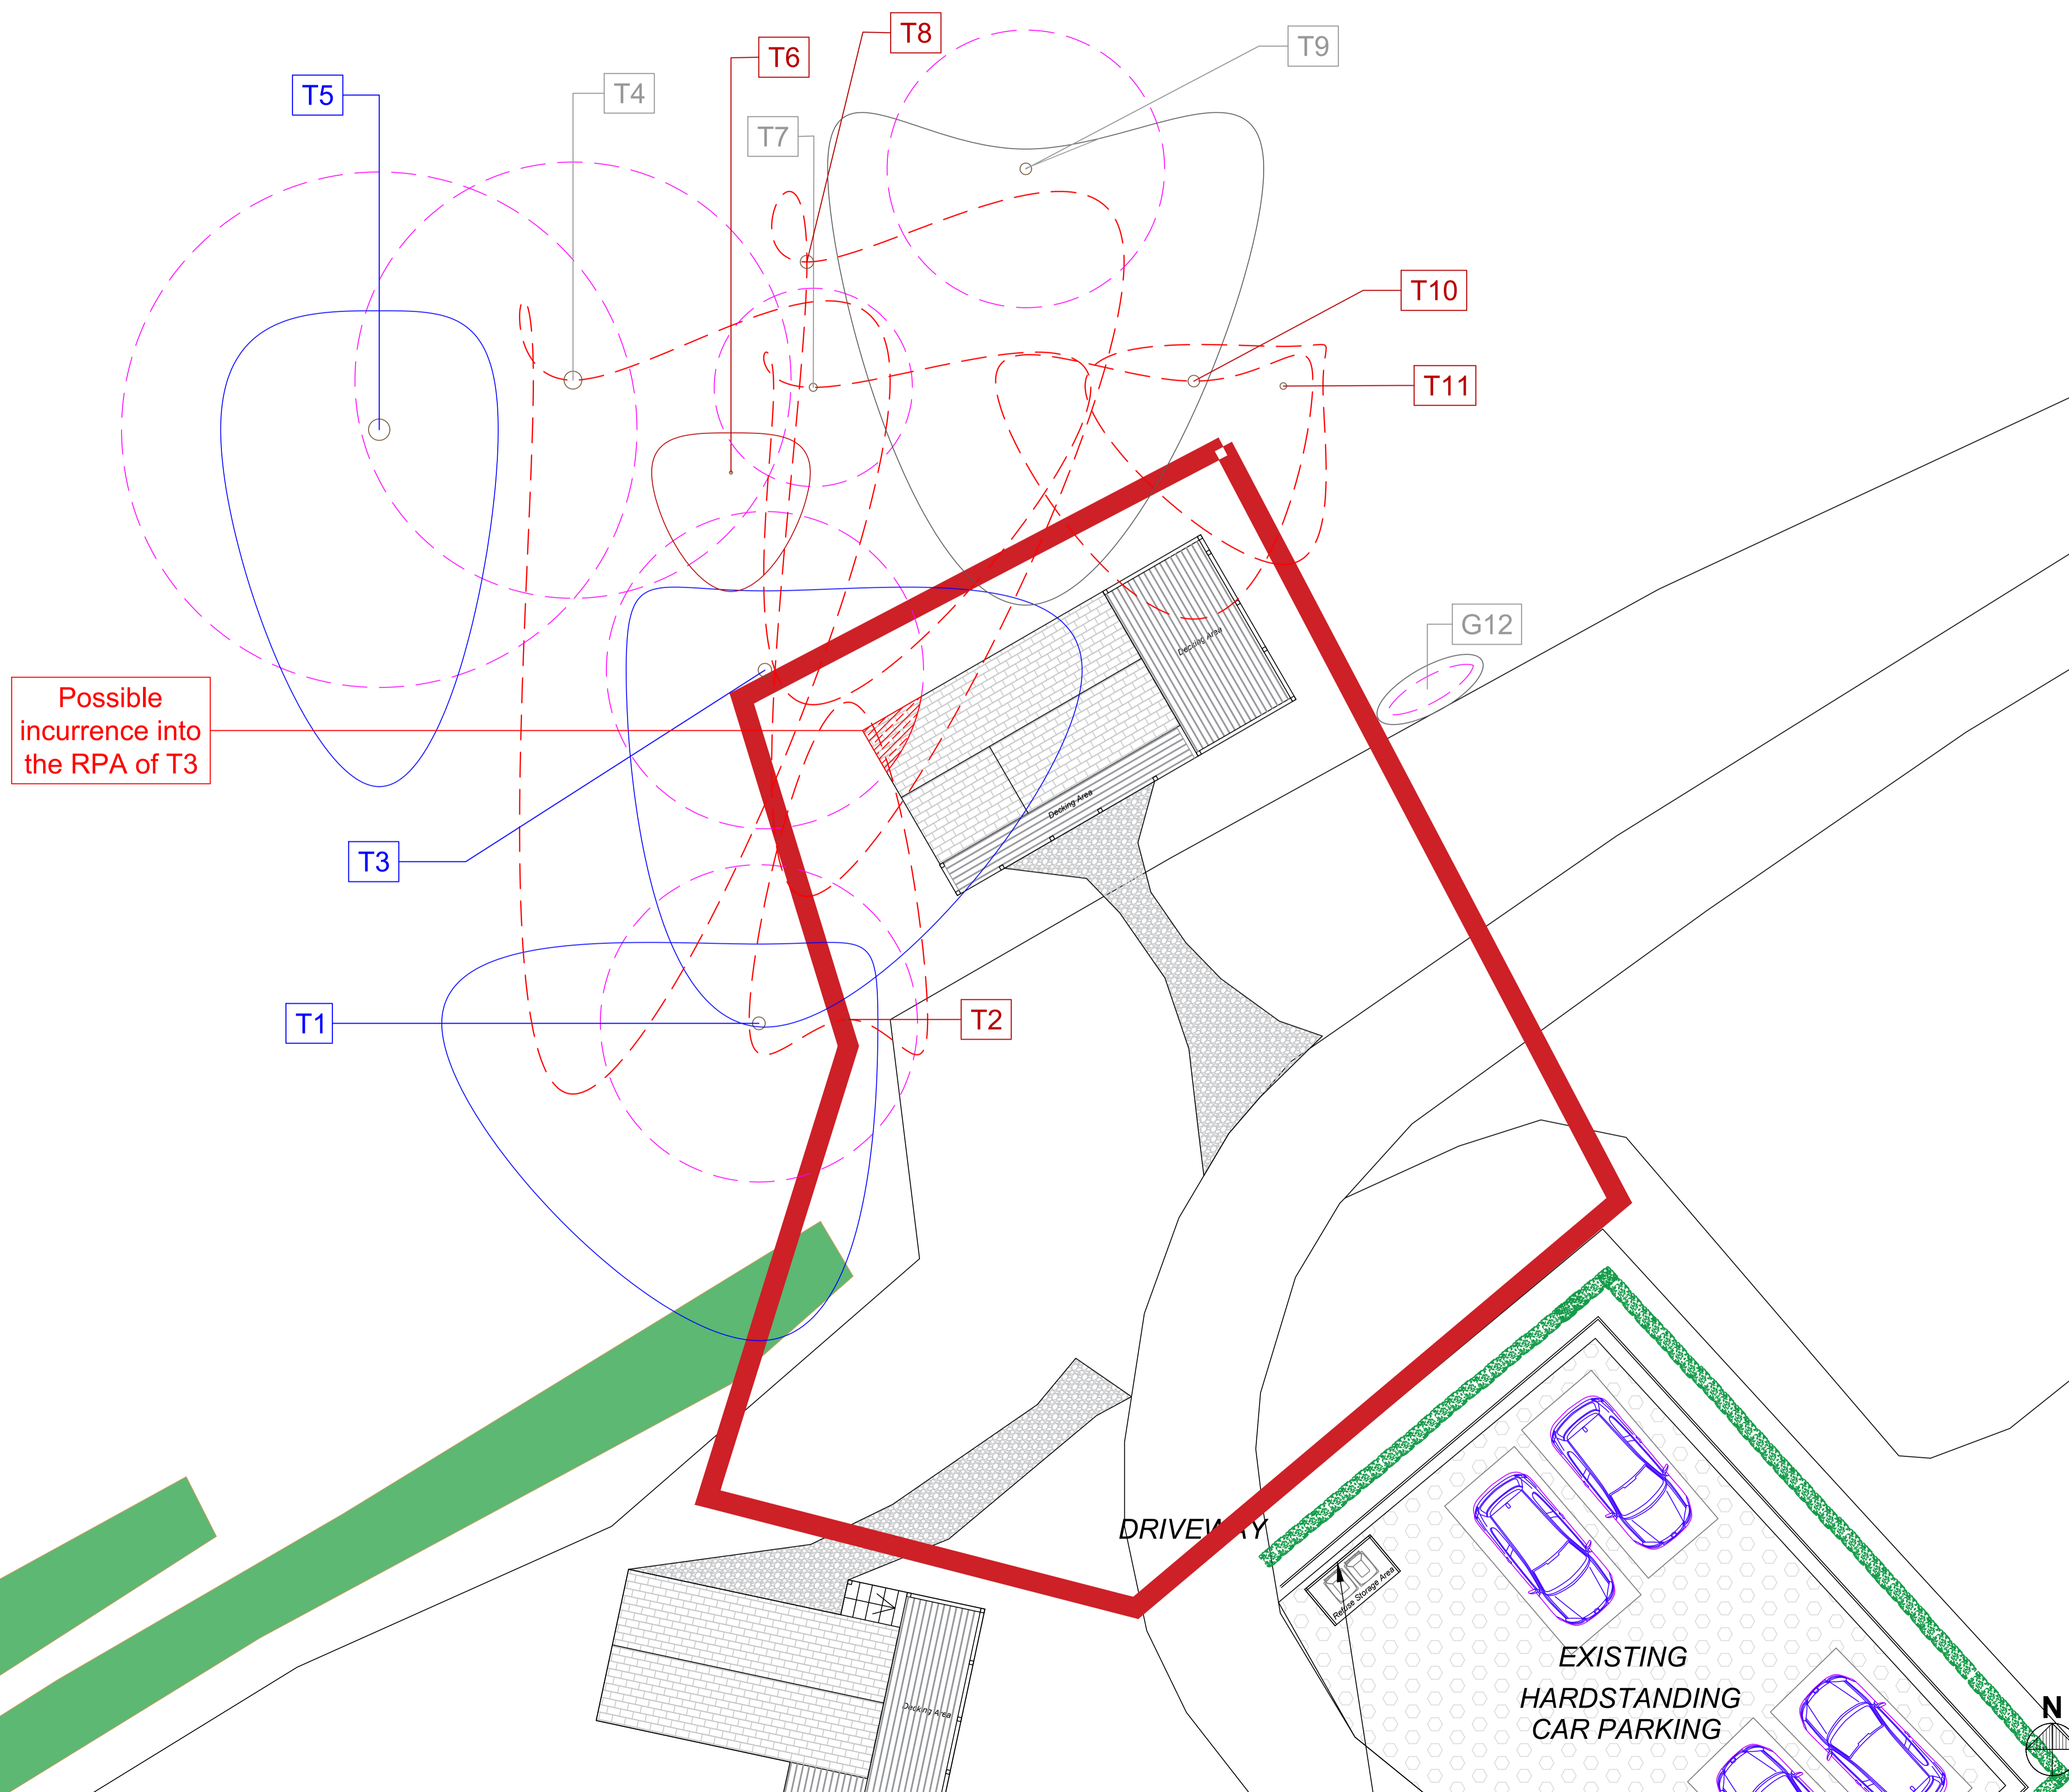
The exact impact within T3 can not accurately be gauged at this time due to the potential inaccuracy of tree location data. However, development should not encroach within 4m of the stem. If this is not viable further arboricultural advice should be sought.

Possible incurrence into the RPA of T3

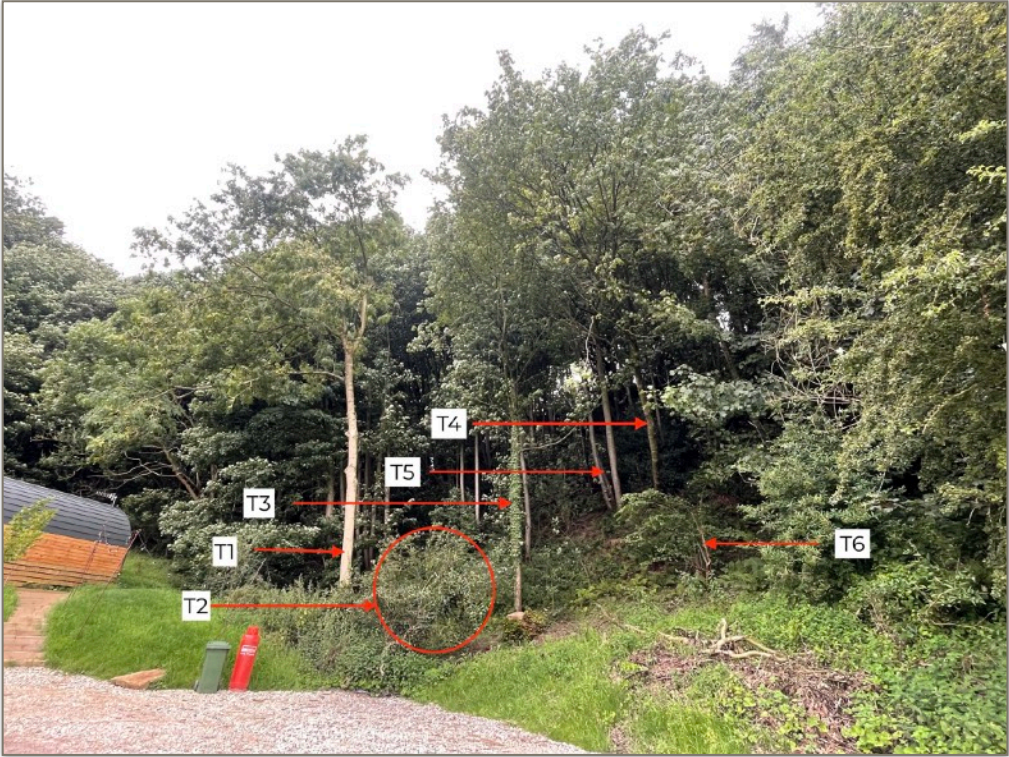
**Figure 1.** The proposed development site with visible surveyed trees labeled.

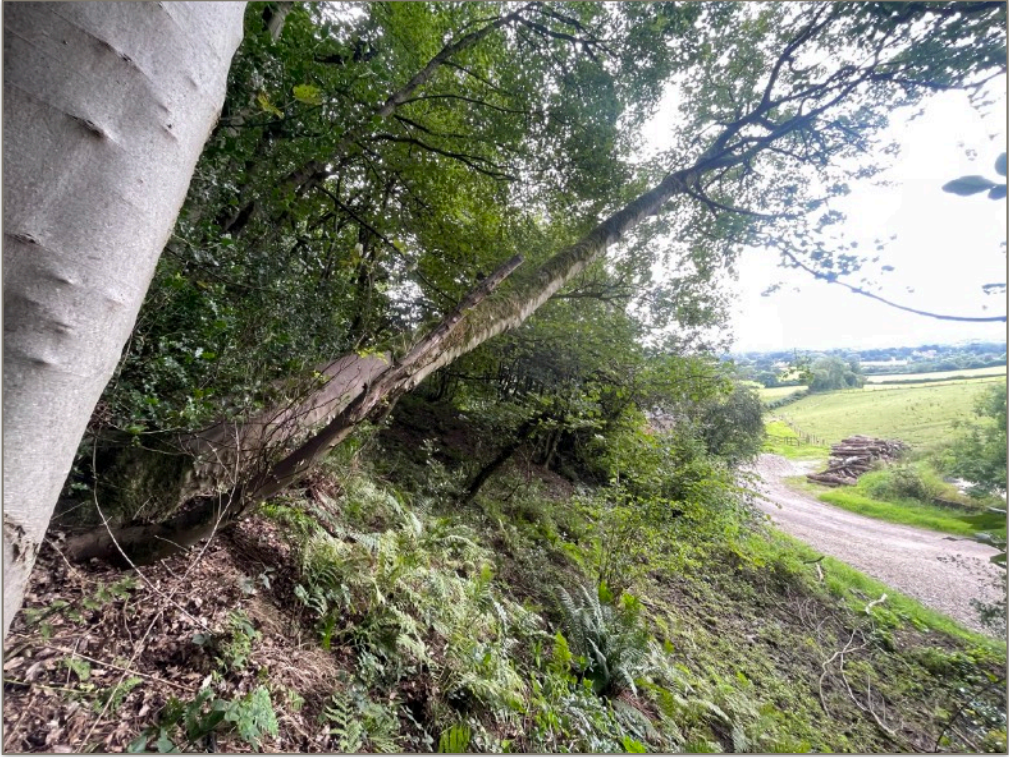
**Figure 2.** The leaning stem of T4 extending over the proposed development site.

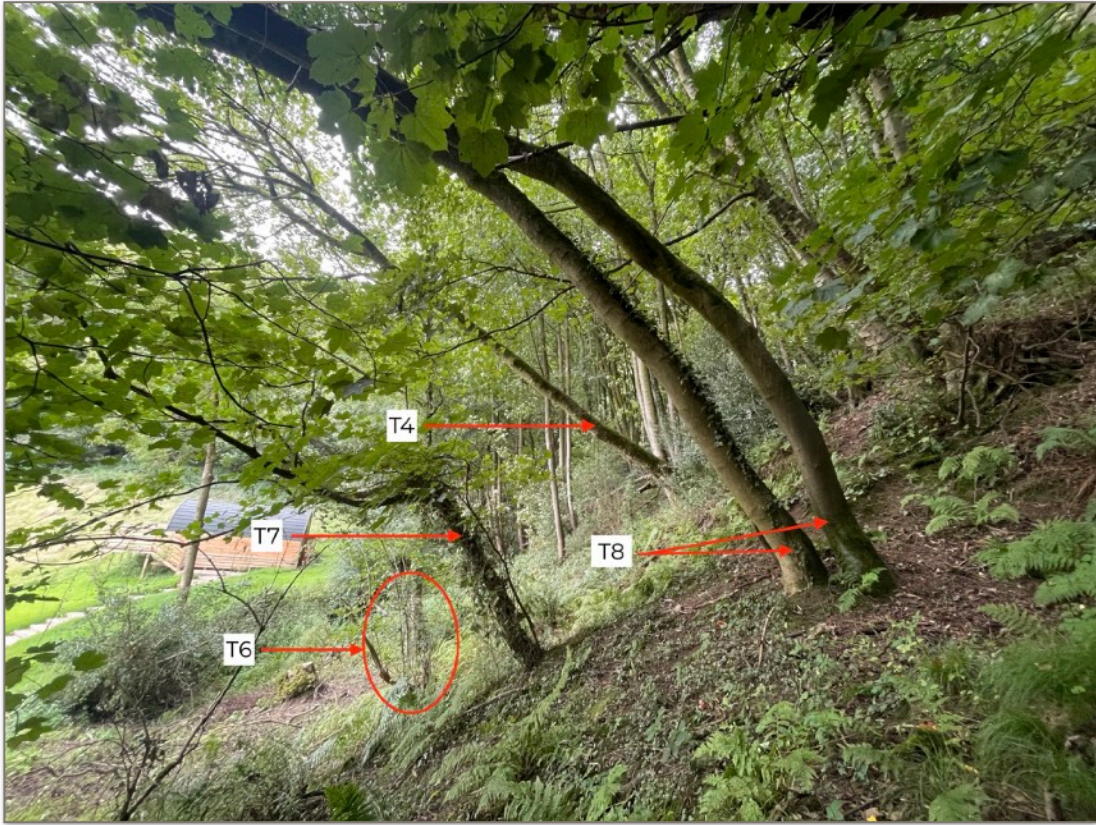
**Figure 3.** Woodland fringe trees growing out from the steep embankment.

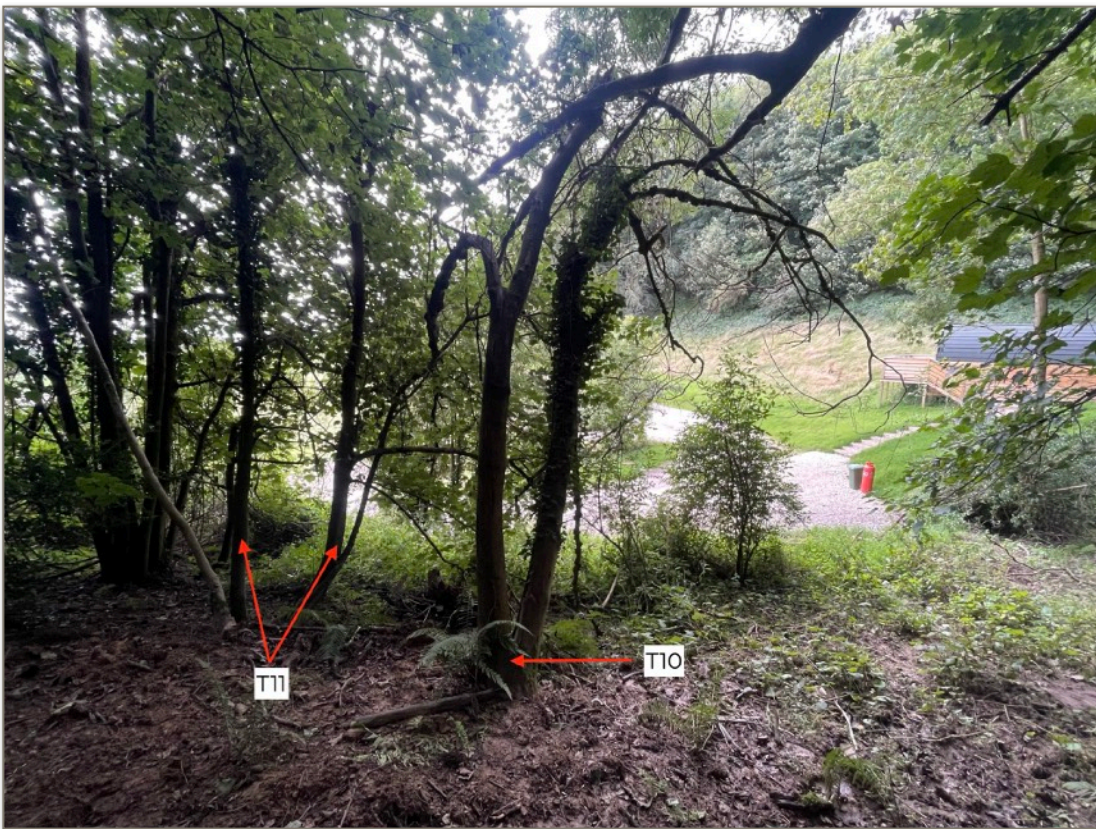
Group / Tree No.	Age & Species	Cat.	Removal due to:		Mitigation required for		Details of how proposed build layout affects trees and recommendations for mitigation.
			Cons.	Cond.	Canopy	RPA	
T10	Dead Ash ( <i>Fraxinus</i> )	U	✓	✓			Dead tree overhanging the development proposal.  No mitigation required due to natural death.
T11	Young Sycamore ( <i>Acer</i> )	U	✓				self set trees in poor condition located close to the development proposal.  No mitigation required due to low retention value.

**Figure 4.** Trees T10 and T11 located to the east of the north east of the site.

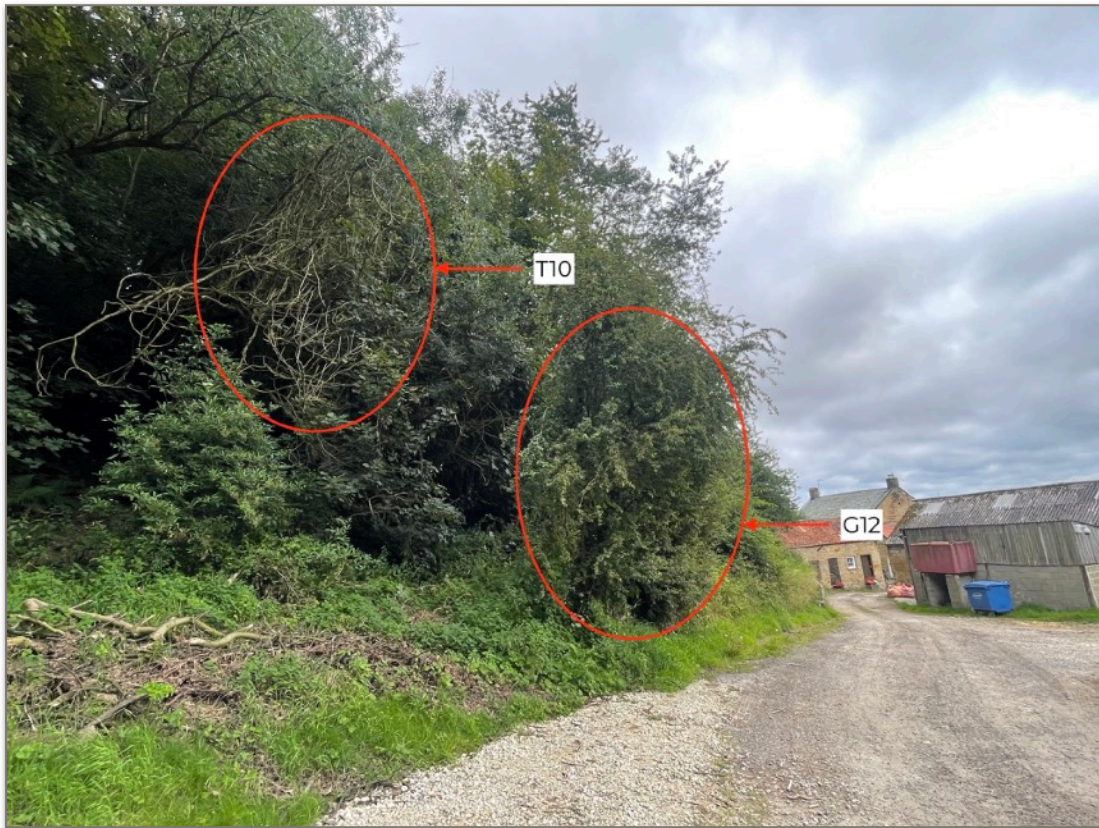
**Figure 5.** Trees to the eastern edge of the development proposal.
