Proposed:
REPLACEMENT WINDOWS
at
YORK HOUSE, KING STREET
ROBIN HOODS BAY

Drawing:
EXISTING
WINDOW SCHEDULE W1.

Drawing No. 423/05 A
Date: AUGUST 2023
Scale: 1/20 Print at A3

Drawing:
EXISTING
WINDOW SCHEDULE W2.

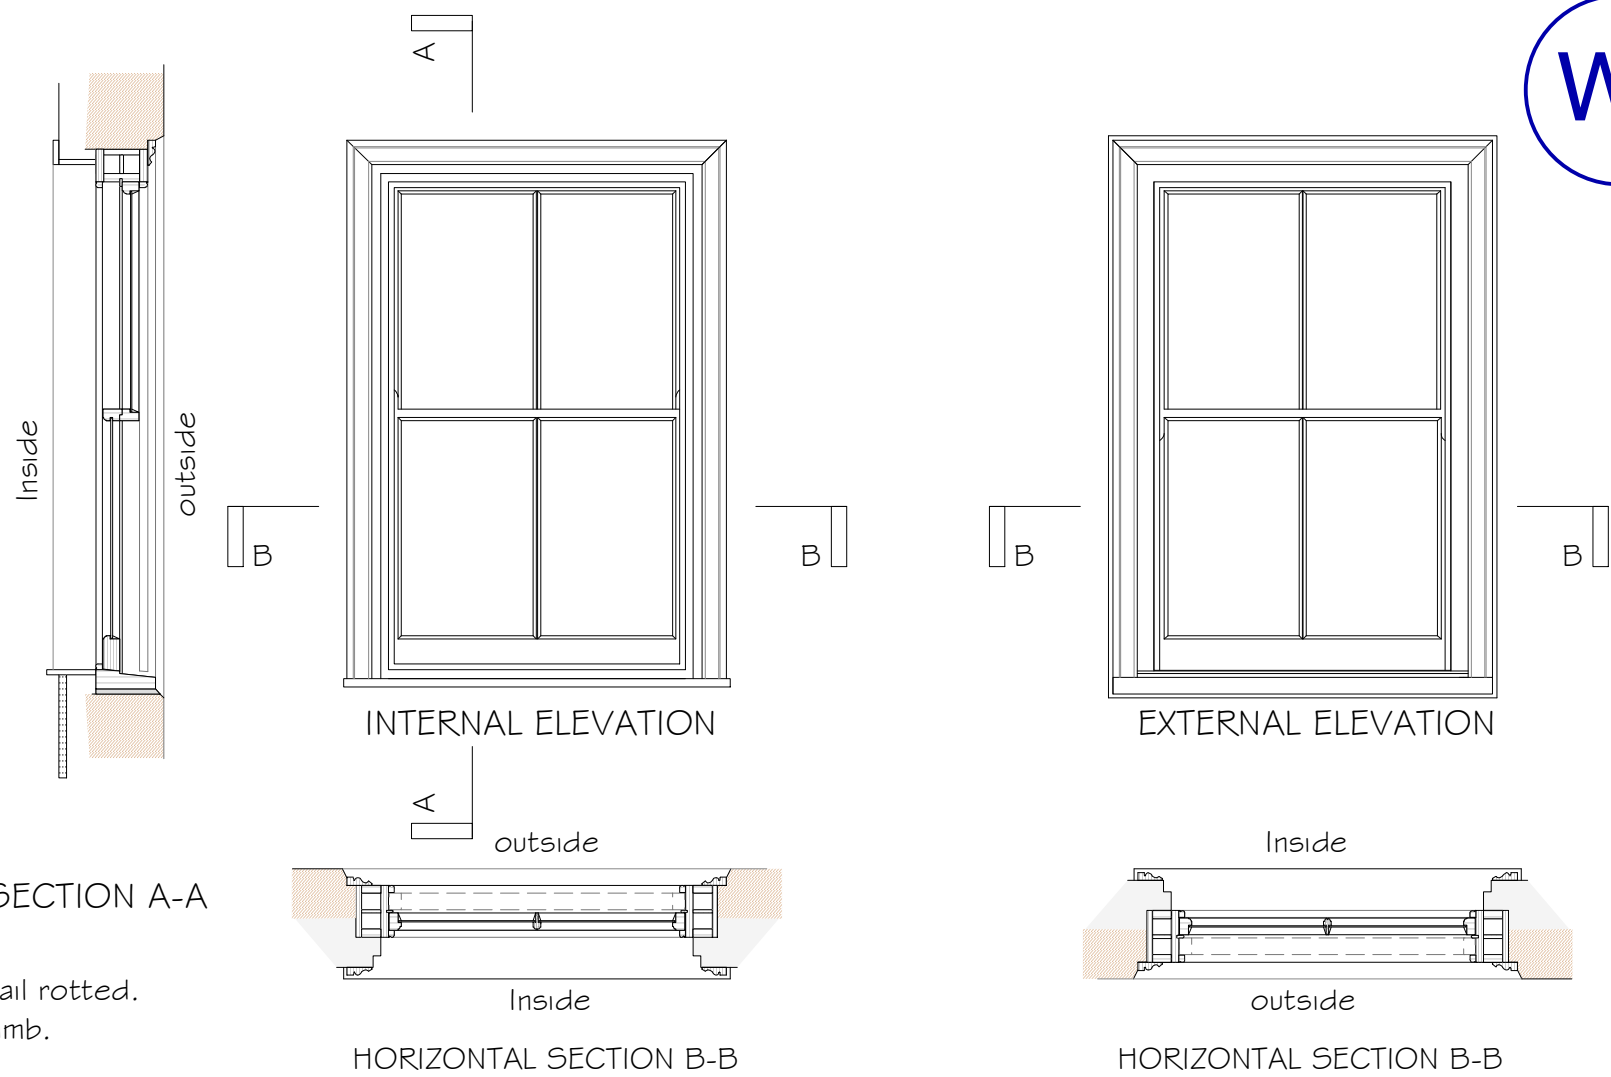
W1

Main visible defects:
Sill, bottom rail and meeting rail rotted.
Staining to rhs upper sash jamb.

Window frame manufacture circa
1980's to 1990's

Cracked paint and surface mould indicates general state of decay throughout the frame components internally & externally. Details of the sash and meeting rails as for W2.

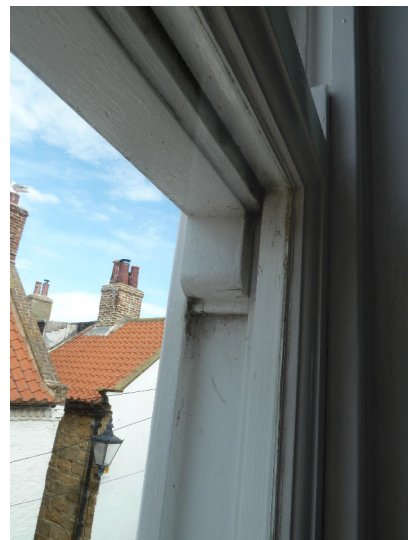
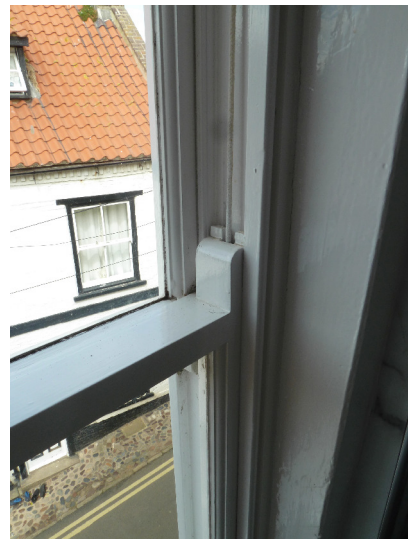
FIRST FLOOR LEVEL BATHROOM. (RHS Viewed Externally).

Cracked paint and surface mould indicates general state of decay. Details at sash horn non-vernacular particularly composite planted sections to sash cord channel. These details also apply to W1.
