Structural Report

Barn

Beacon Hill Farm

STRUCTURAL REPORT ON BARN AT BEACON HILL FARM, RAW WHITBY YO22 4PP

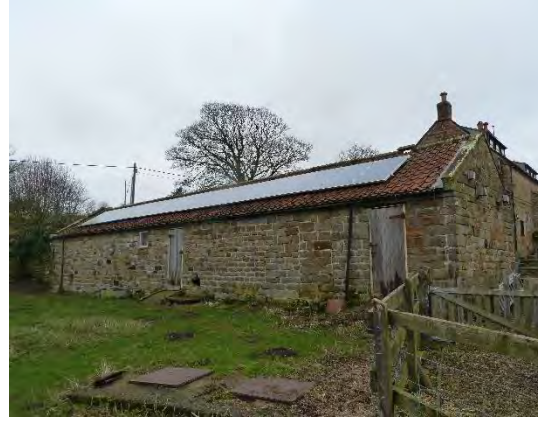
Photo 2: Southern aspect.

Stone built; clay pantile outbuilding used for storage. The western end is open to the environment allowing swallow nesting. A bank of solar panels sits on the southeastern roof.

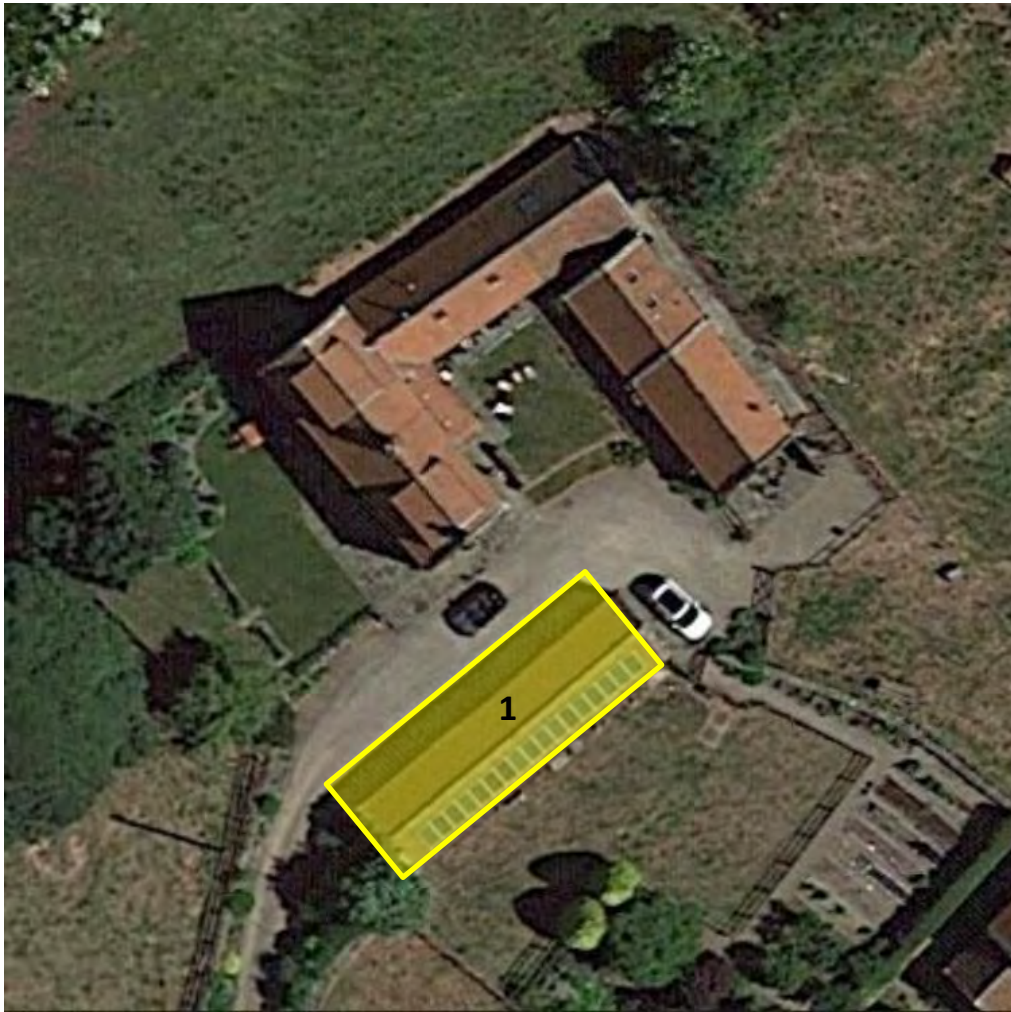
Figure 3. Visual Inspection Results.

Building ref	Description & photos	PBRH features
<p>Building 1: Low risk of supporting roosting bats</p>	<p>Traditionally built stone outbuilding with a clay pantile roof. The building is split into two closed areas and a section at the southwestern end which is open to the environment. There are many lifted tiles along the southeastern aspect, as well as crevices in the fascia and lifted flashing at the gable ends. Internally there are exposed timber trusses which are cobwebbed, there are some tears in the bitumastic lining and some gaps in the lintels however these are also cobwebbed. No evidence of roosting bats (droppings/feeding remains) identified. There was evidence of nesting birds in the form of swallow nests.</p> <div style="display: flex; flex-wrap: wrap;"> <div style="width: 50%; text-align: center;">   <p>Photo 3: Northwestern aspect.</p> </div> <div style="width: 50%; text-align: center;">   <p>Photo 4: Southeastern aspect.</p> </div> <div style="width: 50%; text-align: center;">   <p>Photo 5: West.</p> </div> <div style="width: 50%; text-align: center;">   <p>Photo 6: Internal structure.</p> </div> <div style="width: 50%; text-align: center;">   <p>Photo 7: Crevices in fascia.</p> </div> <div style="width: 50%; text-align: center;">   <p>Photo 8: Crevices in fascia.</p> </div> <div style="width: 50%; text-align: center;">   <p>Photo 7: Lifted tiles.</p> </div> <div style="width: 50%; text-align: center;">   <p>Photo 8: Lifted flashing.</p> </div> </div>	<p>Lifted pantiles. Crevices in the fascia.</p>

This building was determined to have a low risk of supporting roosting bats. This was due to the identification of areas of potential bat roosting habitat including: lifted clay pantiles on the southeastern roof, crevices in the fascia and lifted flashing on the gable ends. Internally, there was a limited number of masonry crevices and some gaps in the lintels, these were however cobwebbed. The roof is lined with bitumastic lining internally, this had some tears in places. There was no evidence of roosting bats found inside the building. It is highly unlikely void flying bats are utilising this space, but there is some potential habitat for low numbers of day roosting crevice dwelling bats.

9.2.1 Replacement crevice roosting habitat will be provided on site through the installation of professional long-lasting crevice bat boxes on site, on the western gable

end. It is recommended that a total of two habitat features are provided. External bat boxes should be Schwegler Type 1FF wall bat roosts which can be affixed to external walls and/or Type 2F general purpose bat boxes affixed to retained trees on site.

9.2.2 Prior to the commencement of any works to areas where potential bat roost habitat has been identified, bat emergence surveys, in line with current Bat Conservation Trust Good Practice Guidelines will be carried at the appropriate time of year (May-September) and in suitable weather conditions.
