Contracting & Consulting Arborists

Your Ref March 2022

Our Ref Egton Yo211UT

Arboricultural survey on Highway Trees adjacent to the public footpath and roadway

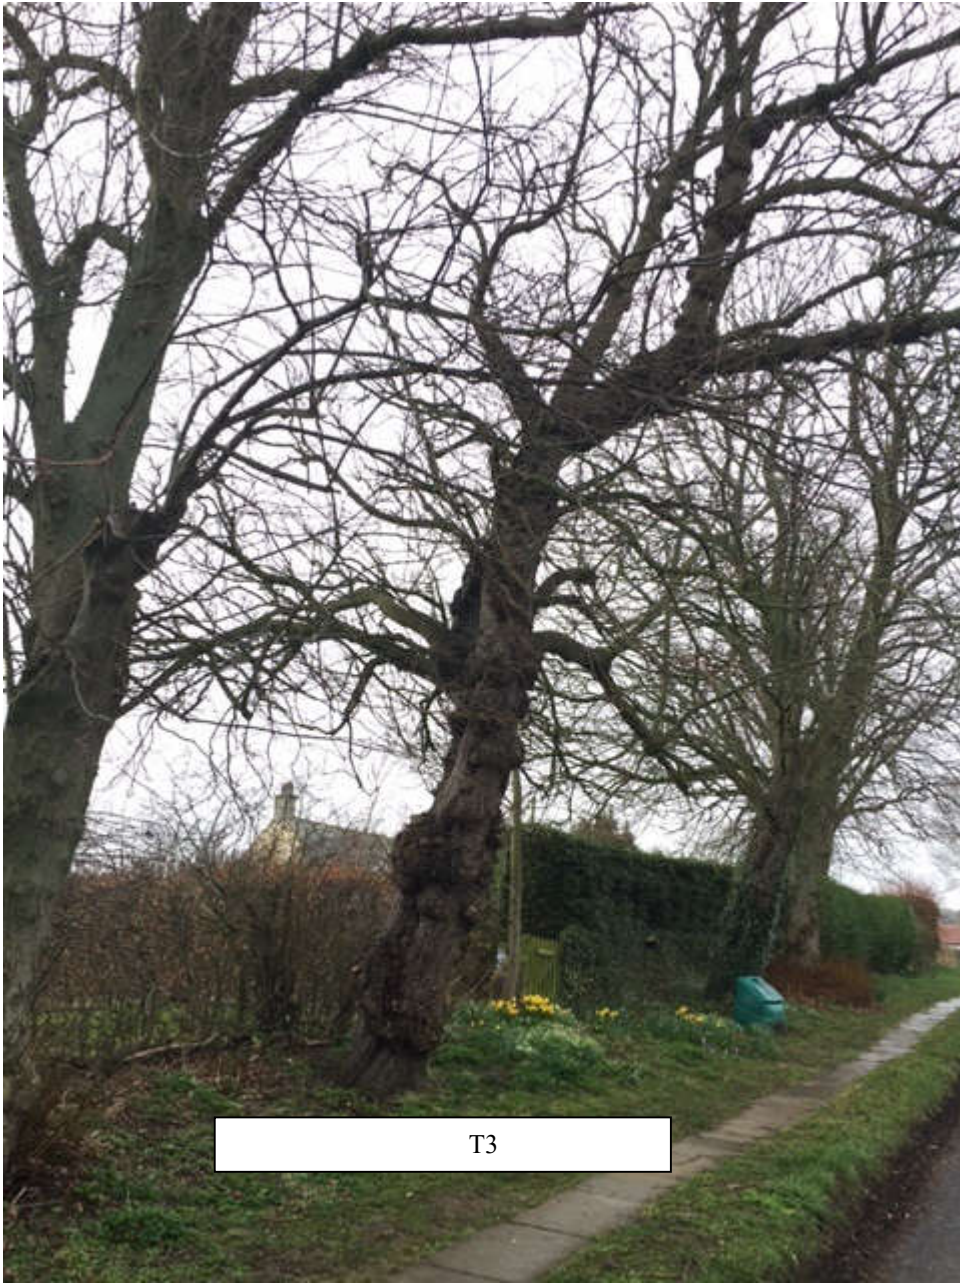
- T3 Horse chestnut 12m S/Mature leaning form Dysfunction Fungii & Galls **REMOVE TREE & Grind Stump**
- T4 Lime S/mature 14m **Crown lift and basal cut back epicormic growth**

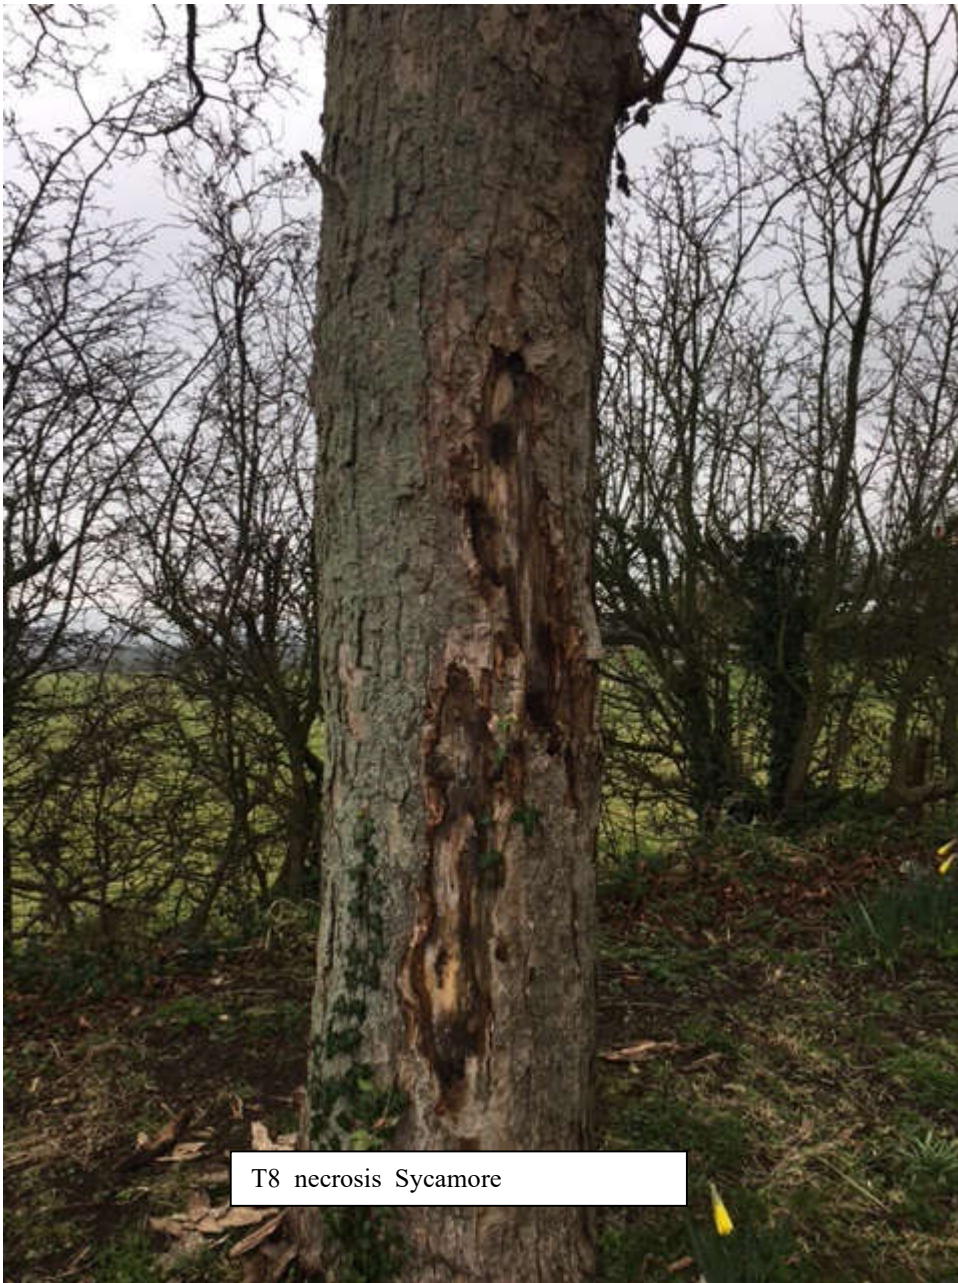
T8 necrosis Sycamore

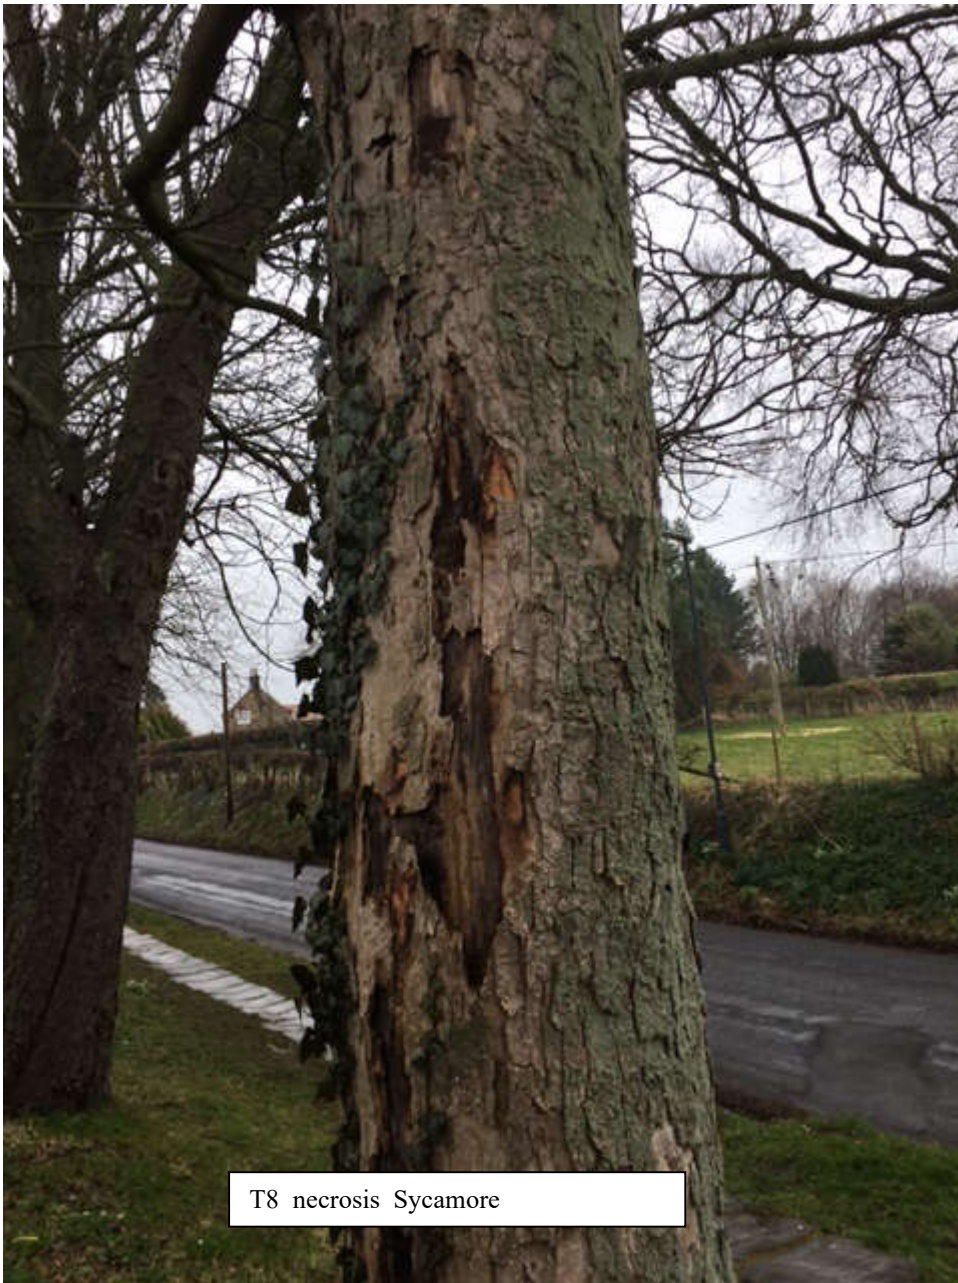
T8 necrosis Sycamore

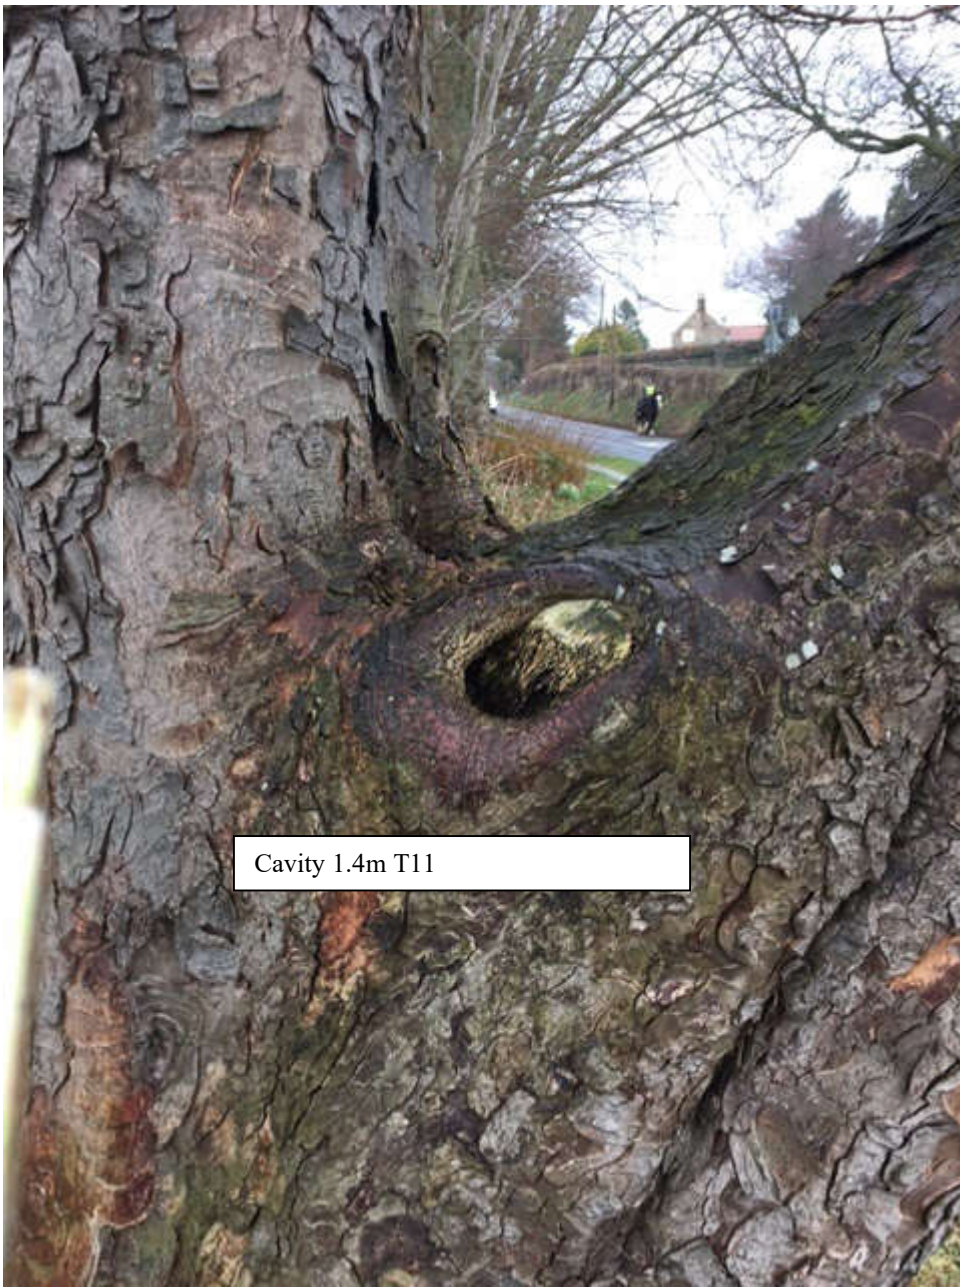
- T10 Lime under mature 12m **crown lift, clear deadwood, remove basal epicormic growth**
- T11 Horse chestnut semi Mature co dominant leaning form Bleeding Canker decay at 1.4 mt and union with 15cm deep wet cavity descending into co/dom union
REMOVE TREE & Grind Stump

Cavity 1.4m T11

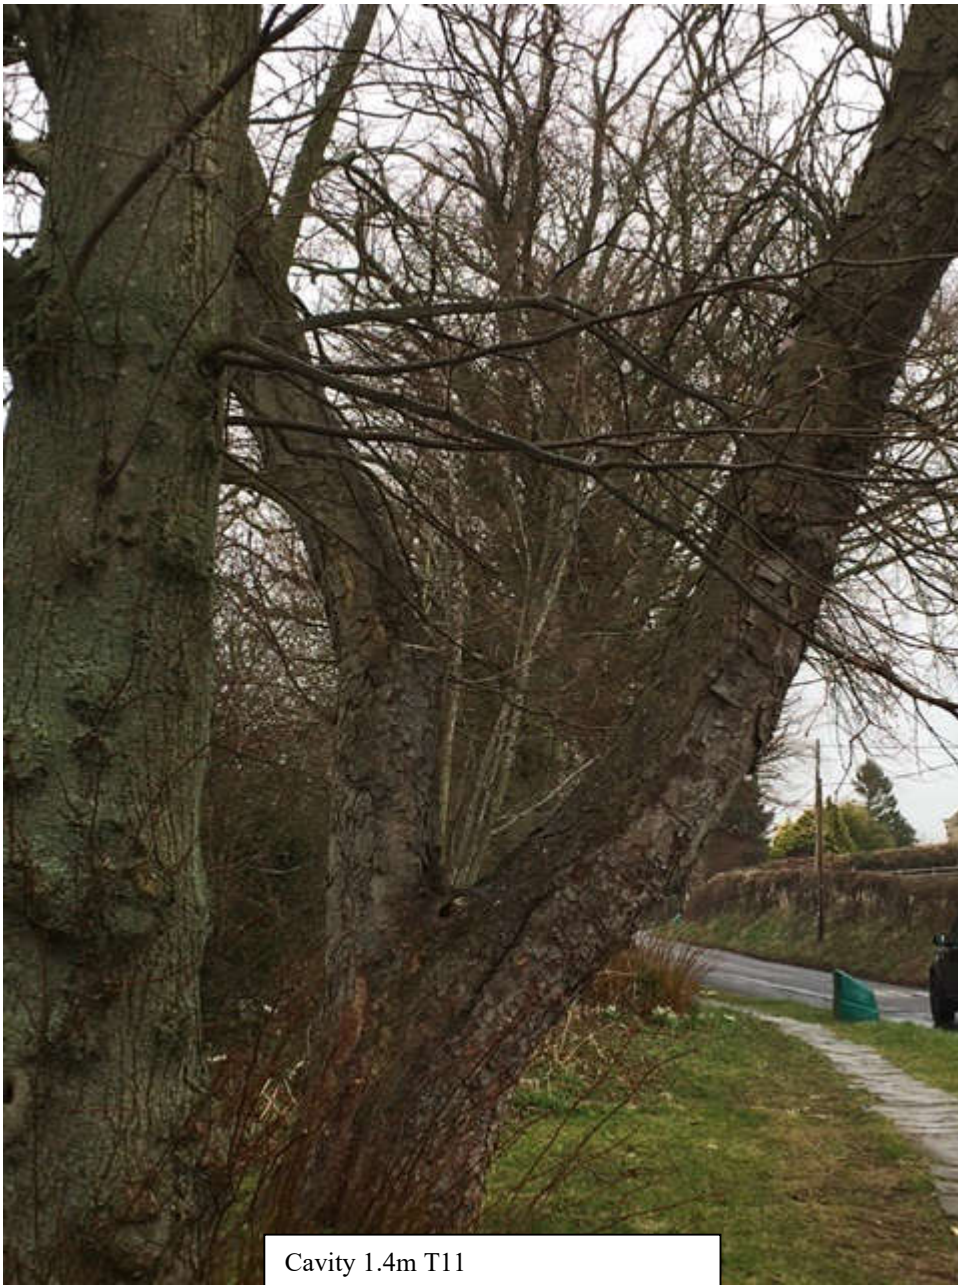
Cavity 1.4m T11
