elliottconsultancy ltd.
arboricultural consultants

Location:
**Woodleigh House
Main Road
Aislaby**

Survey Type:
Arboricultural Survey

Ref:
ARB/AE/2543

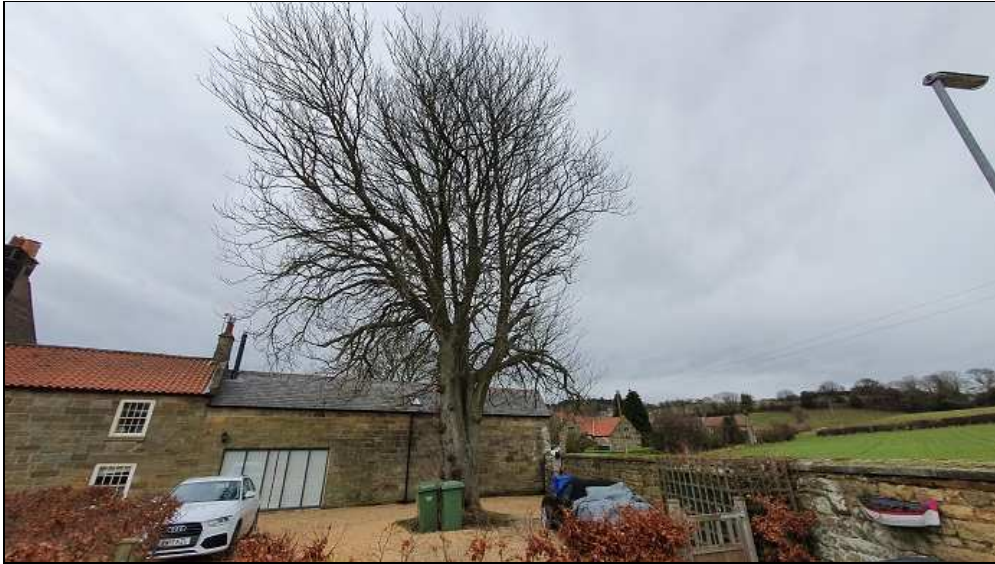
Figure 2: subject tree

Rooting and basal area are in good condition with no evidence of fungal infection, root-plate movement, decay, or any significant restricted growth. Some minor surface root damage was noted due to impact but without structural or physiological significance. Buttressing is characteristic of age and species with no defects noted.

The tree stem is in reasonable condition but with some areas of necrotic bark, probably due to Horse Chestnut Canker. The lack of any new exudates connected to this pathogen suggest the tree has tolerated this infection and the subsequent bark damage. An area of bacterial flux was also noted on the stem, but again this may be a secondary symptom of some minor internal dysfunction due to the impact of canker and does not appear to have any current physiological bearing.

The stem bifurcates at 2m becoming 3 co-dominant stems. The union between the stems is acute but reasonable with no evidence of cracking or failure.

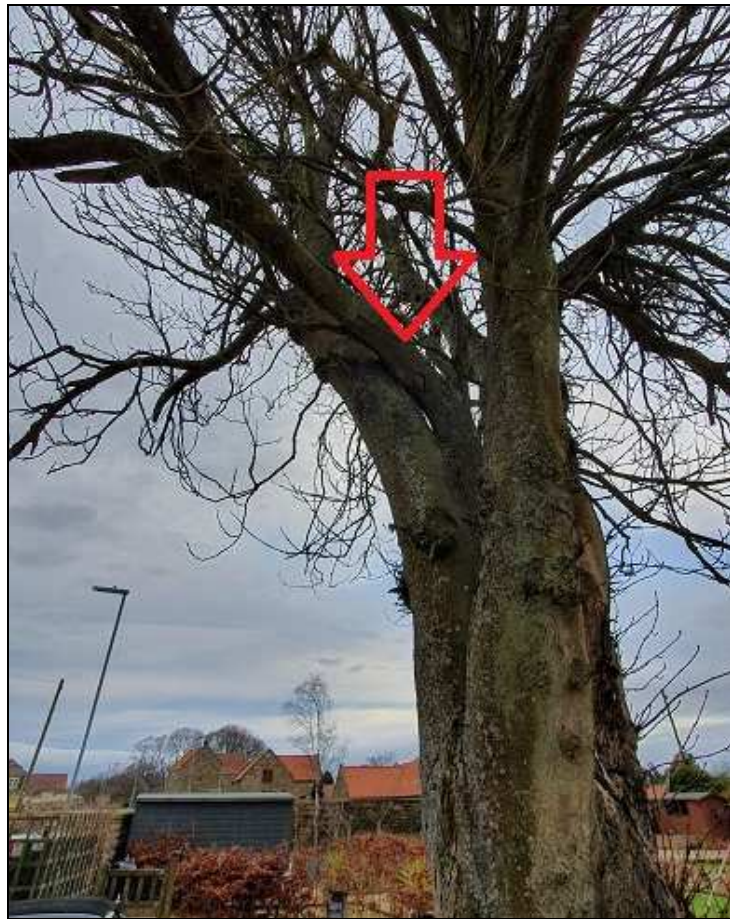
Figure 3: Crossing stem.

At 4m a sub-dominant scaffold limb crosses over a larger stem to the north. This crossing stem may cause damage to the lower stem and become weakened by the ongoing incremental growth of both stems.

- Remove smaller crossing stem from 4m – remove back to the stem.
- Prune back small diameter branch overhang from building – to provide 2.5m clearance of roofline.
- Remove crown deadwood.
