## DESIGN AND ACCESS STATEMENT

### Proposals for internal plaster repairs.

### THE OLD CHURCH OF ST STEPHEN FYLINGDALES NORTH YORKSHIRE

May 2018

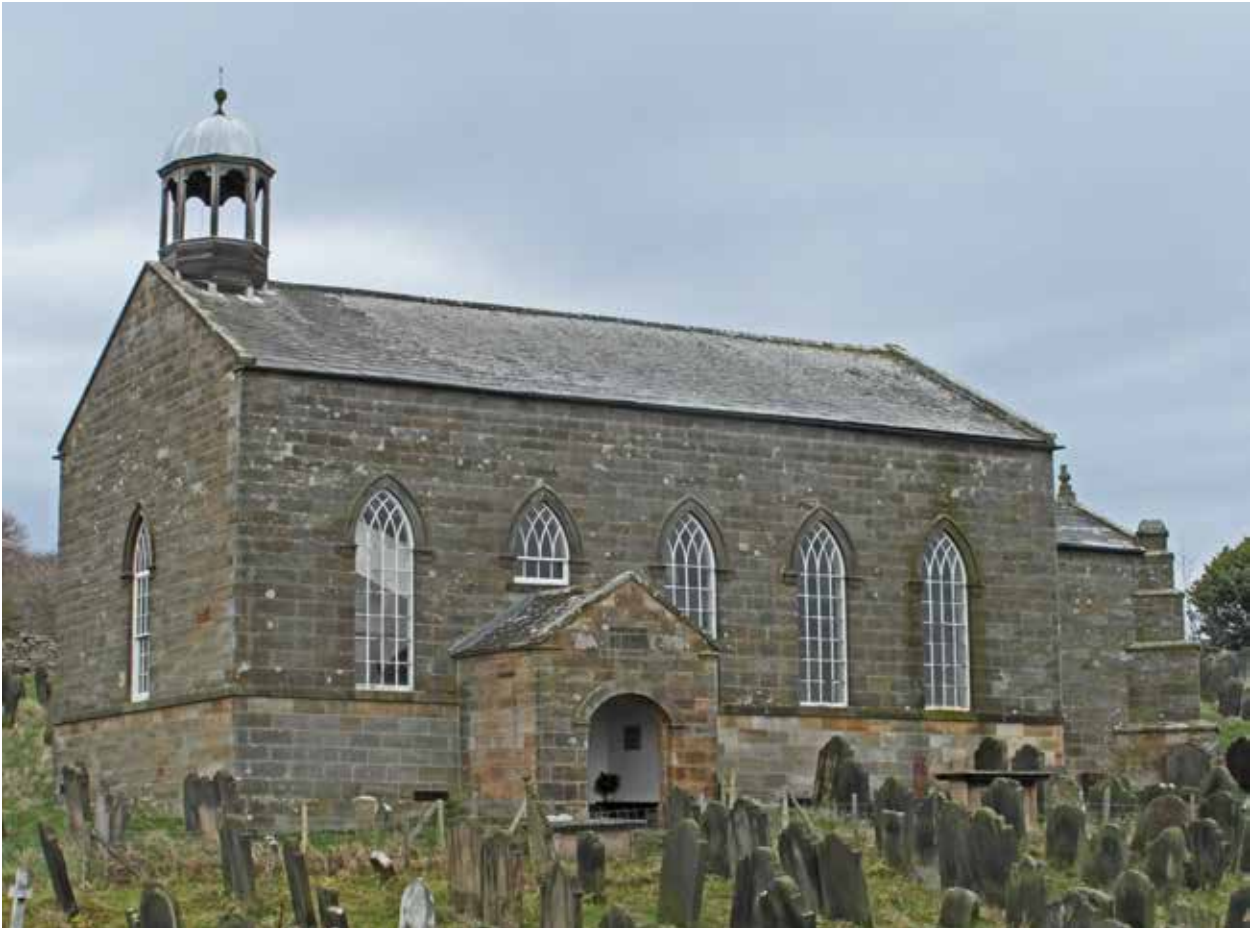
Old St Stephens - south elevation of nave and south porch before redecoration of windows.  
The churchyard slopes up steeply from south to north and is tightly packed with headstones.

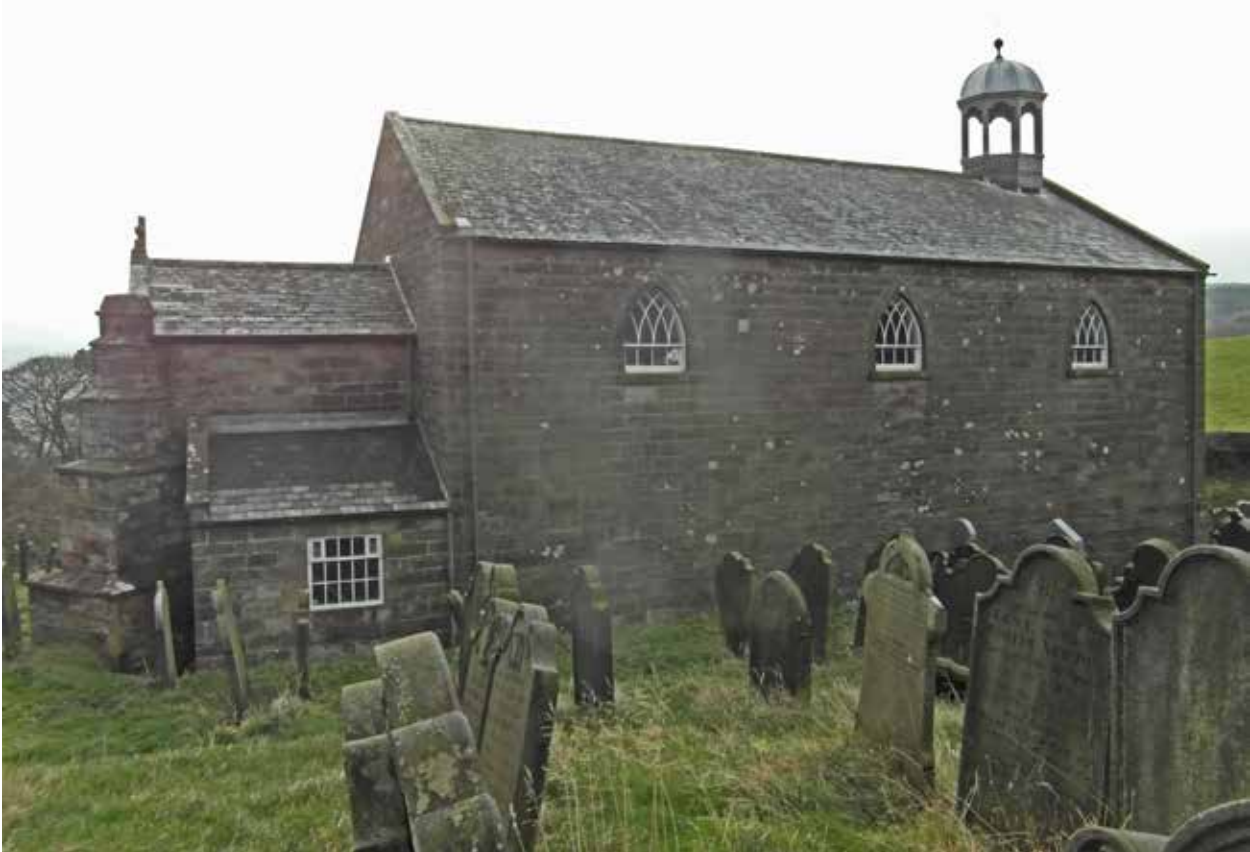
North elevation of nave, chancel and vestry.  
The ground level on this side is higher than church floor level.

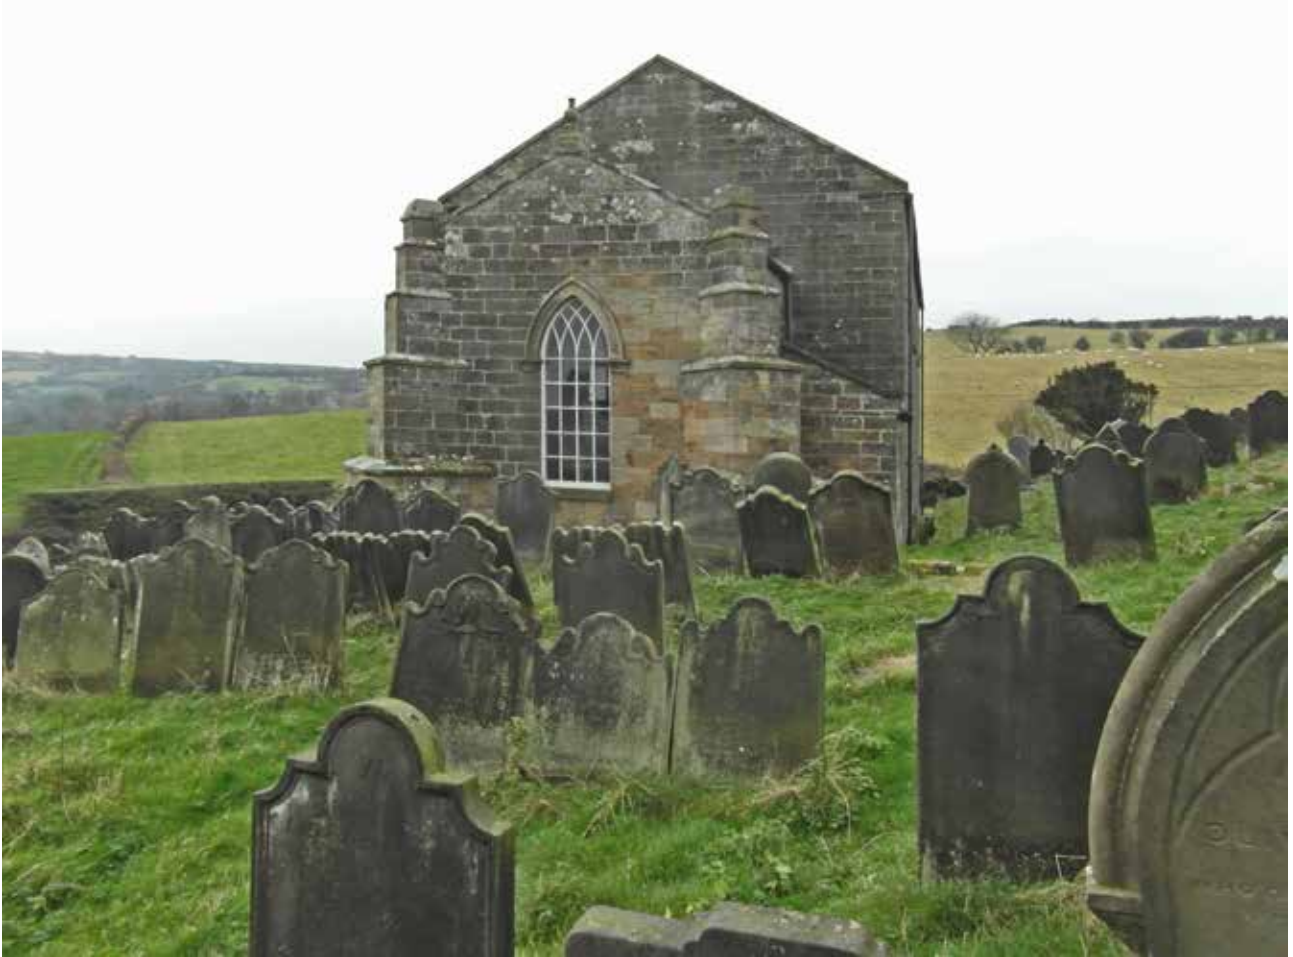
East elevation

A retaining wall on the north side keeps the higher ground level away from the wall but the ground appears to abut the east wall.

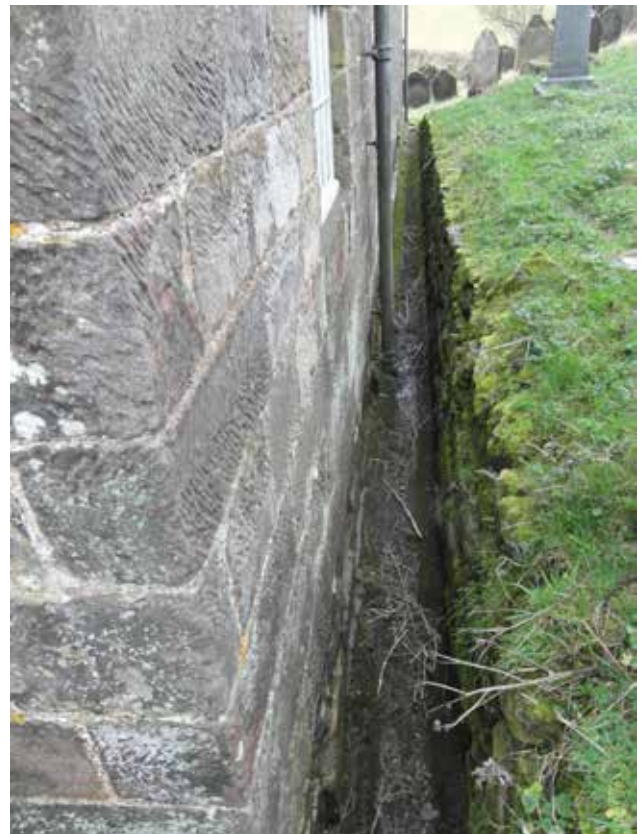
North side of nave - a retaining wall holds back the higher ground level.

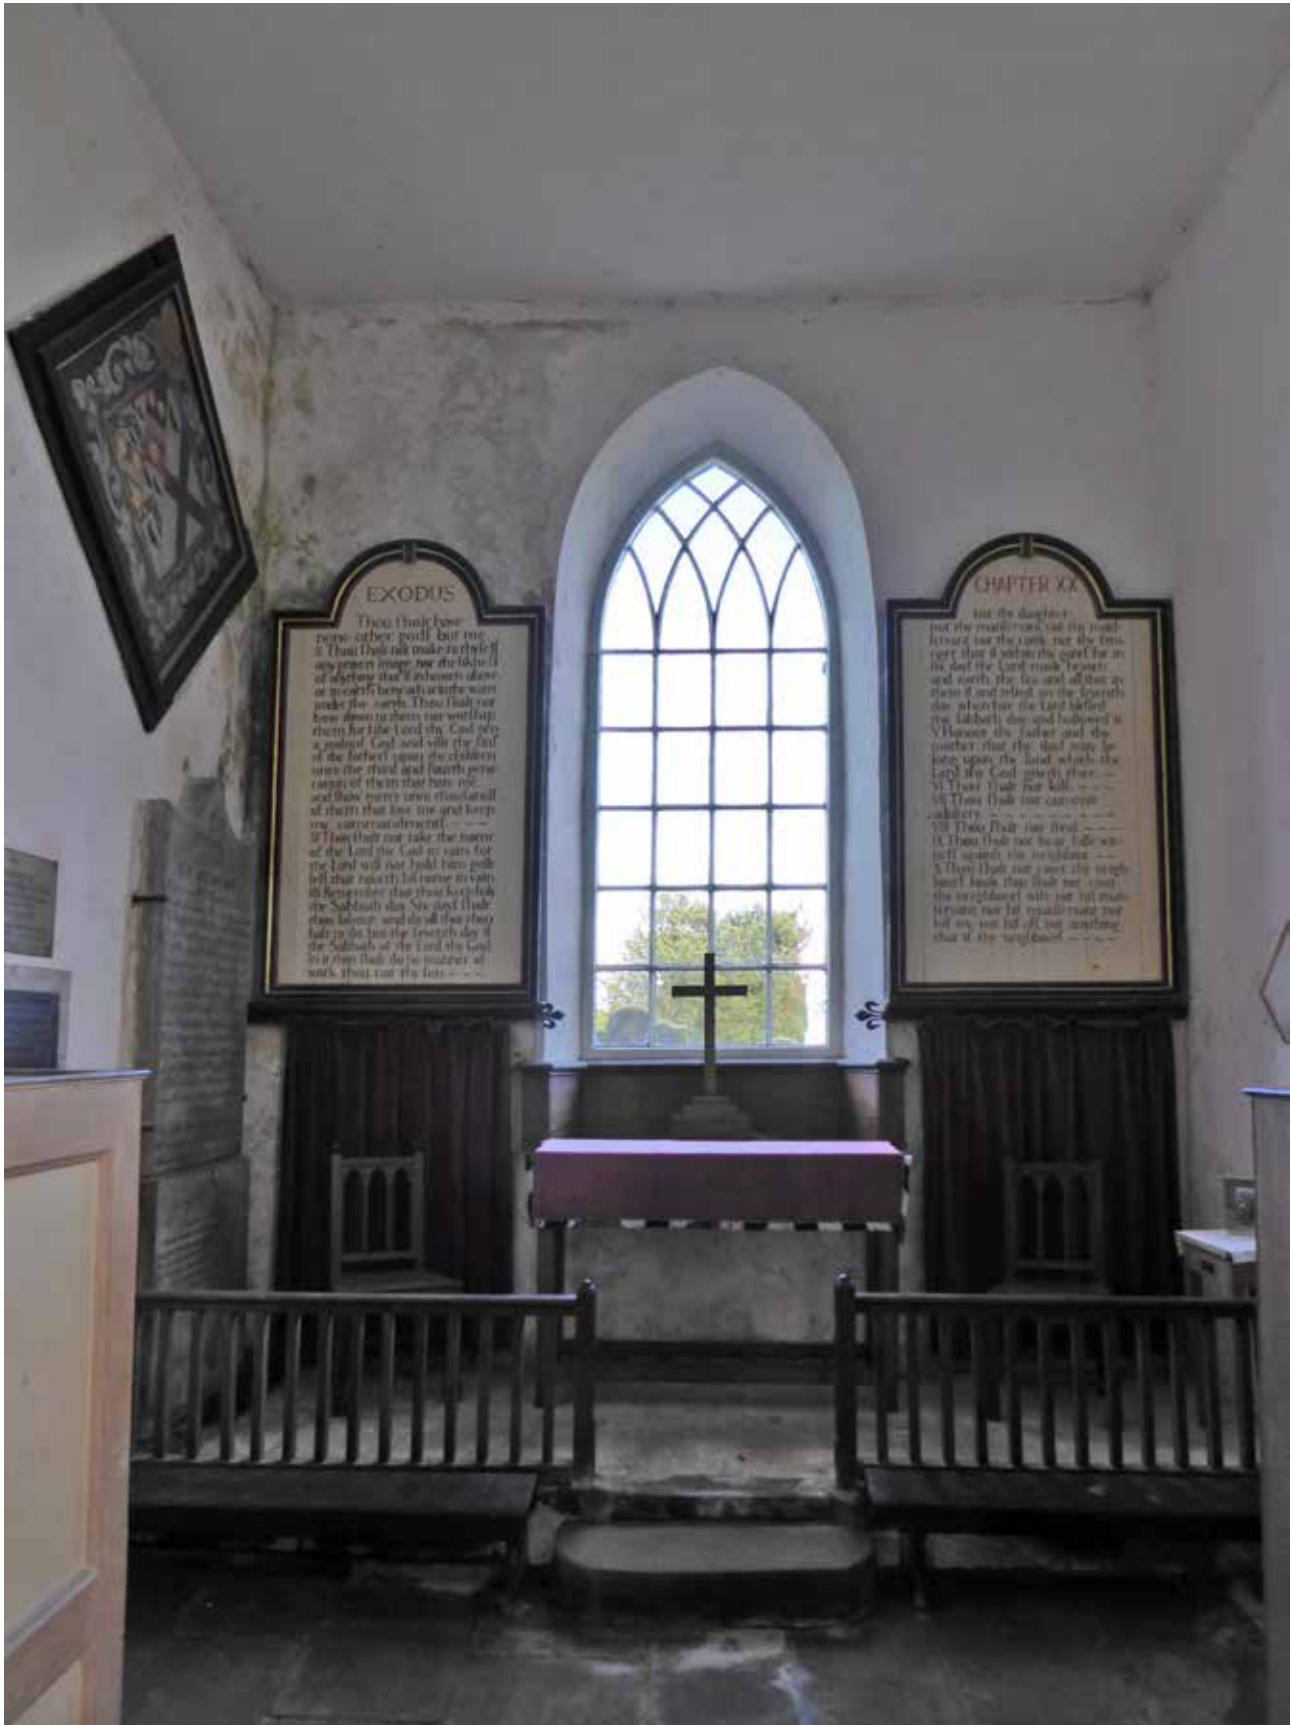
Chancel, east wall.

Damage to the northeast corner has been caused by a mis-aligned gutter. This has been corrected and the walls are beginning to dry. Conservation is planned of the hatchment on the north wall and two commandment boards by an Accredited Conservation-Restorer and will allow access to the plaster behind. Access will allow identification and removal of failed and cementitious plaster.

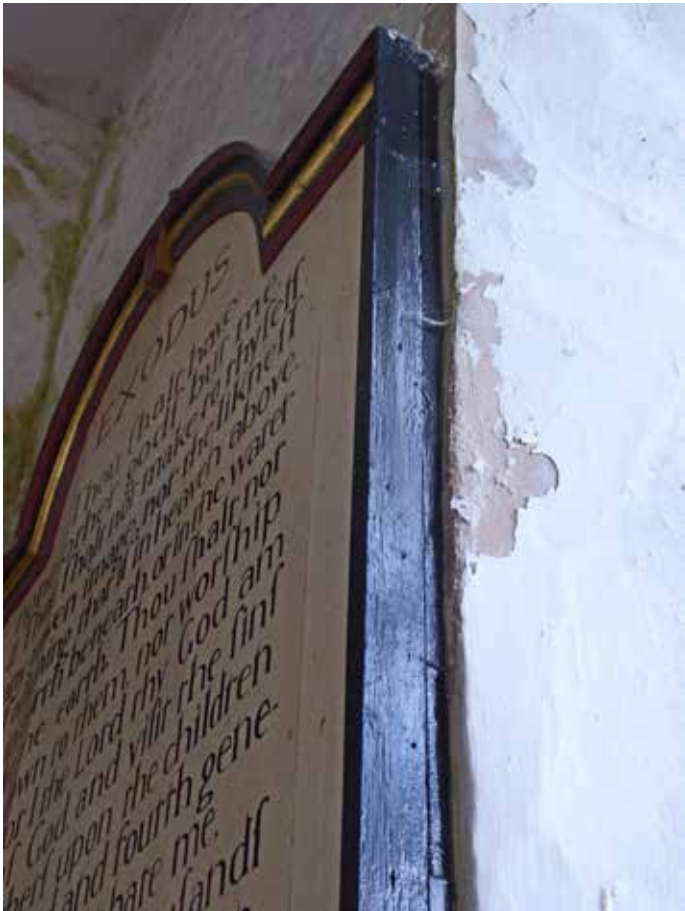
East window, north jamb.  
Gypsum plaster has been used in a repair. A lack of breathability is causing this to fail again.

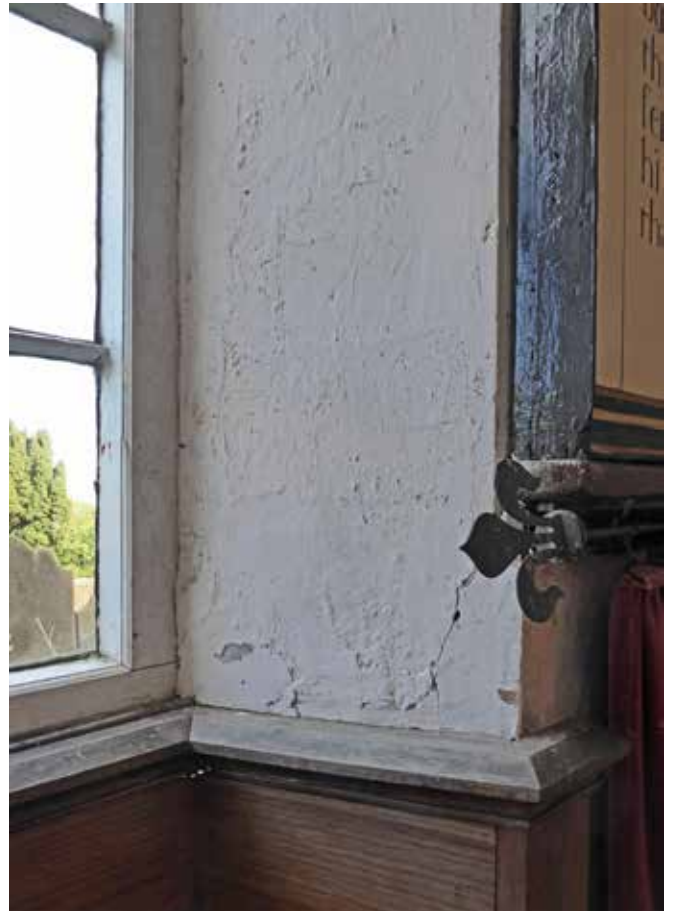
East window, south jamb.  
Plaster in this area has failed and no longer adhered to the masonry behind.

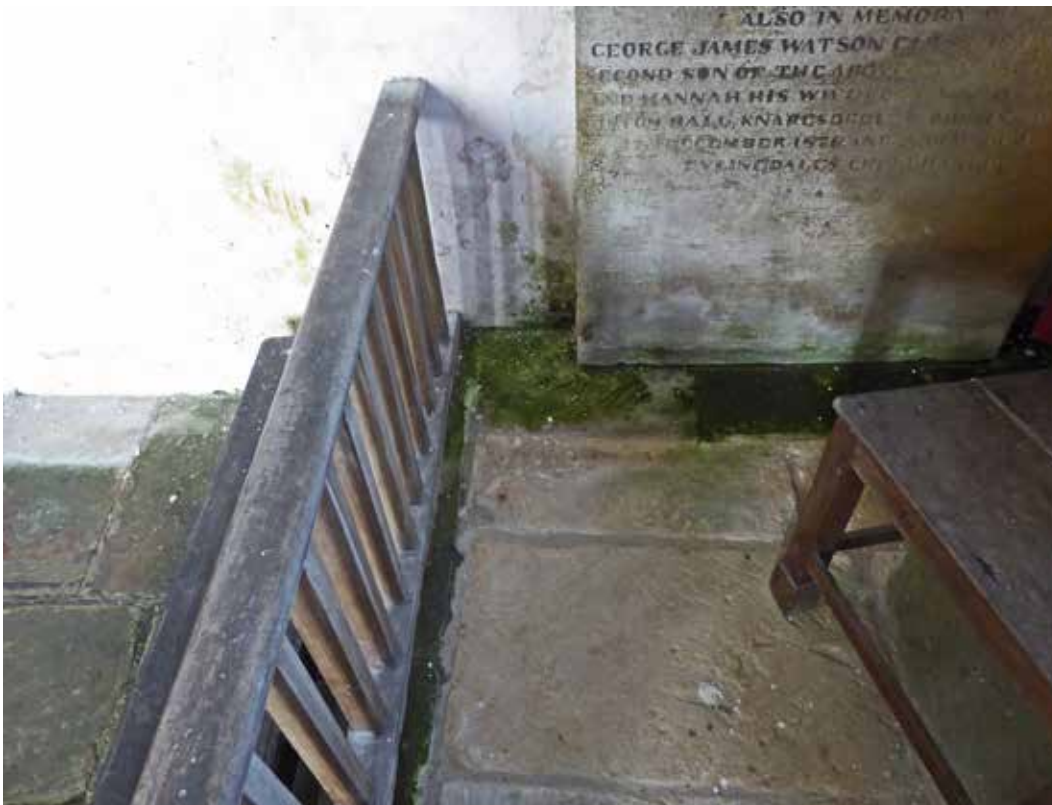
Chancel north side floor.  
Algal growth indicates high levels of moisture in the floor, not helped by the concrete render and cement floor screed of the vestry behind.

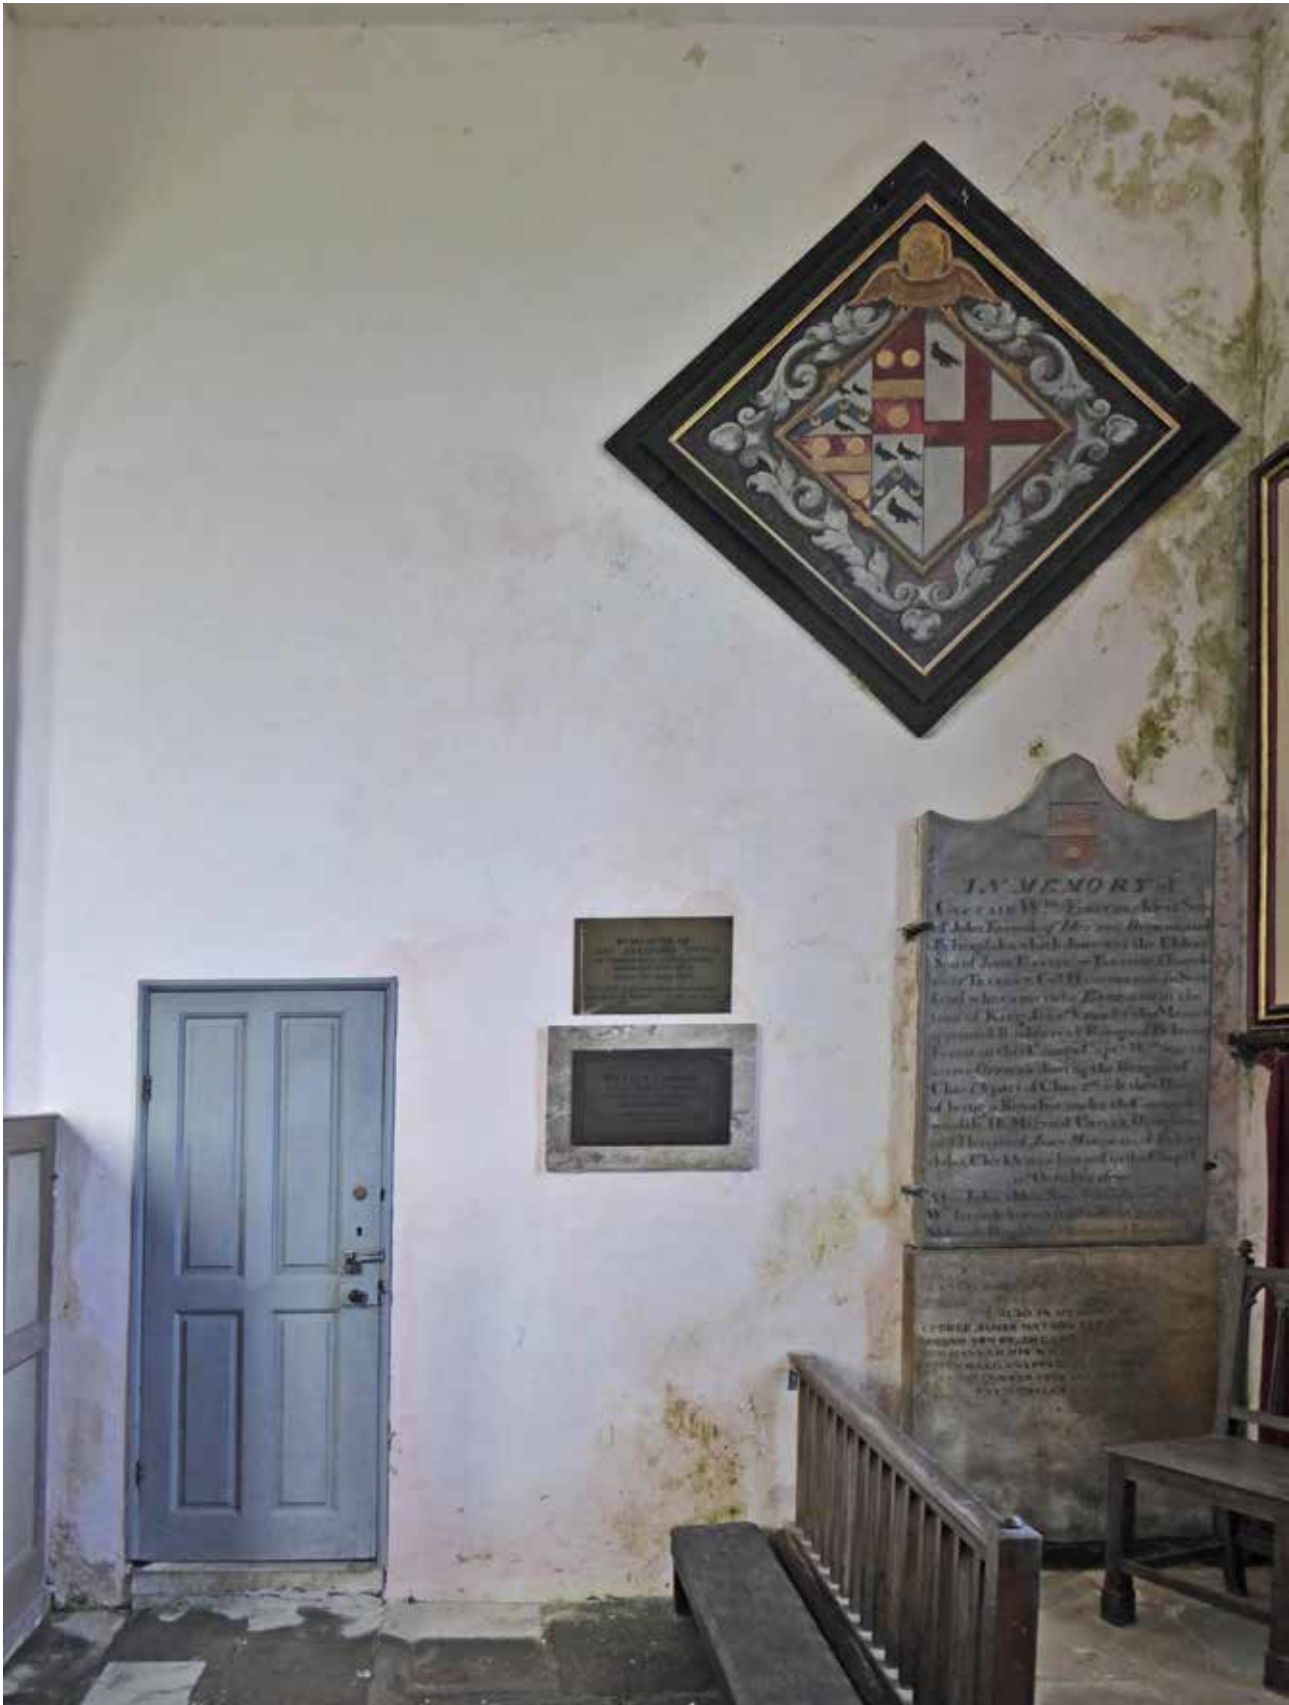
Chancel north wall.

Dampness in the northeast corner may have damaged the plaster and areas have failed around the vestry door. Plaster above this door may have been replaced with a cementitious render. Conservation of the hatchment is planned.

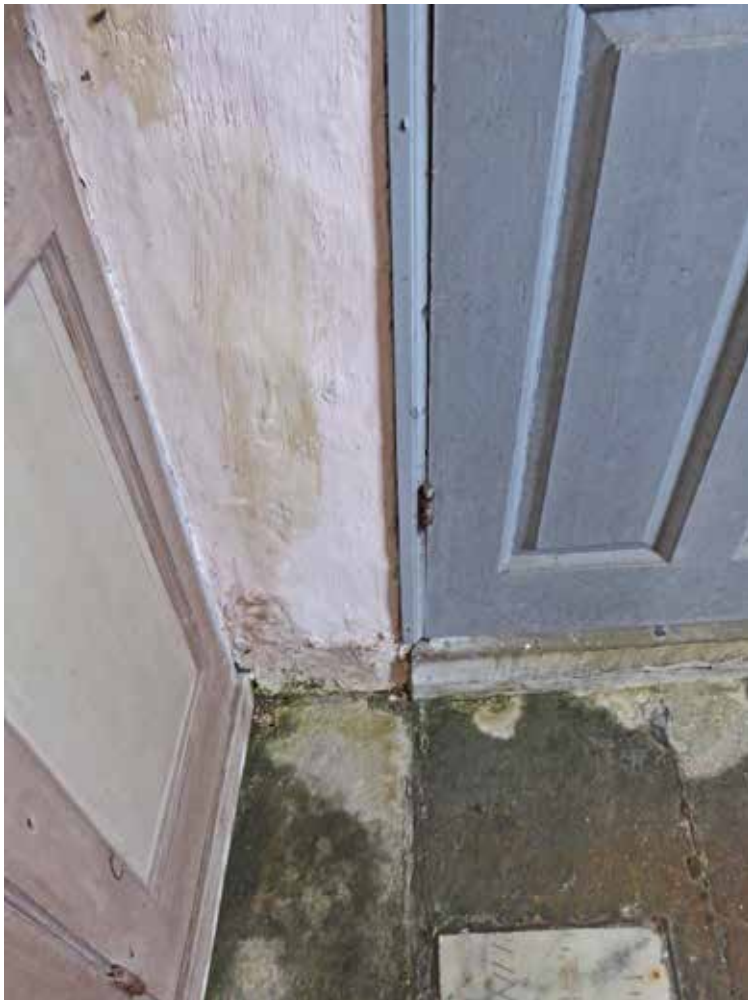
Chancel north wall.  
Plaster has failed to the side of the vestry door,  
on the east side a gypsum plaster repair has  
previously been carried out and this is now  
failing.

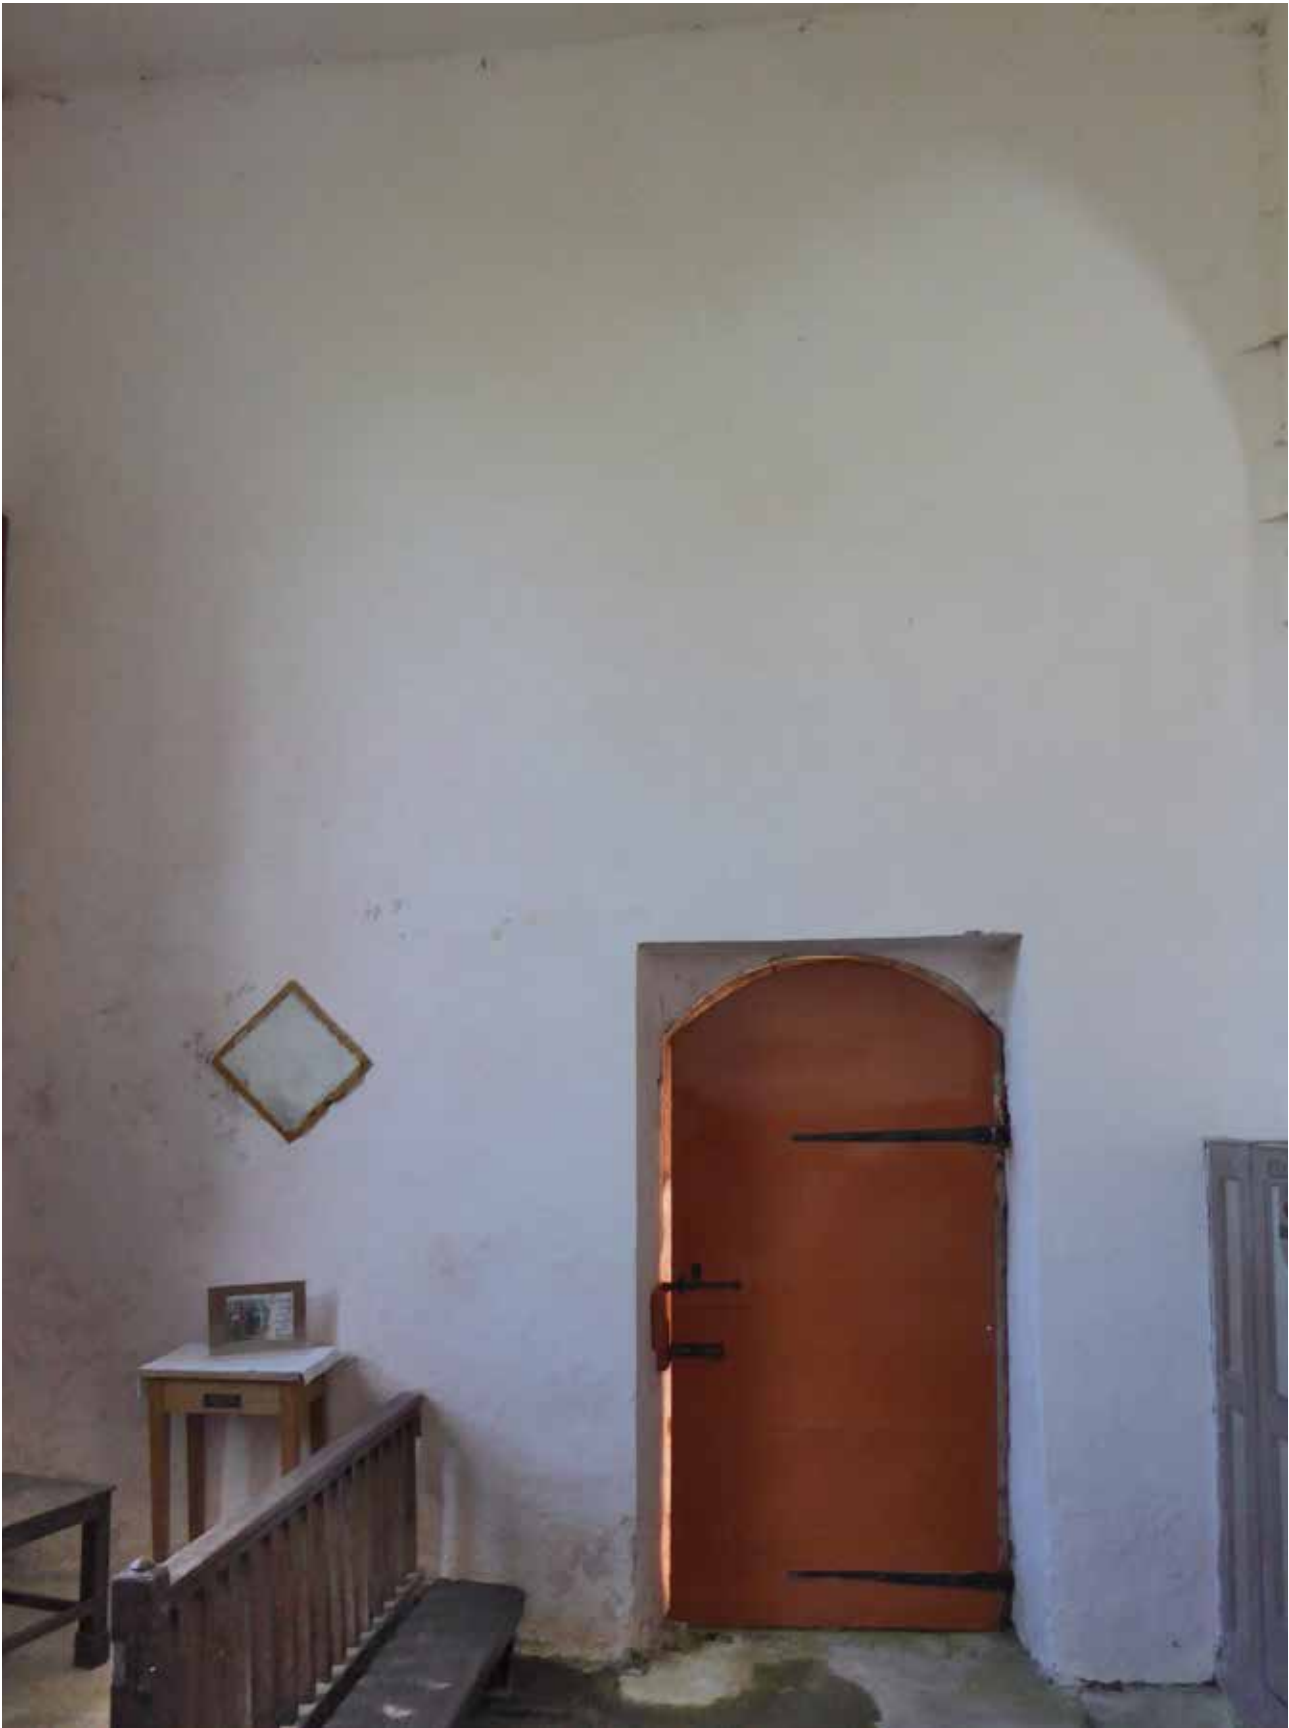
Chancel south wall.

There are local areas of loose plaster on this wall. A large section of wall around this door appears to have been replaced with a hard cementitious render, trapping a moisture in the masonry behind.

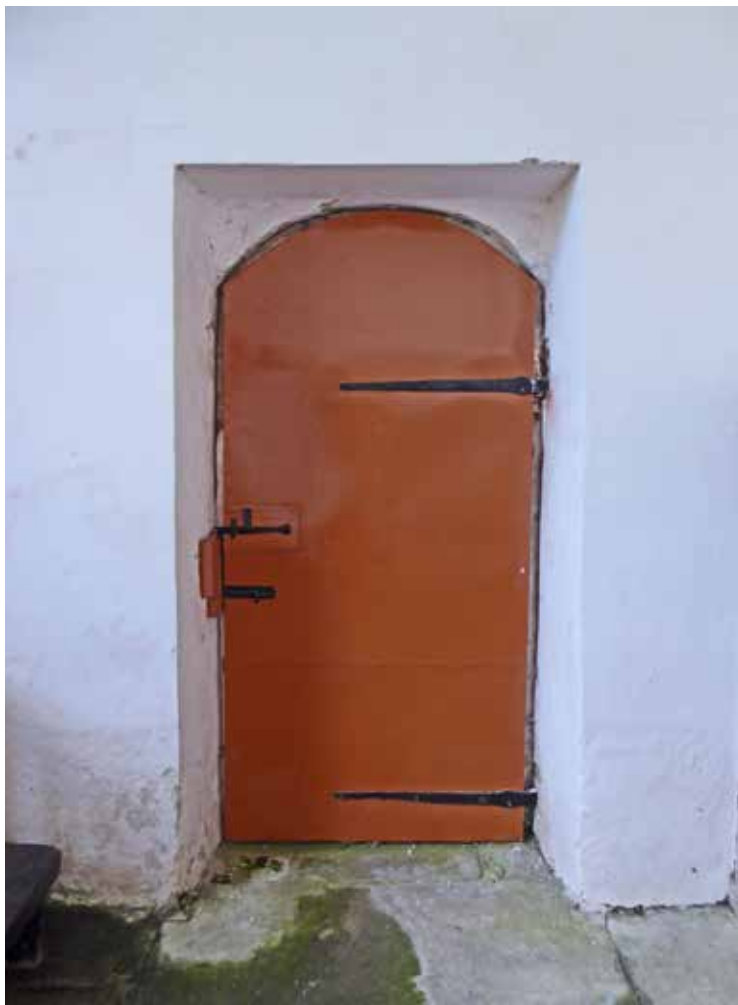
South chancel door.  
Much of the plaster around this door  
appears to have been replaced with a  
hard cement render.
