Ref 3.452

April 2018

STRUCTURAL APPRAISAL
OF
'YORK HOUSE'
KING STREET, ROBIN HOOD'S BAY
FOR
MR & MRS J WHITELEY

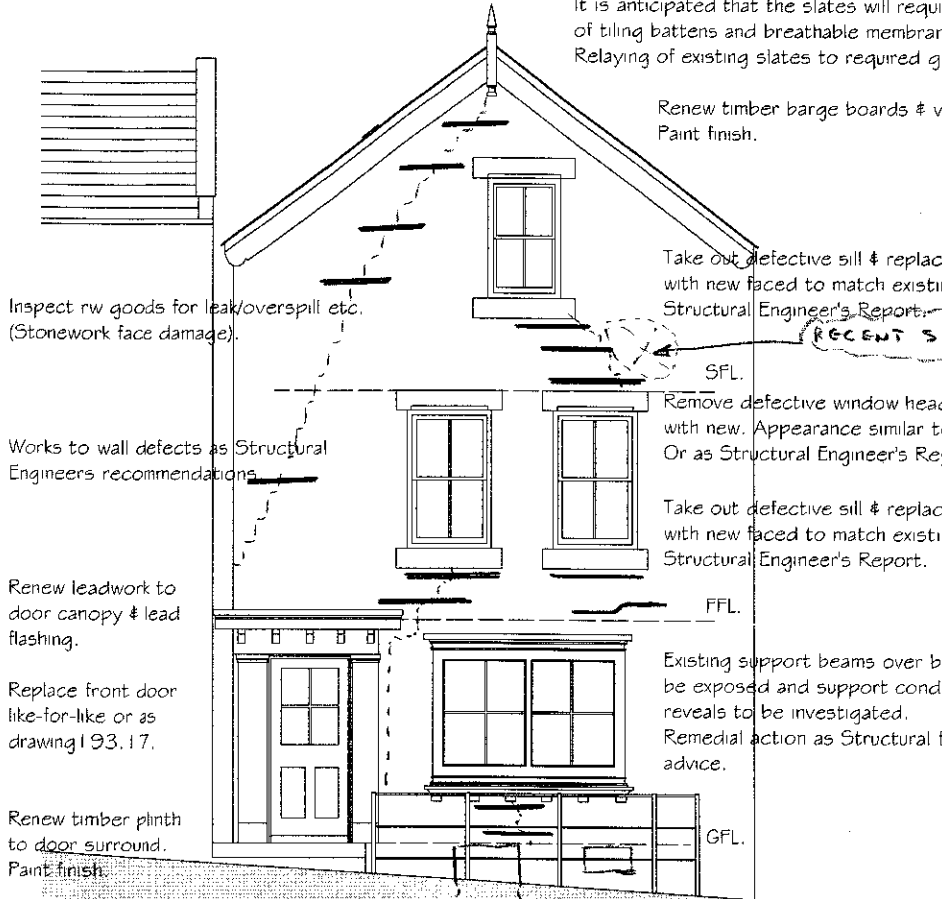
Main roof of house to be inspected by specialist roofing contractor. Areas of uneven slating, patching, broken & missing slates, & yawning, give the impression that a complete overhaul may be required. It is anticipated that the slates will require removal and the replacement of tiling battens and breathable membrane underlay will be necessary. Relaying of existing slates to required gauge and lap.
