From: Gerry Rogerson
Sent: 01 November 2018 20:44
To: Helen Webster
Subject: NYM/2018/0536/FL - GREEN END FARM, GREEN END, GOATHLAND

Arboricultural Impact Assessment Proposed development at Green End Farm, Goathland, Whitby.

Date of Survey: 10th October 2018

Date of report: 15th October 2018

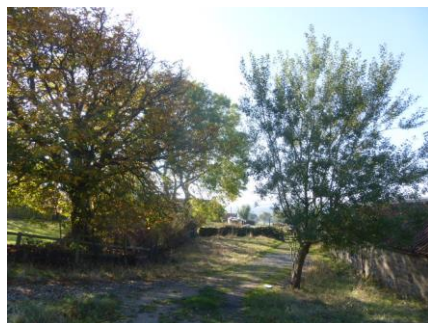
- 6.2 Tree T1 is a mature specimen of Ash situated in the south-west corner of the neighbouring properties garden. It forms part of an old boundary hedge, comprising other ash, elder, goat willow and snowberry (*Symphoricarpus*) It is a tree in fair condition with no obvious defects and a little deadwood present in the canopy, as would be expected in a tree of this age. As there is a proposal to alter the ground levels in this area, it is important that a root protection zone is set up to ensure no damage is caused to this specimen as well as T2 and T3 which form part of the same boundary.

- 6.3 Tree T2 is another mature specimen of ash, located 2 metres to the north-east of T1. It is co-dominant from 0.25 metres. Both stems appear fine with no obvious defects. Minor deadwood present in canopy.

- 6.3 Tree T3 is a mature Horse Chestnut. It is a small specimen for its age and in a poor condition. Large areas of bark are missing on the main stem, with areas of decay present. The main branches all show cracking of the bark along their length. Canopy is full although leaves are small. Along with the two ash trees on this boundary, there will need to be a root protection zone set up. Full details given in Tree protection Plan.

Fig 1. Looking south along public access track. Shows T1 – T4.

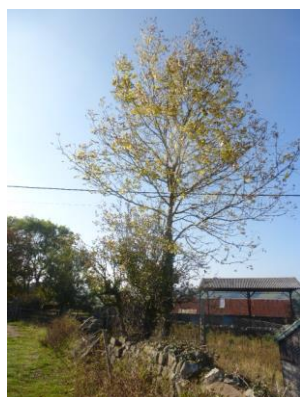
- 6.5 Tree T5 is an old crab apple growing from the base of an old dry stone wall, forming the boundary of a small enclosure to the north-east of Barn 2. The original stem has long since decayed and the tree is now a collection of suckers from the base of the original tree. If retained, there will need to be a root protection zone set up.
- 6.6 Tree T6 is a young ash sapling adjacent T5. No defects are present on this tree, a root protection zone will be required should it be retained.

Fig. 2. T5 and T6.

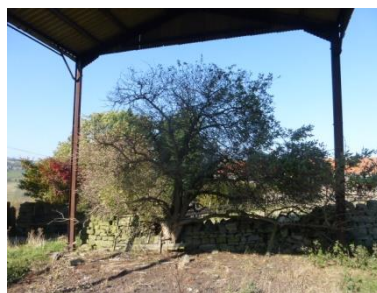
- 6.7 Tree T7 is a large mature specimen of Elder. It is growing at the base of a drystone wall adjacent the open-sided Dutch barn in the farm yard. It has no obvious defects, but if the Dutch barn is to be demolished, it is unlikely that the tree will survive in its current state without the benefit of the shelter.

This large elder could be retained, and if so will require an RPA of a minimum 1m radius from the base of the tree. It will also probably benefit from a crown reduction all over, from which it will regrow, or otherwise, its amenity could easily be replaced by replanting. Elder (*Sambucus nigra*), Guelder Rose (*Viburnum opulus*), wild or bird cherry (*Prunus avium*, *Prunus padus*), or cultivars of rowan (*Sorbus aucuparia*) would all be suitable.

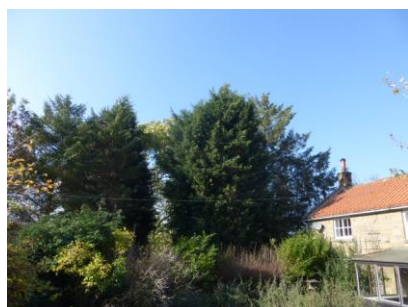
The Leylandii have both done well and are now at a size where they are causing significant shade issues, both to the farm house and to the other planting within the area, including the veteran ash. The remaining planting is generally in poor condition. Of the Norway Spruce, I estimate that 50-60% is dead or dying, due to a combination of lack of light and pressure from grazing sheep. The trees were originally planted at one metre intervals and have not been thinned. The small ash trees, which are mainly around the edge of the plantation have all been ring barked by sheep to a height of 40-50cm and while they are currently still alive, their likely contribution is less than five years. A number of trees within the plantation will need to be removed as part of the development. The remaining trees should be selectively thinned and new planting put in. This will be detailed in the tree protection plan.

Fig. 4 showing G9 and G12 including Leyland cypress.

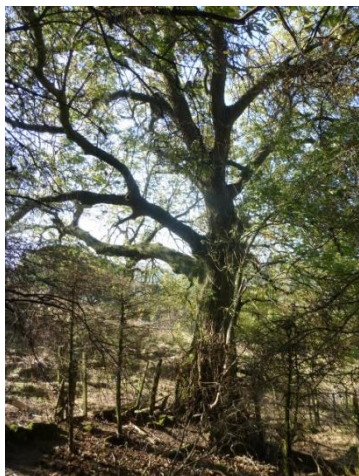
Fig. 6. T13.

6.13 Tree T13 is a veteran Ash situated in the north-west corner of the plantation. An impressive tree with good form and a wide spreading canopy mainly to the south and west. The spruce plantation and Leyland Cypress are now at a height where they are suppressing the growth of the canopy and some large limbs have died back. It would benefit from the spruce and

Cypress being removed to allow more light and more importantly grazing sheep need to be excluded to prevent compaction at the root zone and grazing of bark.

Excluding grazing sheep from this area is imperative to prevent further damage to the bark and relieve compaction around the rootplate. Ideally excluding sheep on the far side of the fence line would also help, if this was possible. A layer of woodchip spread no deeper than 10 cm underneath the canopy would help to relieve compaction.

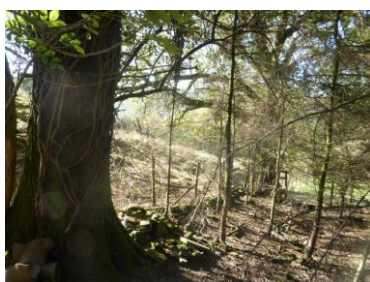
Fig. 7. T14.

- 6.14 Tree T14 is another veteran Ash also along the boundary fence of the plantation. Both trees are excellent specimens and all effort should be taken to improve the area by keeping sheep out and felling the spruce around them to allow more light to the canopy.

T14	Ash	18(2)	820mm [1]						V	Situated on west boundary of shelterbelt. Wide spreading canopy Ivy on main stem, which has been cut. Dead branch on North-east suppressed by Leyland cypress and spruce.	A	G	20+	Remove dead branch. Other recommendations as T13	9.8	304.2

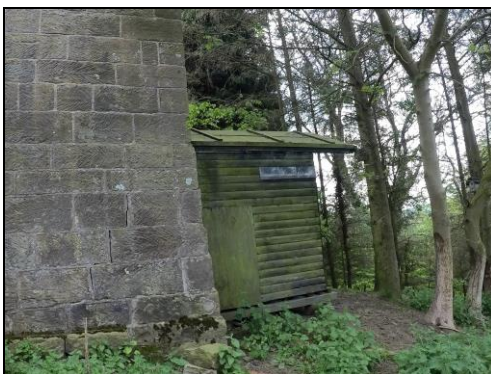
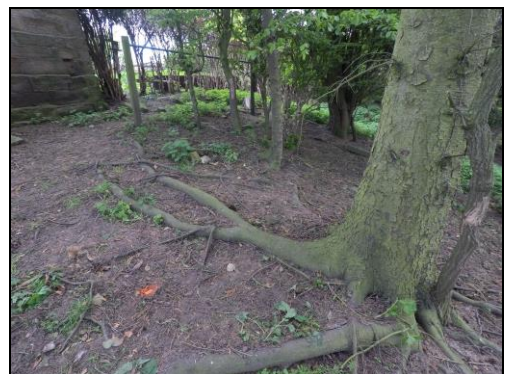
Figures 13 & 14: Evident subsidence to the north-west corner of the Main House, attributed to the extensive tree root systems of Larch and Leylandii trees in close proximity

It is therefore proposed that these Larch and Leylandii be removed. This will make way for the extension, and also will allow views of the large Ash trees from within the site and allow opportunity for some ground cover landscaping on the embankment (see figures 21 & 22). Other trees along the south-west boundary will also remain, keeping intact the screening of the west end of the house from the lane. To compensate for the removal of the Larch and Leylandii, new Beech trees are proposed to the foot of the embankment. These will be planted as large standards.

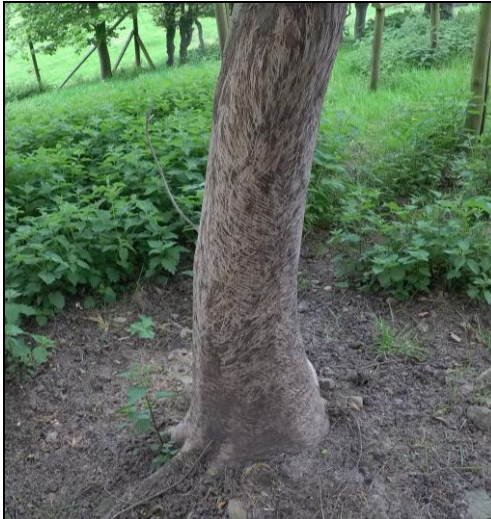
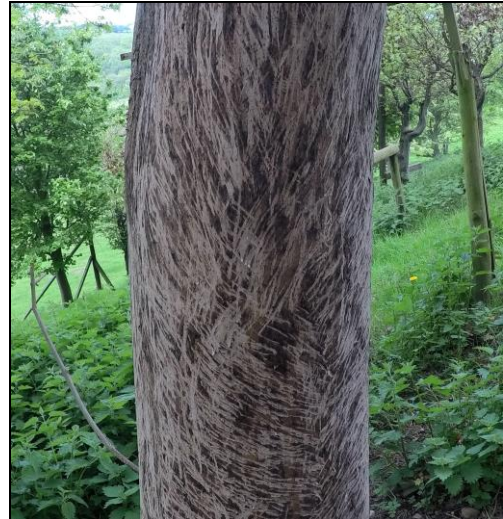
Figures 15 & 16: Ash trees on western embankment, ringed this season by invading sheep

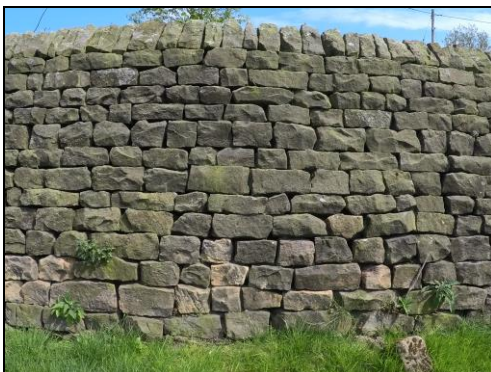
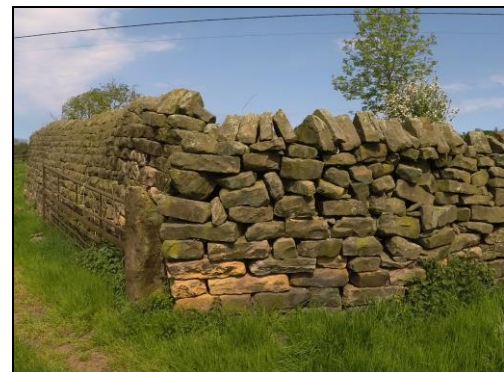
Existing drystone walls will be retained, though a portion of the partially collapsed wall enclosing the existing corral to the east of the courtyard will be reconstructed on a new alignment, to open up views from Barn 2 (see figure 18 below). Similarly, to the east side of the corral the existing wall is also partially collapsed, and will be reconstructed on the same alignment with a new opening to allow vehicular access.

Figures 17 & 18: Existing drystone walls to corral to be retained; where wall is in deteriorated / partially collapsed state, wall to be reinstated, with some realignment as noted
