**STRUCTURAL REPORT
ON
BARNs AT
BEACON FARM
BEACON BROW ROAD
SCALBY
YO13 0PQ**

MCB/SLB/42192 Rpt001

**STRUCTURAL REPORT ON BEACON FARM, BEACON BROW ROAD,
SCALBY, YO13 OPQ**

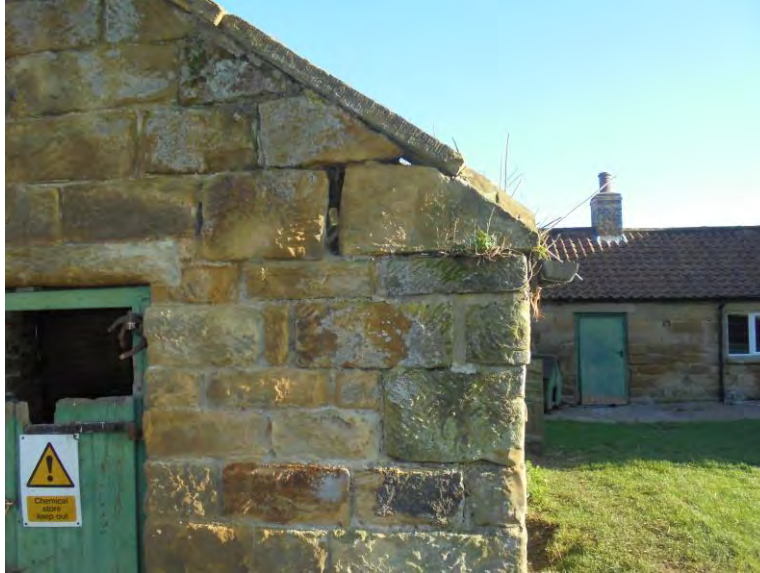
Photograph No. 1

- 3.2 To the West gable end of the West barn there is evidence of wall movement at eaves level. (See photo 1)
- 3.3 At the gable end of the East Barn there is vertical cracking on the face of the lintel above the window. This is a clear sign the lintel has been overloaded and failed. Someone has attempted to repair the lintel with mortar. (See photo 2)

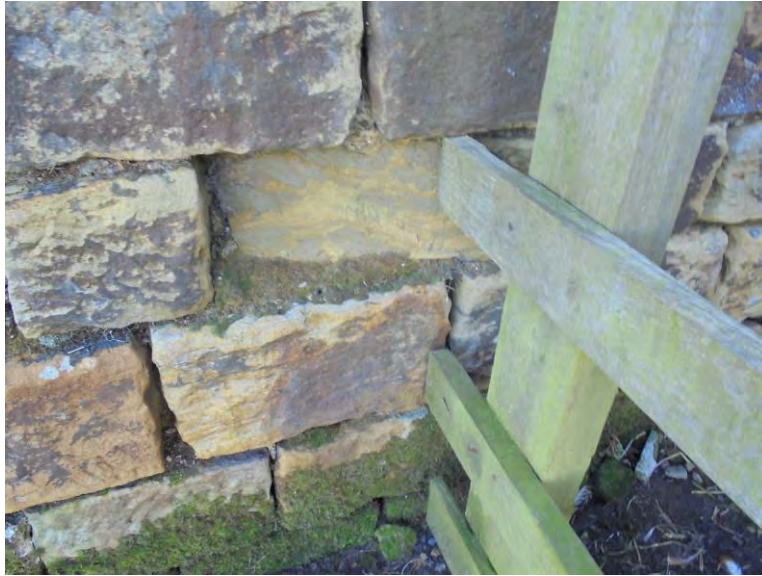
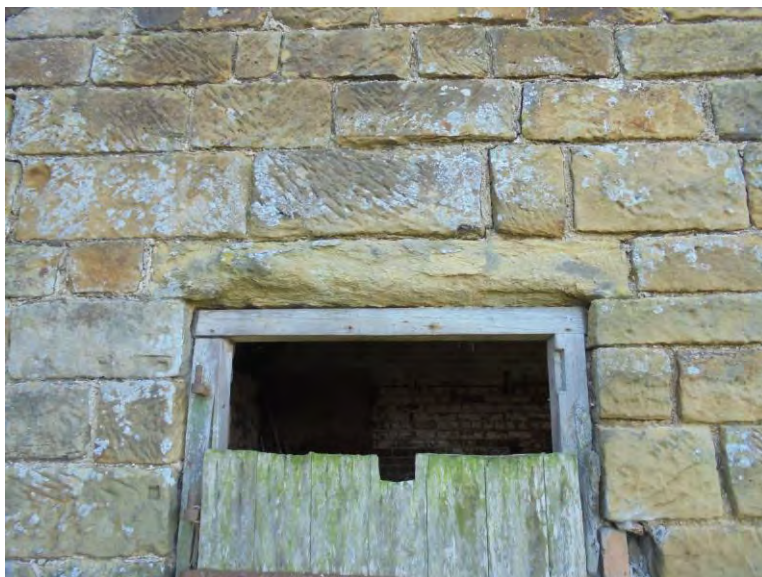
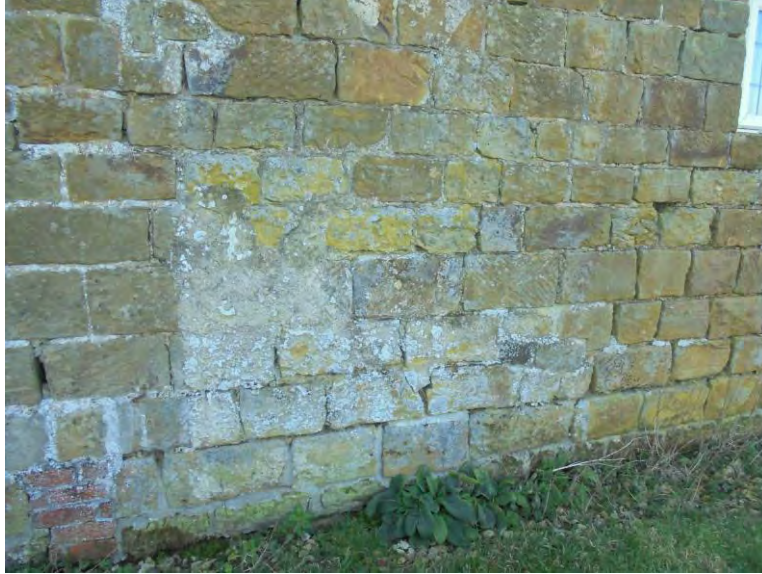
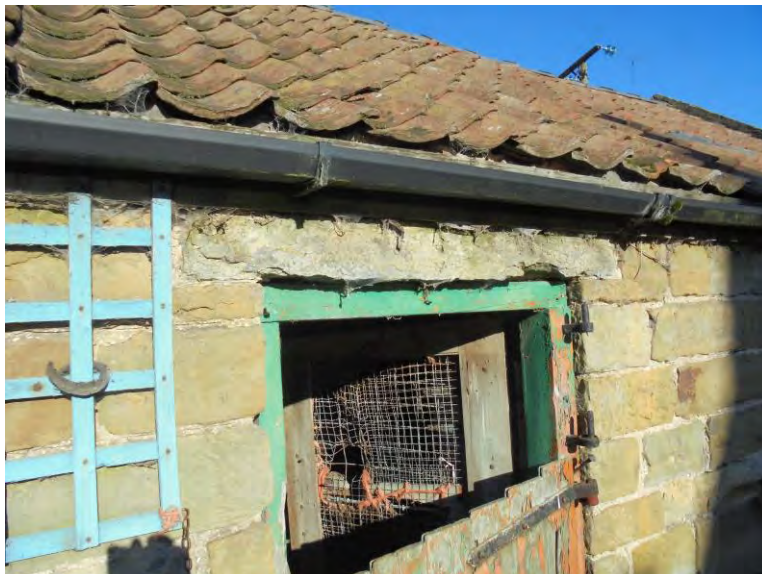
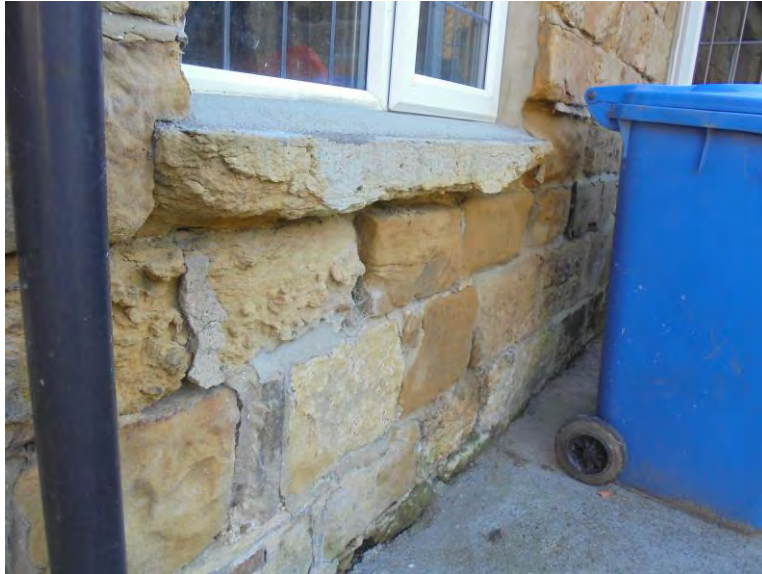
- 3.4 Stonework walls and lintels in both barns have suffered from erosion and certain stones in the wall have been eroded as far back as 50mm from the face of the wall. (See photos 3-7)

- 4.1 The receding mortar on the external face is due to weathering. On the internal face it is likely as a result of animal urine when housed indoors. The erosion also appears to have affected the structural integrity of some of the stone lintels.

- 5.1 In the areas where the mortar has receded and eroded the walls require repointing. This applies to both internal and external faces of the stonework.

- All cracked and severely weathered mortar joints should be raked out to a minimum depth of 30mm and be repointed with a mortar which will give some degree of flexibility such as a 1:1:6 (lime) or plasticised mortar. Any cracked, broken or severely weathered stone should be cut out and new units, of a similar pattern and material, be built in using a mortar similar to that as used in the repointing. When work is carried out adjacent to the damp proof course, great care should be taken to ensure that no damage is done to it or that no mortar bridges across it. All broken or severely weathered stone below the damp proof course should be cut out and be replaced with a good dense matching brick/stone built in cement mortar and the work is to be carried out in short lengths, so that the stability of the stonework above is not impaired.

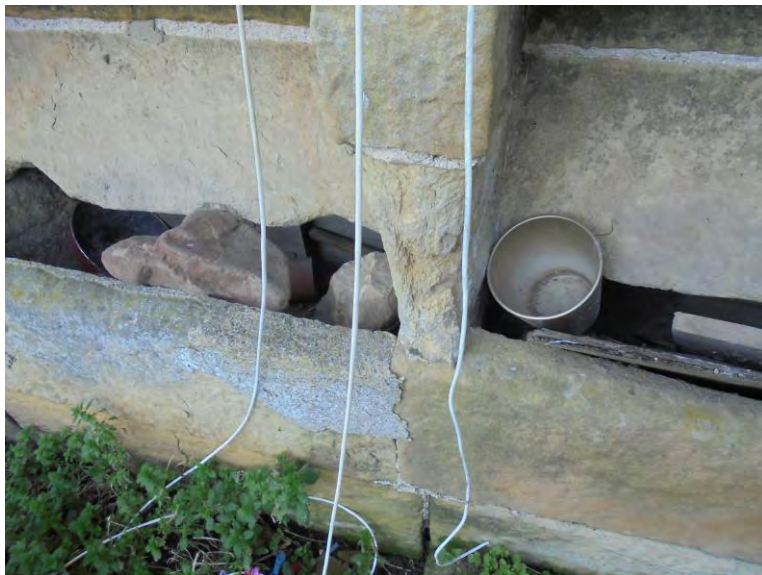
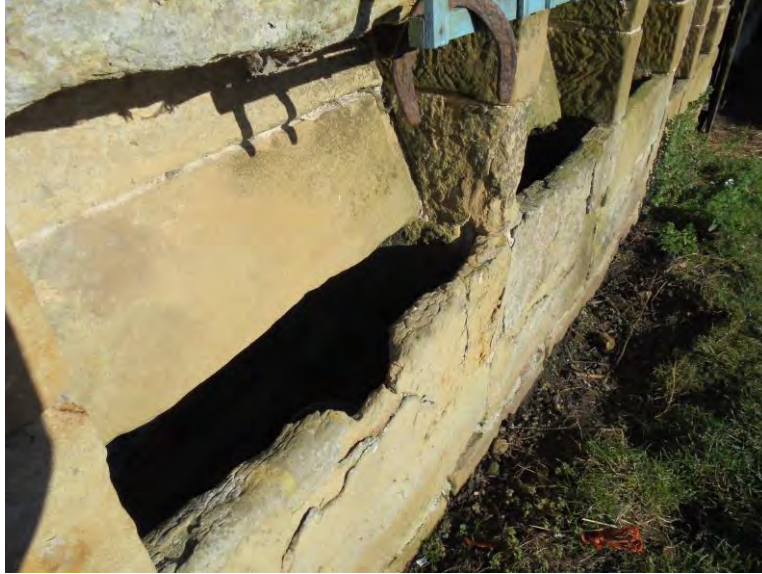
- 3.5 The troughs on the front elevation of the West barn have eroded, compromising the structure, and need replacing. (See photos 8-10)
- 3.6 There is a diagonal line of cracked mortar at the corner of the rear wall and East end gable. (See photo 10)

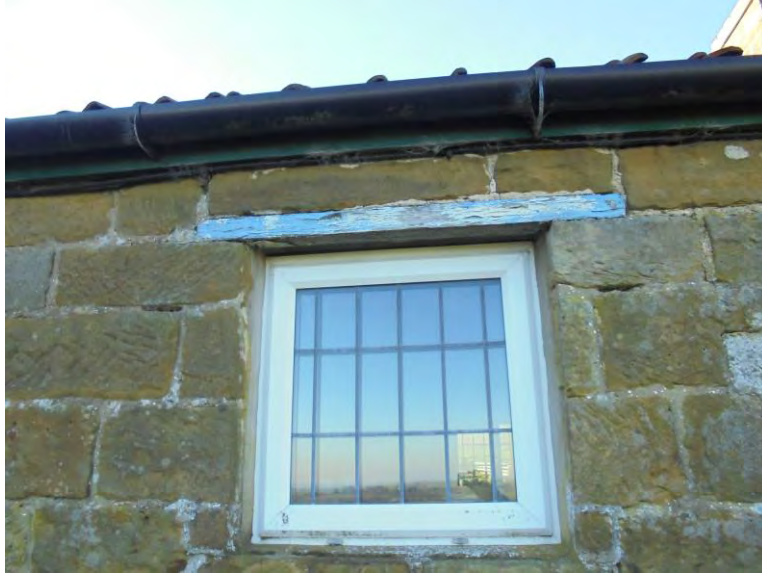
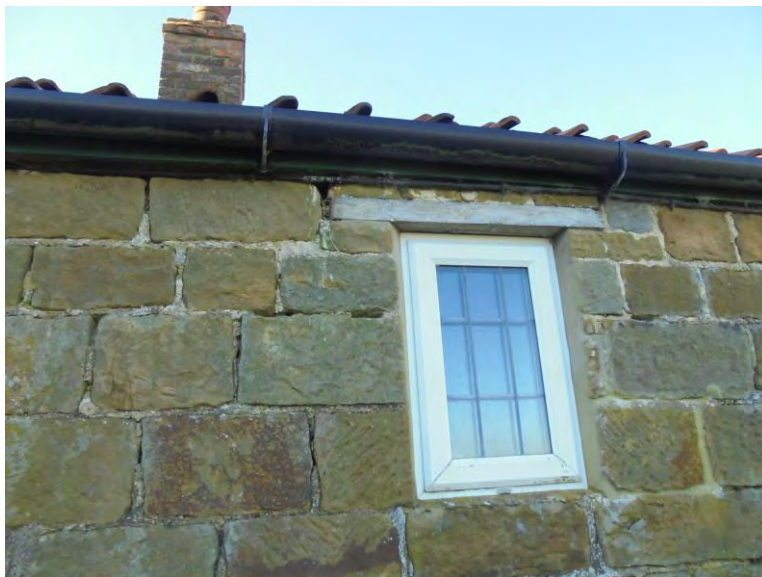
- 3.7 Slender timber lintels have been used above windows on the rear face of the East barn. (See photos 11 & 12)
- 3.8 At the north corner of the West Barn there is evidence of historical movement, indicated by the large gaps between the stonework. (See photo 13)

- 4.4 Within both barns timber lintels appear to have been used in both the exterior and internal walls. The timber lintels may have been used to replace stone lintels post construction.

- 5.4 All timber lintels present in both barns should be replaced with suitably designed lintels.
- 5.5 The corner of the rear wall and East gable in the west barn. At the time of the survey there was no evidence of active movement. The corner wall should be stitched back if possible with Sockfix anchors from Helifix or similar approved. However the movement is likely historic therefore repointing the wall should be sufficient.

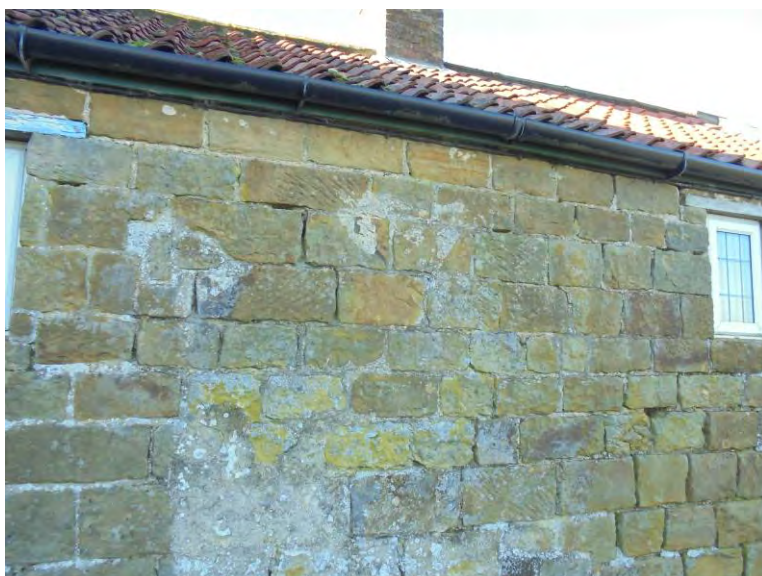
Photograph No. 14

- 3.9 The wall at the rear elevation of the East barn is bulging outwards slightly. (See photo 14)

- 5.2 To ensure further movement of the rear wall of the East barn does not occur, we recommend that the rear wall is tied back the central spine wall with Sockfix anchors from Helifix. The anchors should be installed as per manufacturer's recommendations.

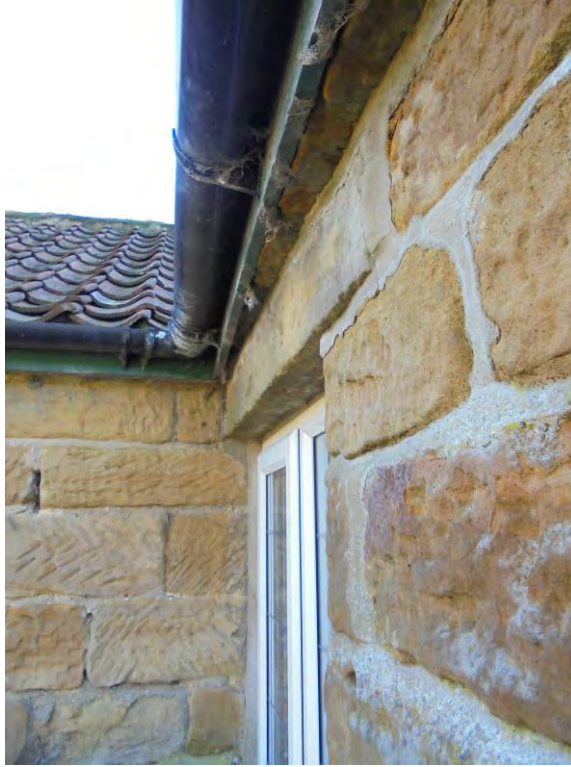
Photograph No. 15

- 3.10 The lintel above the corner window (front face of the east barn) is slightly out of position. (See photo 15)

- 5.3 All of the stone lintels that show signs of cracking, previous repair or erosion should be replaced with suitably designed lintels.
- 5.4 The stone lintel in above the doorway, detailed in point 3.10, should be pushed back into position.

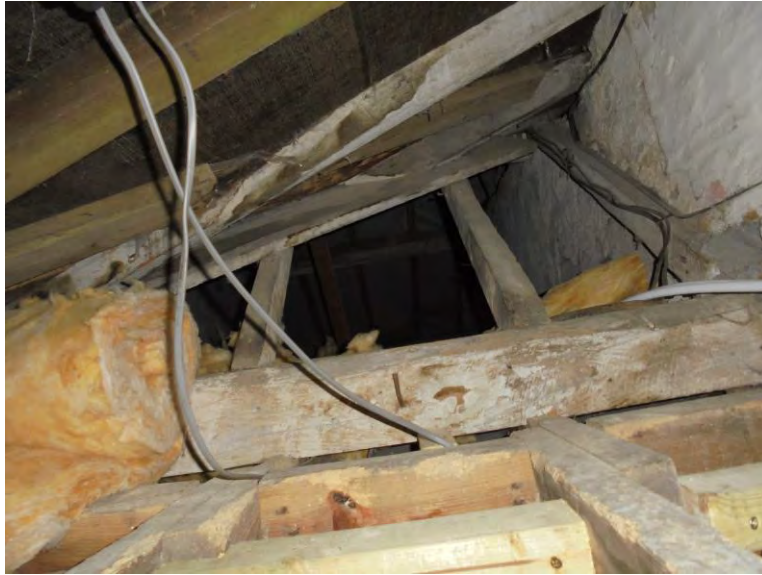
Photograph No. 23

- 3.10 There are concrete floors present with a step approx 100mm difference in the floor levels.
- 3.11 The concrete floor and ceiling are of recent construction.
- 3.12 There are several cracks to the render finish of the central spine wall. The general direction is diagonal and it's origin is the bottom corner where the spine wall meets the rear external wall. (See photos 16-19). Cracks also present on the reverse side. (See photo 20)
- 3.13 The walls below 1m (above FFL) are generally in disrepair. Mortar joints have eroded and washed out. (See photos 21 and 22).
- 3.14 There was limited roof access. Inspection photos from the hipped roof show the main roof structure is of timber rafters spanning onto purlins and ridge beams. (See photo 23)

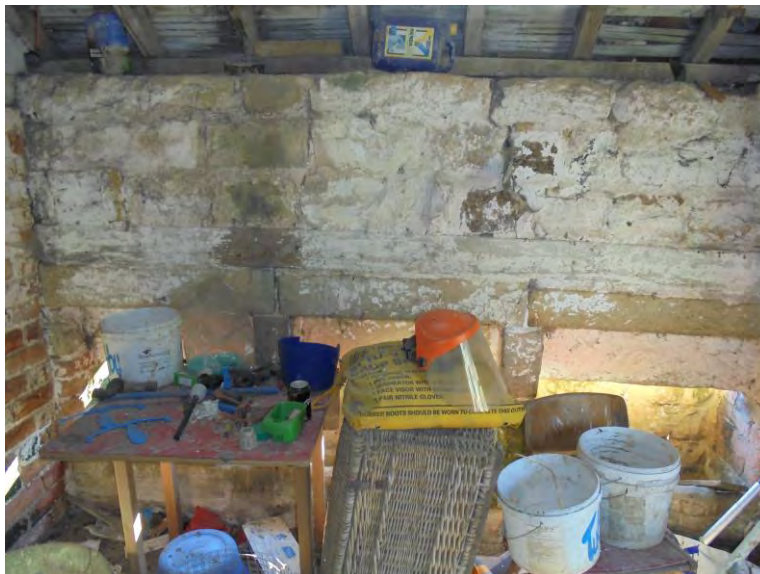
Photograph No. 26

- 3.15 The barn is separated into three sections by two brickwork spine walls from front to rear. Stone floors are present throughout. Floor levels step to each section.
- 3.16 The corner wall of the West end gable section is in a bad condition. Mortar joints are receded and previous repairs attempted. (See photo 24)
- 3.17 The timber lintel in the West end gable section above doorway is overloaded. (See photo 25)
- 3.18 The timber lintel in the West end gable section above the troughs is overloaded. (See photo 26)

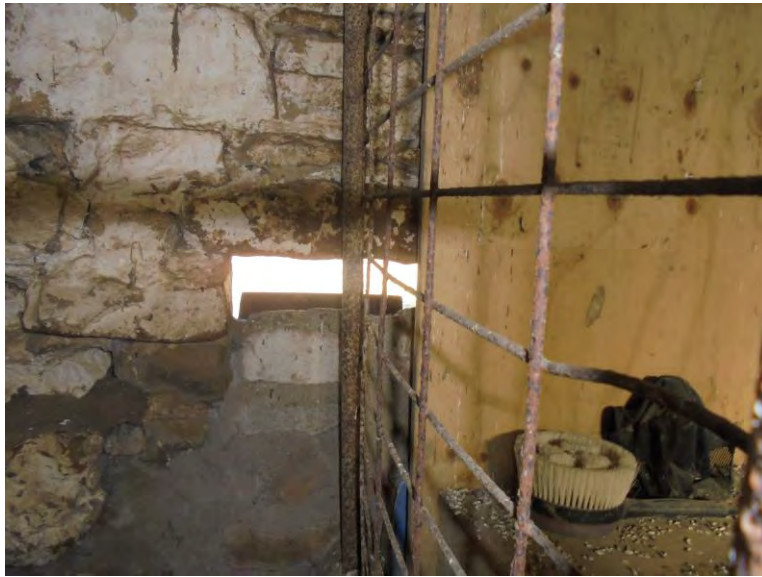
Photograph No. 27

-
- 3.19 The Stone lintel above the window in West end badly corroded. (See photo 27)
- 3.20 In the central section the rear stone walls below 1m above FFL are receding and stonework appears to be corroding. (See photo 28)

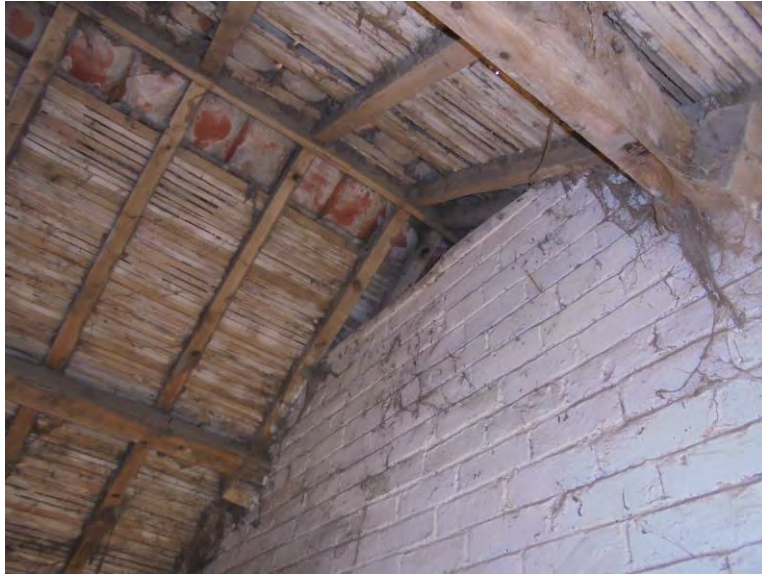
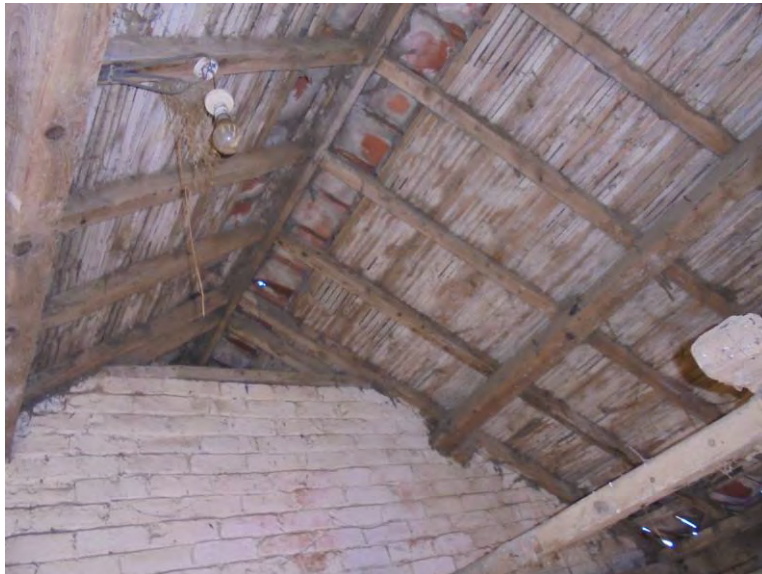
- 3.21 The roof in the West Barn appears to be in good condition. No distress was visible at the time of survey. (See photos 29 and 30)
- 3.22 Stone walls badly deteriorated upto 1m above FFL within the East end section. Mortar joints have significantly receded resulting in large gaps between the stonework. Stonework has also eroded (See photos 31-33)

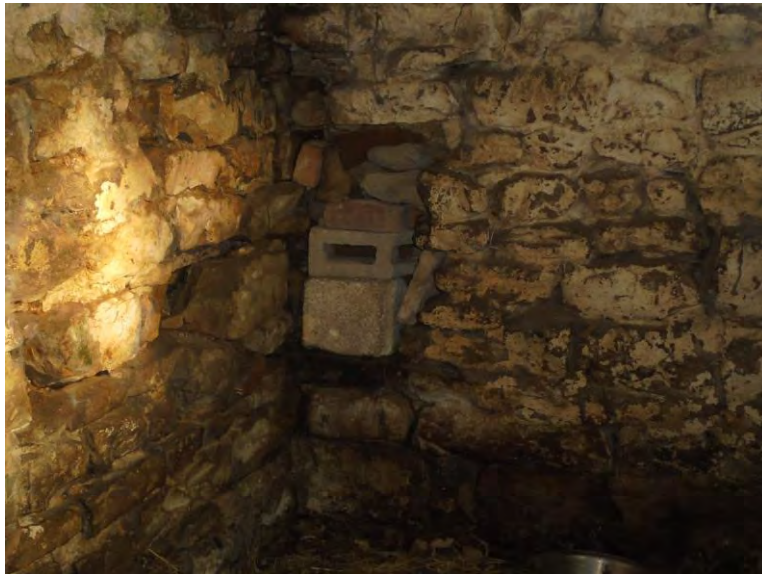
Photograph No. 34

- 3.23 Significant stonework erosion or removal has resulted in a large hole in the corner where the rear wall meets the gable end. The hole has been filled with rubble fill. (See photo 34)

- 4.5 There are several stone lintels in the exterior wall that show signs of suffering from weather erosion and previous repair.
- 4.6 The hole in the internal face of the corner of the East barn was likely cause by eroded stonework and settlement of the foundation. These factors would have resulted in the stonework cracking. They would have then been removed and replaced with rubble fill.

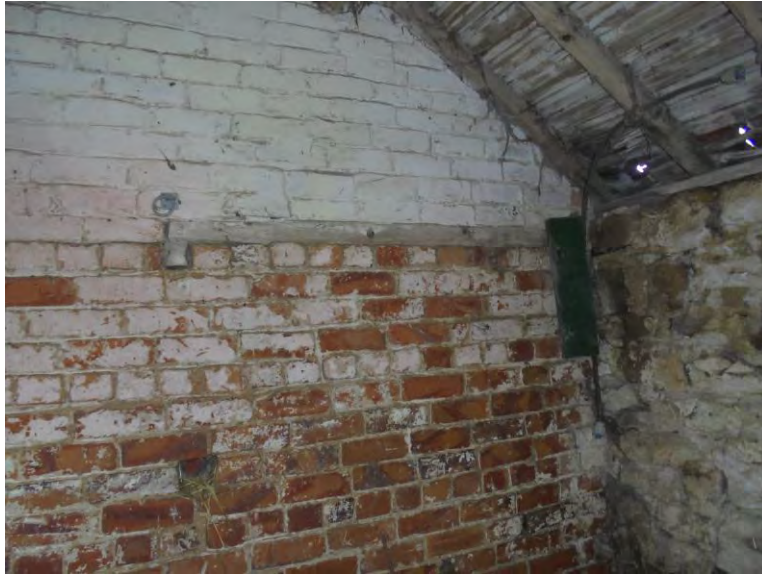
Photograph No. 35

- 3.24 Timber infill used at eaves level in separating wall. (See photo 35)
- 3.25 A manhole cover is present in the corner of the East section at the gable end. It was not lifted and inspected. (See photo 36)

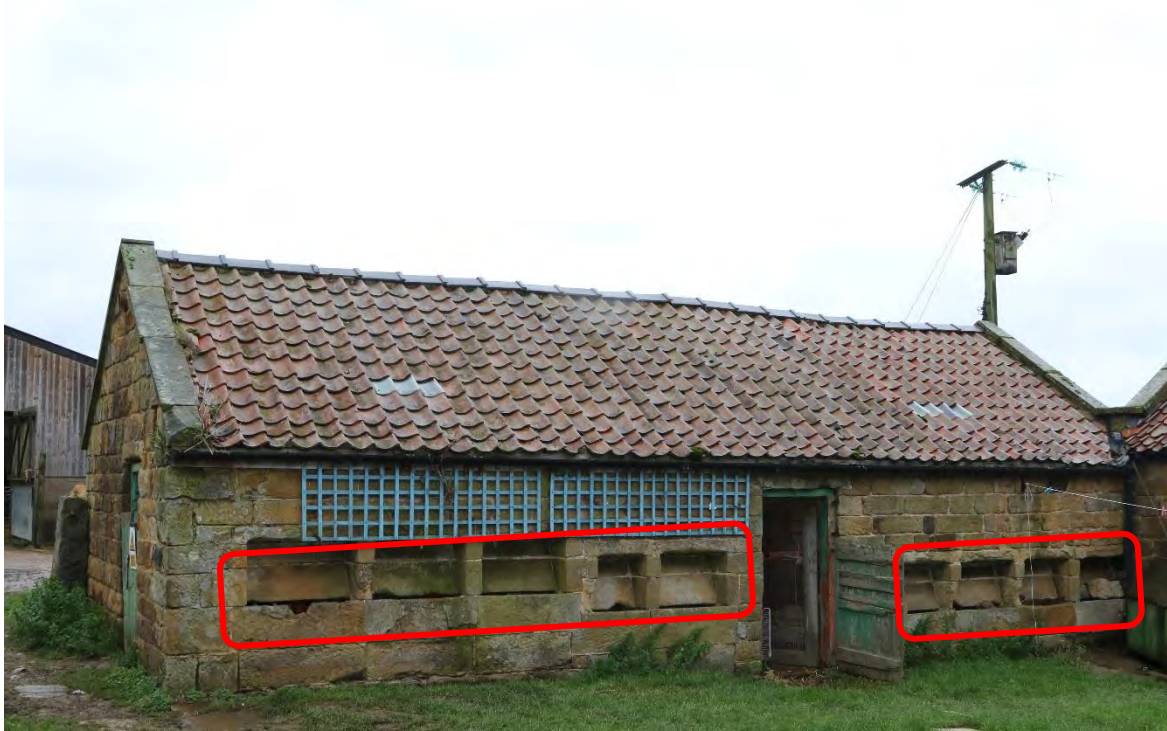
The use of Pantiles across the roof coverings demonstrated multiple gaps (Image 1, 3, 4) across both facing elevations from deterioration/damage caused by age. These features looked to offer roosting availability for crevice dwelling bats along with access within the internal areas of the building for both void & crevice dwelling bats.

Image 1 – South/East facing elevation of the building which demonstrated a Pantile covering to the roof area which looks to offer multiple areas of value to bats along with trough style gaps within the stonework's offering access internally

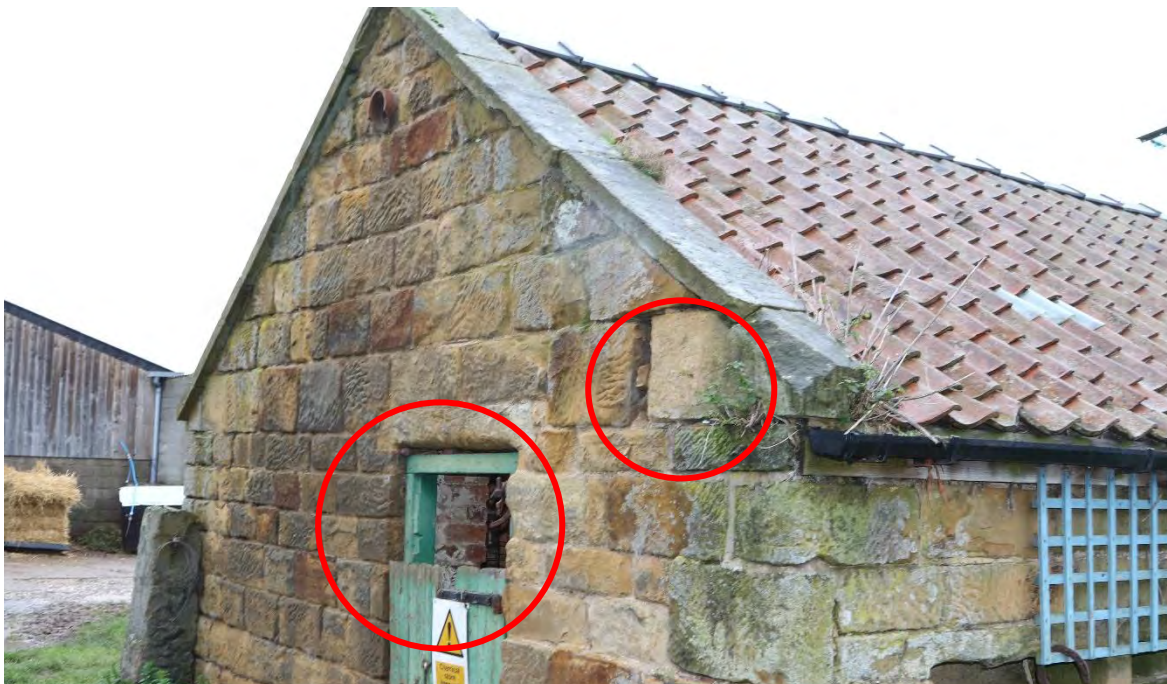
The stonework's externally around the building demonstrated a fair condition for the age with several crevices (Image 2, 6) which would offer value to crevice dwelling bats for day roosting.

Image 2 – South/West facing elevation of the building where an area of deterioration and stable stile door which offer suitable access opportunities for bats to gain access to the internal features within the building

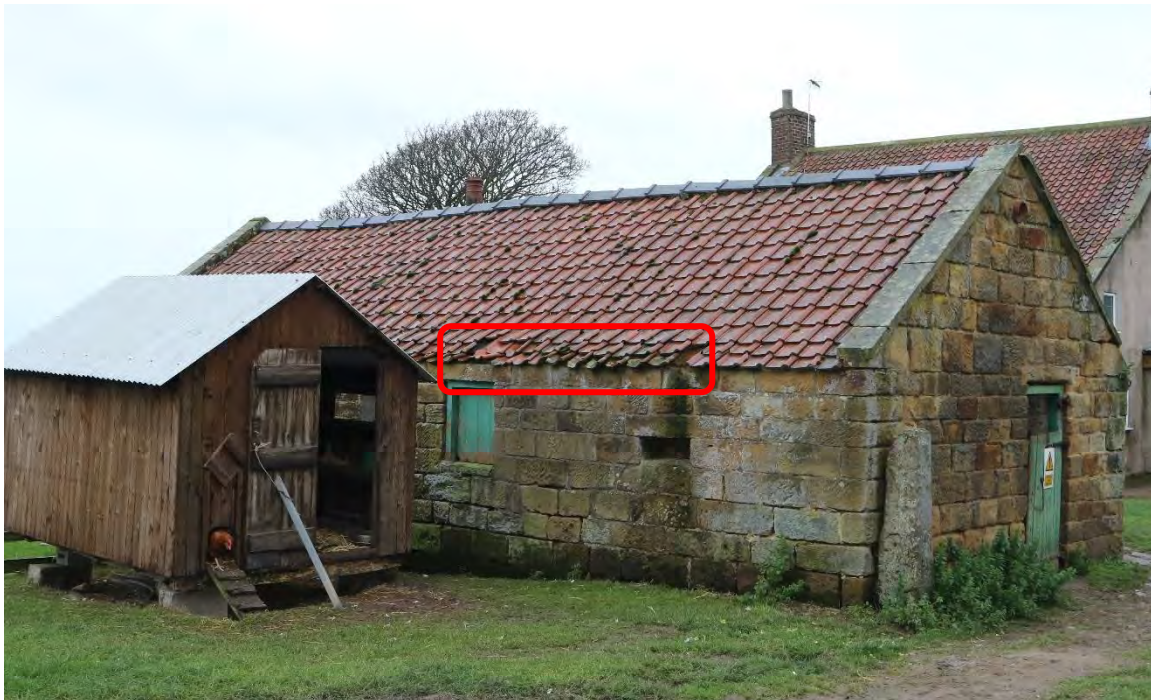
Image 3 – North/West facing elevation of the building demonstrating areas of deterioration/damage to the roof coverings

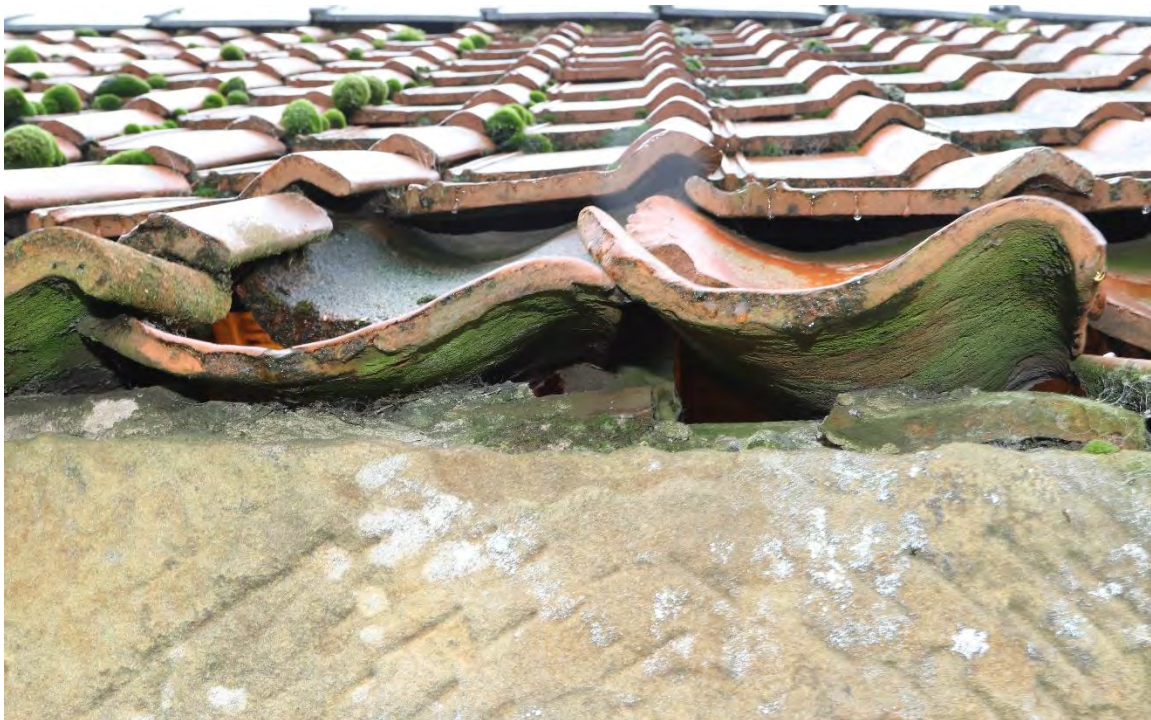
Image 4 – North/West facing roof coverings which offer value to bats with access into the internal areas of the building

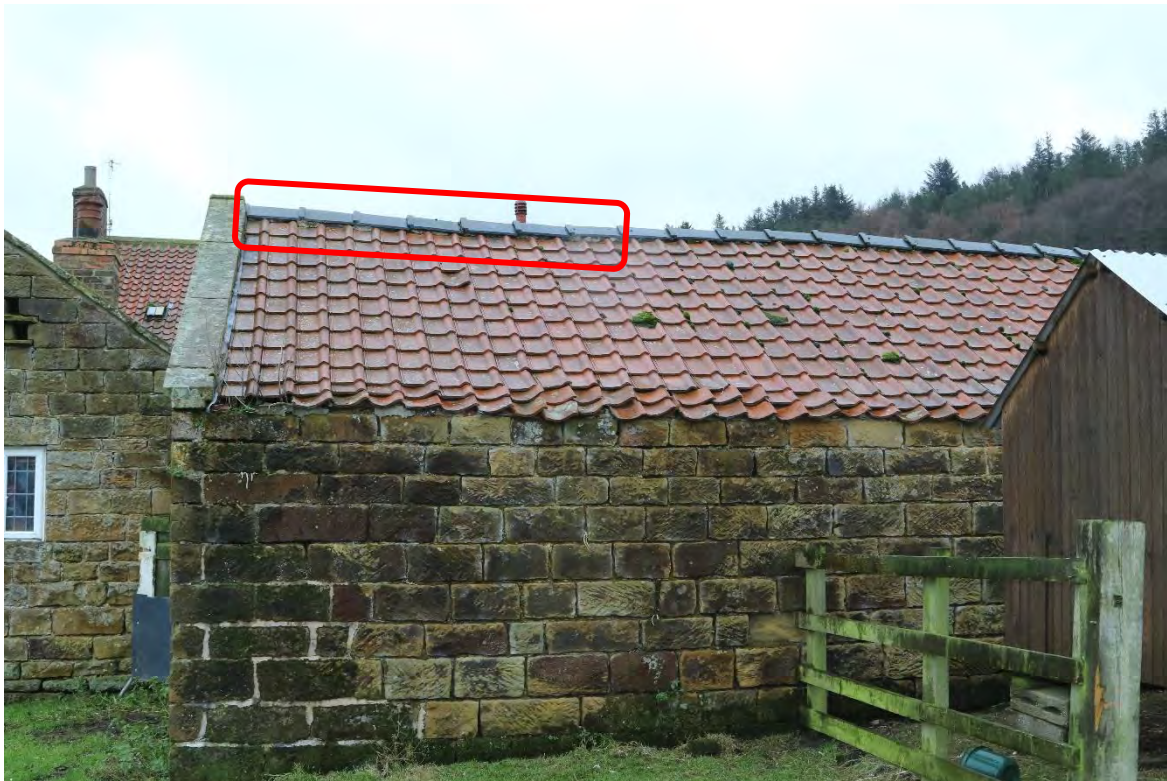
Image 5 – Movement noted within a number of ridge tiles which offer suitable roosting opportunities for crevice dwelling bats

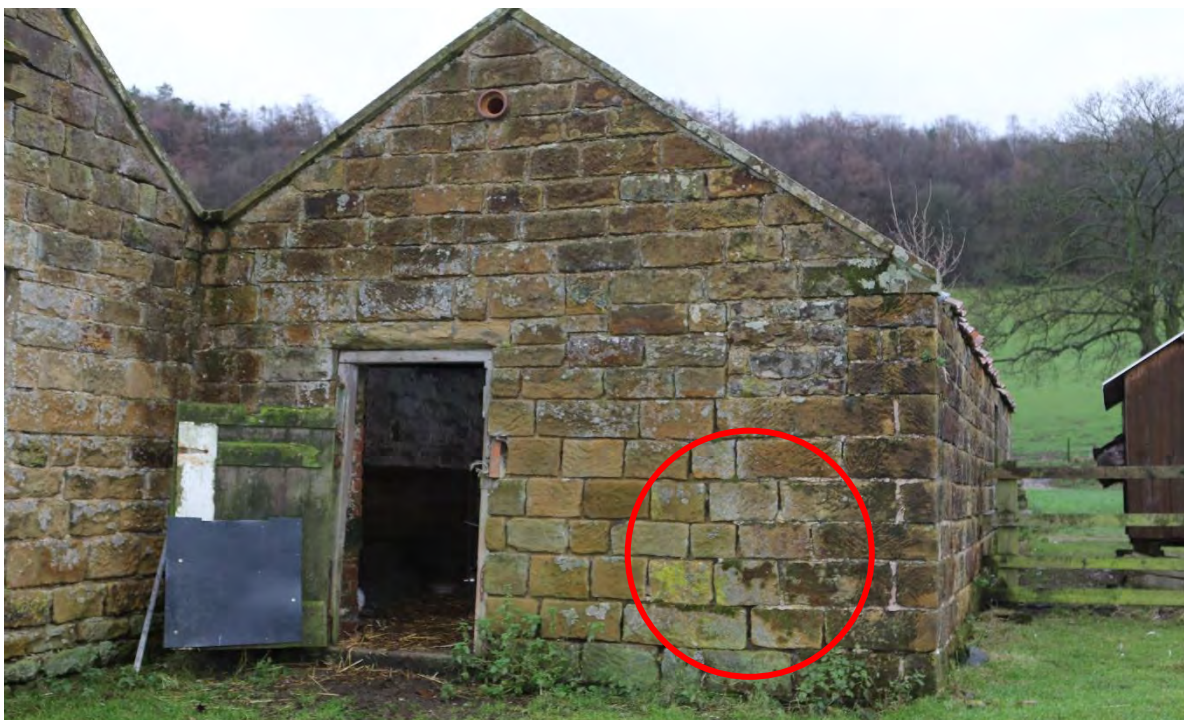
Image 6 – North/East facing elevation of the building in which deterioration has been noted within the stonework's which offer suitable roosting values for crevice dwelling bats within

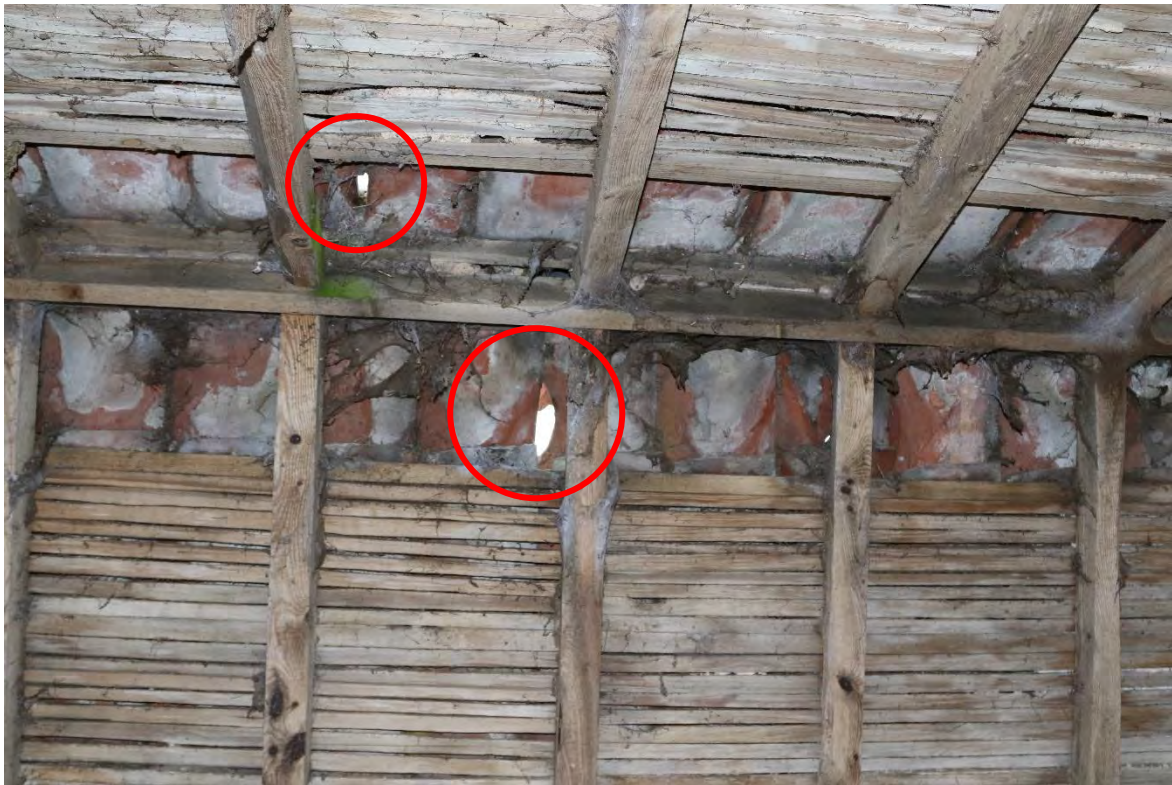
Image 7 – Below the roof coverings where a number of gaps within the coverings of ample size for bats have been identified, also additional timber coverings below

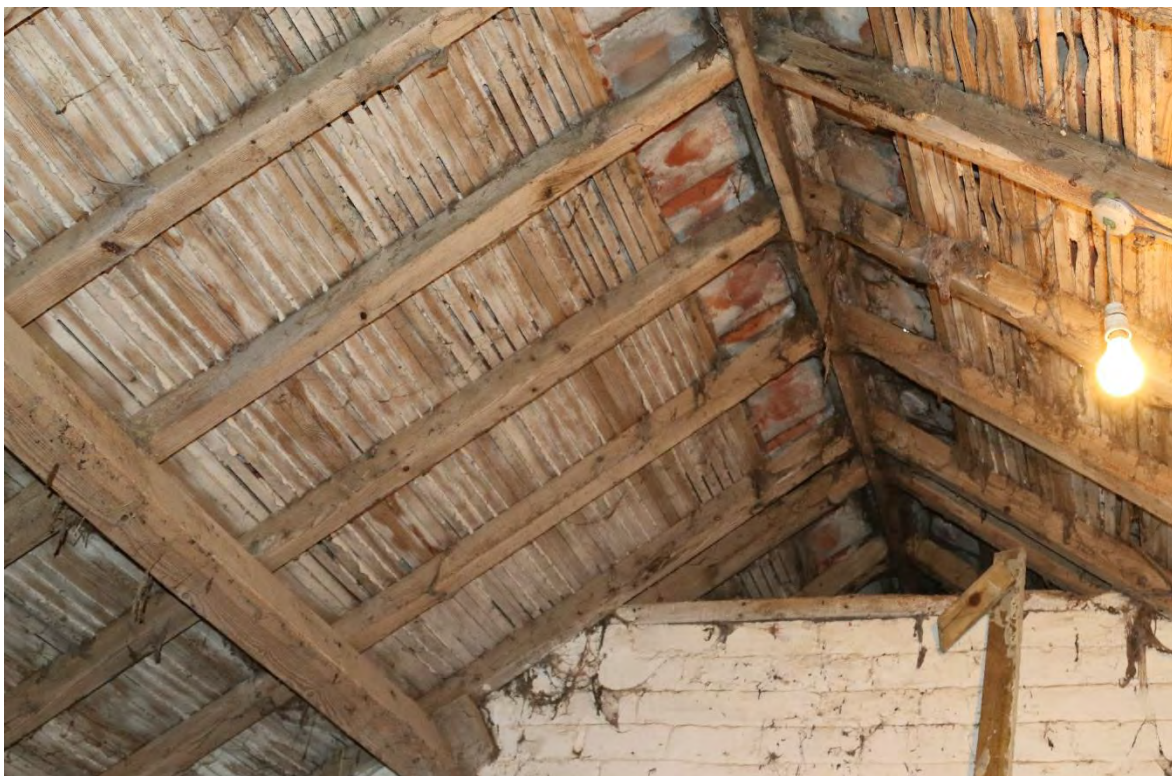
Image 8 – Further views from below the roof coverings within the building

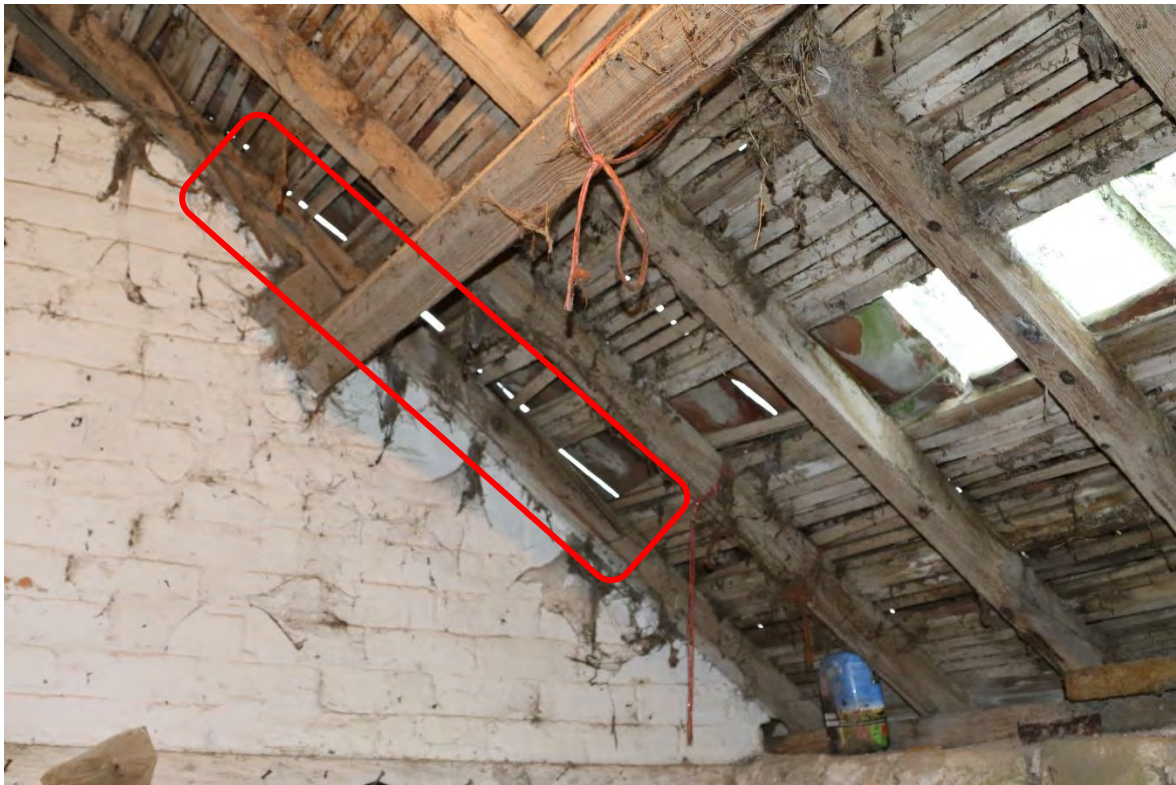
Image 9 – Further views from below the roof coverings within the building in which daylight can be seen above the stonework's

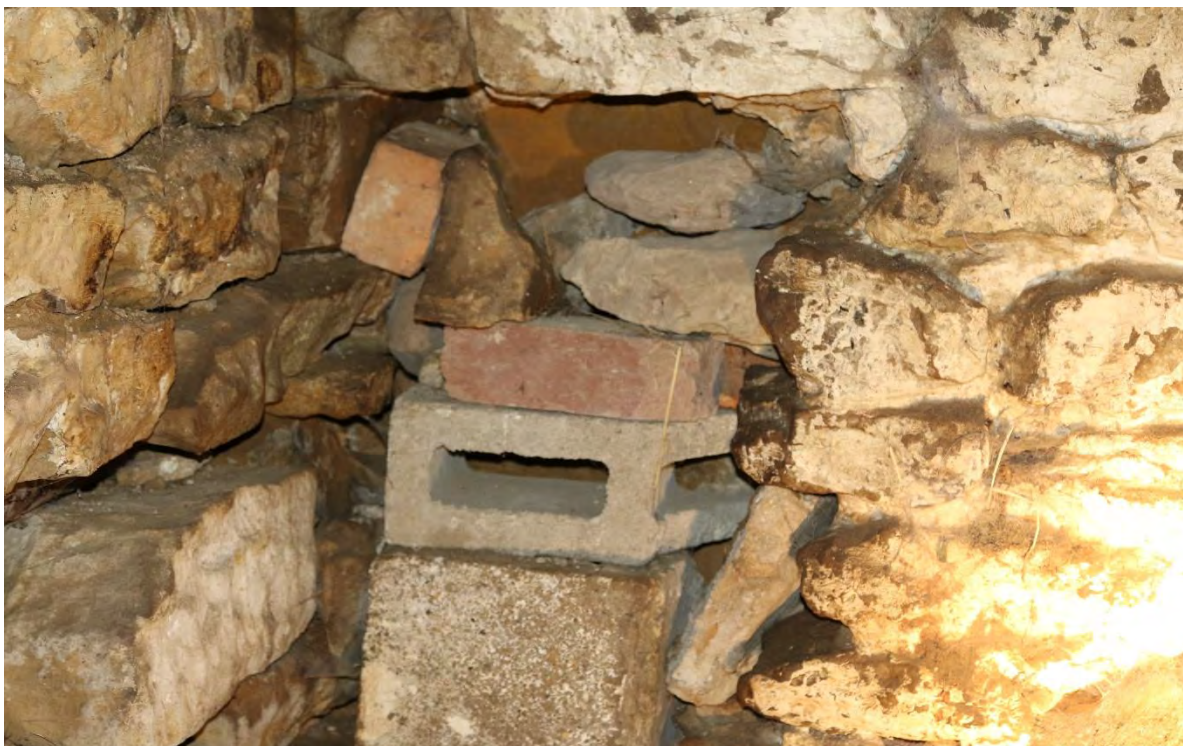
The stonework's internally demonstrated several areas of deterioration leading into suitable roosting environments for crevice dwelling bats (Image 10)

Image 10 – Internal stonework's within the far East area of the building in which a number of suitable roosting areas for crevice dwelling bats have been noted where areas have been patched up and deterioration.
