DESIGN AND ACCESS STATEMENT

Proposals for cupola repairs and modifying north side rainwater goods.

**THE OLD CHURCH OF ST STEPHEN
FYLINGDALES
NORTH YORKSHIRE**

HERITAGE STATEMENT

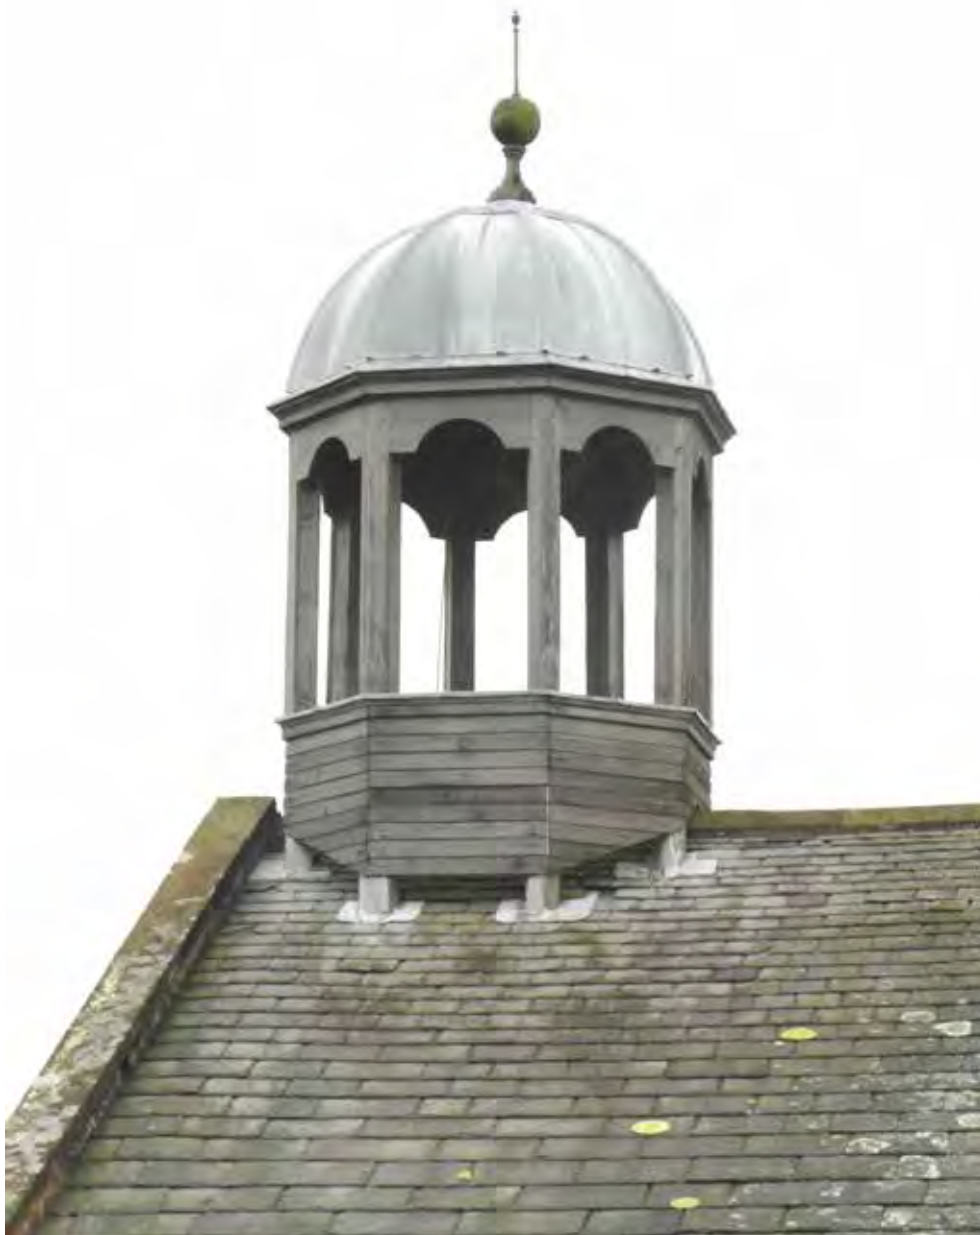
Existing cupola, before investigation of water leaks and removal of horizontal boarding.

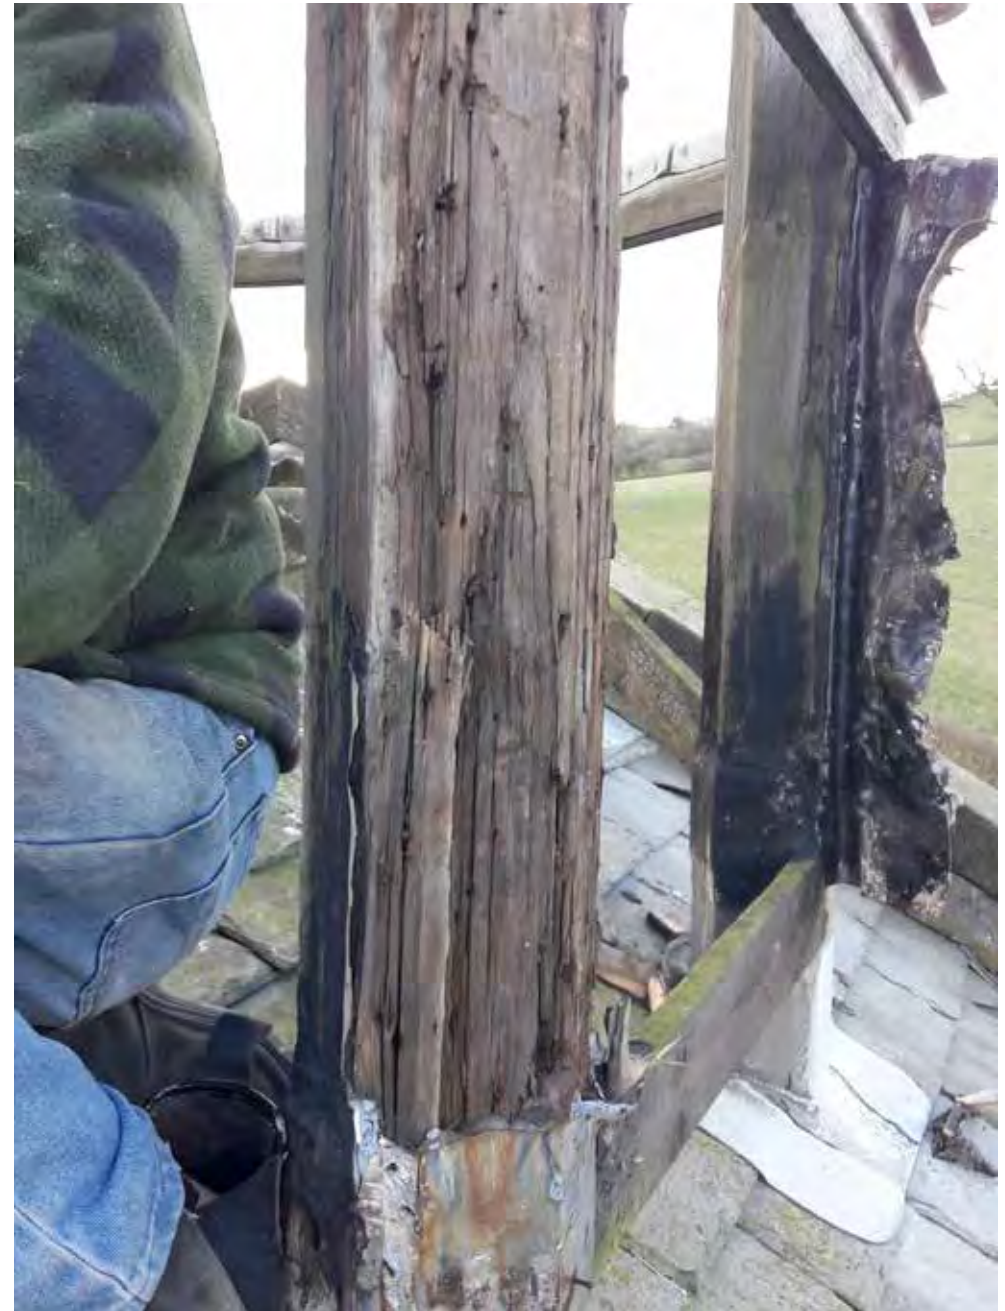
On the roof the extent of the problem was clearer with most of the posts quite decayed in places. With the smooth faces of the timber posts decaying, and becoming rough, forming a weather-tight flashing around each post has become more difficult, allowing water to run down the posts and into the roof. Where extra flashings have been added to these posts they have ultimately not stopped the water from getting in but have inhibited the posts from drying out, promoting decay. During the 2017 survey the external cladding was dismantled to improve the ability of the posts to dry out, slowing down decay.

Behind the boarding there is quite a bit of decay in the timber support posts.

Proposals for the repair and strengthening of the existing cupola structure have been developed by us in conjunction with Mr Gez Pegram, a structural engineer accredited in Building Conservation (CARE). Work involves removing the central decayed sections of each of the eight timber post supports and replacing with purpose made galvanised steel sections. These steel sections will connect to the remaining lower sections of timber remaining in the roof space, and the upper post sections above the roof slates. Flashing around these square steel posts will be easier and more effective than the existing decayed timber posts. Two of the existing timber posts which are embedded in the masonry of the west gable wall will be replaced with stainless steel, rather than galvanised posts. Around the base of the cupola, just above the roof slates, horizontal oak boarding will be reinstated (Mr Freedman is aware this has been temporarily removed to improve air circulation around the posts and slow decay). This boarding will cover any sections of steel posts rising above the slates.

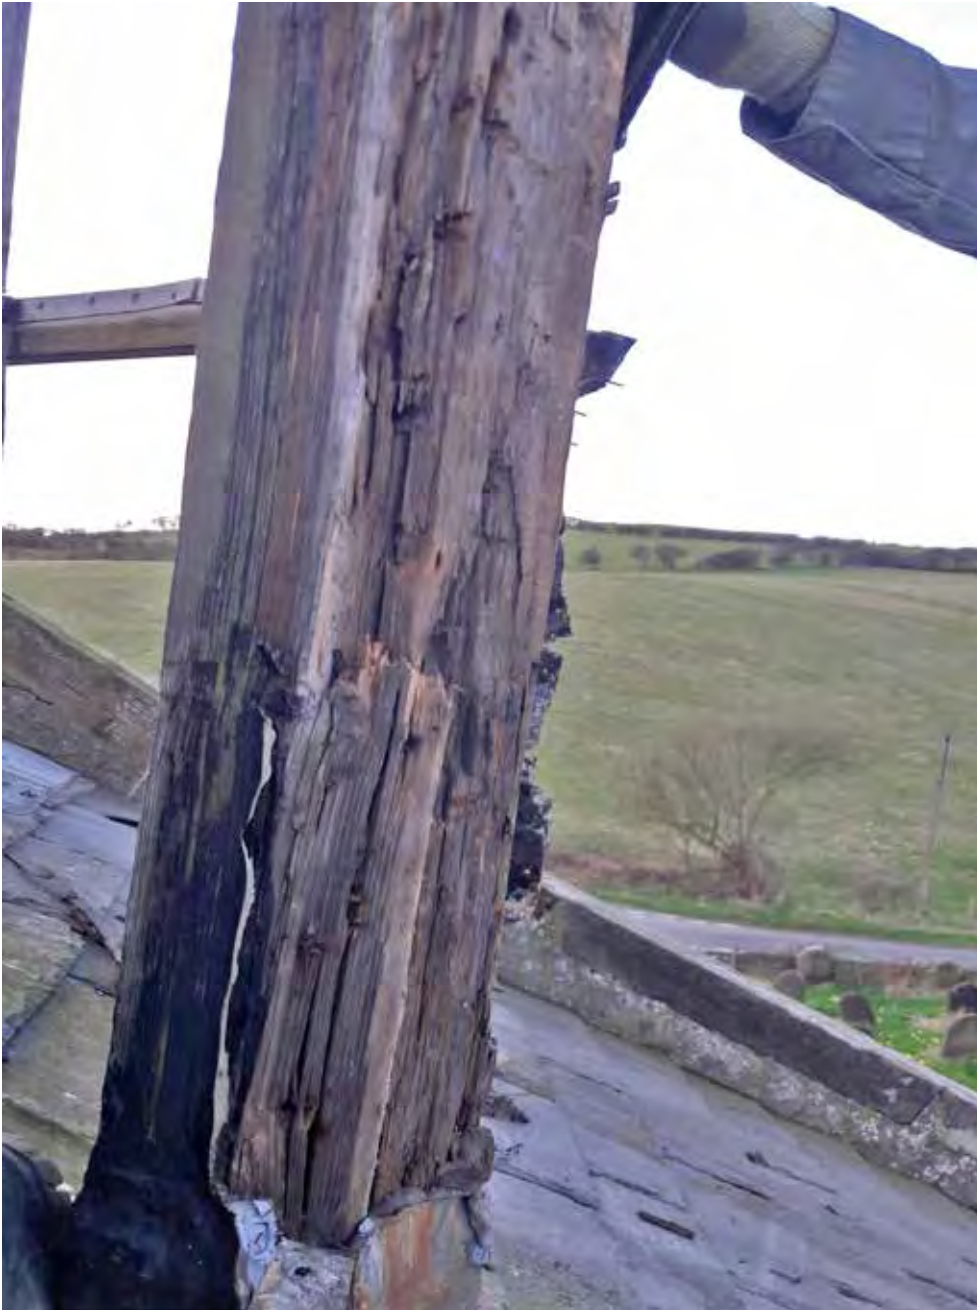
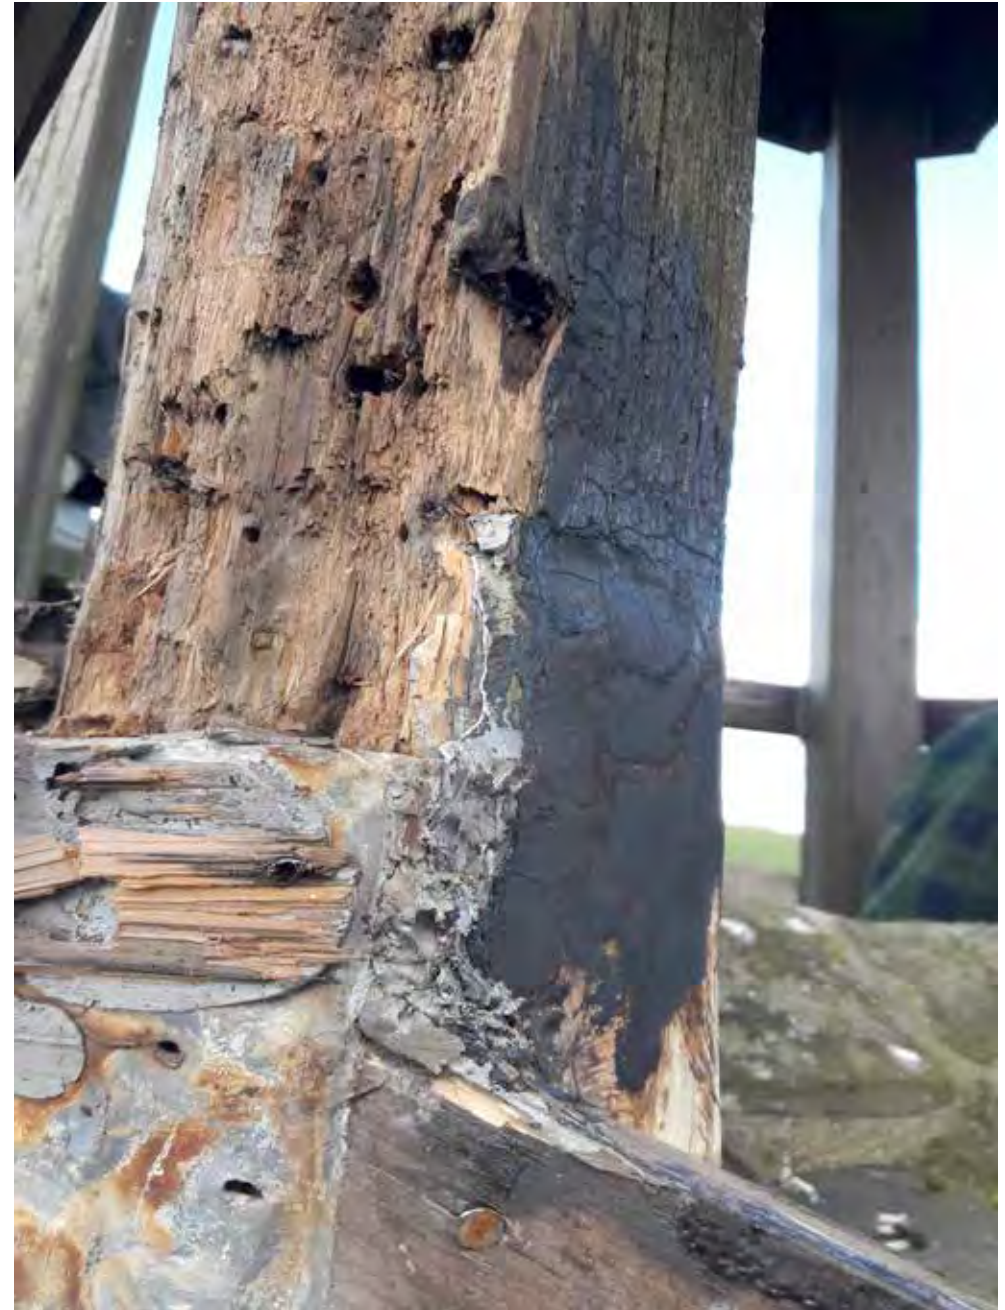
Decay in the timber was not helped by a lack of air movement preventing the posts to dry out.

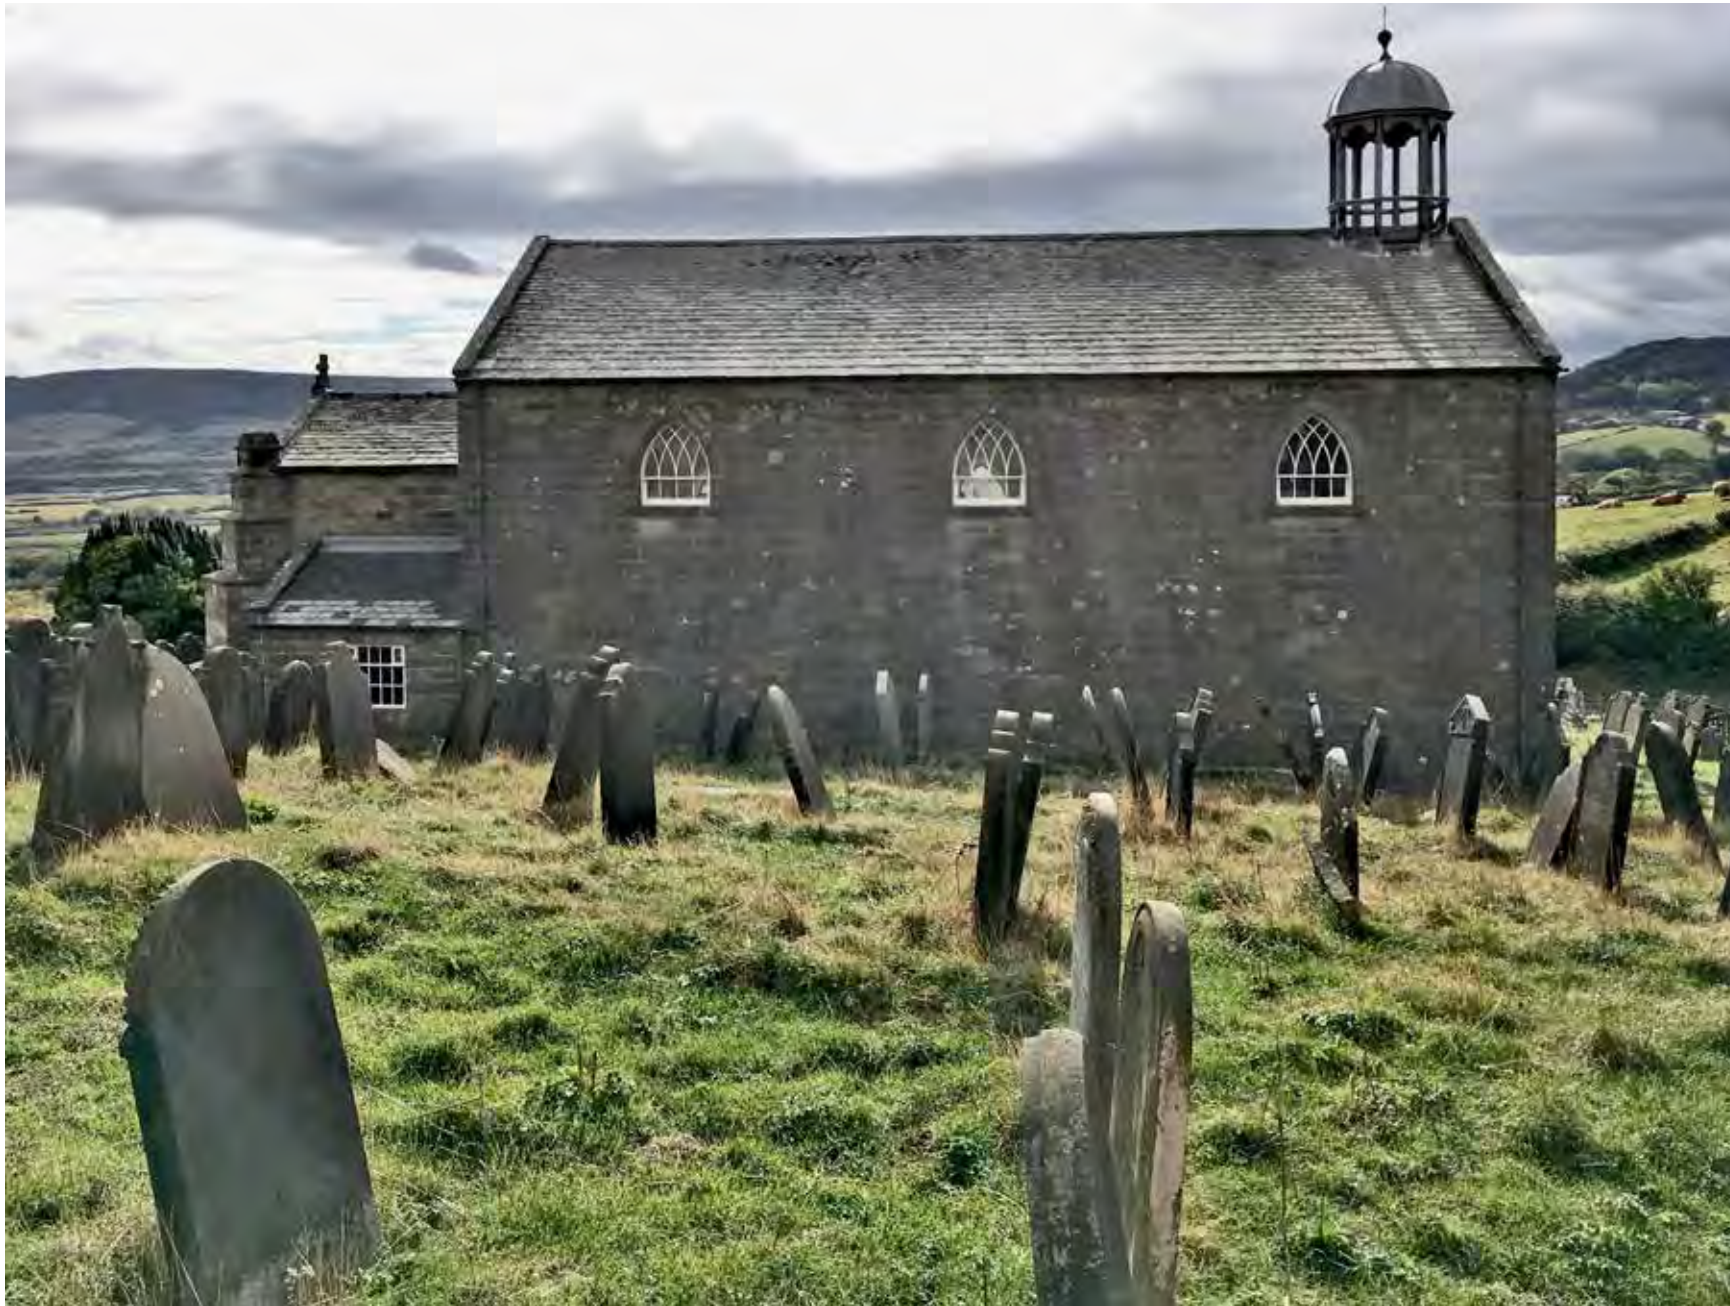
North elevation - the nave gutter drains to a downpipe at each end before being channelled to a gully at the west end of the church. Proposals involve removal of the east (left downpipe). On the south side of the church there is a single downpipe at the east end.

Modifications will involve removing the east cast iron downpipe and reconfiguring the existing gutter to fall westward. The existing downpipe at the west end of the nave will be replaced with a 100mm diameter cast iron downpipe. Where possible existing gutter brackets will be retained and adjusted. New brackets, if required, will be rise and fall type into masonry joints (pointed with 3.5NHL lime mortar). The east end gutter outlet will be replaced with a new stop end.

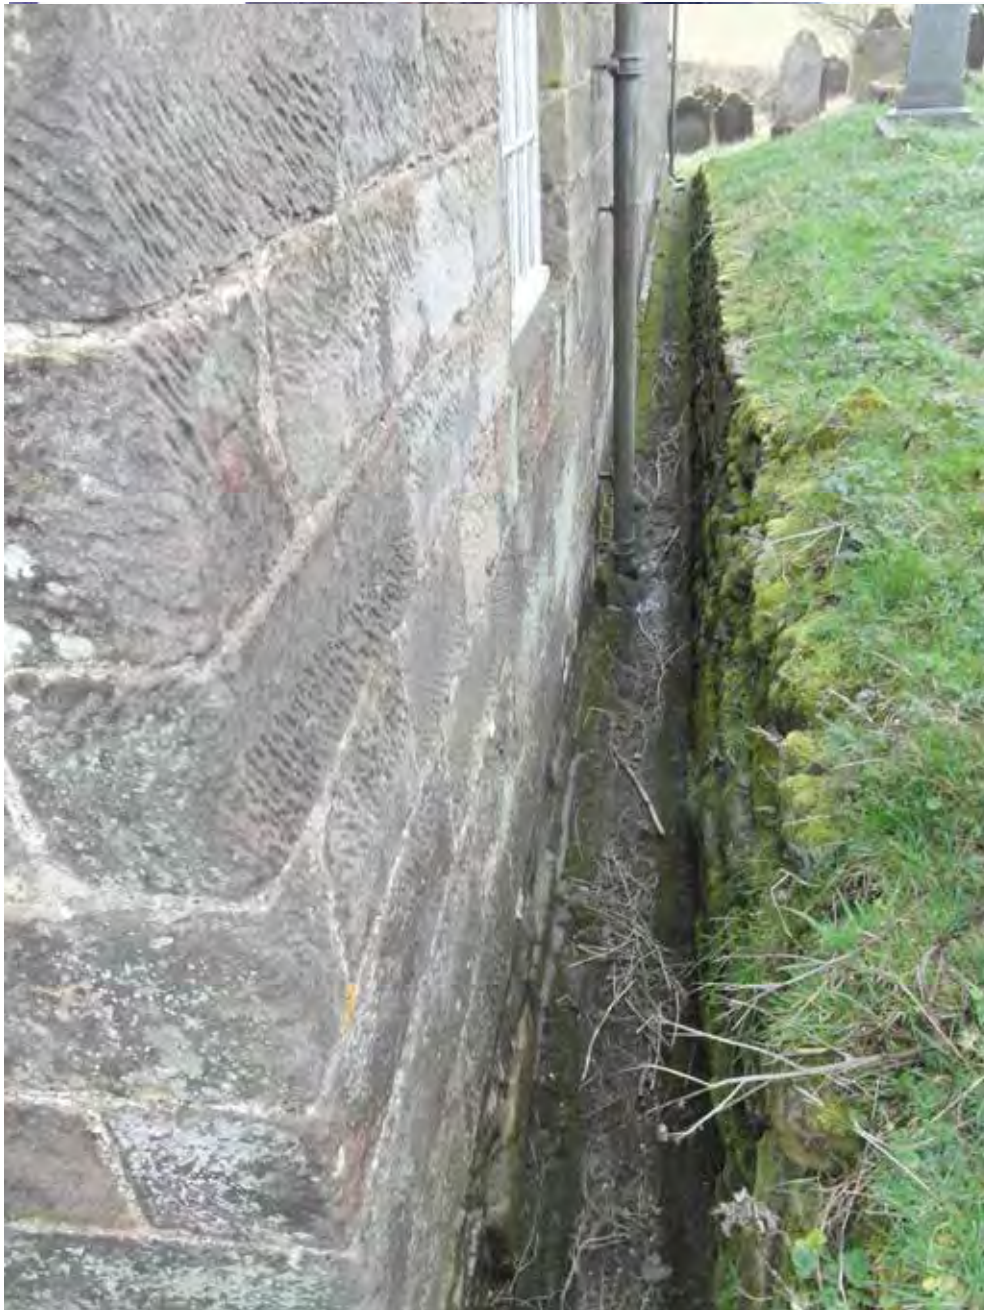
North elevation of vestry and nave. A retaining wall and channel arrangement should direct water to a gully at the west end to discharge to the west of the church.

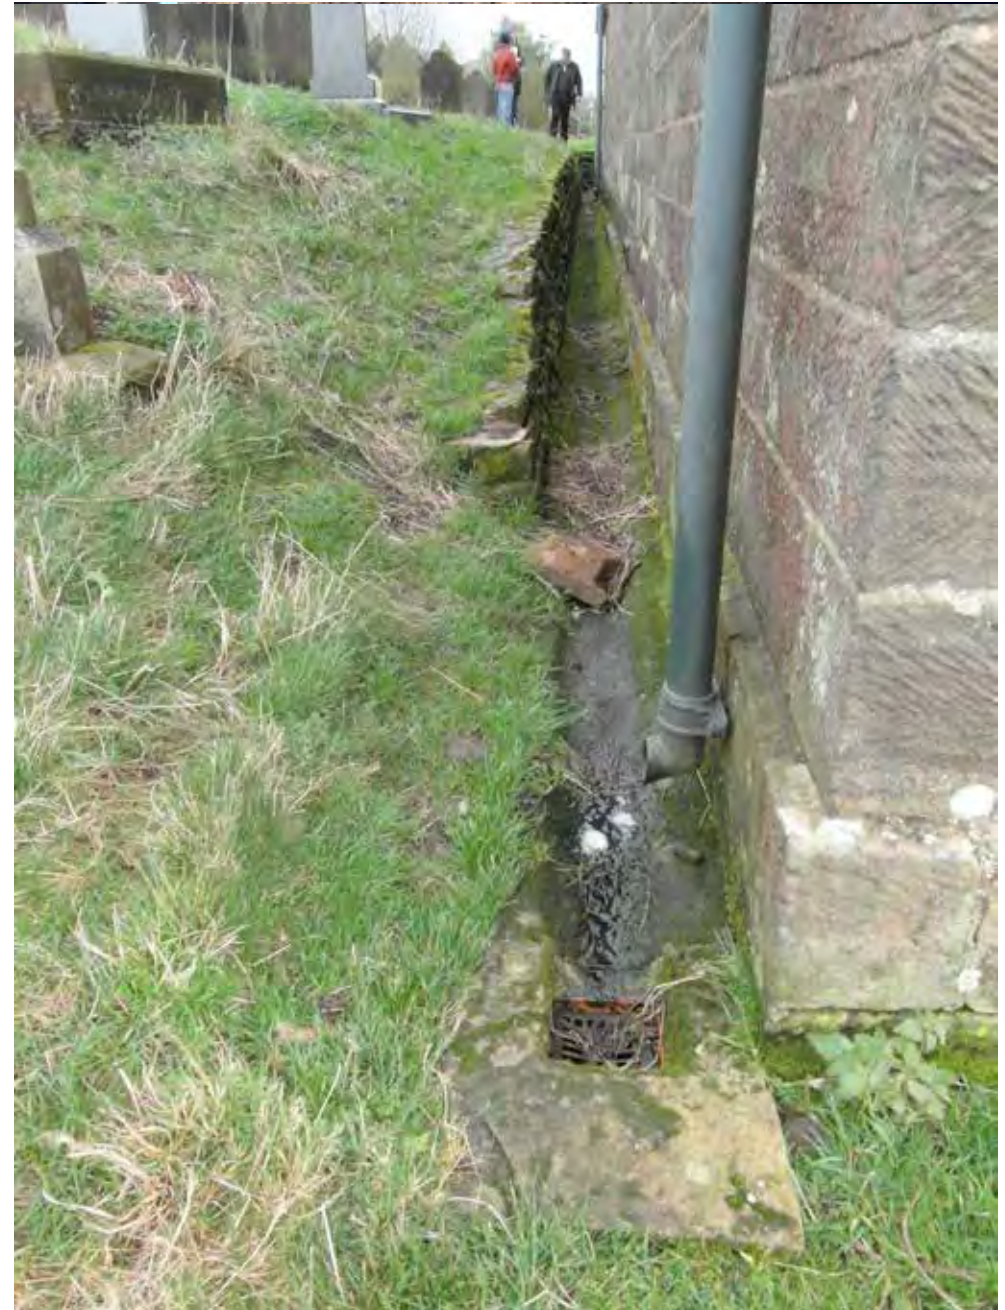
In the existing arrangement the east downpipe discharges into a stone channel at the foot of the nave wall, directing the water to a gully at the west end. It is assumed this gully discharges into a soak away in the churchyard. Unfortunately, as with many of these apron channels once popular at the foot of church walls, the stones have moved leaving them mis-aligned, and open joints. As a result most of the discharge from this downpipe goes into the ground and under the church.

Unfortunately debris, open joints and mis-aligned channel stones allow much of the rainwater to drain into the ground, under the church.

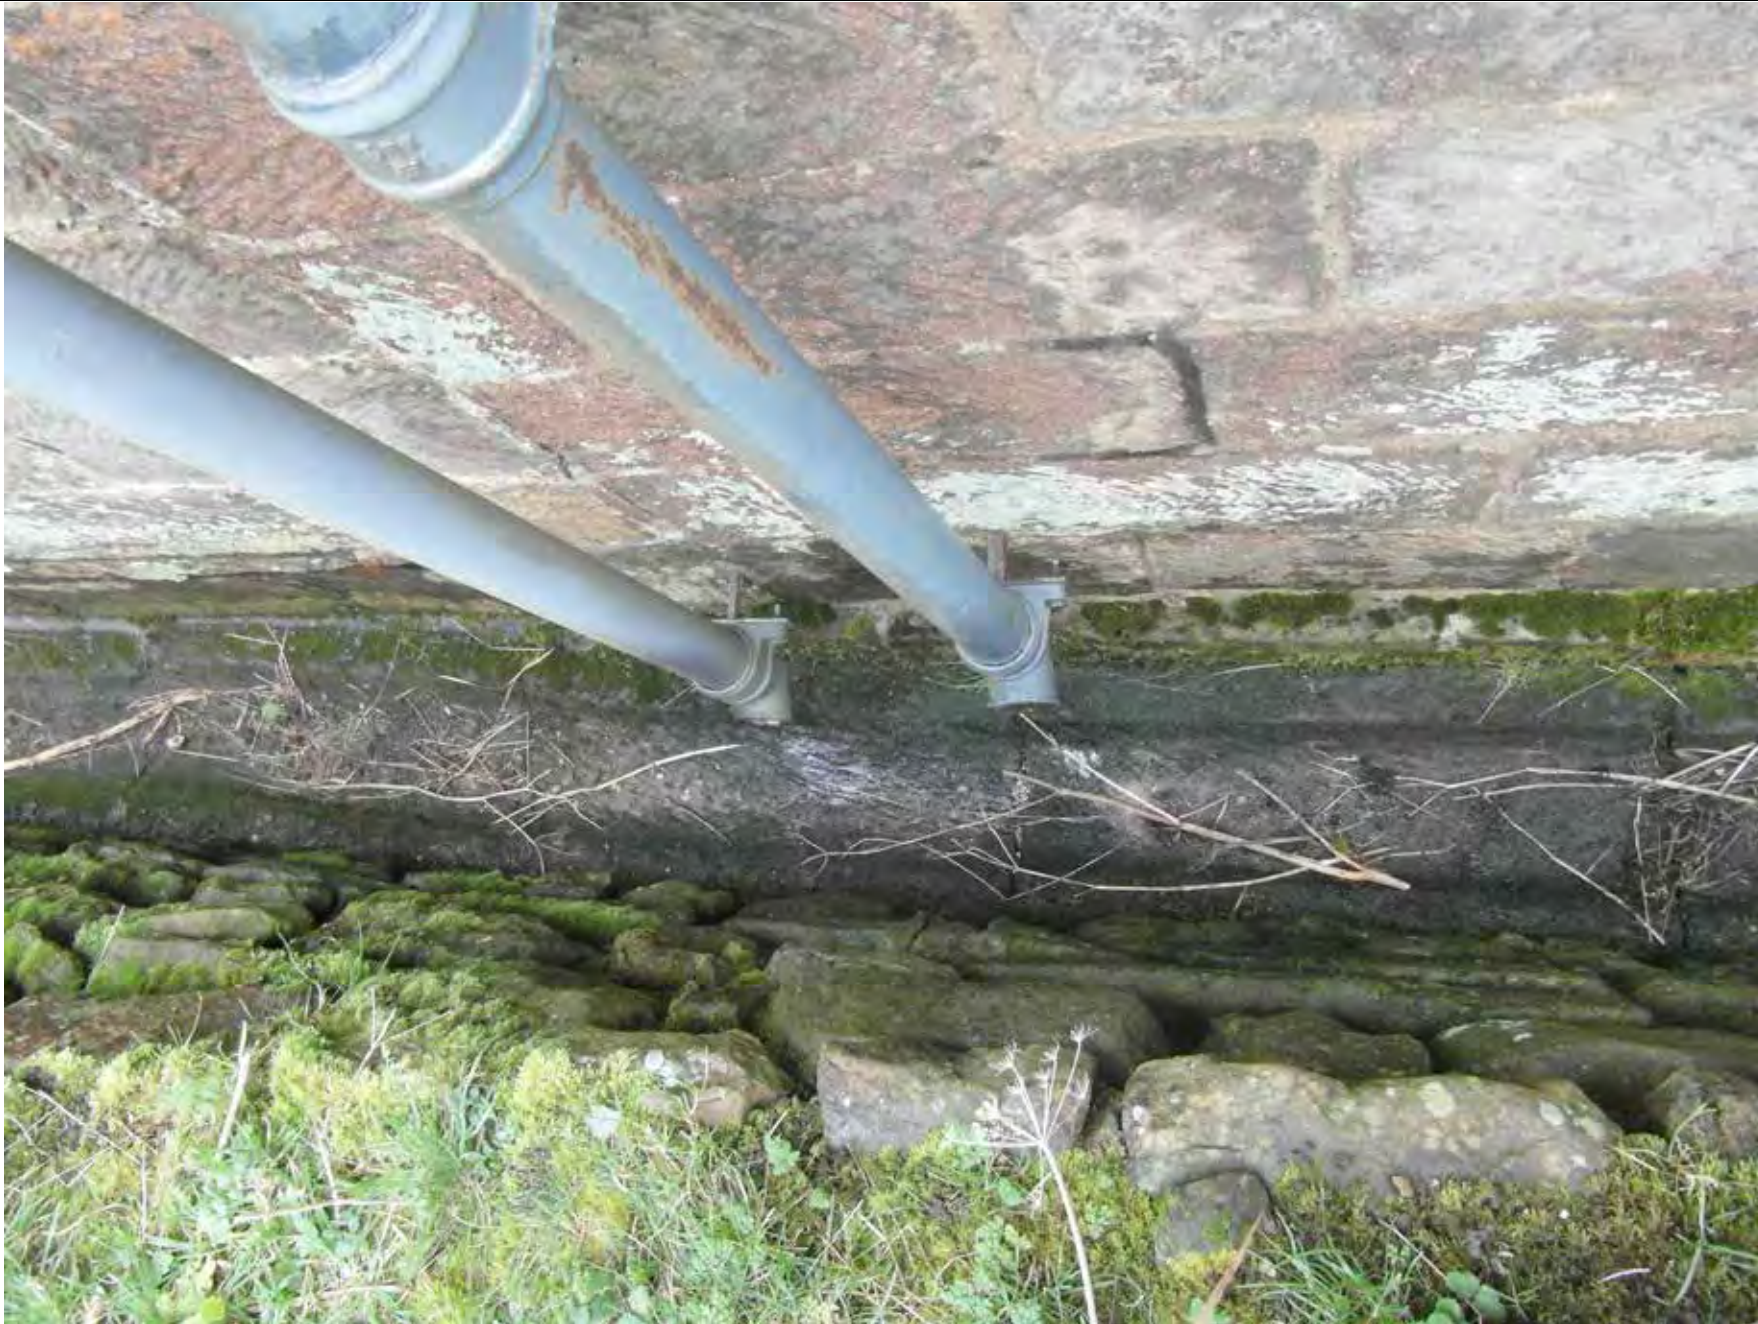
Downpipes from the vestry and nave discharging on to the channel at the foot of the north wall.
While little can easily be done to redirect water from the vestry roof the nave gutter can be adjusted to discharge to the west downpipe only.
