Type	HERITAGE ASSET STATEMENT
Client	S. J.& J. Monk
Client Reference	Faceby Lodge Farm
Our Reference	MD2_414
Produced by	G. McGill
Checked by	P. Davies
Submitted	4 <sup>th</sup> December 2018

- 1.1. This statement has been prepared in support of a planning application for change of use of a group of agricultural buildings at Faceby Lodge Farm to form a holiday complex comprising ten no. holiday units, including managers accommodation (one unit).
- 1.2. As part of the pre-application process, the Local Planning Authority declared that a Heritage Asset Statement should be prepared and submitted with an application because the building complex is adjacent to both a listed building and a listed structure.
- 1.3. The adjacent listed property is separately owned.

- 1.01 Doyle Partnership has been instructed by Signet Planning, on behalf of their Client, to carry out a structural inspection and to prepare a report giving an assessment of the structural condition and integrity of the buildings and to comment upon any remedial works which may have to be undertaken.

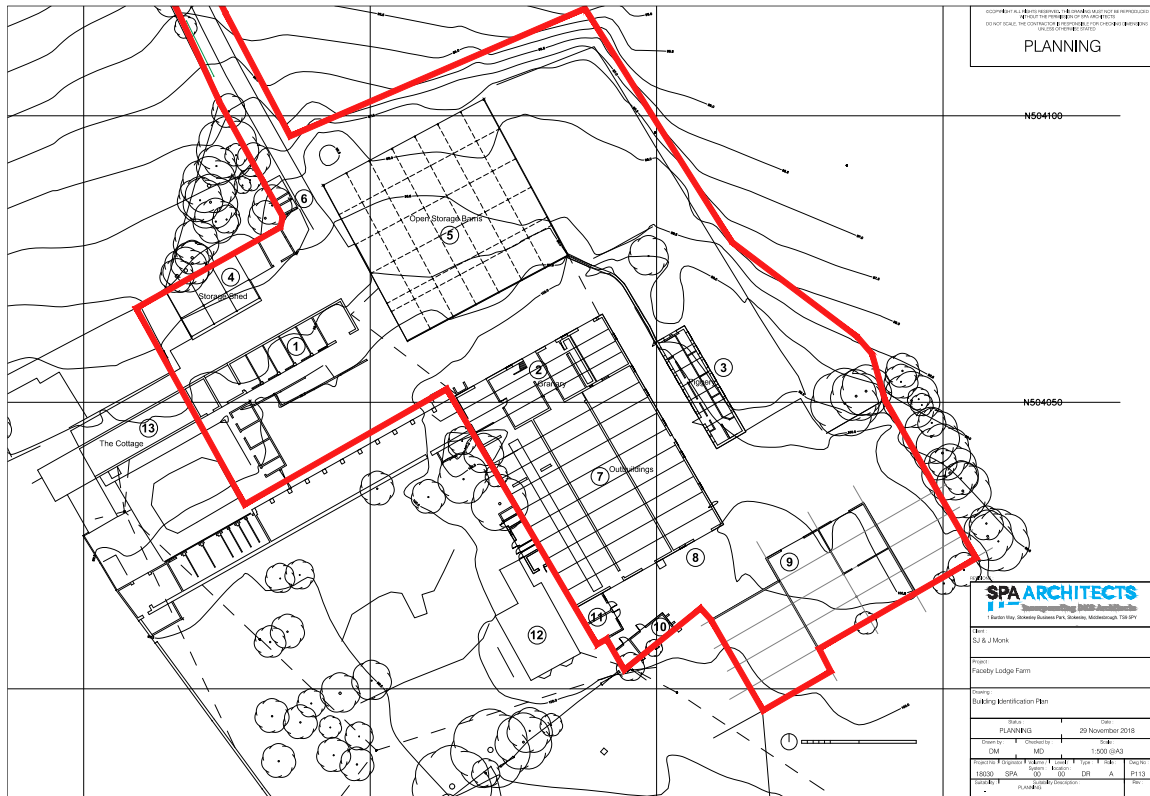
- 3.22 On the south east side of the building complex are some ugly, unattractive sheds fronted by some other relatively modern buildings, which have already part fallen down. These buildings are proposed for demolition without replacement (see Figure 4 building No. 9). Also, to the south of the main buildings is a small brick stable block and tack room which is proposed for demolition (see Figure 4 building No. 10).

Figure 4: Existing building identification plan

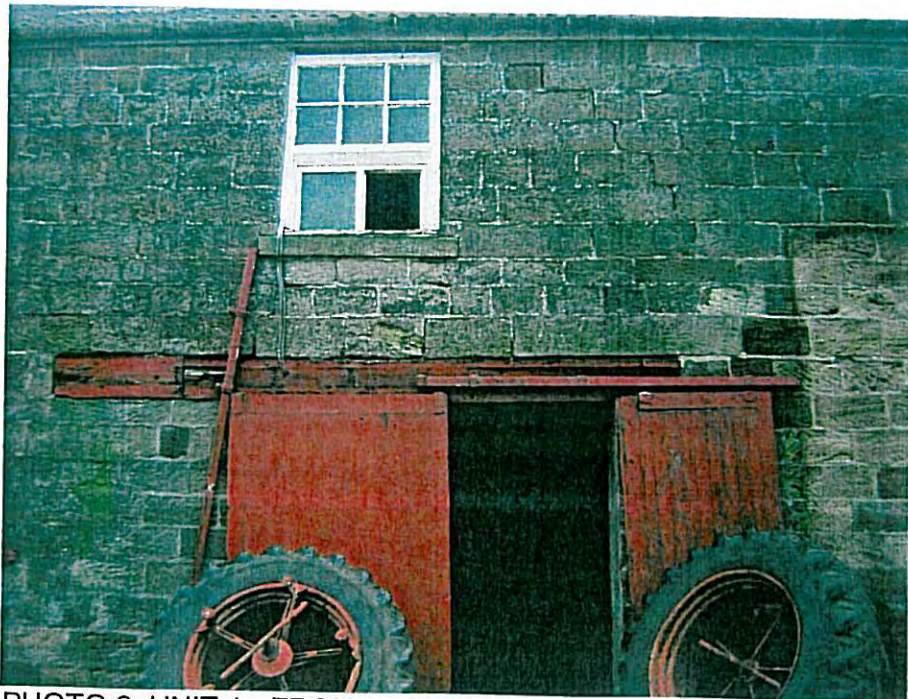
PHOTO 2. UNIT 1 - FRONT ELEVATION (3.01)

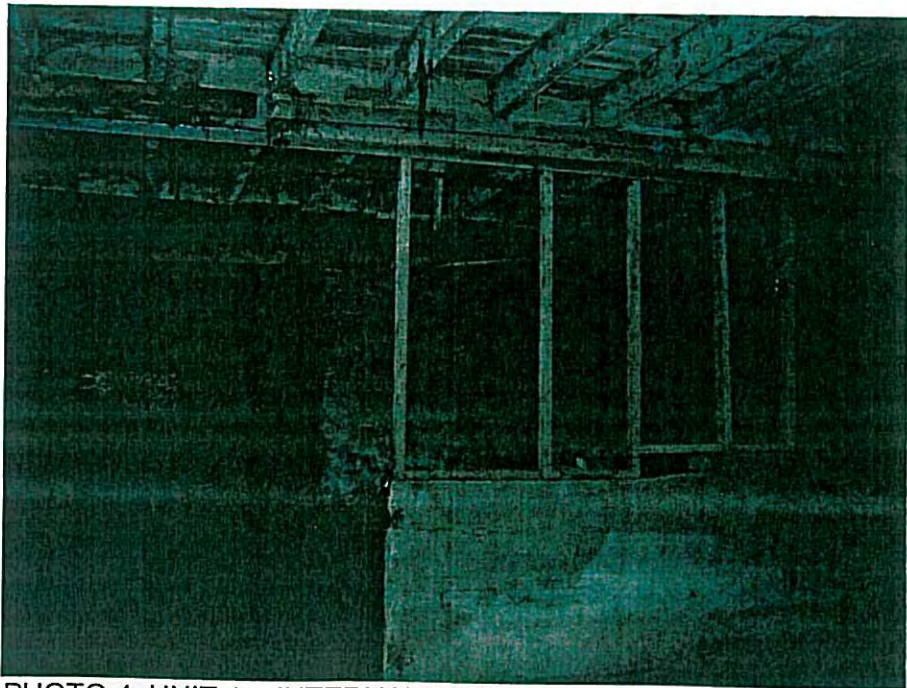
PHOTO 4. UNIT 1 – INTERNAL (3.01)

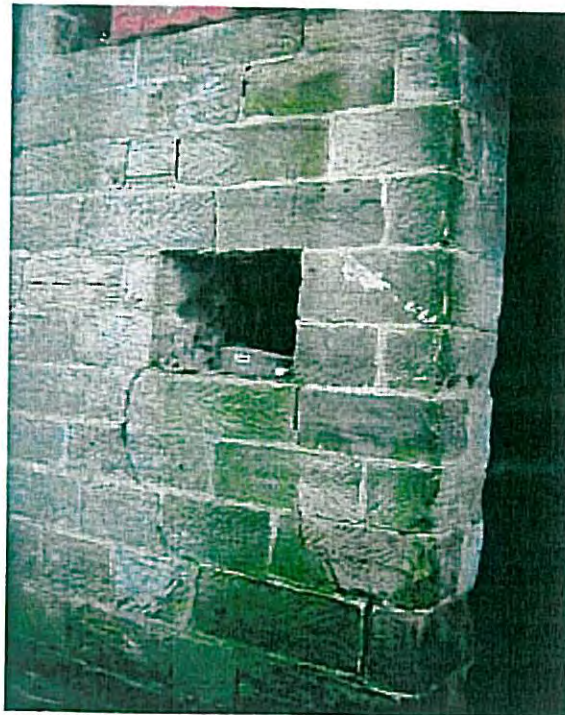
PHOTO 13. UNIT 4 – IMPACT DAMAGE  
(3.04.05)

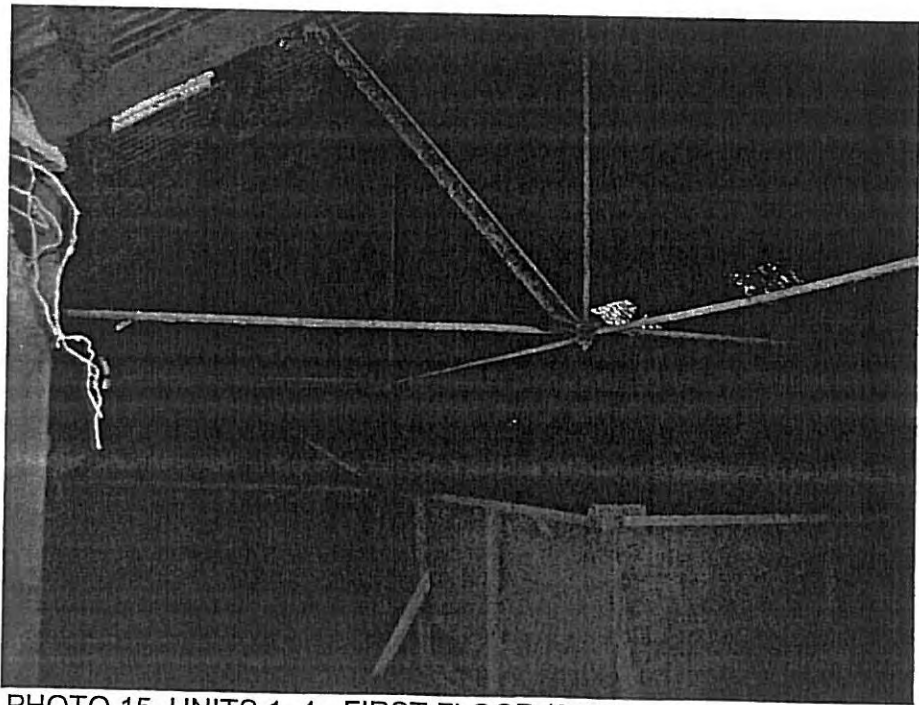
- 3.05.01 The timber first floor was considered unsafe and the open area was viewed only from the top of the stairs. The area appears to have been previously used for grain storage.

PHOTO 15. UNITS 1-4 - FIRST FLOOR (3.05)

- 4.03 The introduction of new internal cross walls will enhance the overall stability of the units.
- 4.04 The first floor boards and joists over Units 1-4 will have to be replaced but the intermediate steel beams could be retained, subject to a structural check.

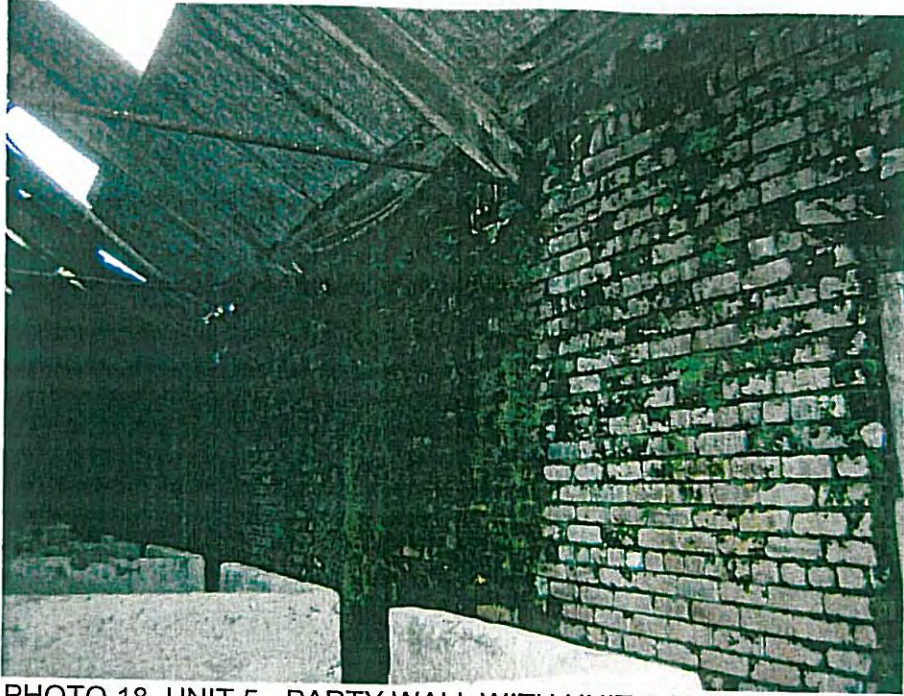
PHOTO 18. UNIT 5 - PARTY WALL WITH UNIT 6 (3.06.06)

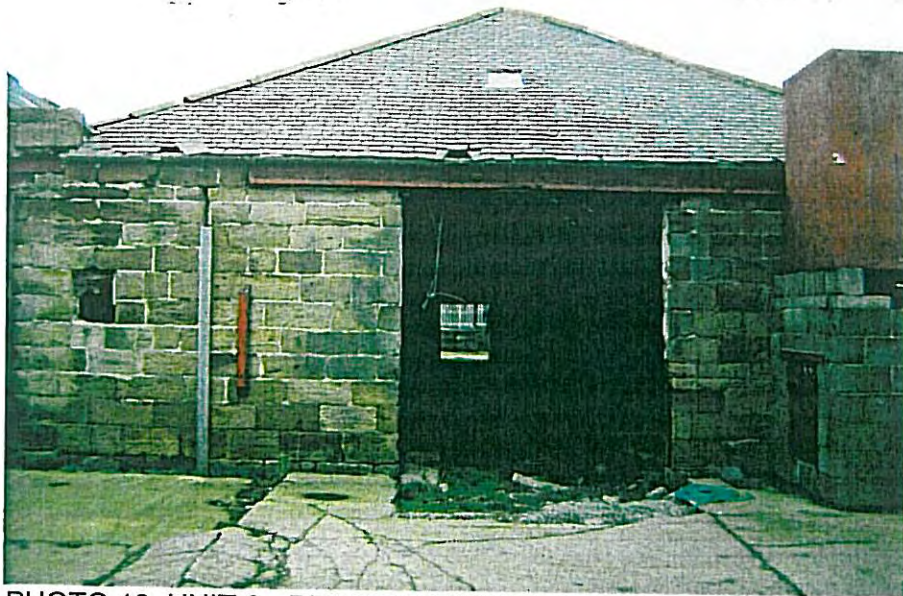
PHOTO 19. UNIT 6 - REAR ELEVATION (3.07)

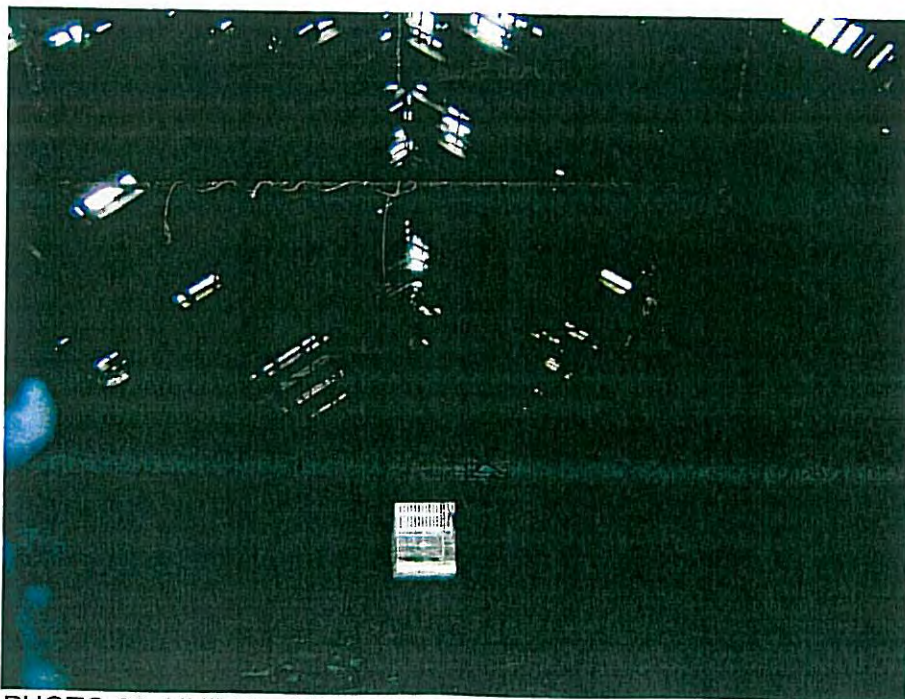
3.07.03 The concrete ground slab has been partially broken out.

3.07.05 Some of the bricks to the internal walls have deteriorated due to the ingress of water.

PHOTO 20. UNIT 6 - INTERNAL

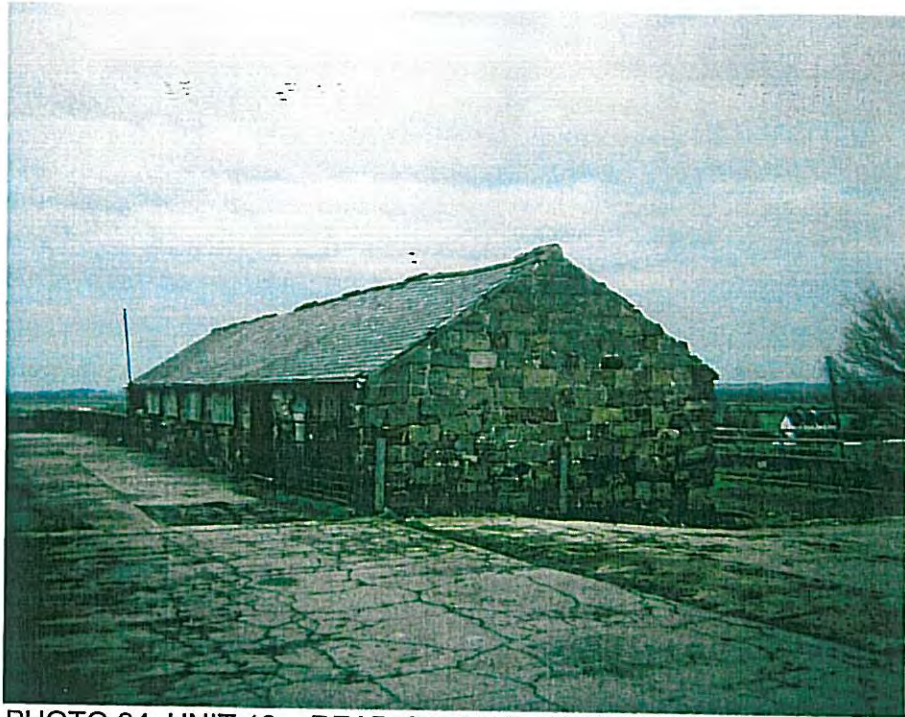
PHOTO 24. UNIT 10 – REAR GABLE & RIGHT HAND SIDE ELEVATION

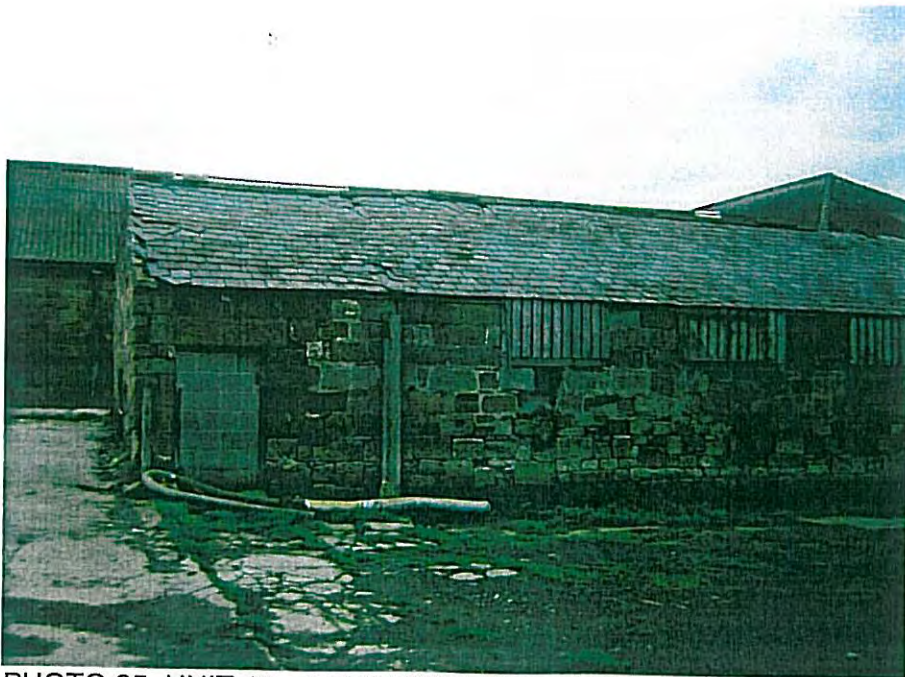
PHOTO 25. UNIT 10 – LEFT HAND SIDE ELEVATION

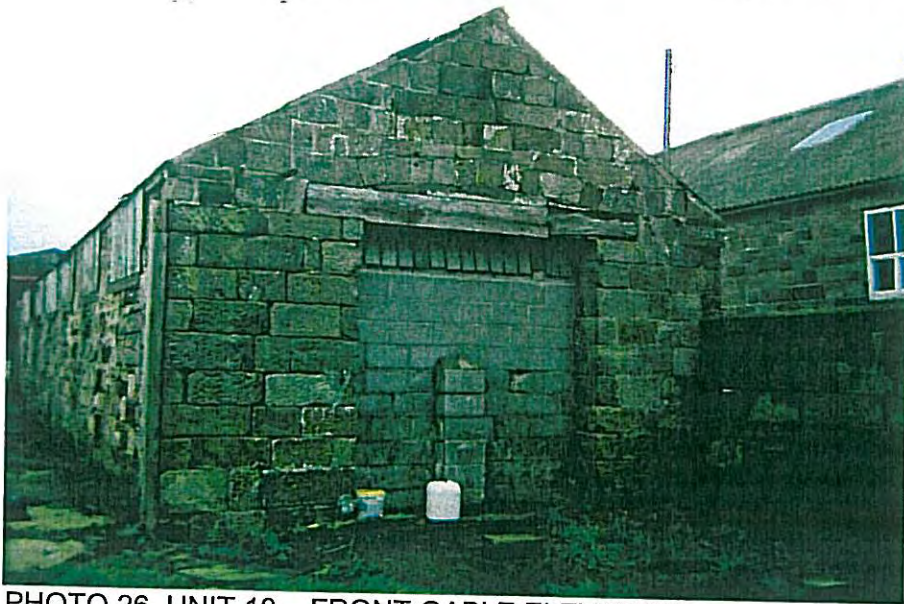
PHOTO 26. UNIT 10 – FRONT GABLE ELEVATION

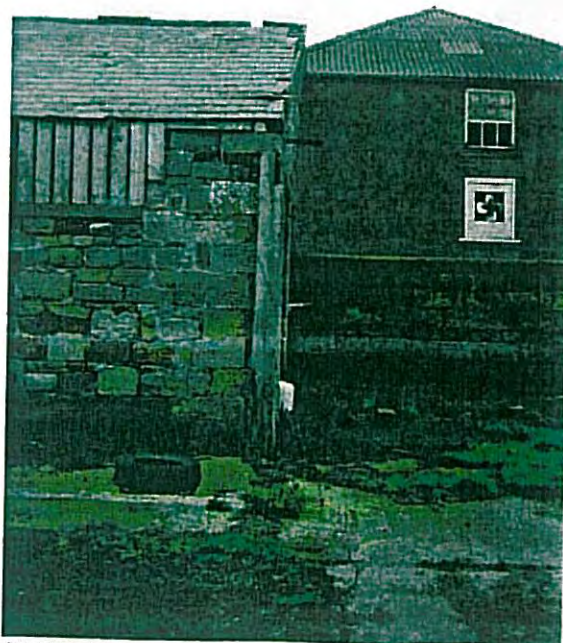
PHOTO 27. UNIT 10 - LEFT HAND SIDE/  
FRONT GABLE
