MRT Ecology

Appendix 4

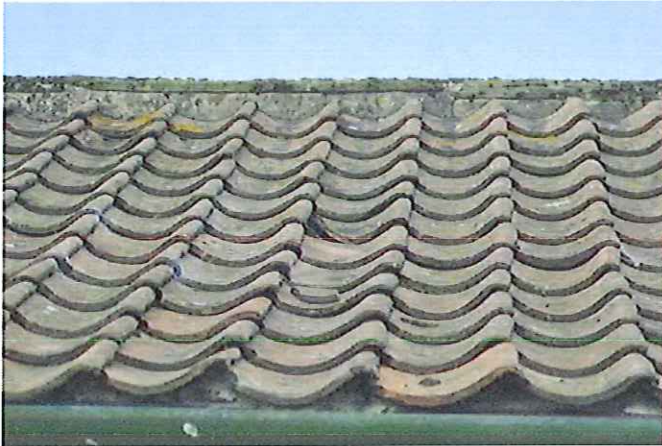
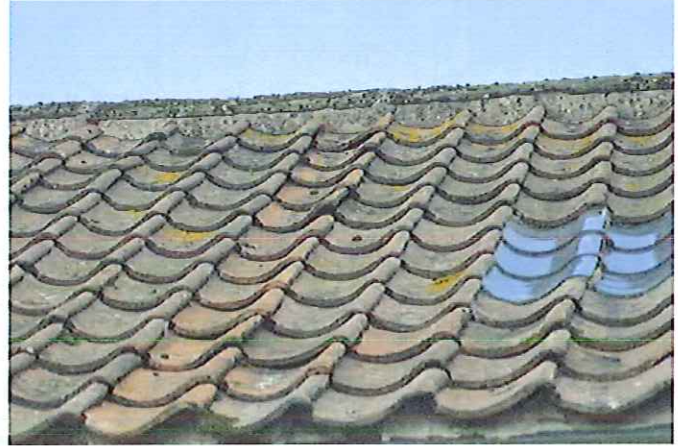
Photos 4 and 5: Photos of roof showing some raised and broken tiles, but intact ridge tiles and pointing.

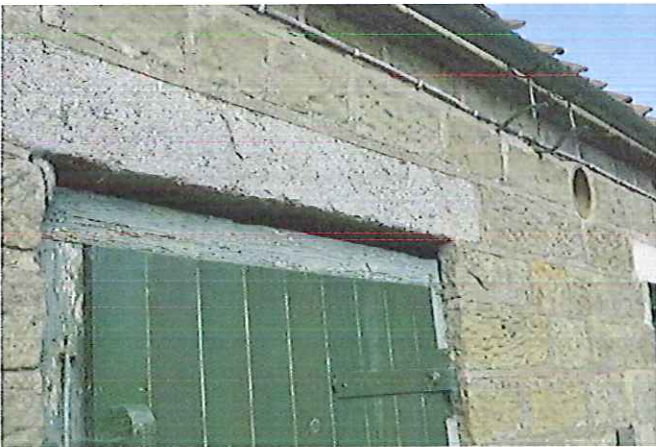
Photo 6: Gaps above doorframe

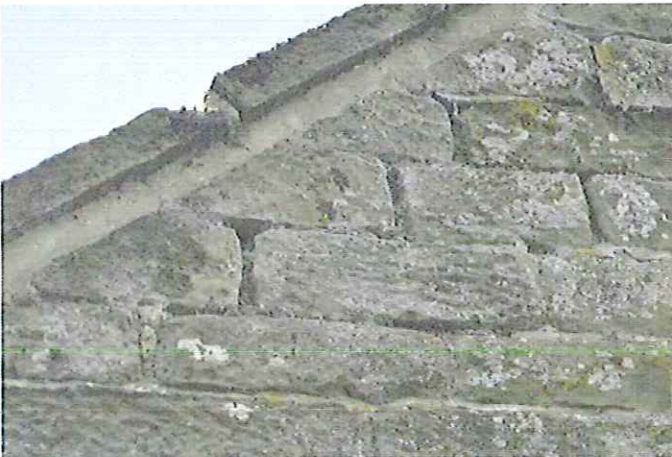
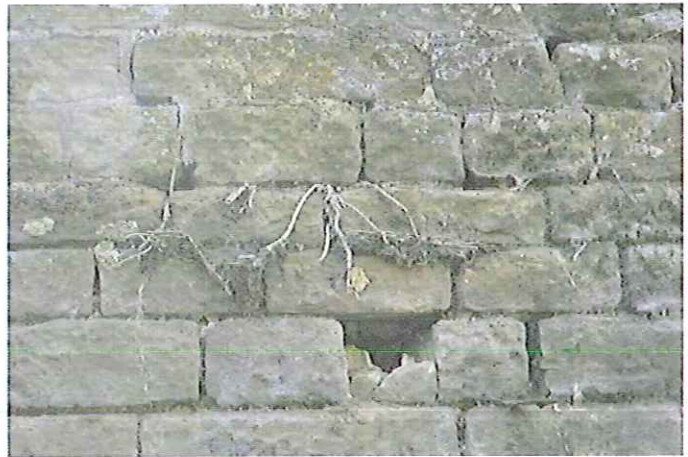
Photo 8 and 9: Cracks and holes in gable end wall.

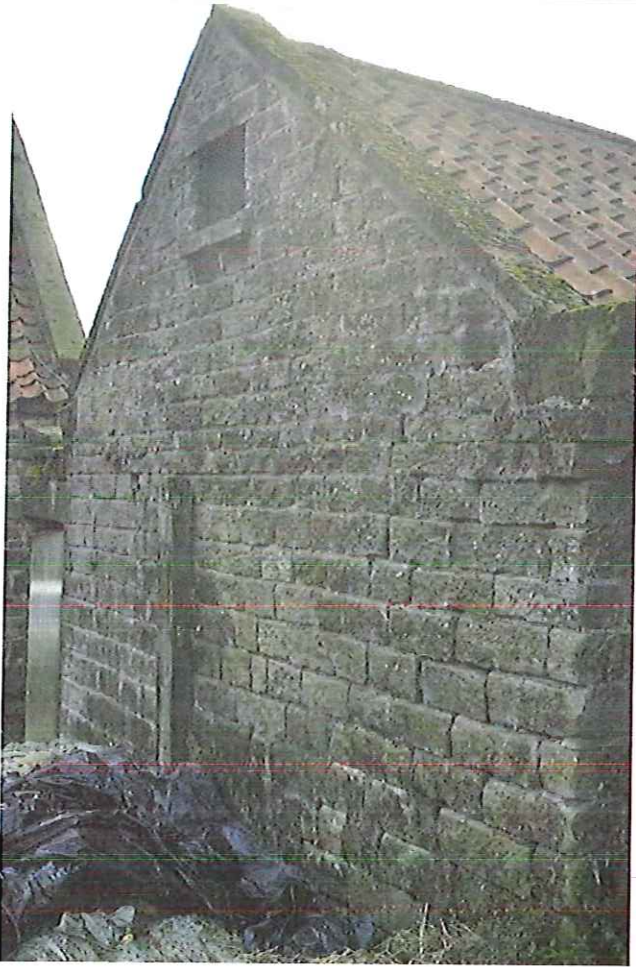
Photo 10: Poor condition of gable end wall

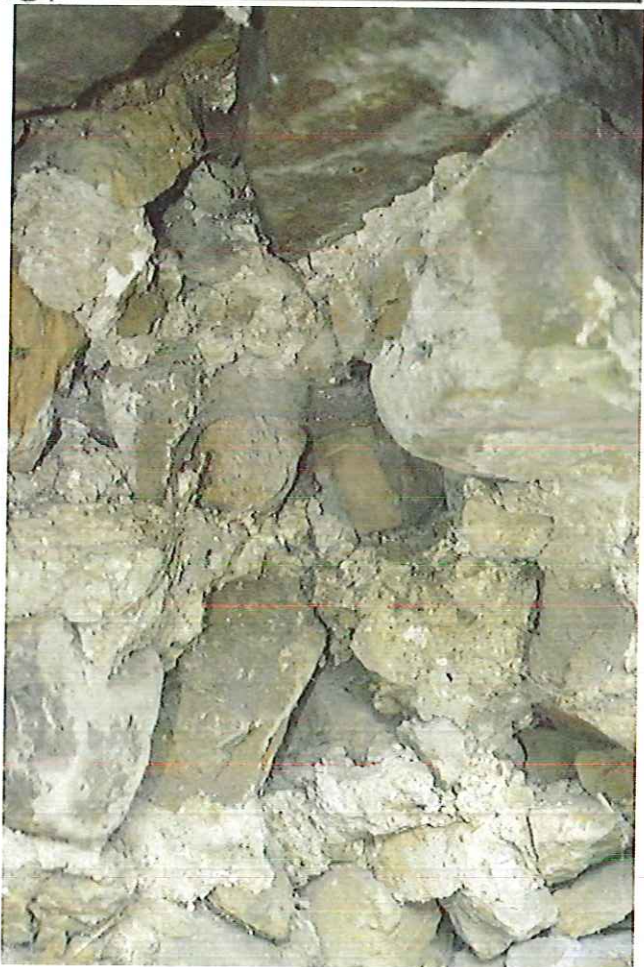
Photo 11: Collapsed area of wall

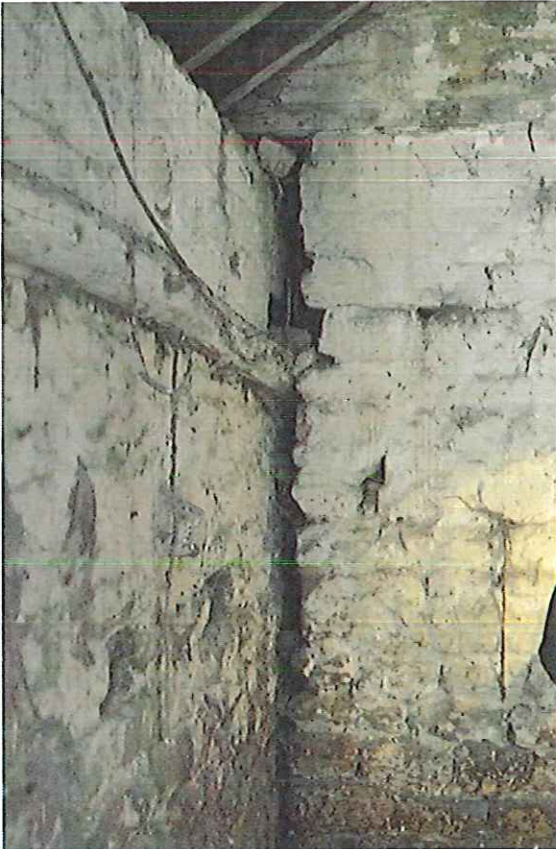
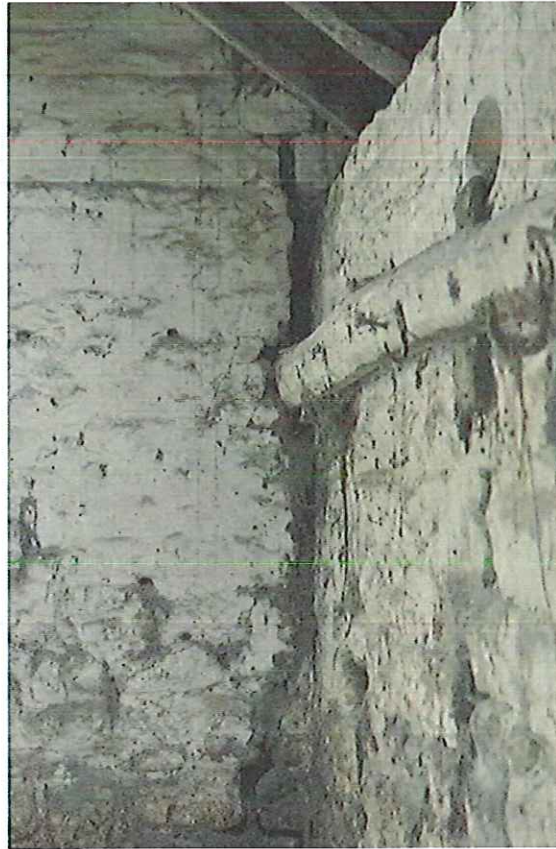
Photo 15 and 16: Cracks between internal and external walls.
