Structural Appraisal

Manor House Farm Barn

Troutsdale – North Yorkshire

Job No. Y15/241

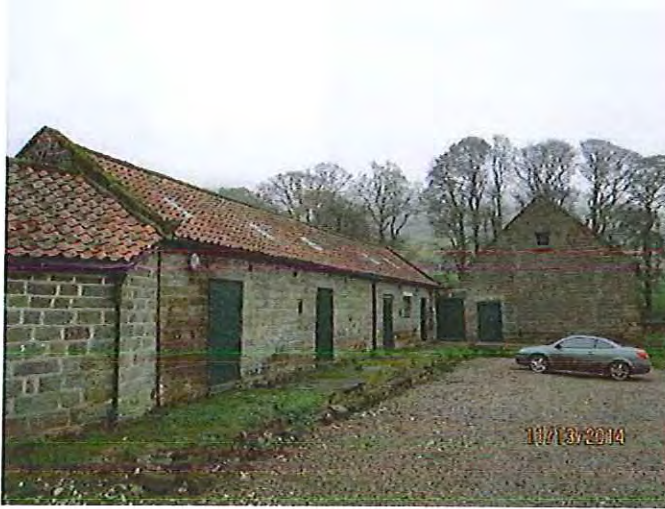
Plate 1
Front Elevation

3. **Observations** – The front elevation had four stable door openings in the dressed stone veneer wall and a further window opening and a door opening to an attached annex that serviced the original stables (see Plate 1 in appendix). The stone walls are in the order of 500mm in thickness and have a dressed sandstone outer leave with a random rubble stone forming the mass of the wall. Both stone and mortar looked to be in reasonable condition. Granite lintels formed the outer leaf support for the wall to create a square opening and the inner masonry was supported on timber arched lintels (Plate 2). At eaves level there were 8 circular vent holes penetrating the wall and these were in vitrified clay. A vertical crack was noted at the window position extending from the cill to the ground. To the front of the elevation is a raised, level concrete hardstanding of similar datum to the internal ground floor that is generally, approximately 500mm above ground level. The north eastern gable end, Plate 3, when viewed externally is in poor condition, with major mortar erosion and with the mortar being soft and crumbly to the touch (Plate 4). The eastern stone kneeler at eaves level is displaced and rotated slightly from its original position. The rear wall is half submerged by compacted bedding and manure from cattle abutting the wall to a level of approximately 1.2m in depth. In several places the wall had been partly demolished presumably by cattle pushing against the wall resulting in failure/partial collapse of the wall (See Plates 5 and 6). The adjacent steel structure forming the adjoining barn was seen as independent of the stone barn but did not form part of the inspection.

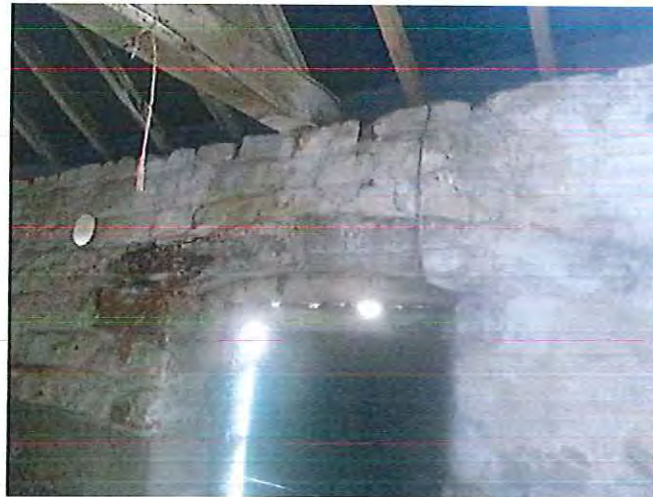
Plate 2
Timber Lintel

- b) Timber lintels internally should be replaced using reinforced concrete lintels to suit the wall thickness whilst leaving the present out leaf granite stones alone.

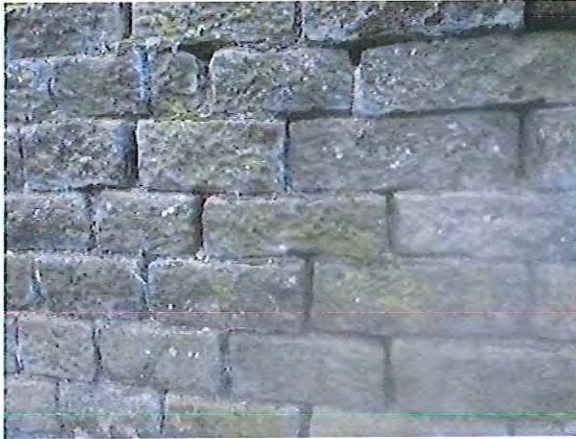
Plate 4
Mortar Loss to
Gable

- a) The walls will require re-pointing using softer lime based mortar with some flexible joints introduced where necessary. Total reconstruction will be required to the gable end and minor reconstruction to the rear wall using reclaimed stone materials and traditional lime mortar techniques.

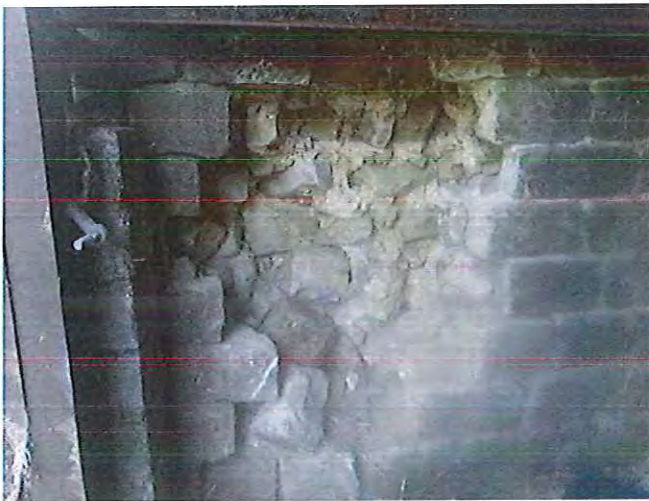
Plate 5
Damage to Rear
Wall

Avoid lateral loading of the rear wall from the adjacent barn by good housekeeping or by providing an effective internal barrier to avoid further damage to the wall. All manure against the walls should be removed as soon as possible.

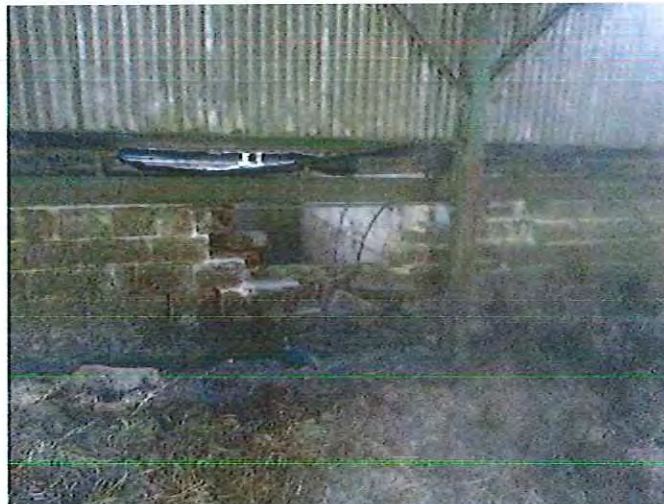
Plate 6
Further Damage to
Rear Wall

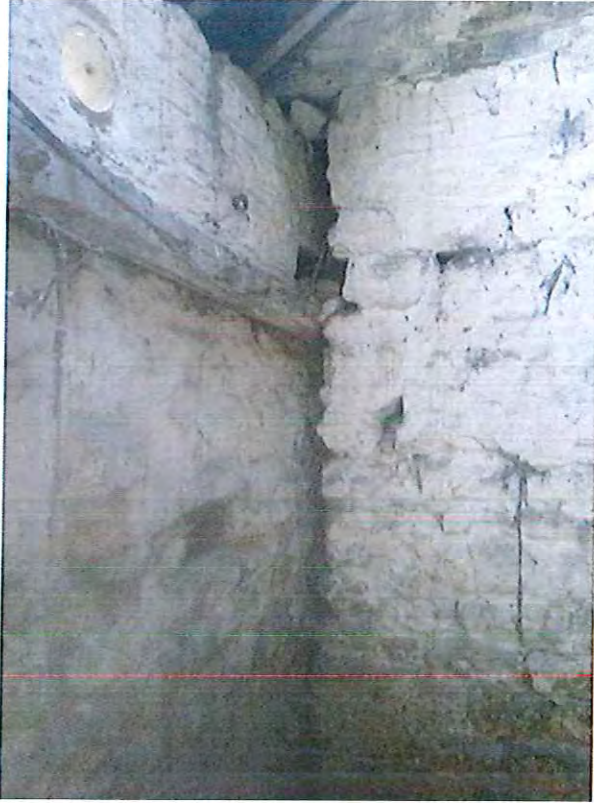
rear walls from ground to eaves level in some cases and in the worst case movement was as great as 100mm, Plate 7. Elsewhere several vertical cracks were present under purlin bearing positions. Timber tie beams were evident at eaves level and cracking near to these was also evident. The front wall to the property had rotated outwards at eaves and so was not vertical.

4. **Discussion** – The main front elevation forming the main stable block is in satisfactory condition but is not vertical and in its present condition is reliant upon the roof alone as lateral restraint. Intersecting walls have been rendered ineffective as a result of significant cracking. The rear wall is not intended for stacking wet manure against it and this could result in structural instability of the whole building. Damage to the walls will require reconstruction using reclaimed material where possible. To ensure overall stability of the structure is maintained it is essential that structural ties be incorporated from front to rear on gable end and at dividing walls with face plates visible on each elevation just below eaves level. The gable end has severe mortar loss and should be taken down and re-built using the reclaimed dressed stone and random rubble to suit. The coping stones to gables should be removed and made more weatherproof and the kneeler stones reset to line and level.

Plate 7
Wall Separation

- e) Through ties and restraint straps with remedial ties are required to all intersecting walls and gables to restore the structural integrity of the building. The lack of verticality of walls can be tolerated structurally providing that the ties are provided.

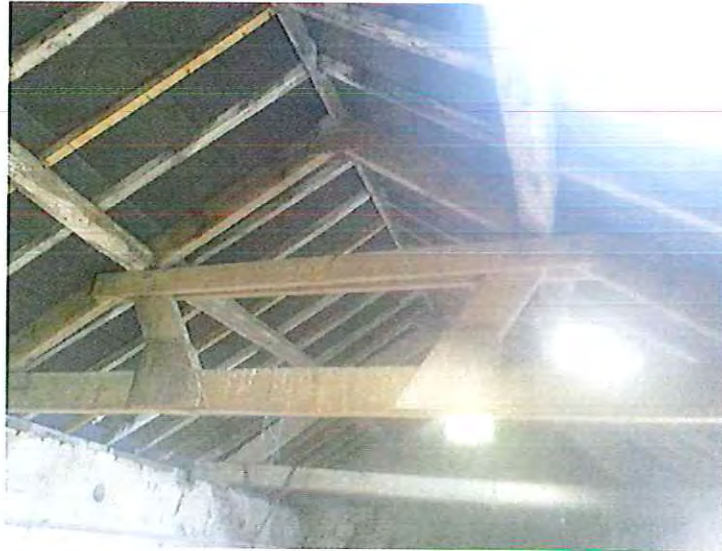
Viewed externally, the roof covering appeared to be in reasonable condition with no significant sag evident. Externally there is no significant sagging evident. When viewed internally the construction comprises traditional common rafters forming the slopes, spanning onto timber purlins (one per slope) and these in turn span onto either triangular timber support frames or masonry crosswalls at typically 2.9m centres. Timbers appear to be in reasonable condition and quality with only a few members subject to wet rot in areas of prolonged exposure to the elements. Beetle/insect infestation was noted throughout, but timber loss was not considered significant. Trusses did not look to be under any significant distress although one truss had shear deflection of the bottom boom and another truss had been stiffened at some time in the past as shown on plate 8.

Roof timbers are generally in good condition but there are some members that are reaching the end of their effective life and may require replacing. Calculations indicate that the roof timbers are generally adequate and may be considered for re-use in their present condition providing that they are effectively treated against fungicide, insect/beetle infestation and rot. Consideration should be given to truss improvement work to at least two of the trusses. One for excessive shear deflection and the other to improve its appearance from that of a previous repair, if it is to be retained.

Plate 8
Stiffened Truss

- c) The roof structure should be checked fully for structural adequacy and timbers strengthened, replaced or stiffened where necessary.
 - d) Internally, new slabs should be incorporated on order to comply with current standards, with an inner cavity and blockwork wall introduced to the whole perimeter wall.
