REDMIRE FARM
TRANMIRE
NORTH YORKSHIRE
YO212BW

PROJECT STATEMENT
(What has happened to date)

12 SEPTEMBER 2016

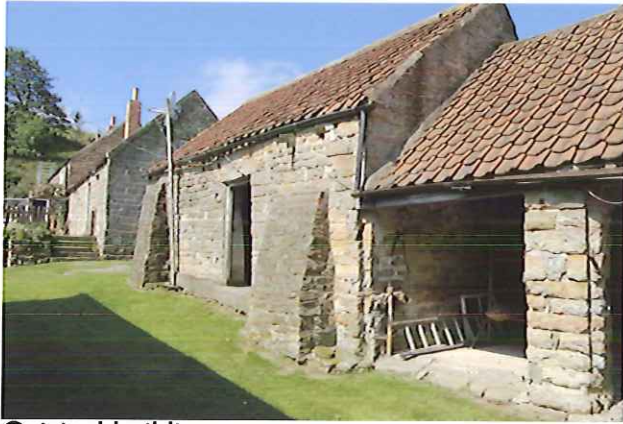
Original building

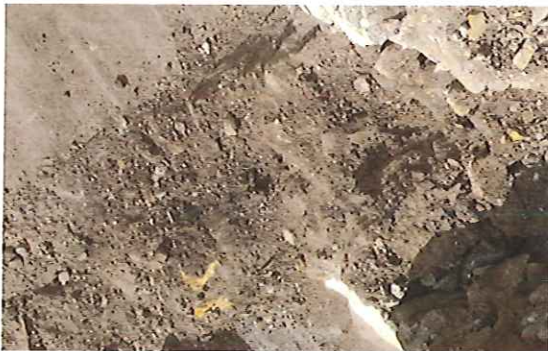
It was found that there were no foundations and that any attempt to disturb the structure resulted in sections of the building collapsing (which happened). The decaying roof timbers further aggravated the work.

Earth Footings

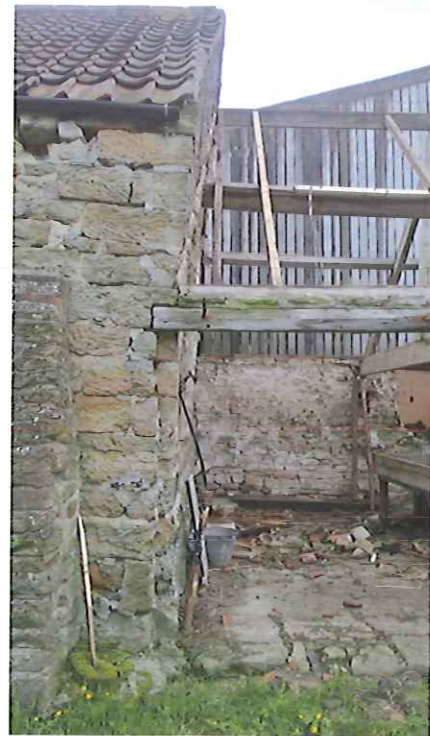
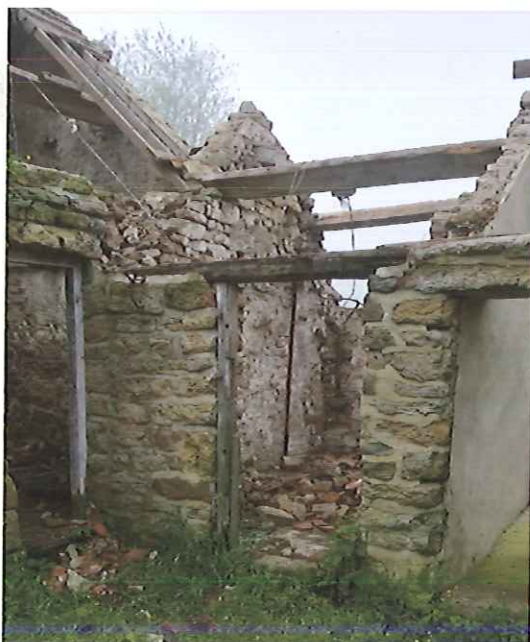
Decayed stone and mortar

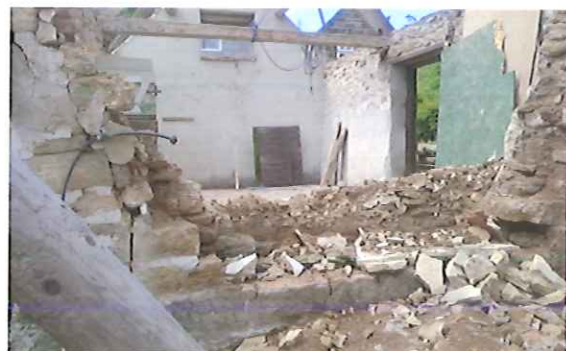
Earth and rubble filled walls

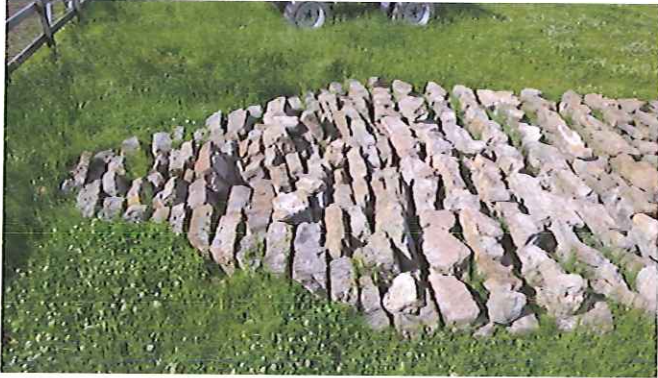
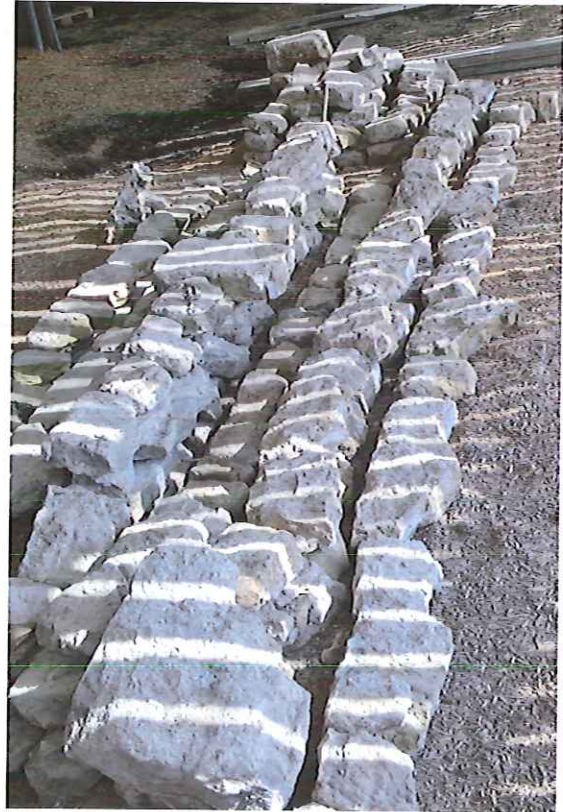
Any stone that had to be removed from the walls have been recorded and set out on the ground in order to ensure accurate reinstatement

The parts of the structure that have not been affected have been protected in order to ensure that they can be included as part of the reinstatement of the building.
