29 SEP 2013

REPORT ON VISUAL INSPECTION OF OUTBUILDINGS AT TROUTSDALE MILL.
CONVERSION OF OUTBUILDINGS INTO DOMESTIC RESIDENTIAL ANNEX

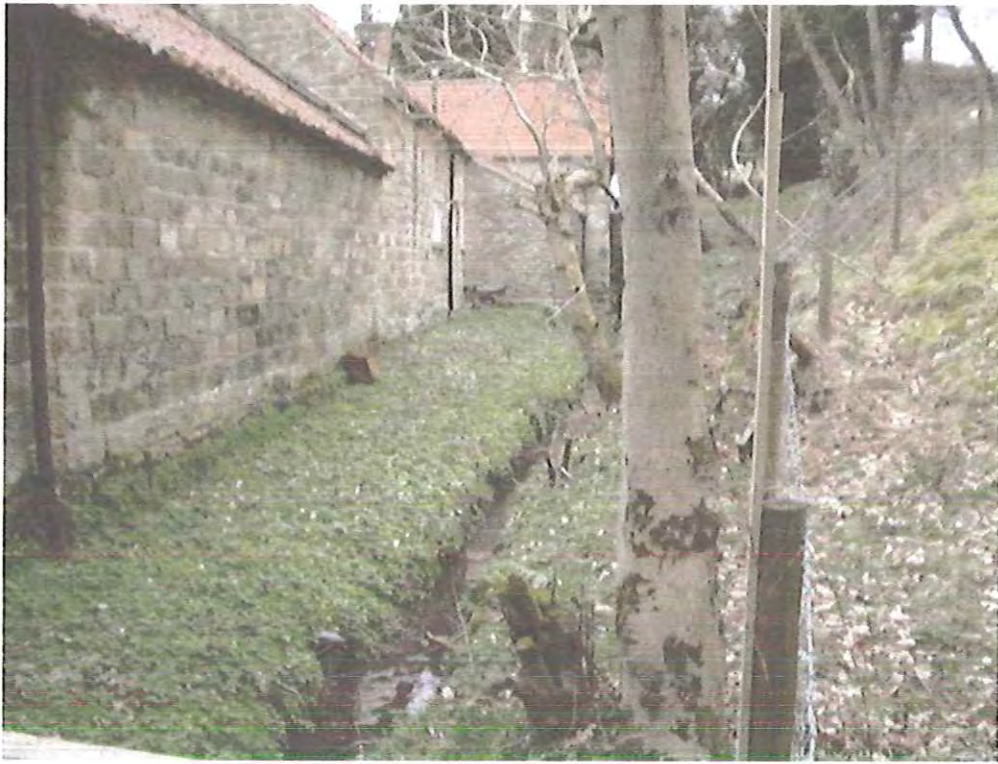
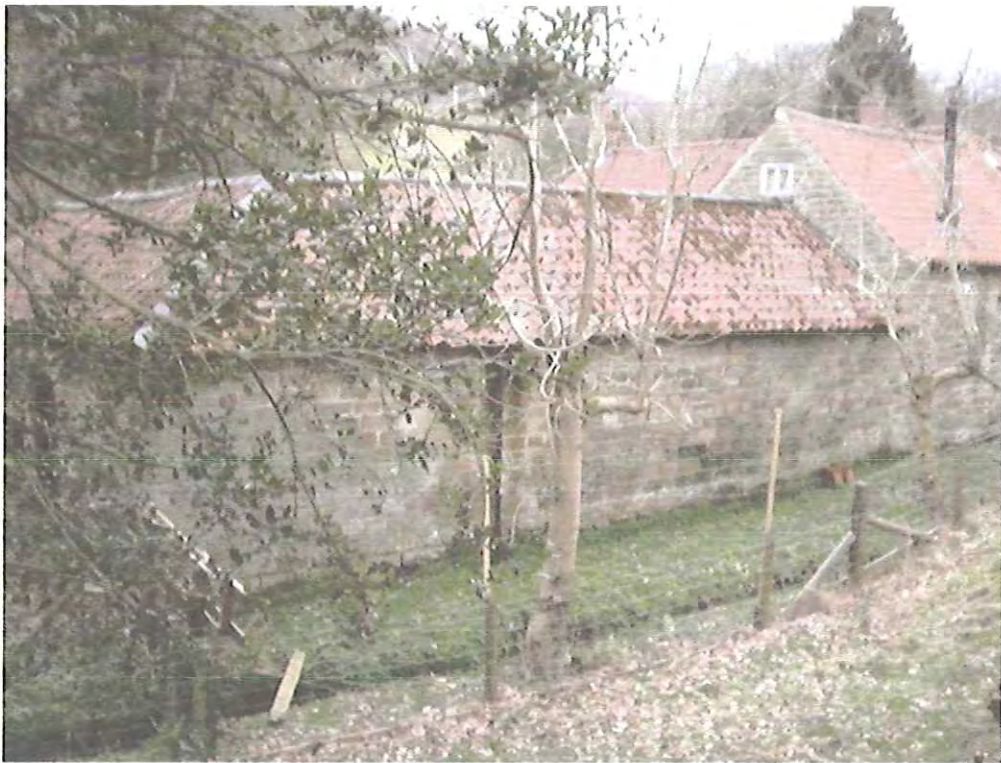
Figure 1 - NORTH WALL

This wall appears to be reasonably sound & straight with little evidence of any significant foundation settlement or lateral movement.

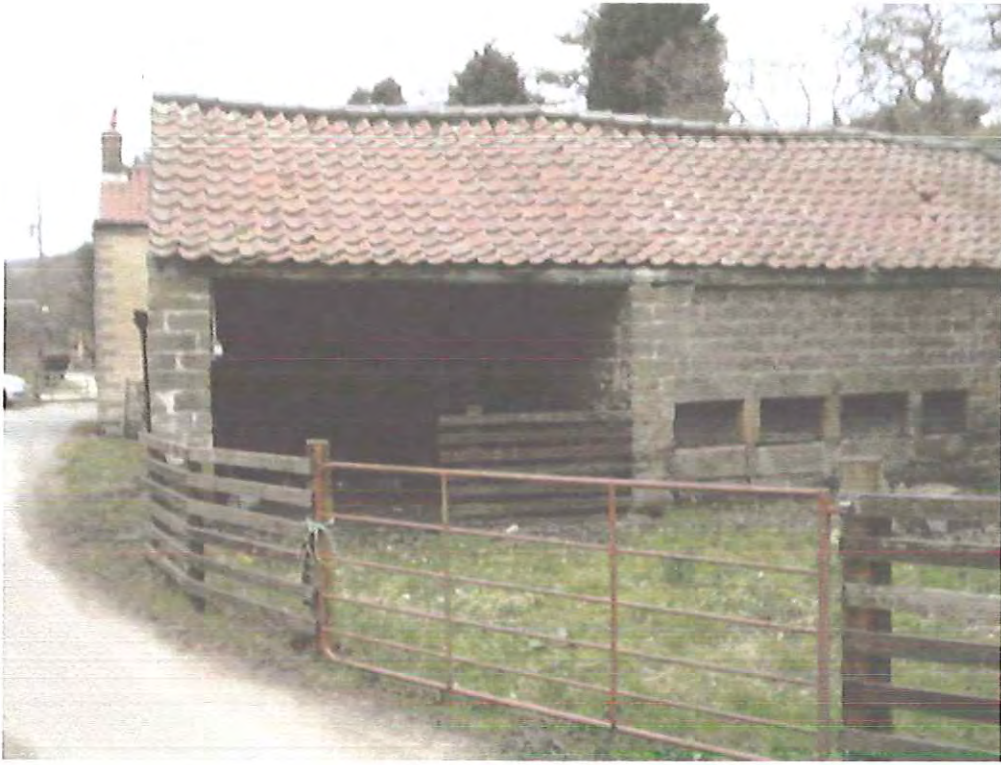
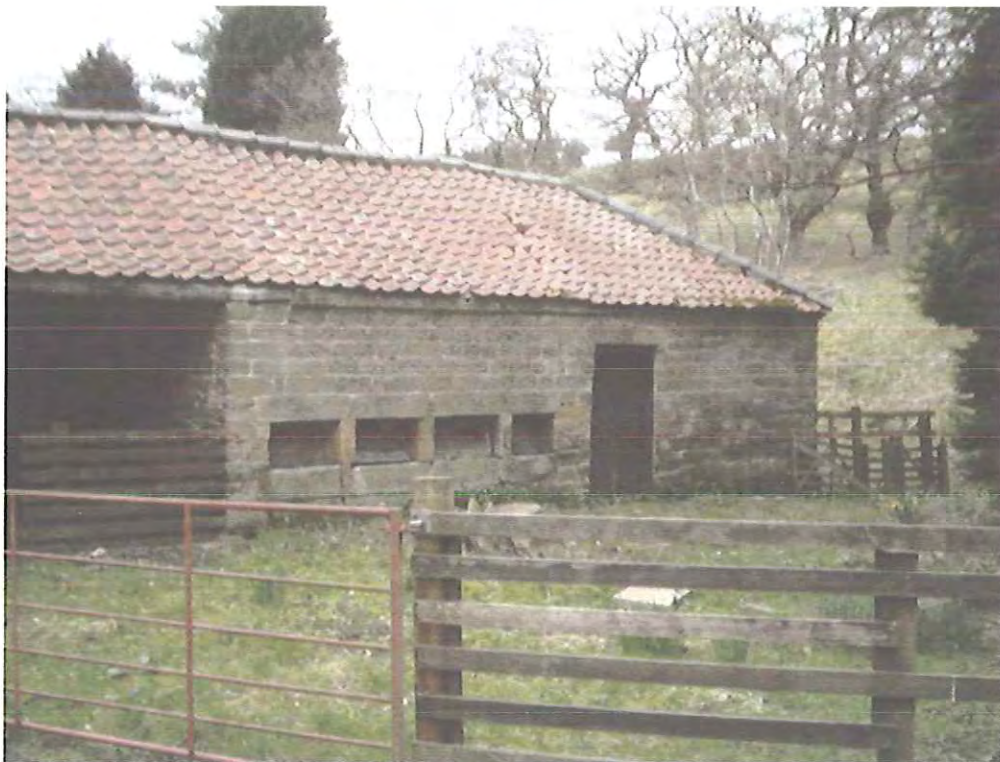
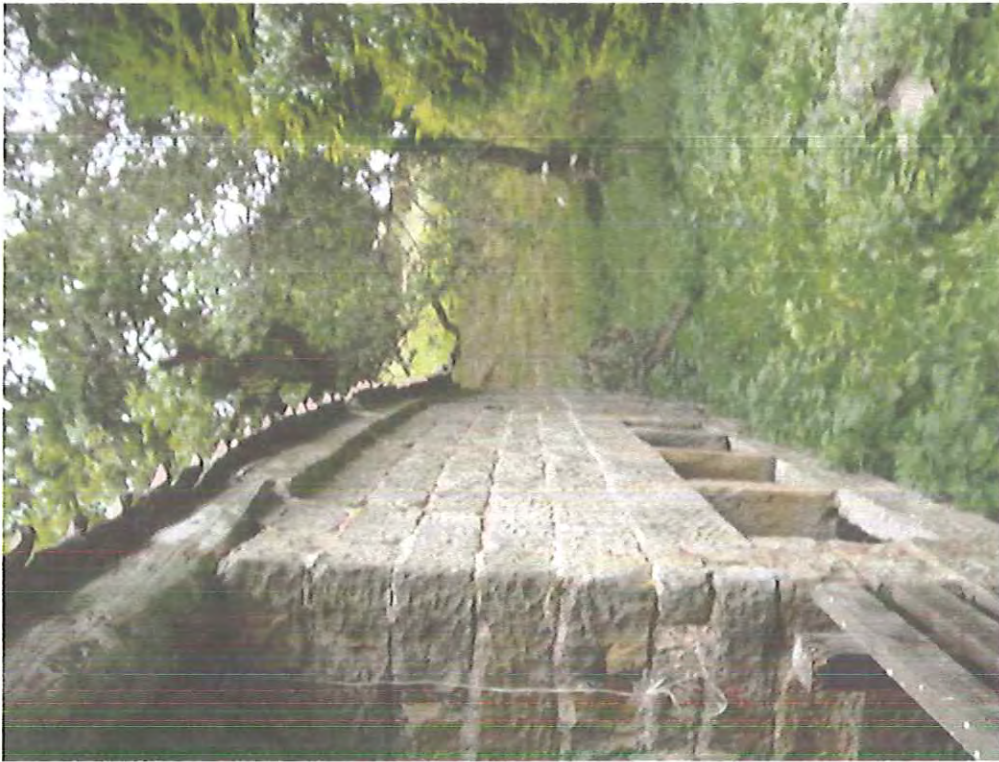
Figure 3 - EAST WALL

The wall to store 4 exhibits considerable lateral movement. There are four animal feeding troughs built into the wall just above ground level with the wall over propped from thin narrow stone pillars. It would appear that the wall is being pushed out by the roof structure although there may have been some foundation movement caused by softening of the ground from animals feeding in close proximity to the wall. The section of wall to Store 3 from the north corner appears to be reasonably sound although some rebuilding to the jamb of the door opening may be required.

The East wall to Store 4 has suffered considerable lateral movement & needs to be taken down to foundation level & rebuilt off a new foundation on firm natural ground. The upper section of wall to Store 5 also needs to be taken down to approximately the top of the low external wall & rebuilt ensuring full & adequate bond into the remaining walls. The top of the walls will need to be suitably tied into the roof structure.

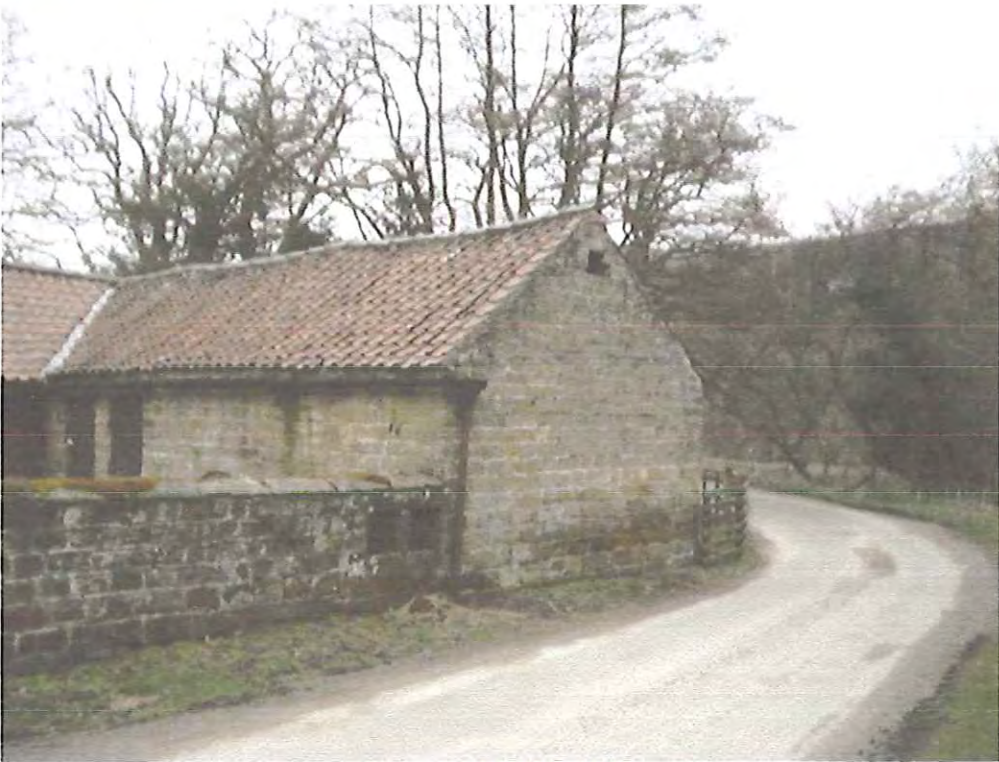
Figure 6 - SOUTH GABLE

The gable wall generally appears sound & true apart from some severe erosion of stone work just above ground level. There is also some cracking of the wall close to the East end of the wall.

Any cracking of the stonework or erosion of stone needs to be locally cut out & made good to provide sound fully bonded Masonry.

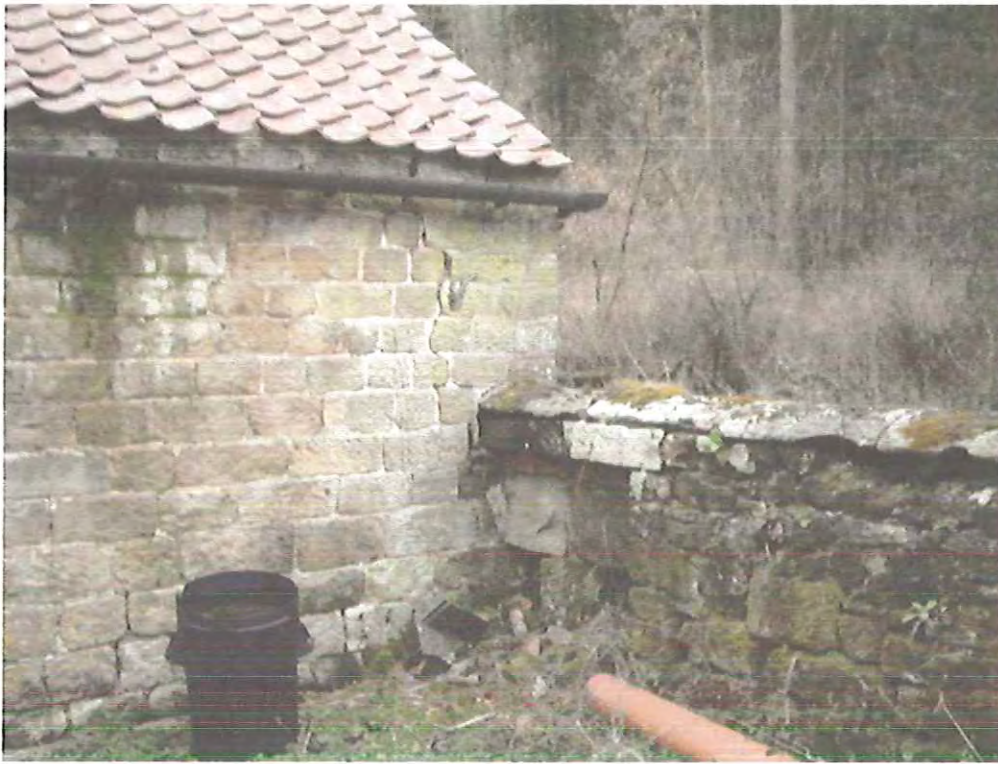
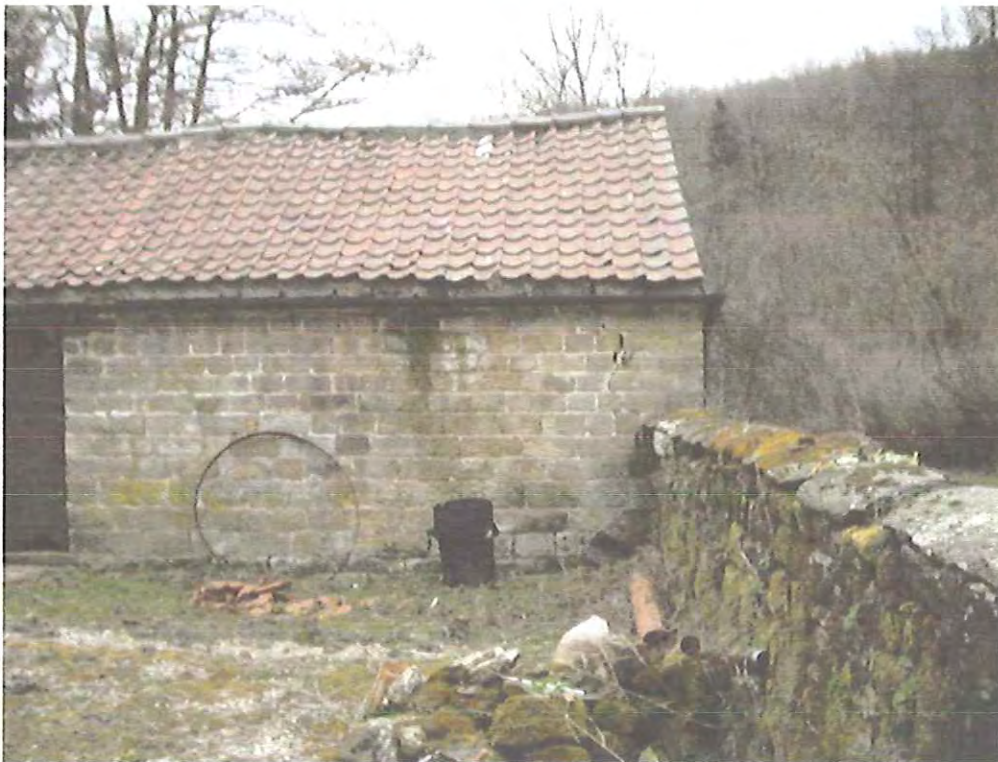
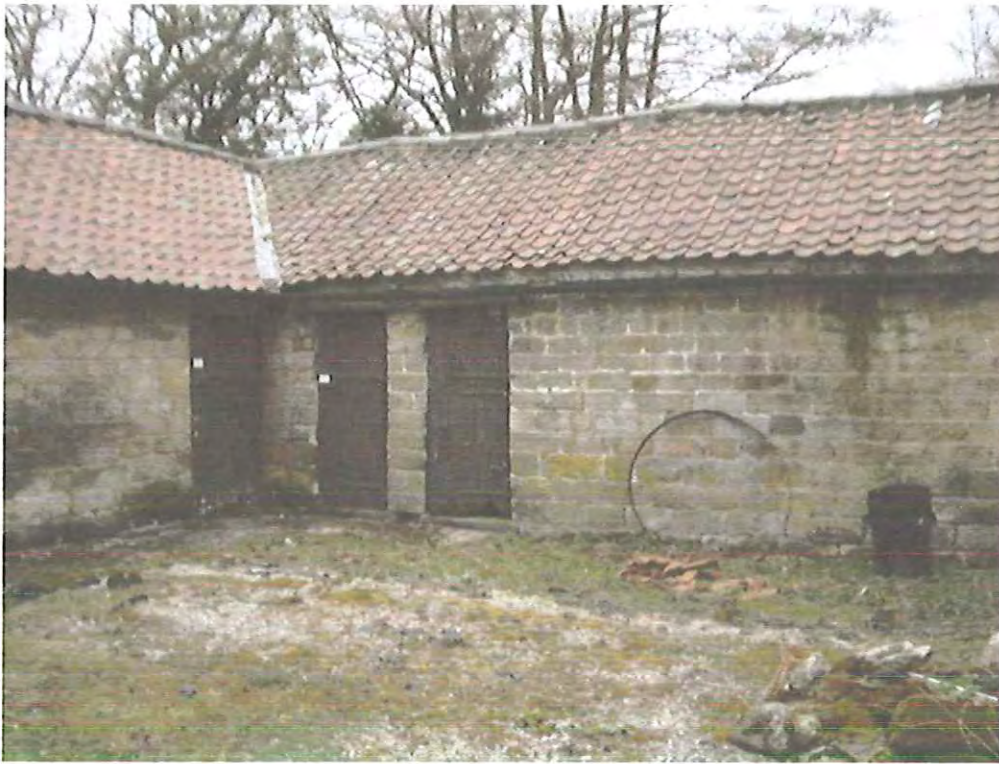
Figure 7 - COURT YARD LOOKING EAST

A vertical crack to the right hand side of the wall extending from eaves level down to the top of the low level external court yard wall was noted. The upper section of this wall to Store 5 also exhibits a lean outwards at the top. The lower section of the wall does however appear to be reasonably sound. The pier between the two door openings to store 4 is poorly supported. A floor drain has been formed directly below the pier with the bottom stones of the pier having minimal bearing both sides of the drain.

The base of the stone pillar between the door openings to Store 4 where the floor drain extend below the pillar needs to be made good. Underpin if necessary.

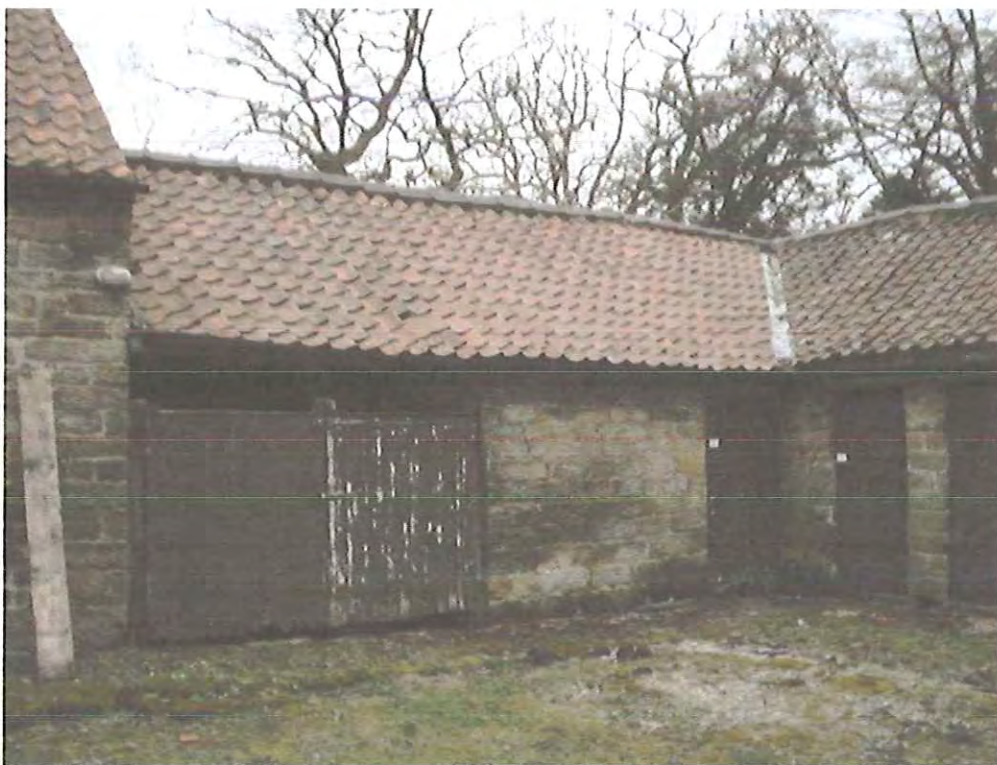
Figure 10 - COURT YARD LOOKING NORTH

The elevation to Store 1 is completely open whilst the stonework to Store 2 appears to be reasonably sound.

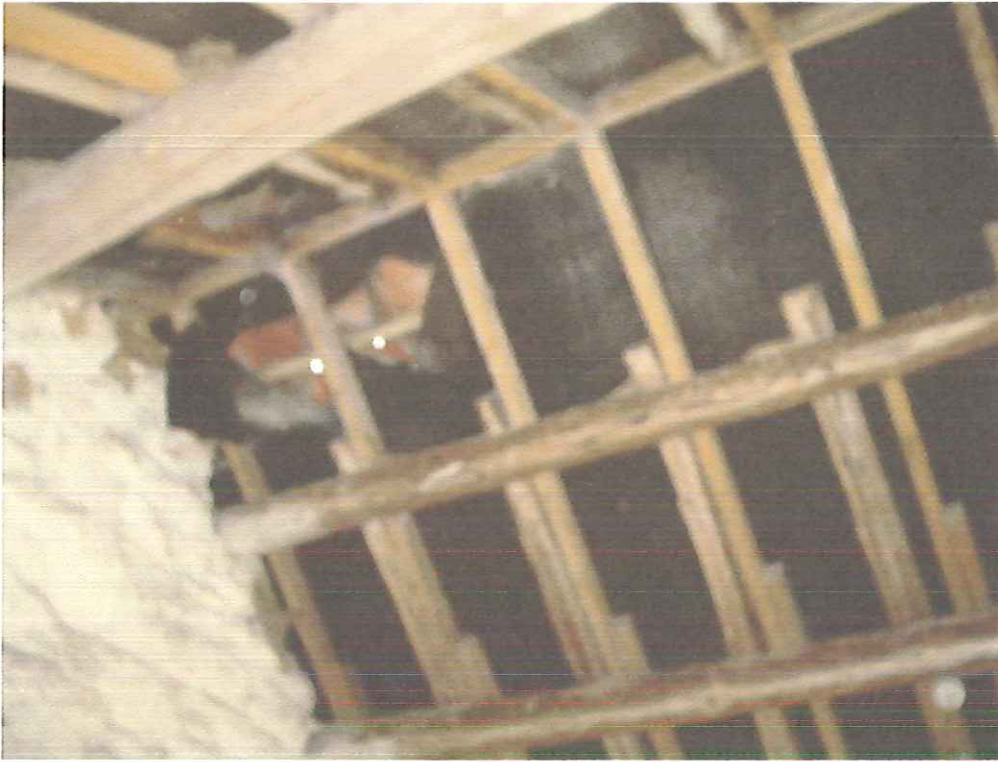
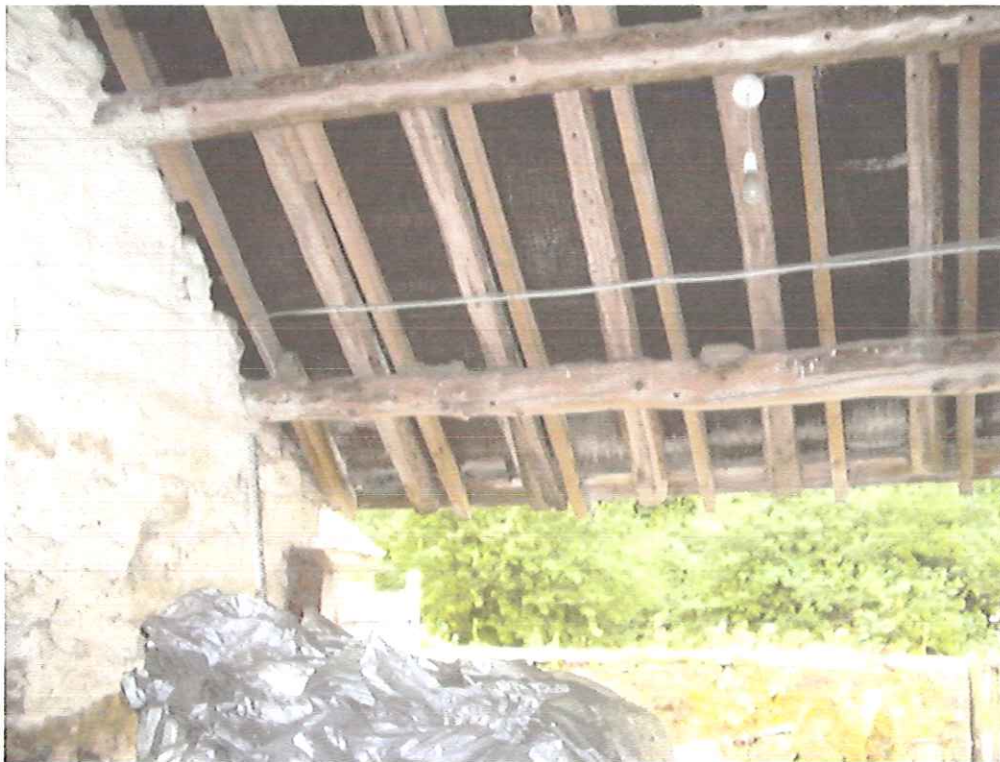
Figure 11 – ROOF-STORE 1 - NORTH SLOPE

The roof structure comprises 4 No. undressed small diameter tree trunk purlins carrying rafters of various ages. Many of the original rafters remain but have been supplemented by the addition of more recent timbers due to deterioration of the original members. The roof is felted indicating that the roof cladding has been replaced in more recent times. Some cracking to the stonework local to the purlin ends was observed due to lack of eaves restraint to the roof structure.

We consider that it is feasible for the outbuilding to be converted into habitable accommodation. Some rebuilding work will be required but the majority of the walls can be retained subject to repair. It would be safer & simpler to replace the whole of the timber roof structure although subject to a thorough examination & inspection it may be possible to retain parts of the structure. Following removal of the roof covering it will be necessary to expose the ends of all rafters & purlin where built into masonry to check for any rot or fungal attack. This would require replacement or repair as necessary before making good the masonry around the purlin ends & solidly building in. Should any of the roof structures be retained then it is recommended that ridge purlins or horizontal ties be provided to eliminate the lateral load at eaves level & purlin ends.

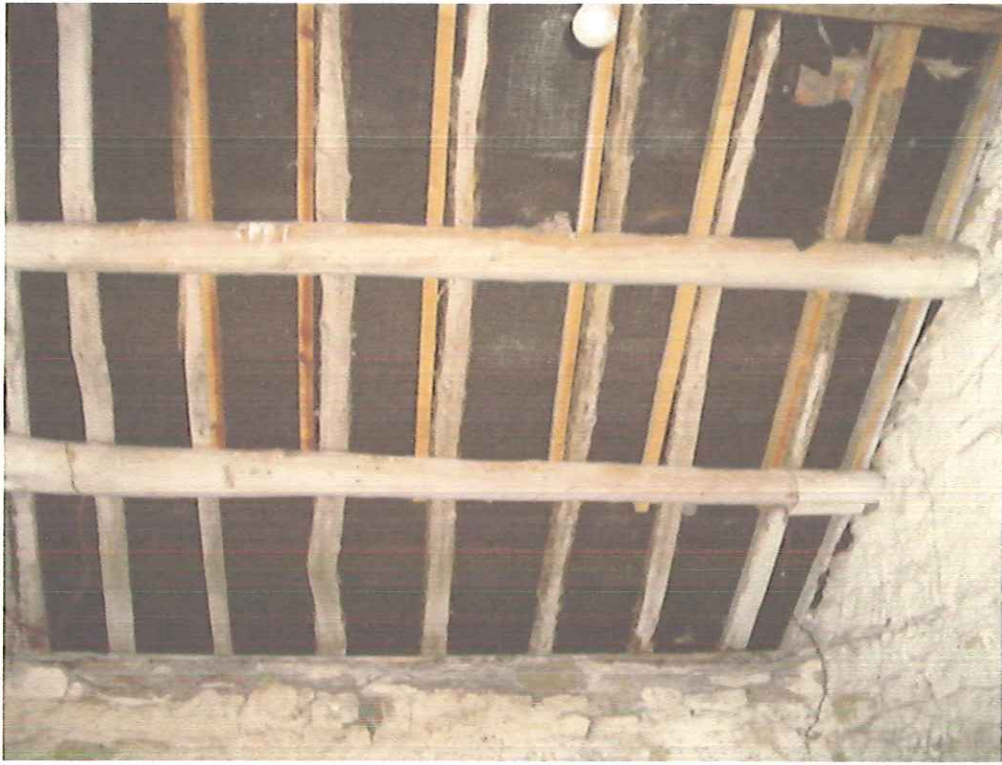
Figure 13 - ROOF-STORE 2

Similar comments to that for Store 1.

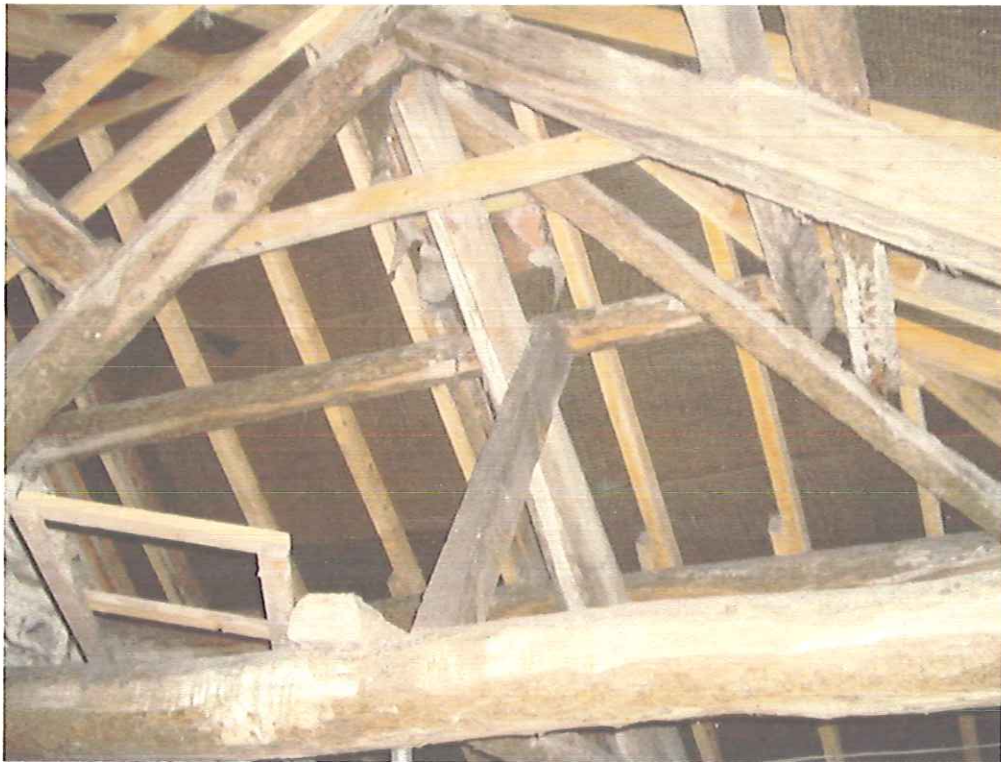
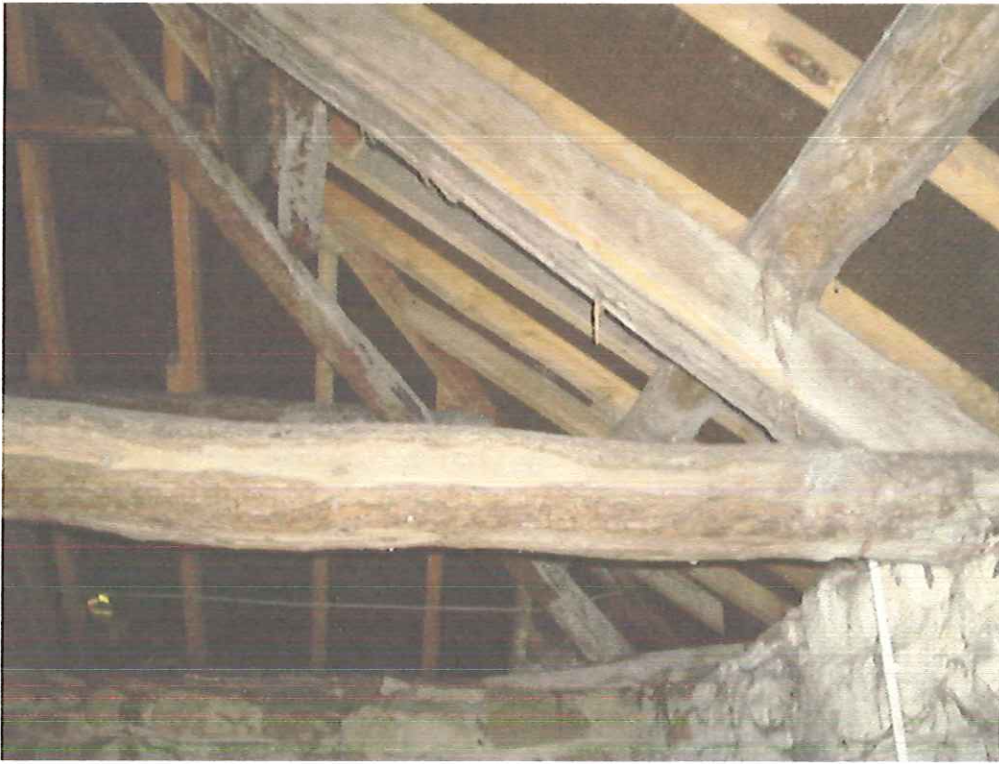
Figure 14 - ROOF-STORE 3-TRUSS

The hipped roof over is supported from a poorly formed full truss & a half truss carrying the hipped rafter. Purlins are as for Store 1 with similar cracking of stonework local to purlin ends. The roof is also felted. A strange timber lintel exists over the door opening to the East wall. A vertical crack exists where the division wall to Store wall abuts the East wall.

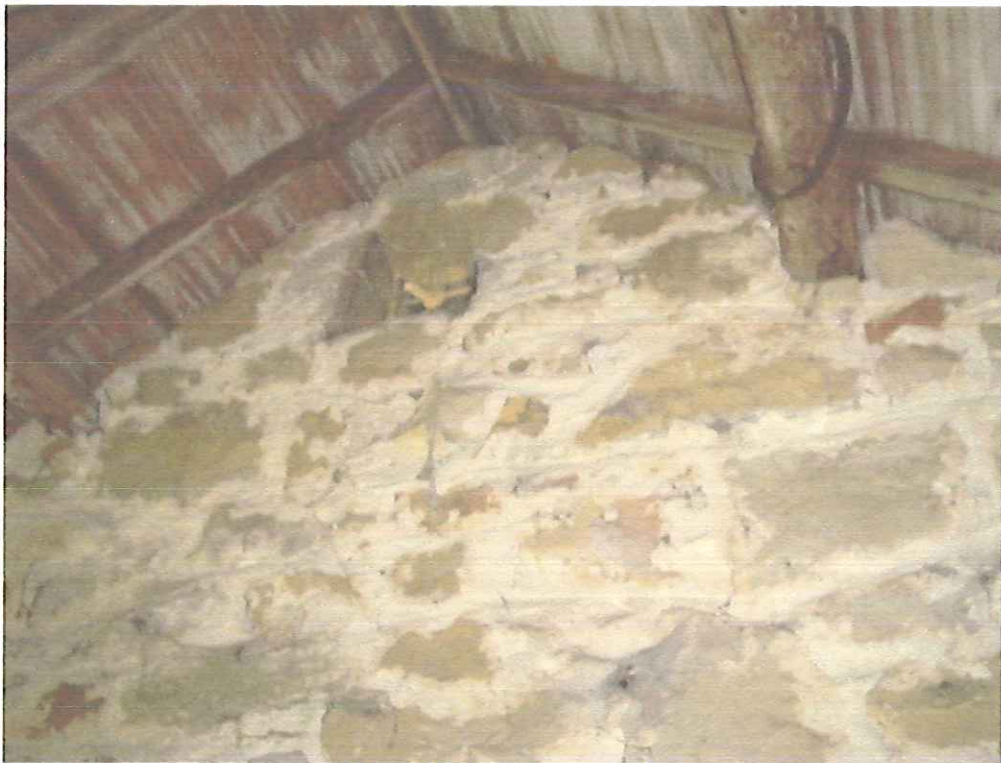
Figure 16 - ROOF STORE 4

Severe vertical cracking where the division walls to stores 3 & 5 abuts the East wall & a similar crack where the division wall to Store 5 abuts the west wall to the courtyard. The roof is unfelted the purlins & rafters all being original. Local cracking to the purlin ends is also evident.

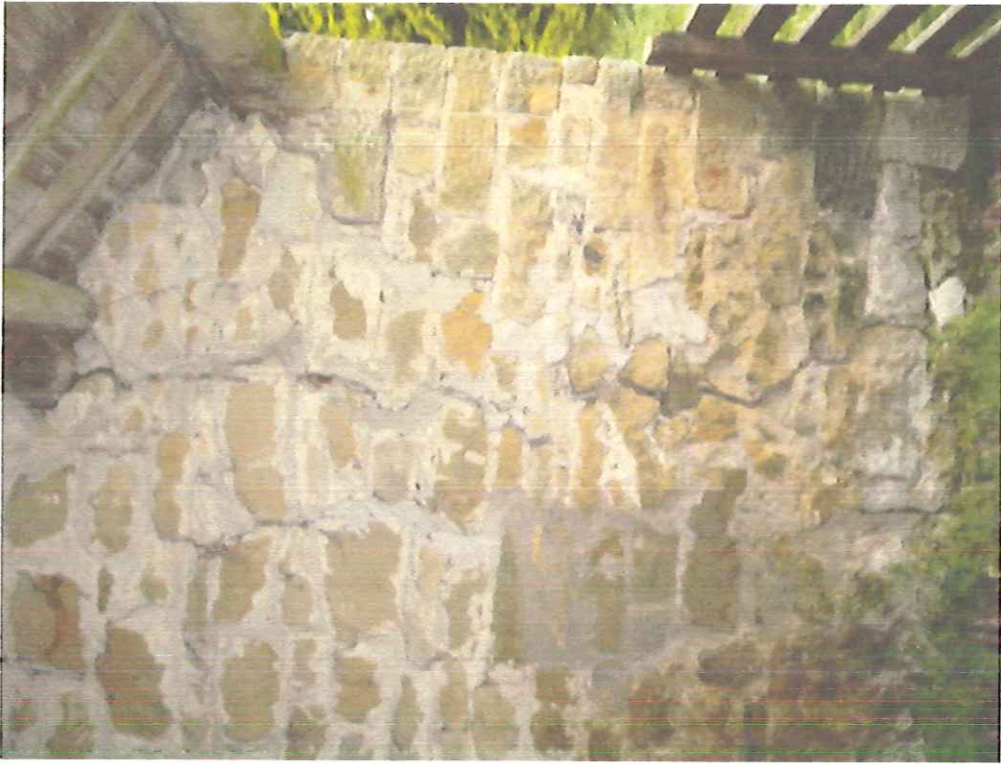
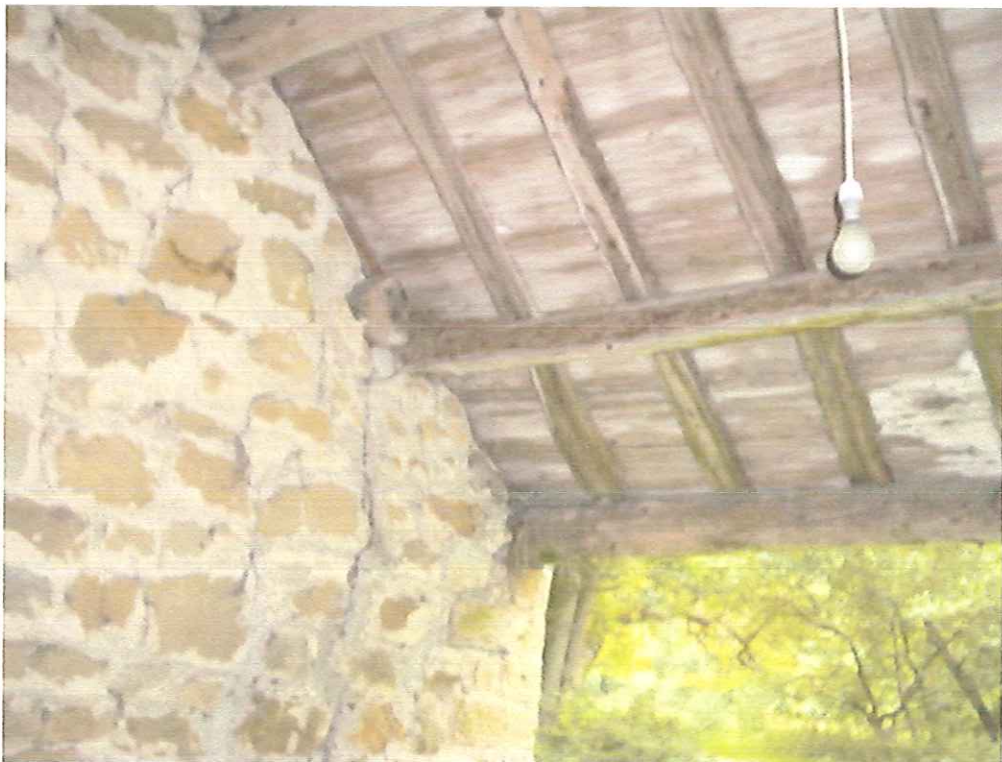
Figure 17 - STORE 5-NORTH WALL

This store is completely open to the elements there being no wall to the East elevation. The roof is unfelted as for Store 4, The severe vertical cracking observed in Store 4 where the division wall abuts the East wall was particularly bad on this side of the wall.
