**VISUAL INSPECTION OF RANGE OF BARNs AT
CALFTHWAITE FARM, CLOUGHTON
SCARBOROUGH**

MR. & MRS. McQUADE

**BY R. O. BIRDSALL M.Sc., M.I.C.E.
CHARTERED ENGINEER**

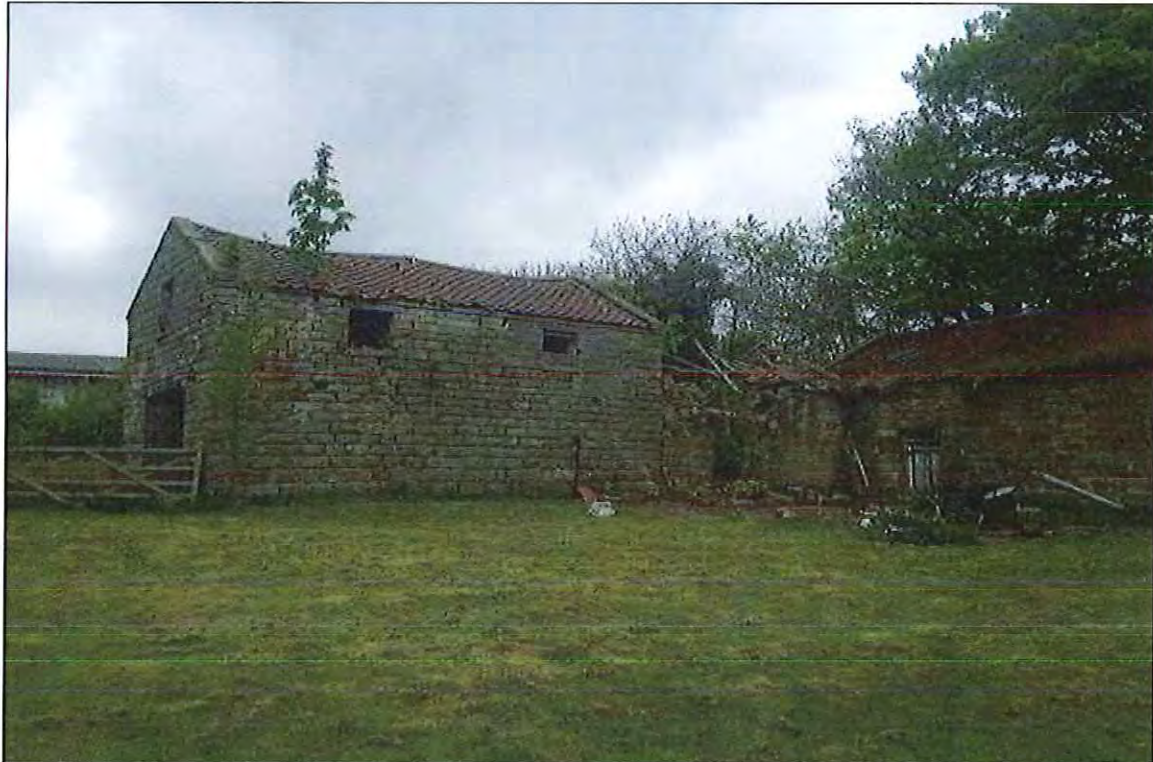
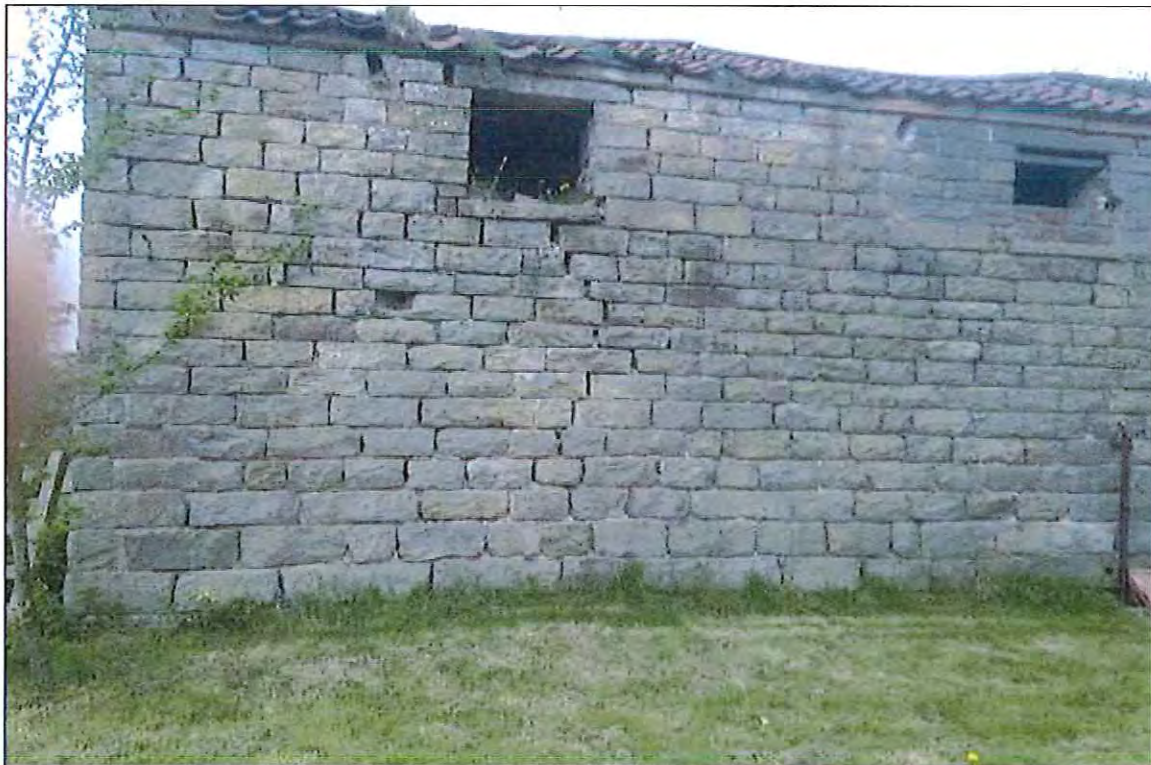
- 2.1.1 The east facing wall of Barn A can be seen in photographs 1 and 2. The wall is in reasonable condition except for a vertical opening of the perpend joints below the most southerly window and a general lack of mortar in the joints.
- 2.1.2 The south facing wall can be seen in photographs 3 and 4. The wall is in reasonable condition except for an opening of the perpend joints on the west side of the main opening and a general lack of mortar in the joints.
- 2.1.3 The west facing wall can be seen in photographs 5 and 6. The wall is in reasonable condition except for damage above the most southerly window and an opening of the perpend joints below the window.
- 2.1.4 The inside of Barn A can be seen in photographs 7 and 8. The walls appear to be in reasonable condition and there is evidence of a previous second floor.

- 2.2.2 The opening of the perpend joints should be repaired by installation of Helifix bars in every other bed joint across the openings.
- 2.2.3 The damage above the window on the west facing wall should be repaired.
- 2.2.4 The general recommendations given in Section 7 below should be followed.

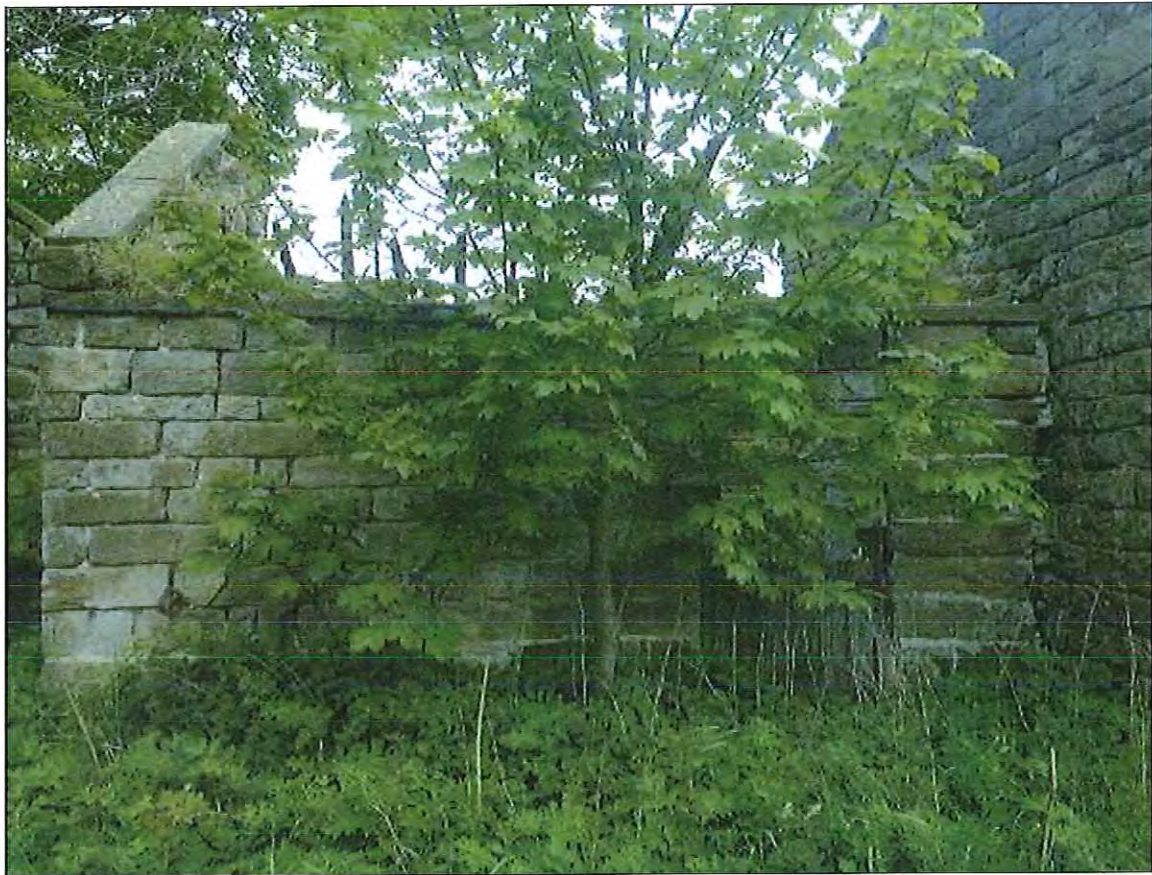
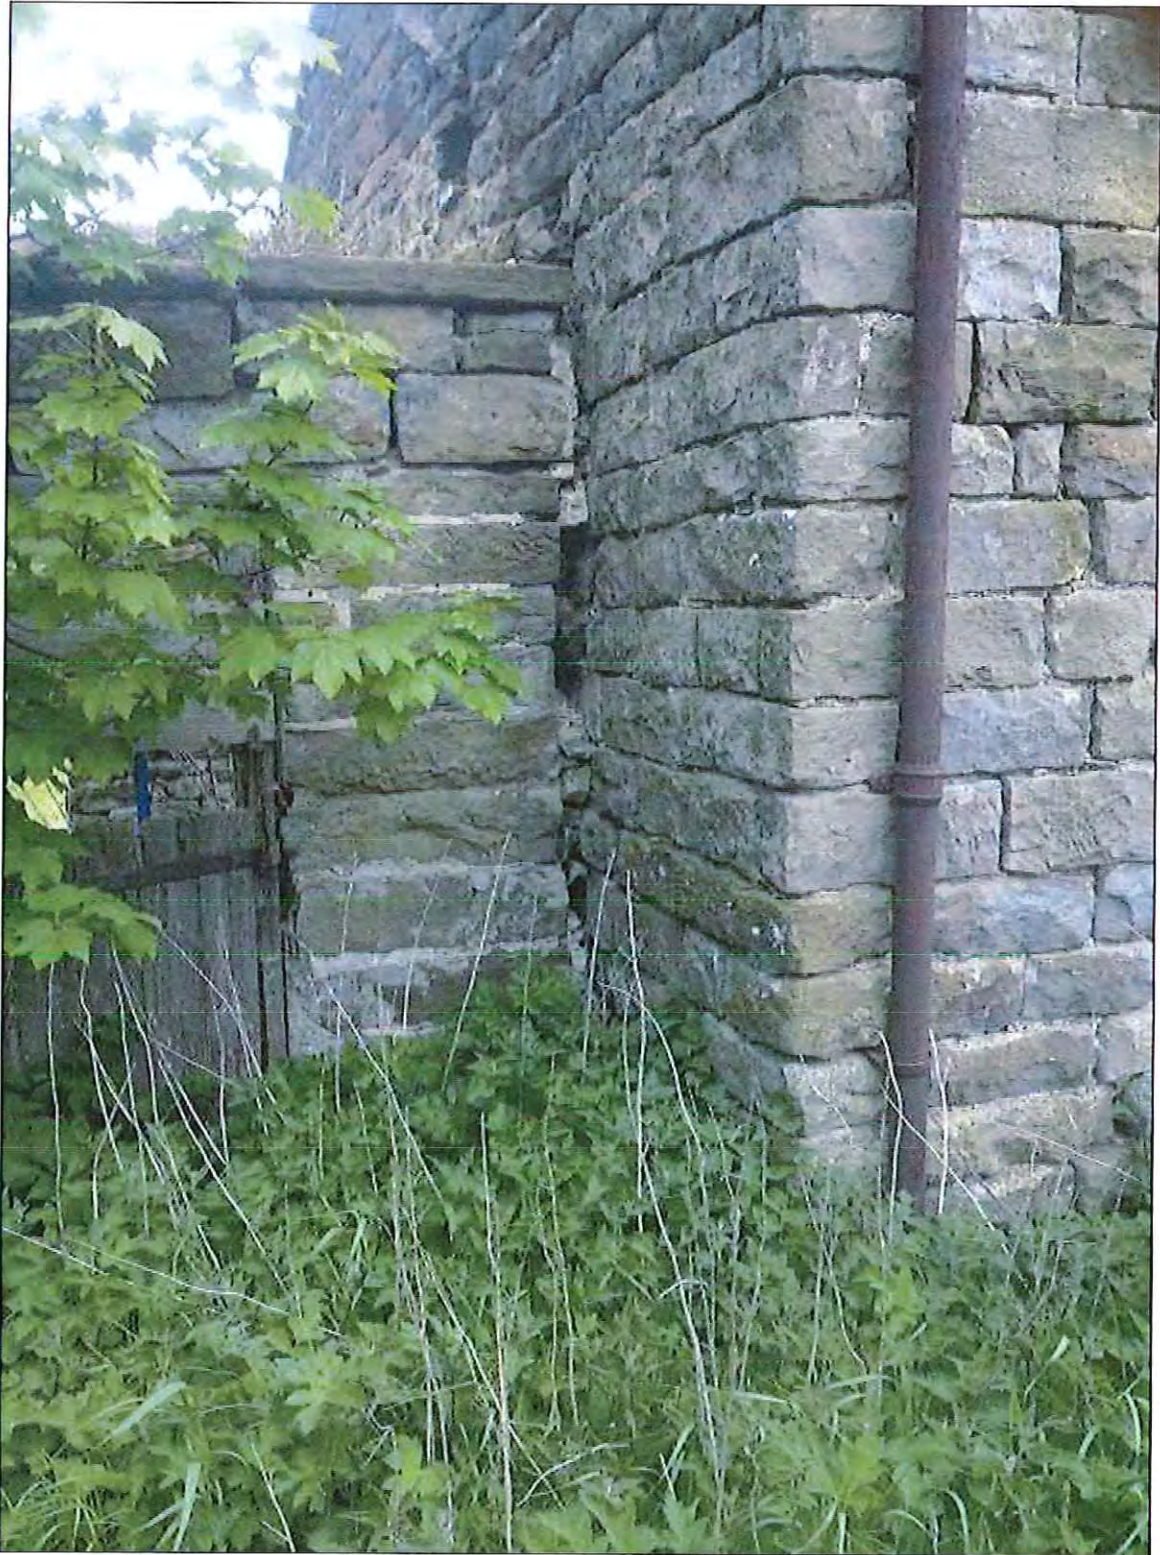
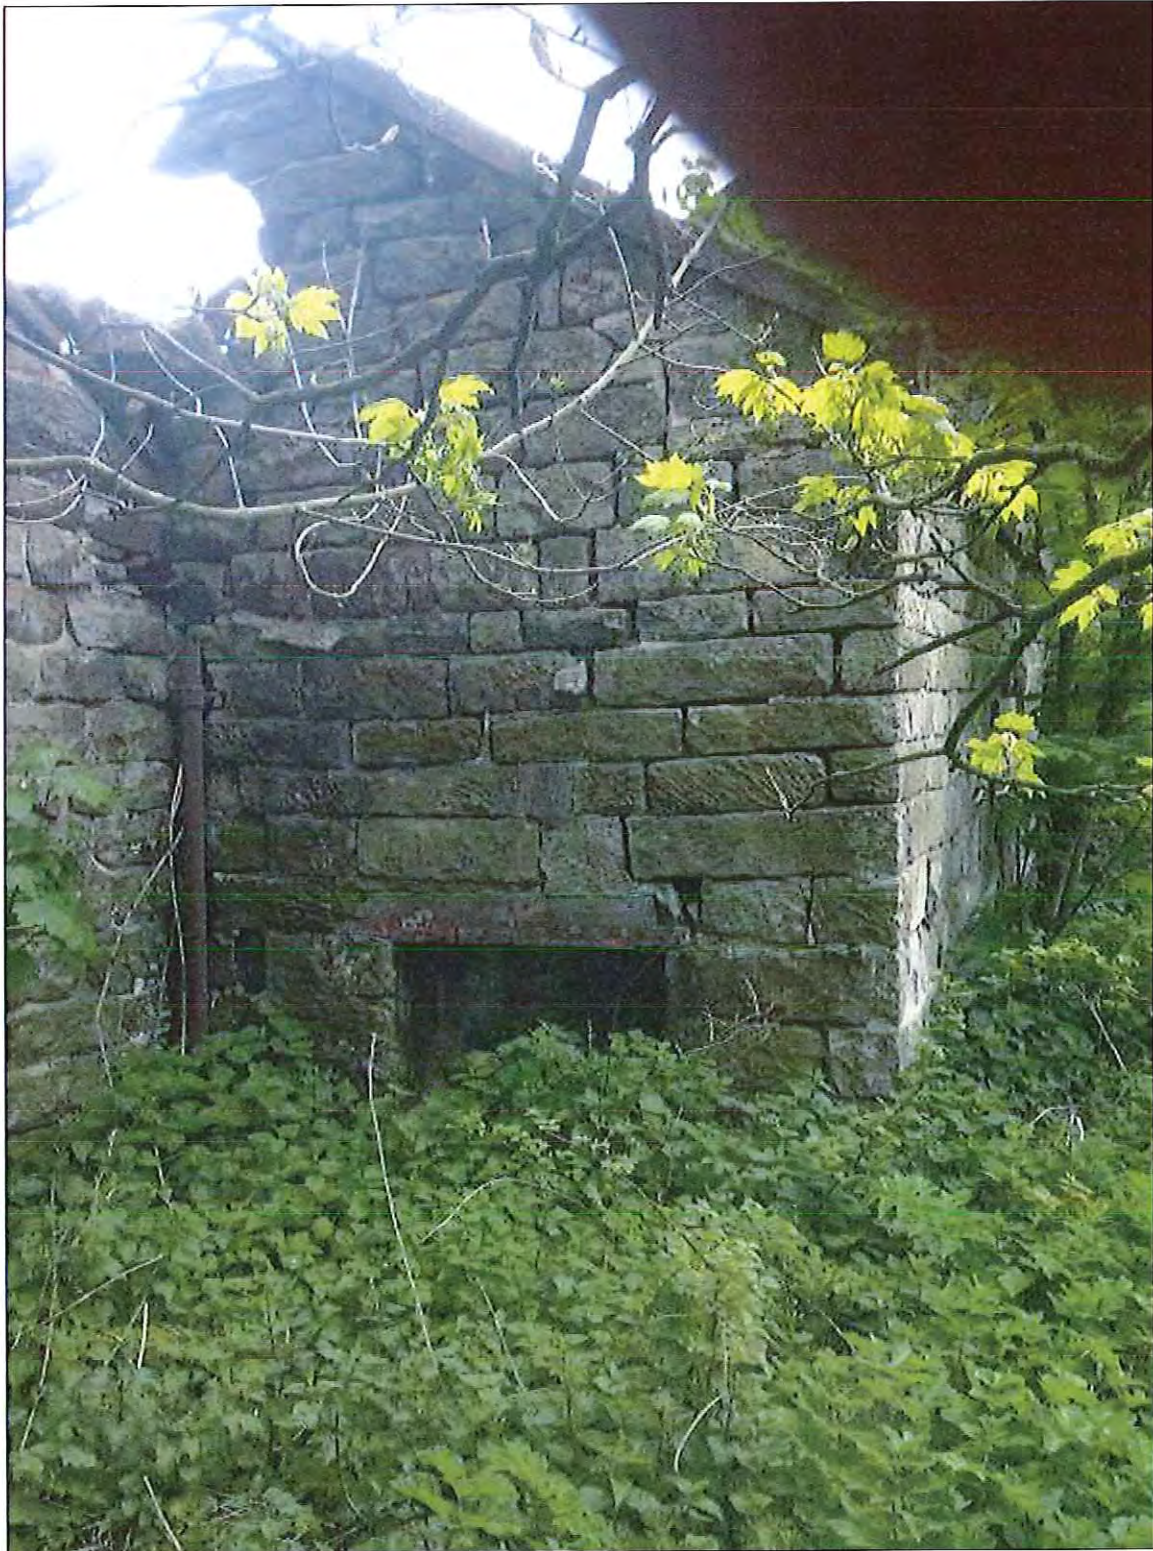
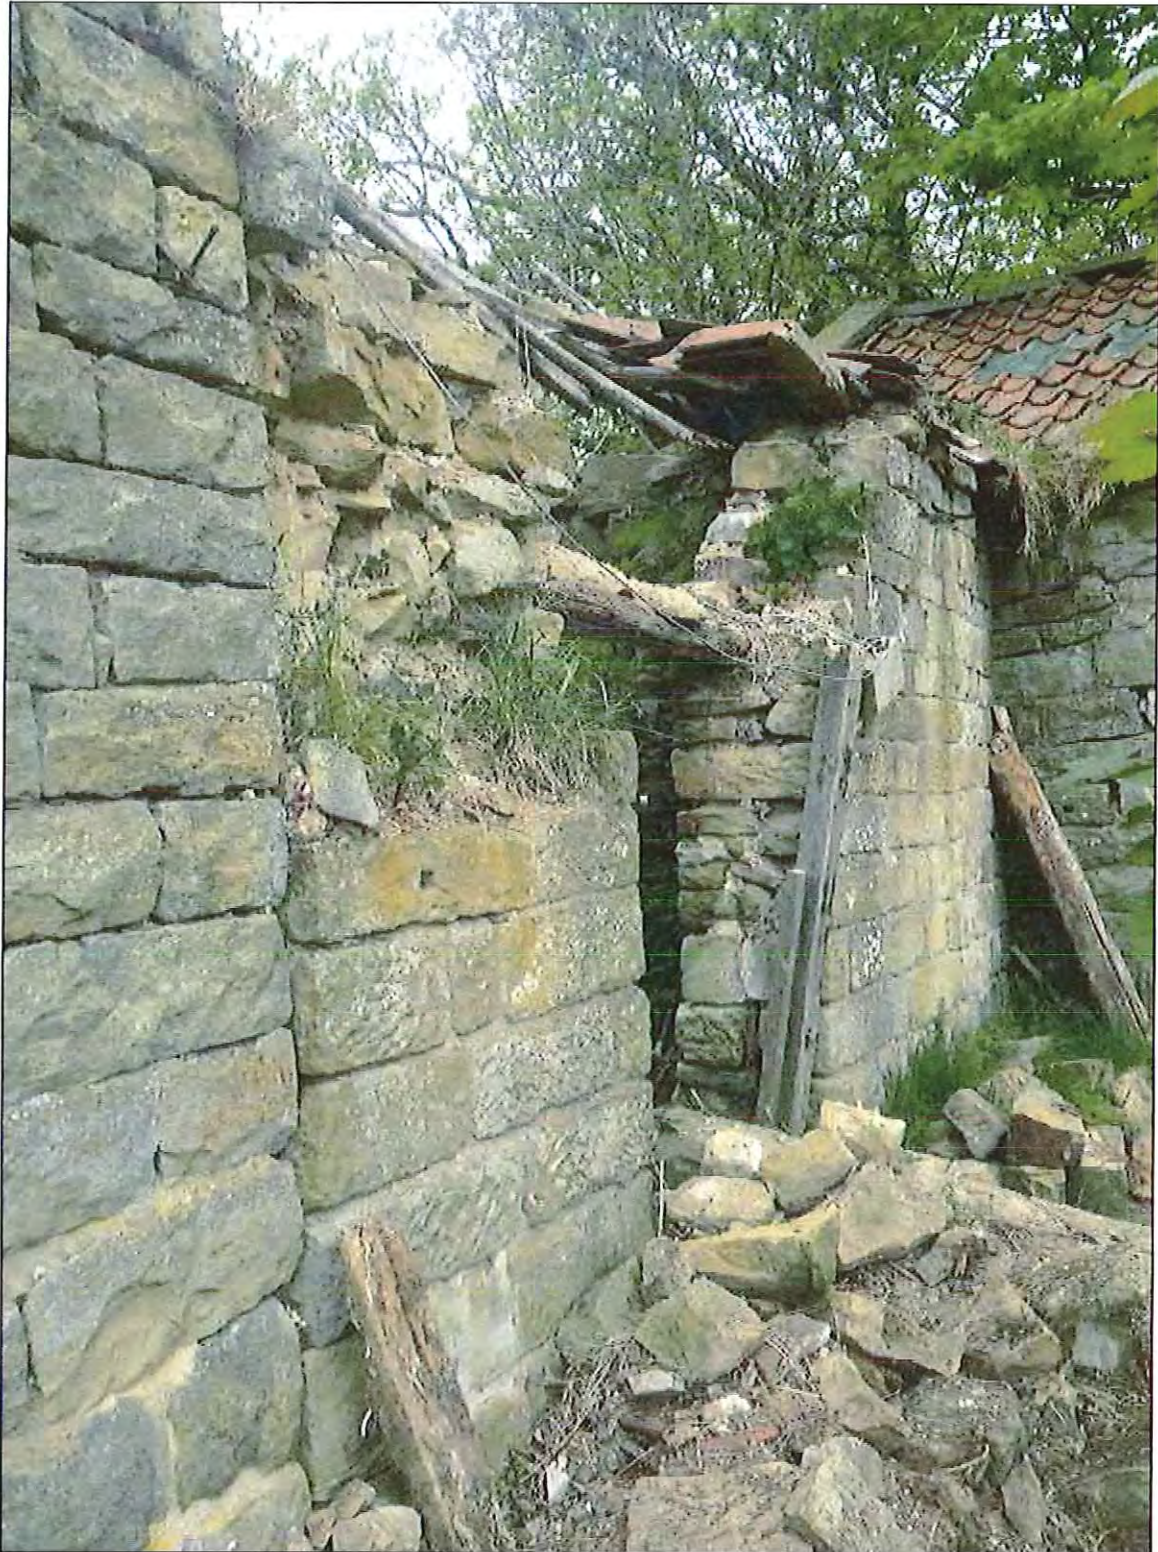
- 3.1.1 The west facing wall of Barn B can be seen in photographs 9 and 10. The wall is in reasonable condition except for a gap between Barn A and Barn B and a general lack of mortar in the joints.
- 3.1.2 The north facing wall can be seen in photograph 11. The wall is in reasonable condition except for an inadequate lintel over the opening and a general lack of mortar in the joints.
- 3.1.3 The east facing wall can be seen in photograph 12. There is damage in the upper half of the wall to the south of the doorway and the wall to the north of the doorway has a lean.

- 3.2.1 The barn is in reasonable condition except for the upper section of the east facing wall. It is, therefore, capable of conversion to a residential-related use without substantial rebuilding. The recommendations below should be implemented as part of any such conversion.
- 3.2.2 The damaged (and missing) upper section of the east facing wall should be carefully rebuilt.
- 3.2.3 The general recommendations given in Section 7 below should be followed.

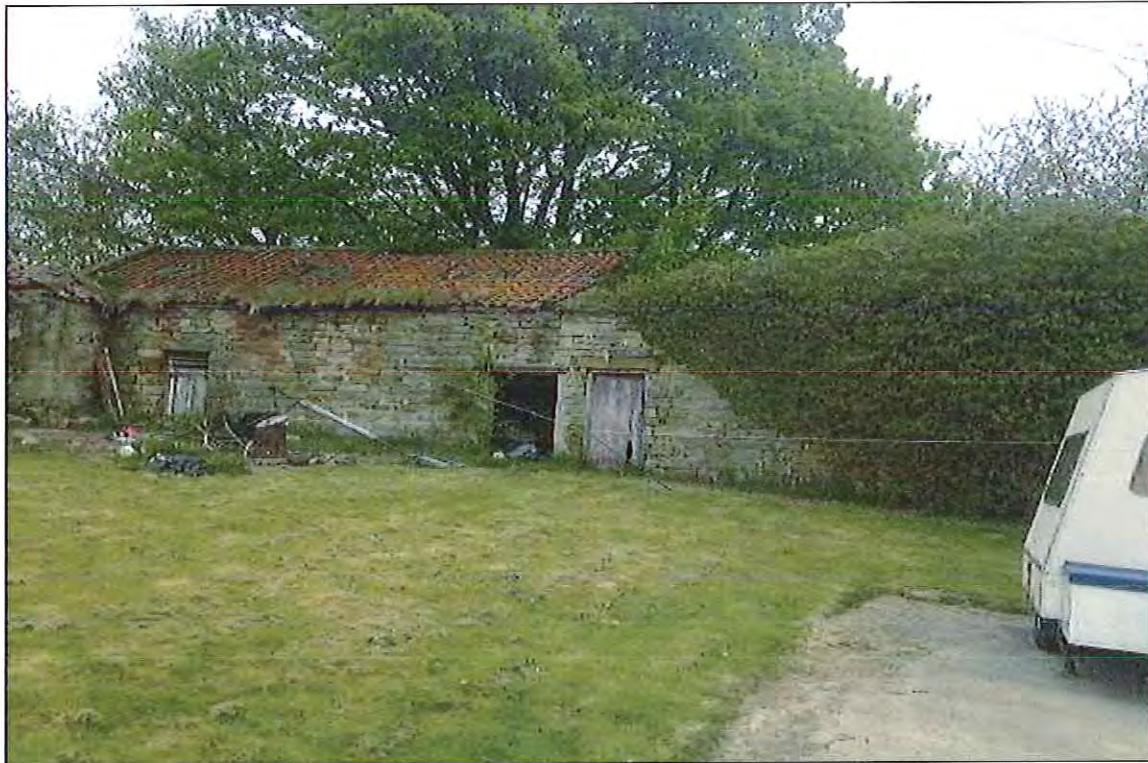
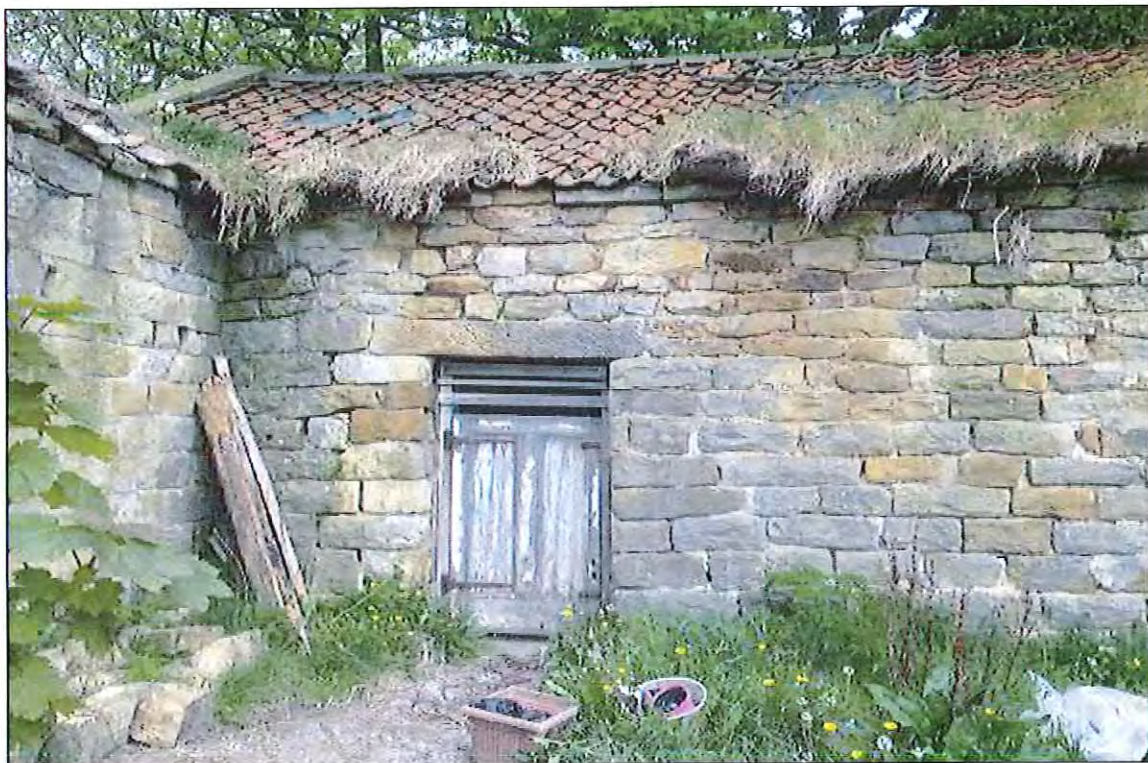
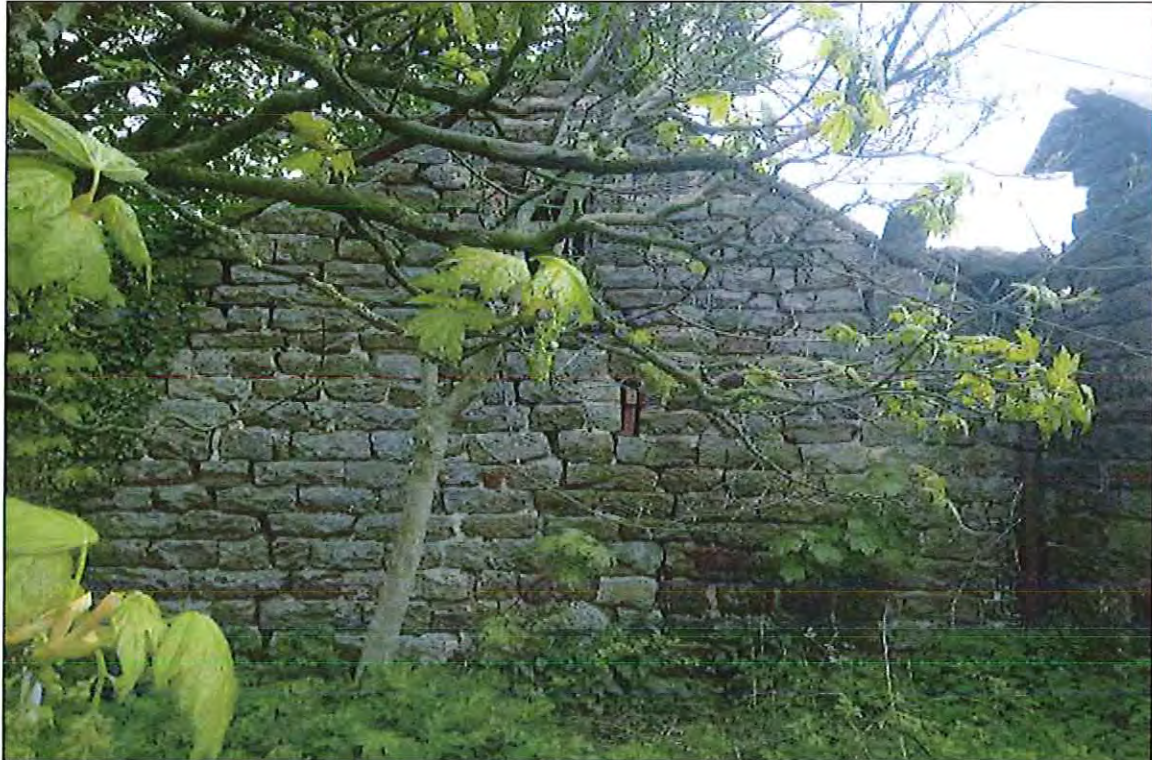
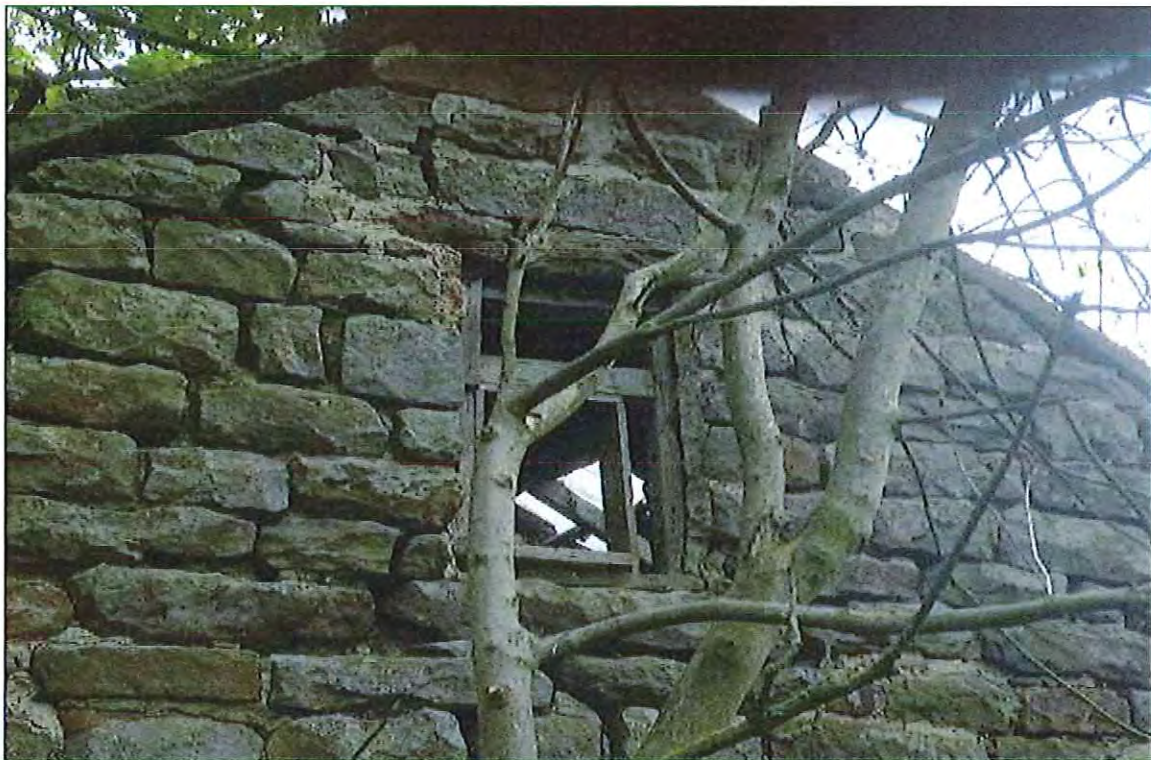
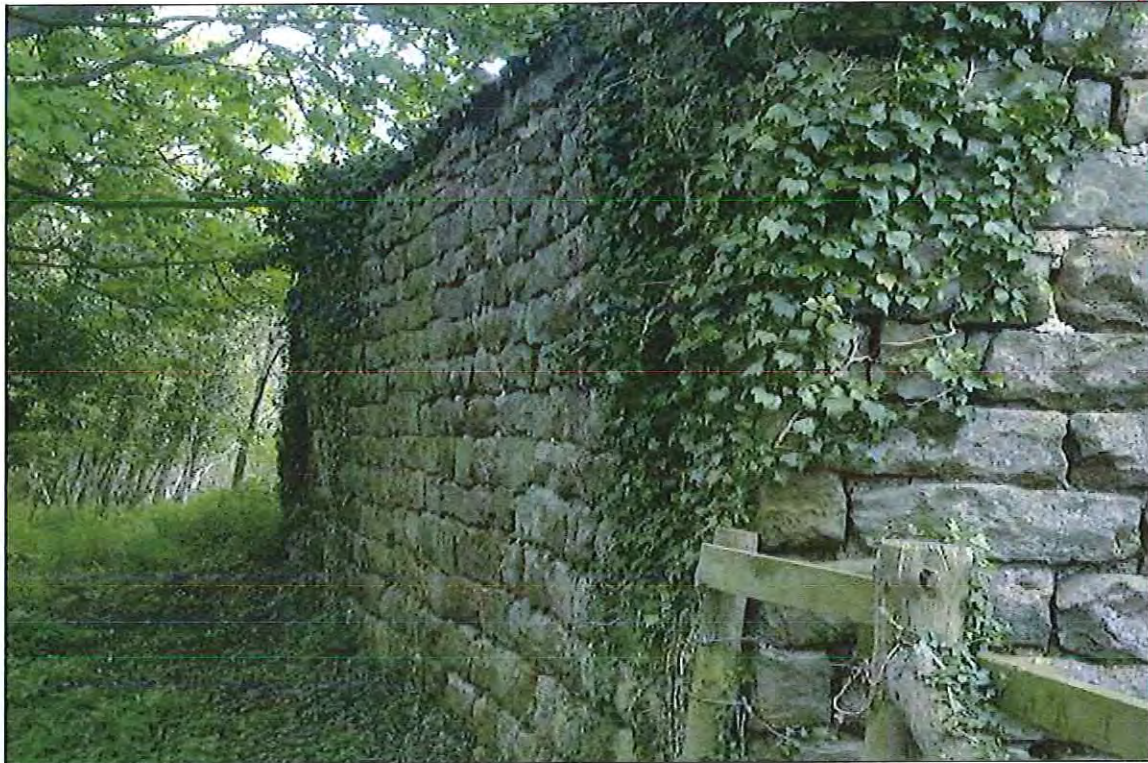
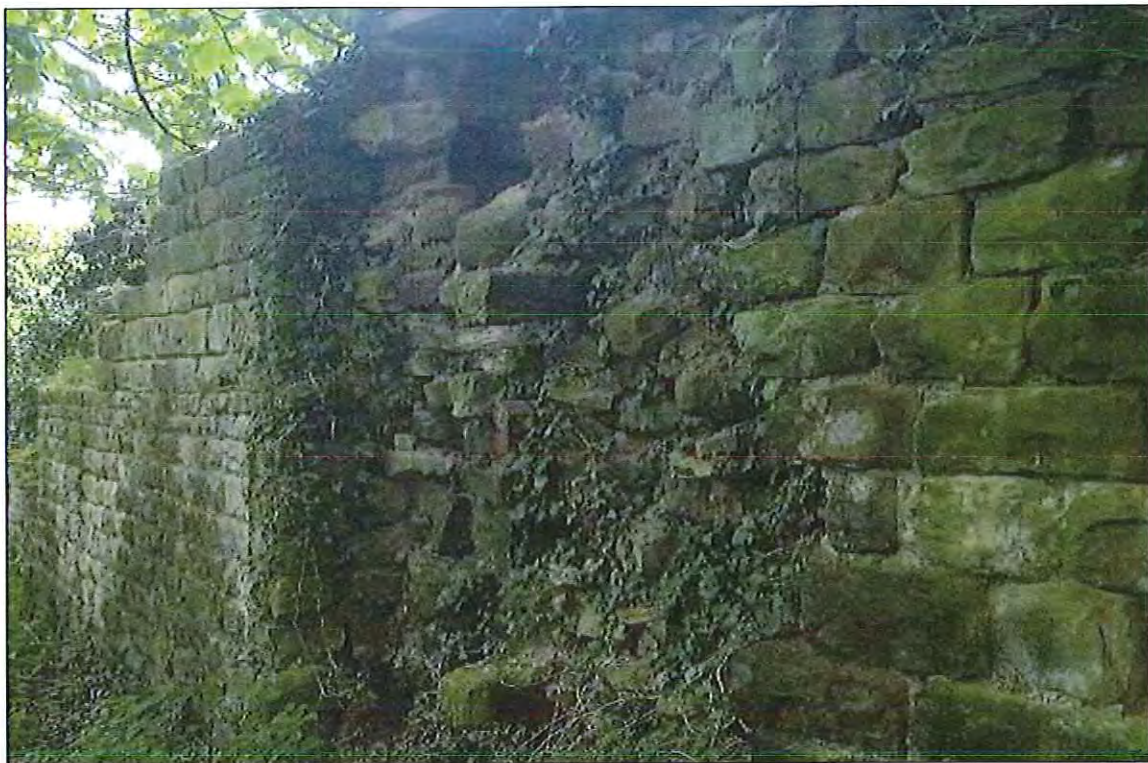
- 4.1.1 The south facing wall of Barn C can be seen in photographs 13 and 14. The wall is in reasonable condition except for some slight damage at the western end of the wall and a lack of mortar in the joints.
- 4.1.2 The west facing walls can be seen in photographs 15 and 16. The wall is in reasonable condition except for some open perpendicular joints and a general lack of mortar. There is an inadequate lintel over the window.
- 4.1.3 The north facing wall can be seen in photograph 17. The wall is in reasonable condition at the western end of the building but towards the east the wall leans and becomes damaged, see photograph 18. This shows partial collapse of the external face of stonework.
- 4.1.4 The inside face of the damaged wall can be seen in photograph 19. There are also cracks in the internal dividing wall, see photograph 20.

- 4.2.1 The barn is in reasonable condition except for the damage on the eastern section of the north facing wall. It is, therefore, capable of conversion to a residential-related use without substantial rebuilding. The recommendations below should be implemented as part of any such conversion.
- 4.2.2 The opening of the perpendicular joints should be repaired by installation of Helix bars in every other bed joint across the openings.
- 4.2.3 The inadequate lintel should be replaced.
- 4.2.4 The leaning and damaged part of the north facing wall should be carefully rebuilt.
- 4.2.5 The general recommendations in Section 7 should be adhered to.

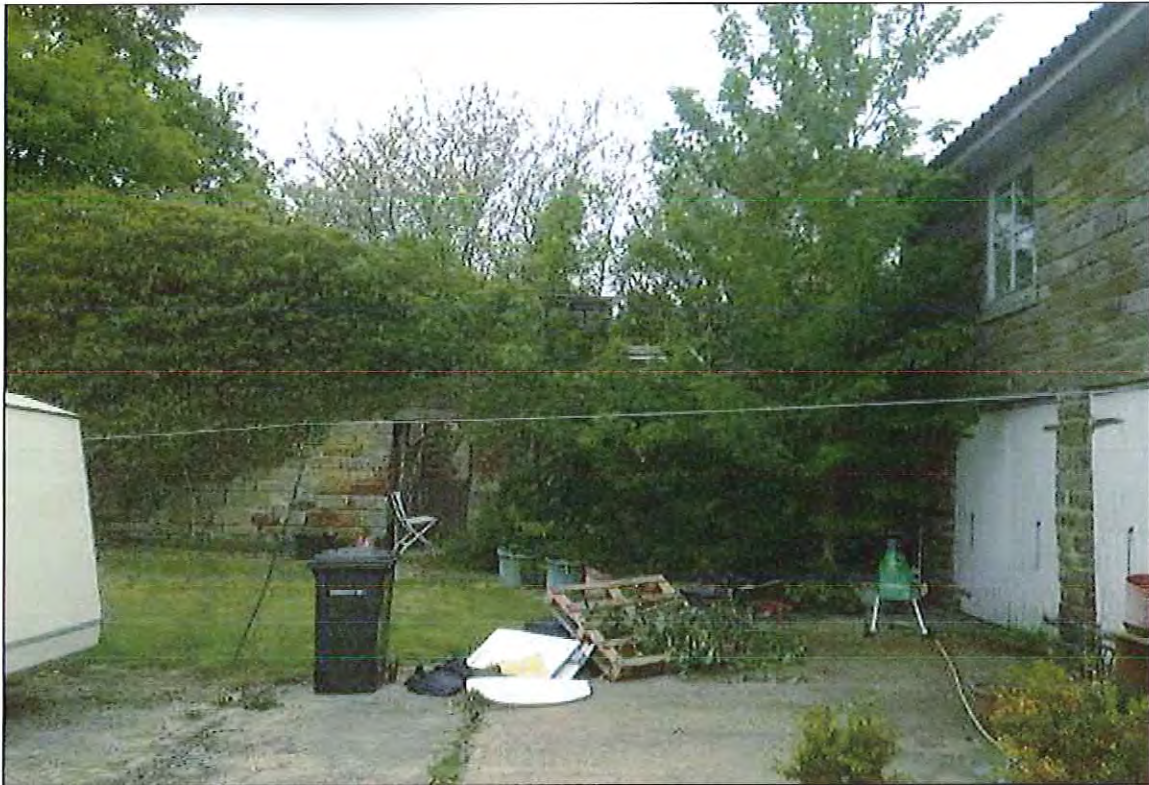
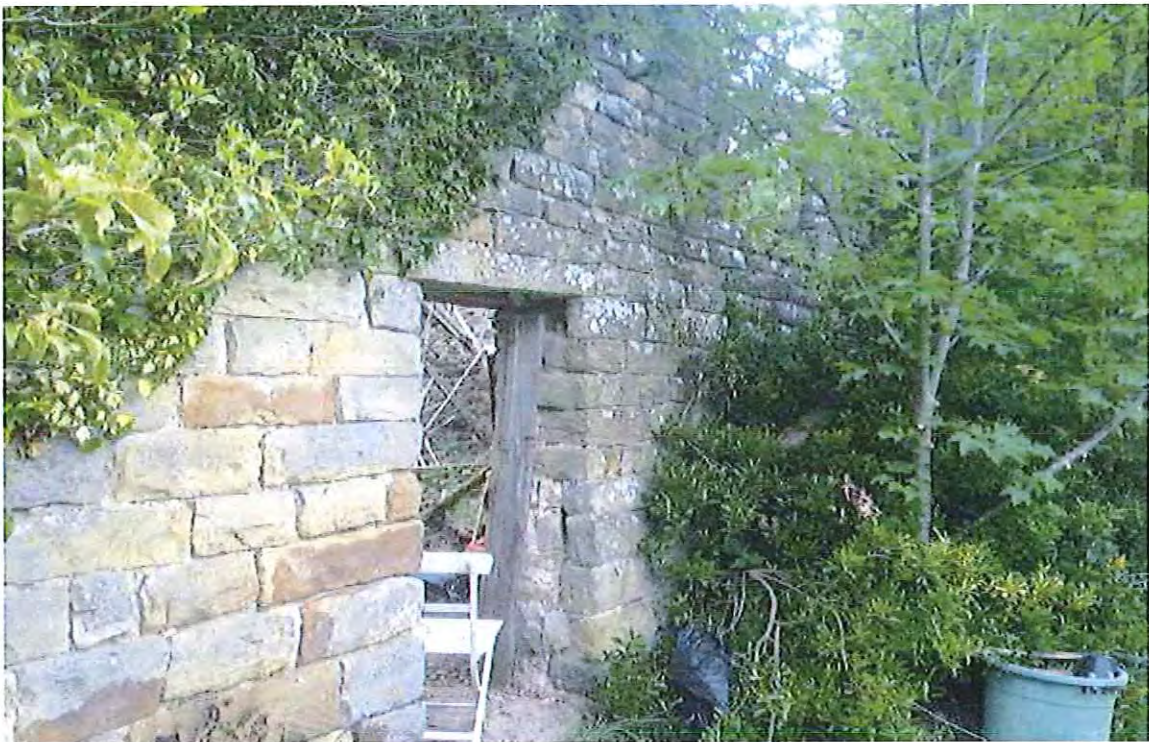
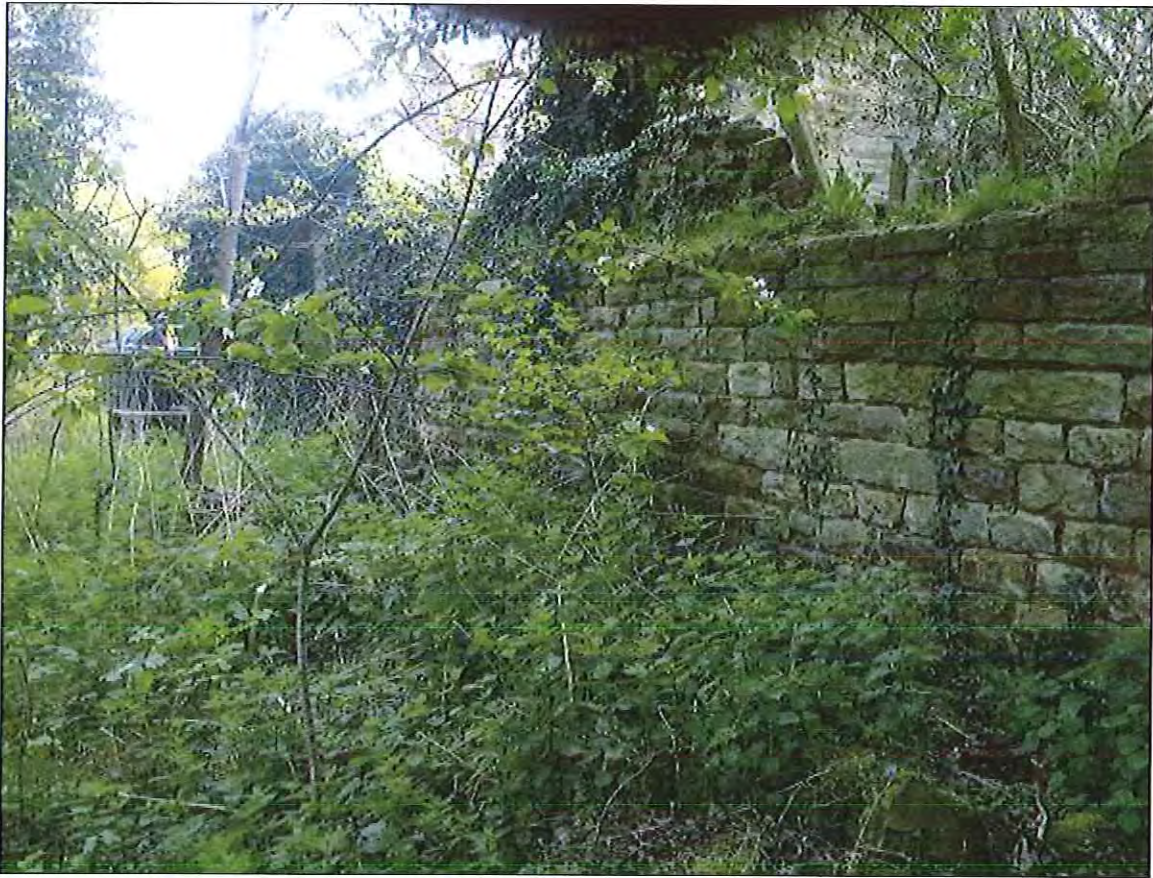
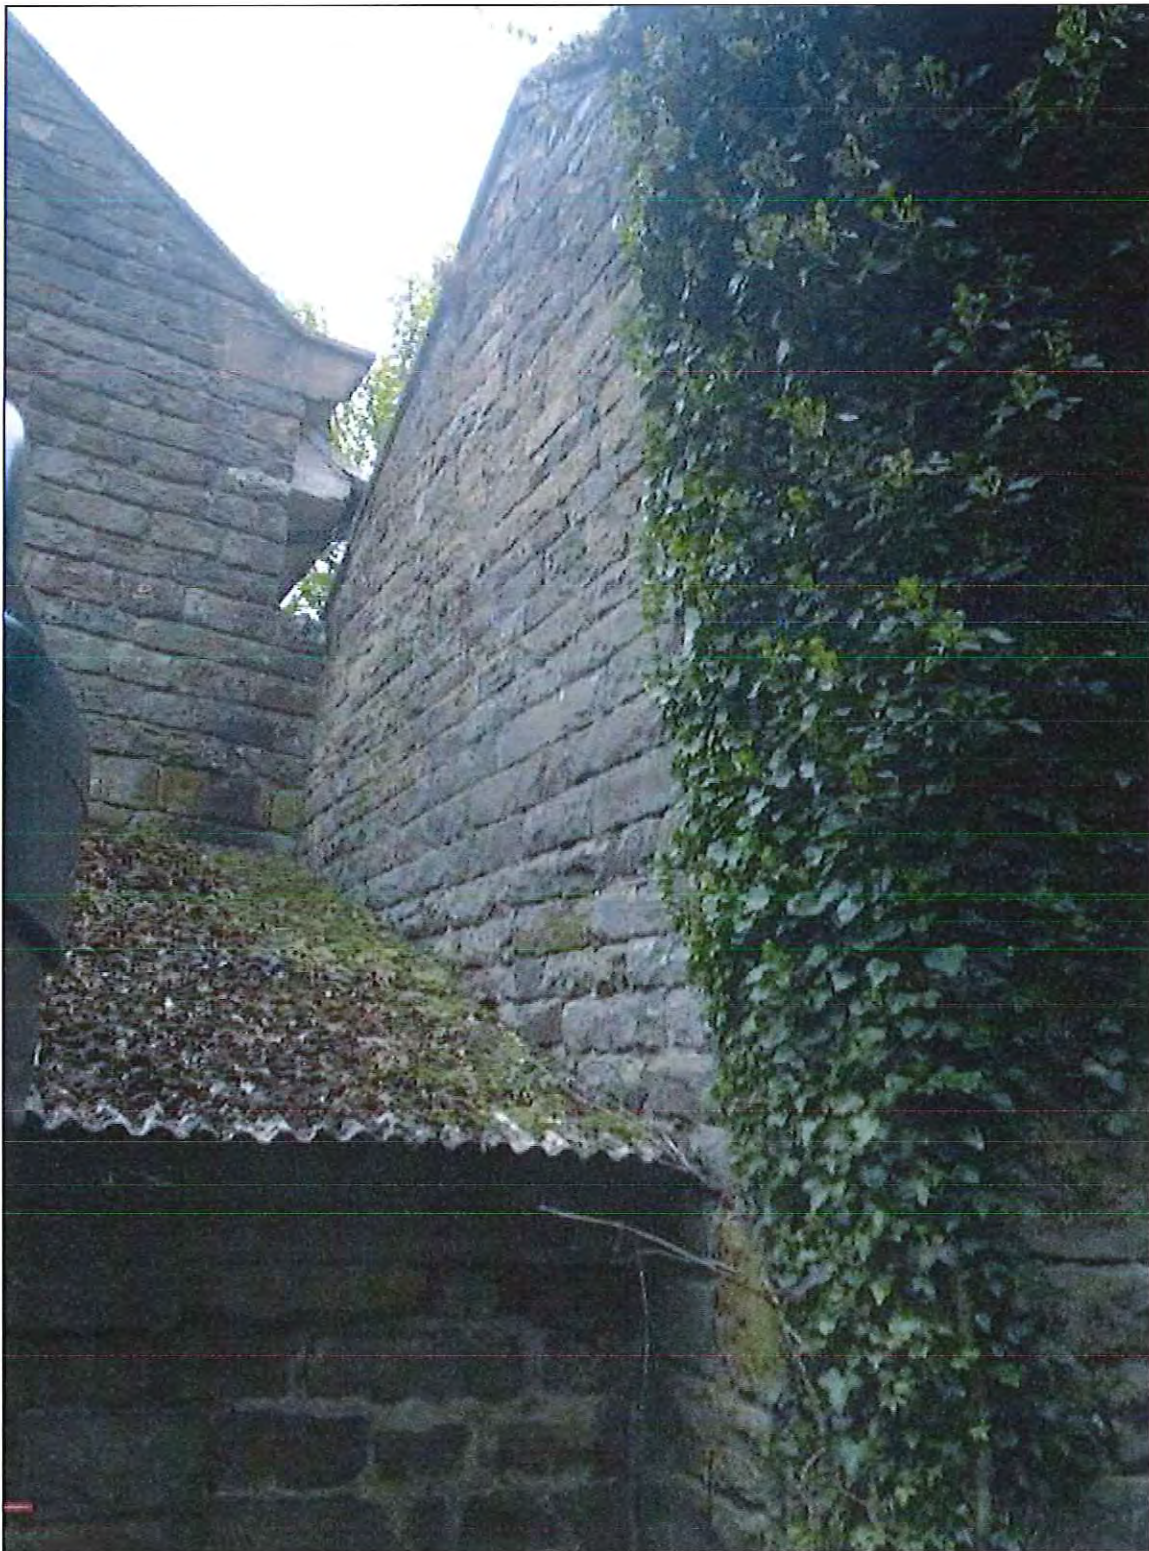
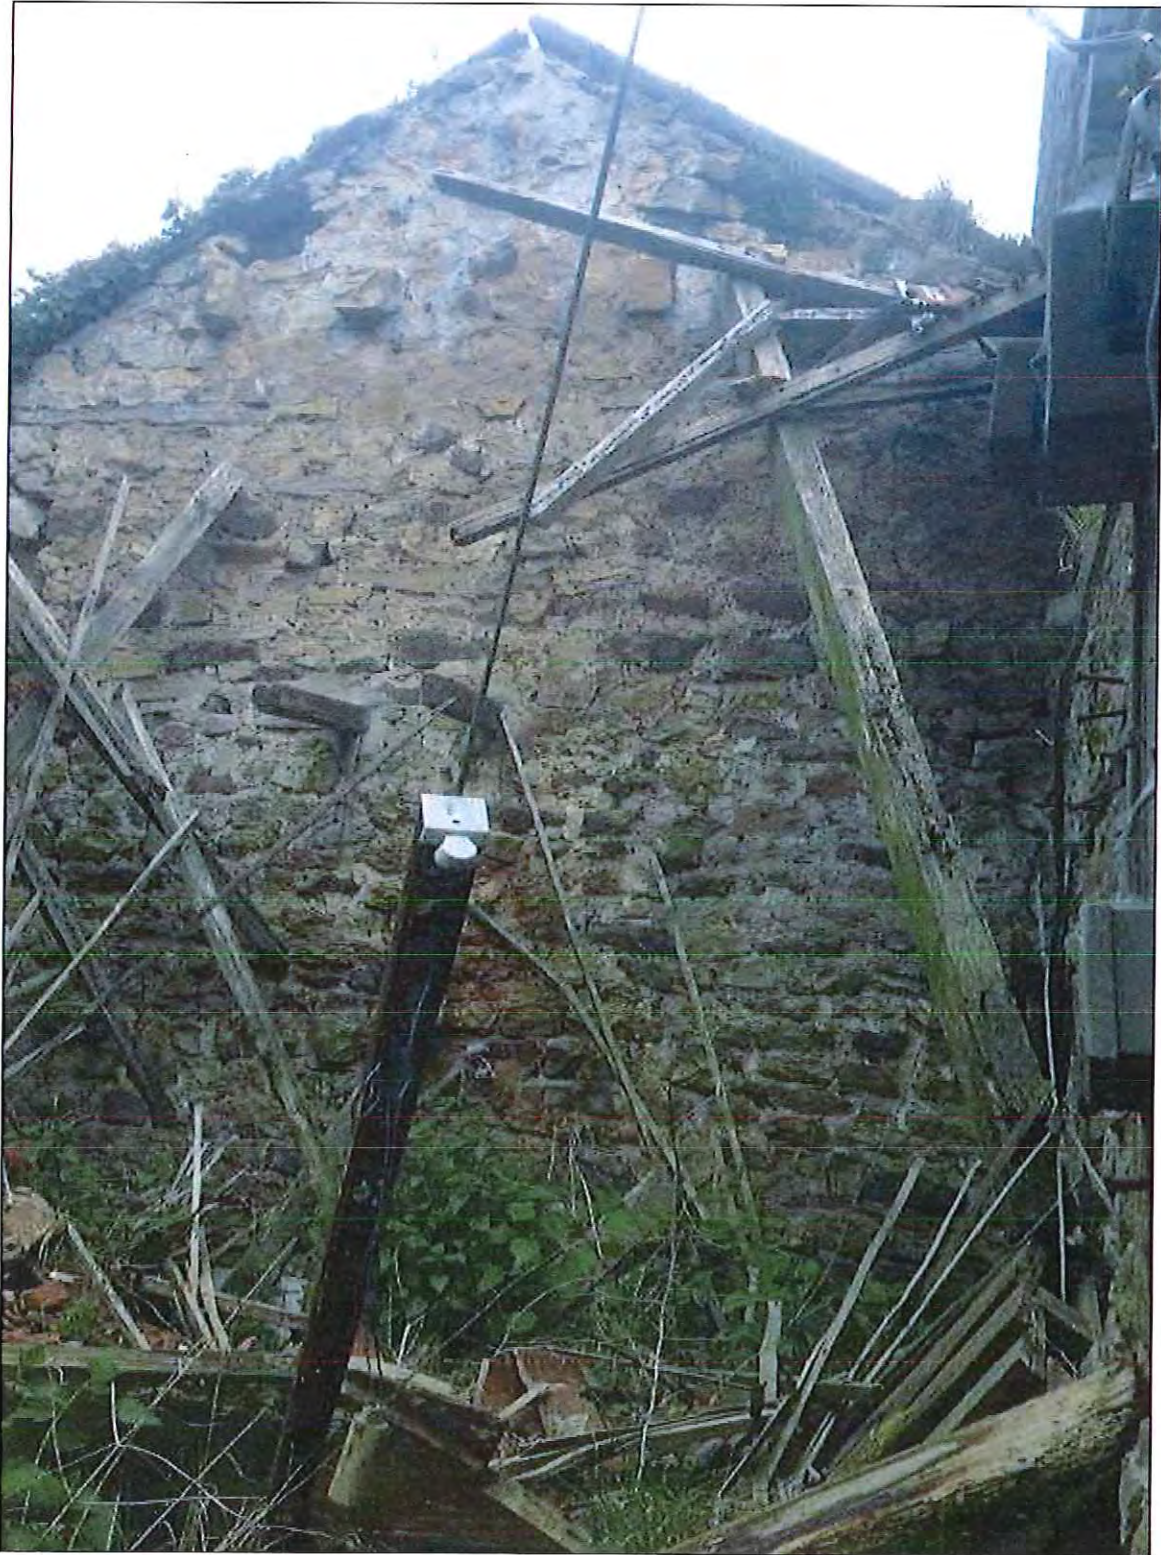
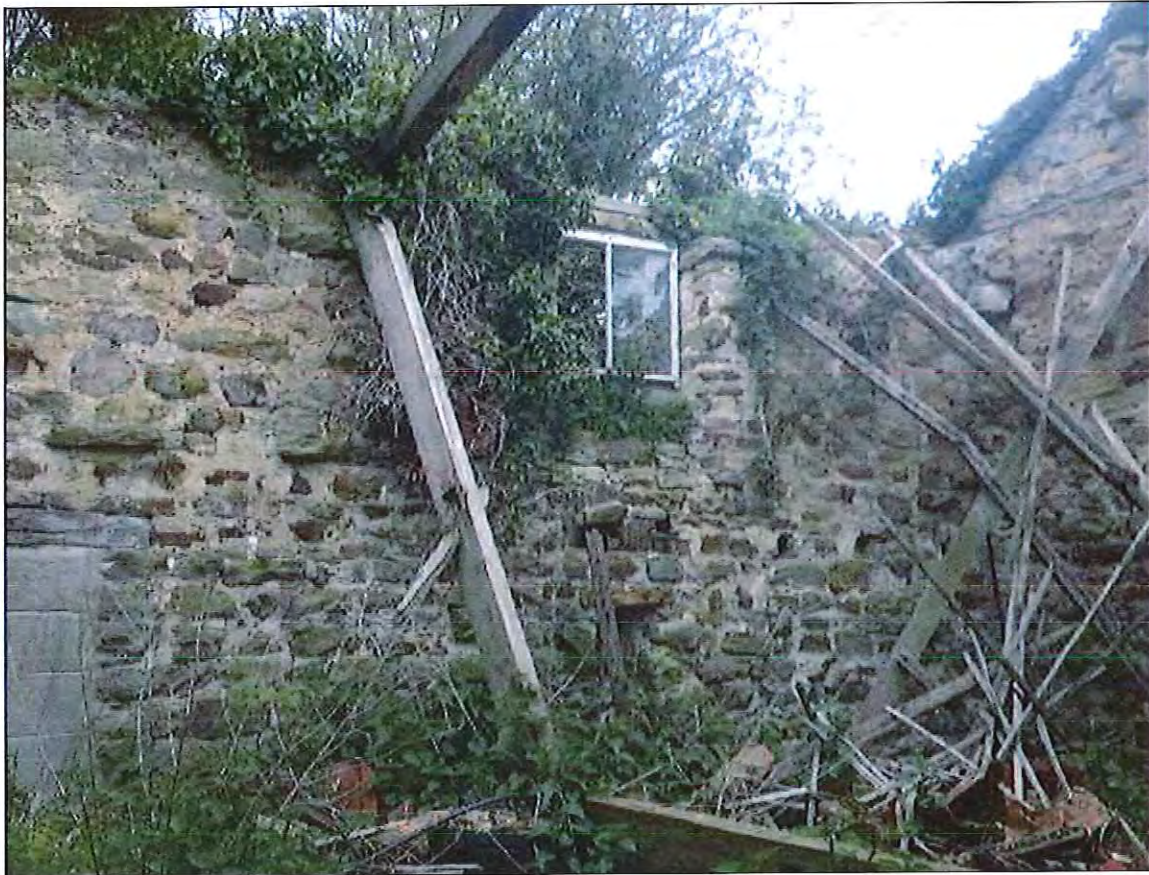
- 5.1.1 The south facing wall of Barn D can be seen in photographs 21 and 22. There is a lot of vegetation on the wall but it appears to be in reasonable condition.
- 5.1.2 The north facing wall can be seen in photograph 23. The lower part of the wall is in reasonable condition but the upper part is missing.
- 5.1.3 The east facing wall can be seen in photograph 24. The wall is in reasonable condition. The internal view on this wall can be seen in photograph 25.
- 5.1.4 The internal face of the north facing wall can be seen in photograph 26. It is in reasonable condition.
- 5.1.5 The party wall with Barn C can be seen in photograph 27. There is damage at the north west corner and a vertical crack in the wall.

- 5.2.1 The barn is in reasonable condition except for the damage on the upper section of the north facing wall and on the party wall with Barn C. It is suitable for conversion to a residential-related use without substantial rebuilding subject to the recommendations below.
- 5.2.2 The damaged part of the upper section of the north facing wall and the party wall with Barn C should be carefully rebuilt.
- 5.2.3 The general recommendations in Section 7 should be adhered to.
