**VISUAL INSPECTION OF RANGE OF BARNs AT
CALFTHWAITE FARM, CLOUGHTON
SCARBOROUGH**

MR. & MRS. McQUADE

**BY R. O. BIRDSALL M.Sc., M.I.C.E.
CHARTERED ENGINEER**

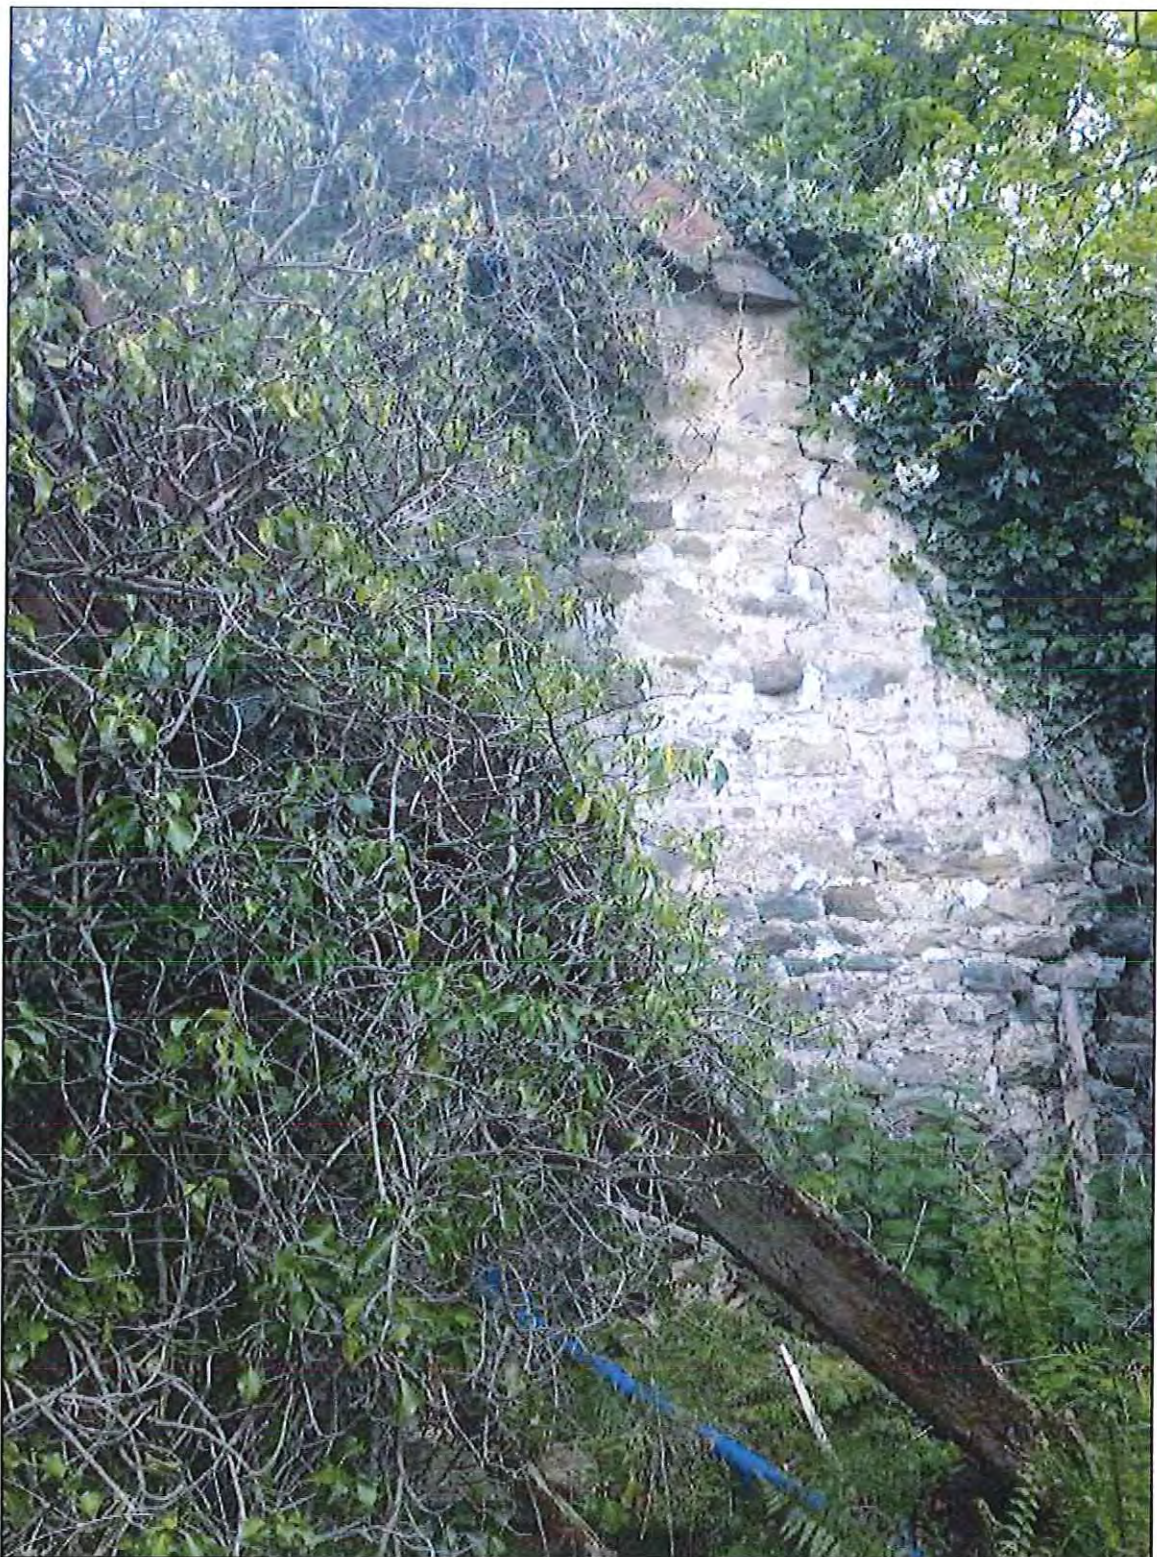
PHOTOGRAPH 27
CALFTHWAITE FARM, CLOUGH – BARN D

- 5.1.1 The south facing wall of Barn D can be seen in photographs 21 and 22. There is a lot of vegetation on the wall but it appears to be in reasonable condition.
- 5.1.2 The north facing wall can be seen in photograph 23. The lower part of the wall is in reasonable condition but the upper part is missing.
- 5.1.3 The east facing wall can be seen in photograph 24. The wall is in reasonable condition. The internal view on this wall can be seen in photograph 25.
- 5.1.4 The internal face of the north facing wall can be seen in photograph 26. It is in reasonable condition.
- 5.1.5 The party wall with Barn C can be seen in photograph 27. There is damage at the north west corner and a vertical crack in the wall.

- 5.2.1 The barn is in reasonable condition except for the damage on the upper section of the north facing wall and on the party wall with Barn C. It is suitable for conversion to a residential-related use without substantial rebuilding subject to the recommendations below.
- 5.2.2 The damaged part of the upper section of the north facing wall and the party wall with Barn C should be carefully rebuilt.
- 5.2.3 The general recommendations in Section 7 should be adhered to.

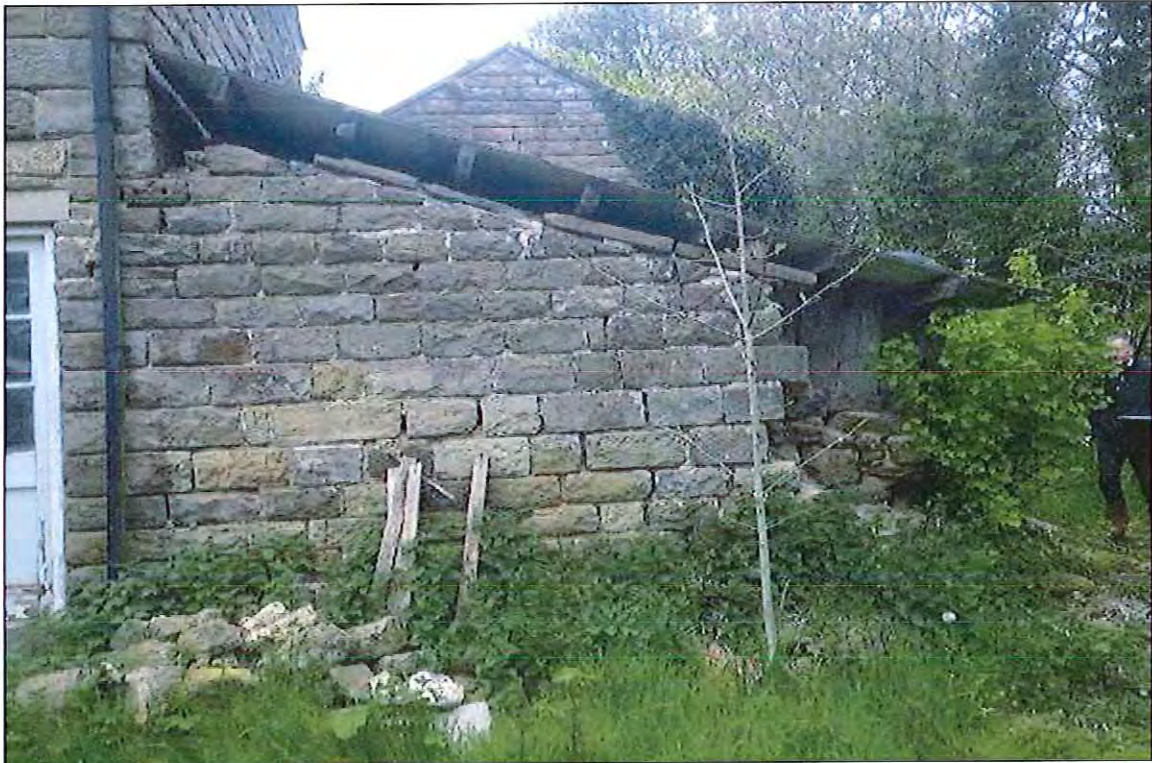
PHOTOGRAPH 28
CALFTHWAITE FARM, CLOUGH – BARN E

- 6.1.1 The east facing wall of Barn E can be seen in photograph 28. The wall is in reasonable condition except at the north east corner.
- 6.1.2 The north facing wall can be seen in photograph 29. The wall is in reasonable condition.

- 6.2.1 The barn is in reasonable condition except for the damage at the north east corner. It is capable of conversion to a residential-related use without substantial rebuilding, with only the damaged north east corner requiring rebuilding works.
