INSPECTION OF 21 EGTON ROAD, AISLABY

Mr. & MRS. CATLEY

**BY R. O. BIRDSALL M.Sc., M.I.C.E.
CHARTERED ENGINEER**

- 1.1 We confirm that we made an inspection of 21 Egton Road, Aislaby (see photograph 1) on 10th May 2017.
- 1.2 The inspection and report is to assess the structural capability of the structure with a view to making significant alterations.
- 1.3 The external walls consist of 250 mm cavity walling with brick outer leaf and block inner leaf. The roof is pitched with timber rafters and purlins clad with red clay pantiles.

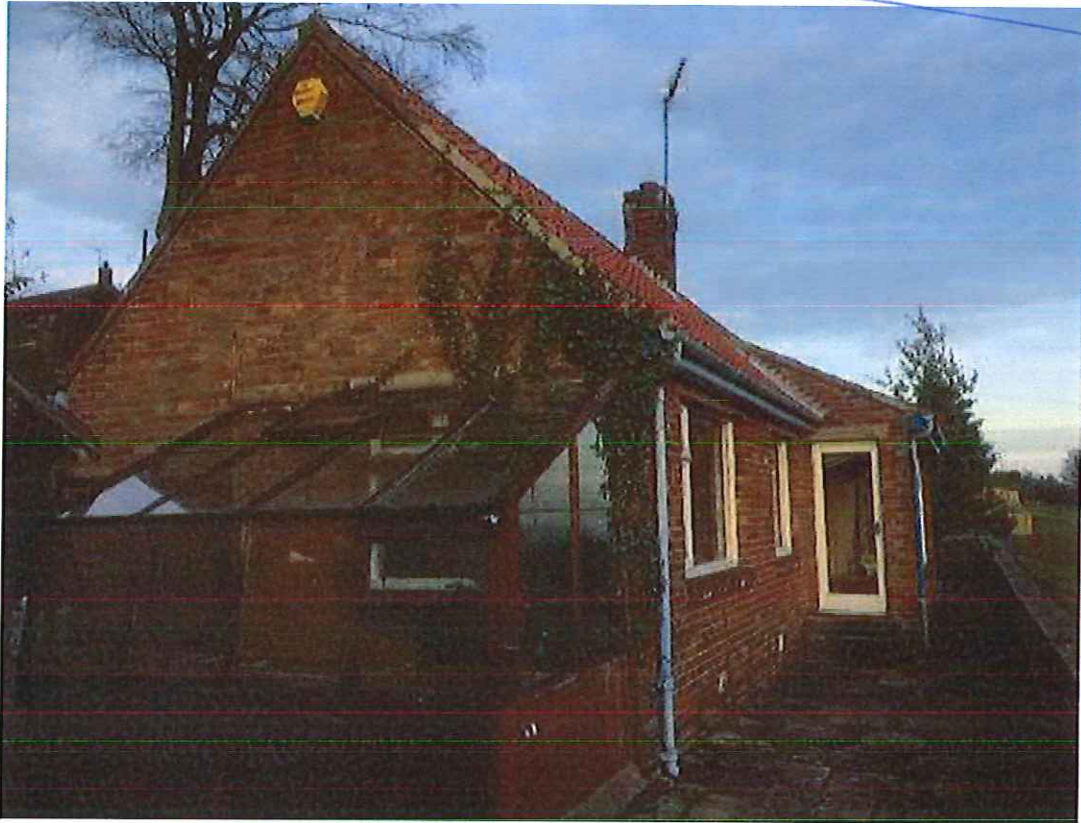
PHOTOGRAPH 1
21 EGTON ROAD, AISLABY

- 2.1 The west facing wall is in good condition, see photograph 1.
- 2.2 The south facing wall is in good condition, see photograph 2 and 3.
- 2.3 The north facing wall is in good condition, see photograph 4 and 5.
- 2.4 The east facing wall is in reasonable condition, see photograph 6 and 7. However there is cracking to the lintel at the north-east corner of the building, see photograph 8.
- 2.5 We have not inspected woodwork or other parts of the structure which are covered, unexposed or inaccessible and we are therefore unable to report that any such part of the property is free from defect.

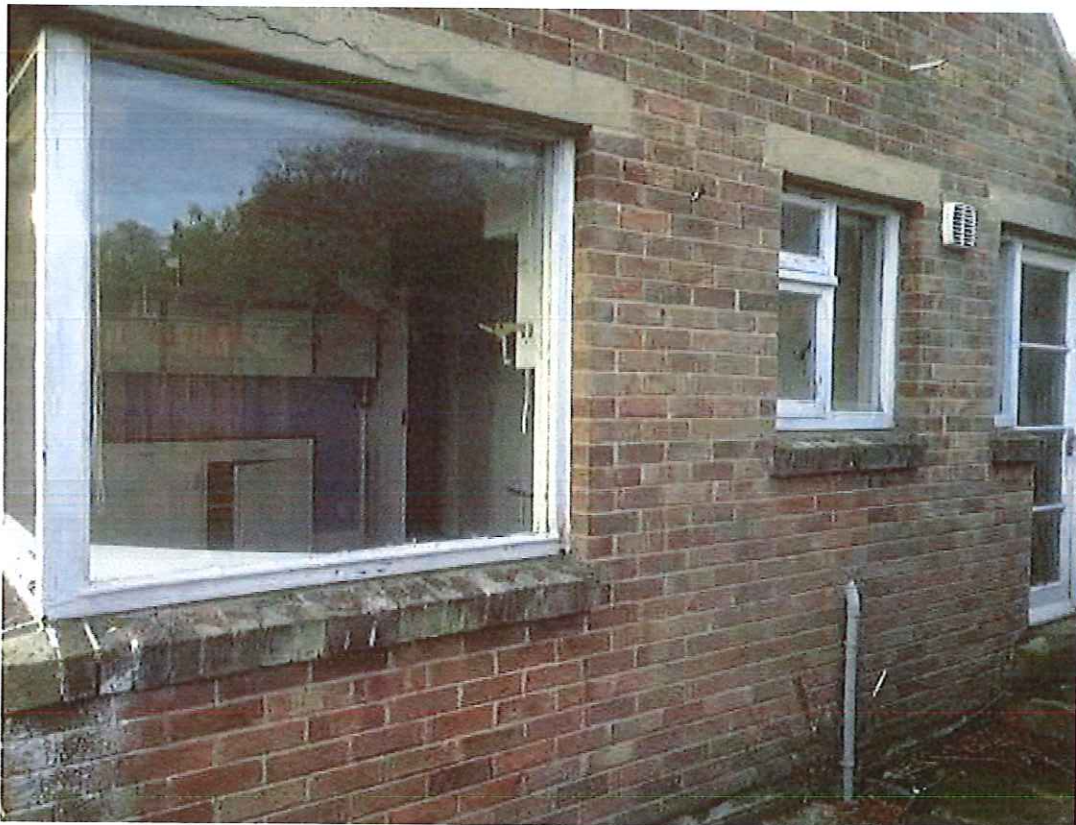
PHOTOGRAPH 6

- 3.1 The property is considered to be satisfactory in its present condition although the windows on the north-east corner and south-east corner of the building are possibly giving rise to some slight movement due to the lack of any masonry on the corners. The existing footings on the north, east and west external walls are fairly shallow but seem to be supporting the existing walling in a satisfactory manner.

- iii/ The windows on the north-east and south-east corners of the building should be removed and replaced with cavity walling to match the existing.
