Structural report
on
outbuildings to the side of
10 South End
Osmotherley
North Yorkshire
DL6 3BL

D F Rawcliffe

29th September 2017

STRUCTURAL REPORT ON OUTBUILDINGS TO THE SIDE OF
10 SOUTH END, OSMOTHERLEY, NORTH YORKSHIRE DL6 3BL

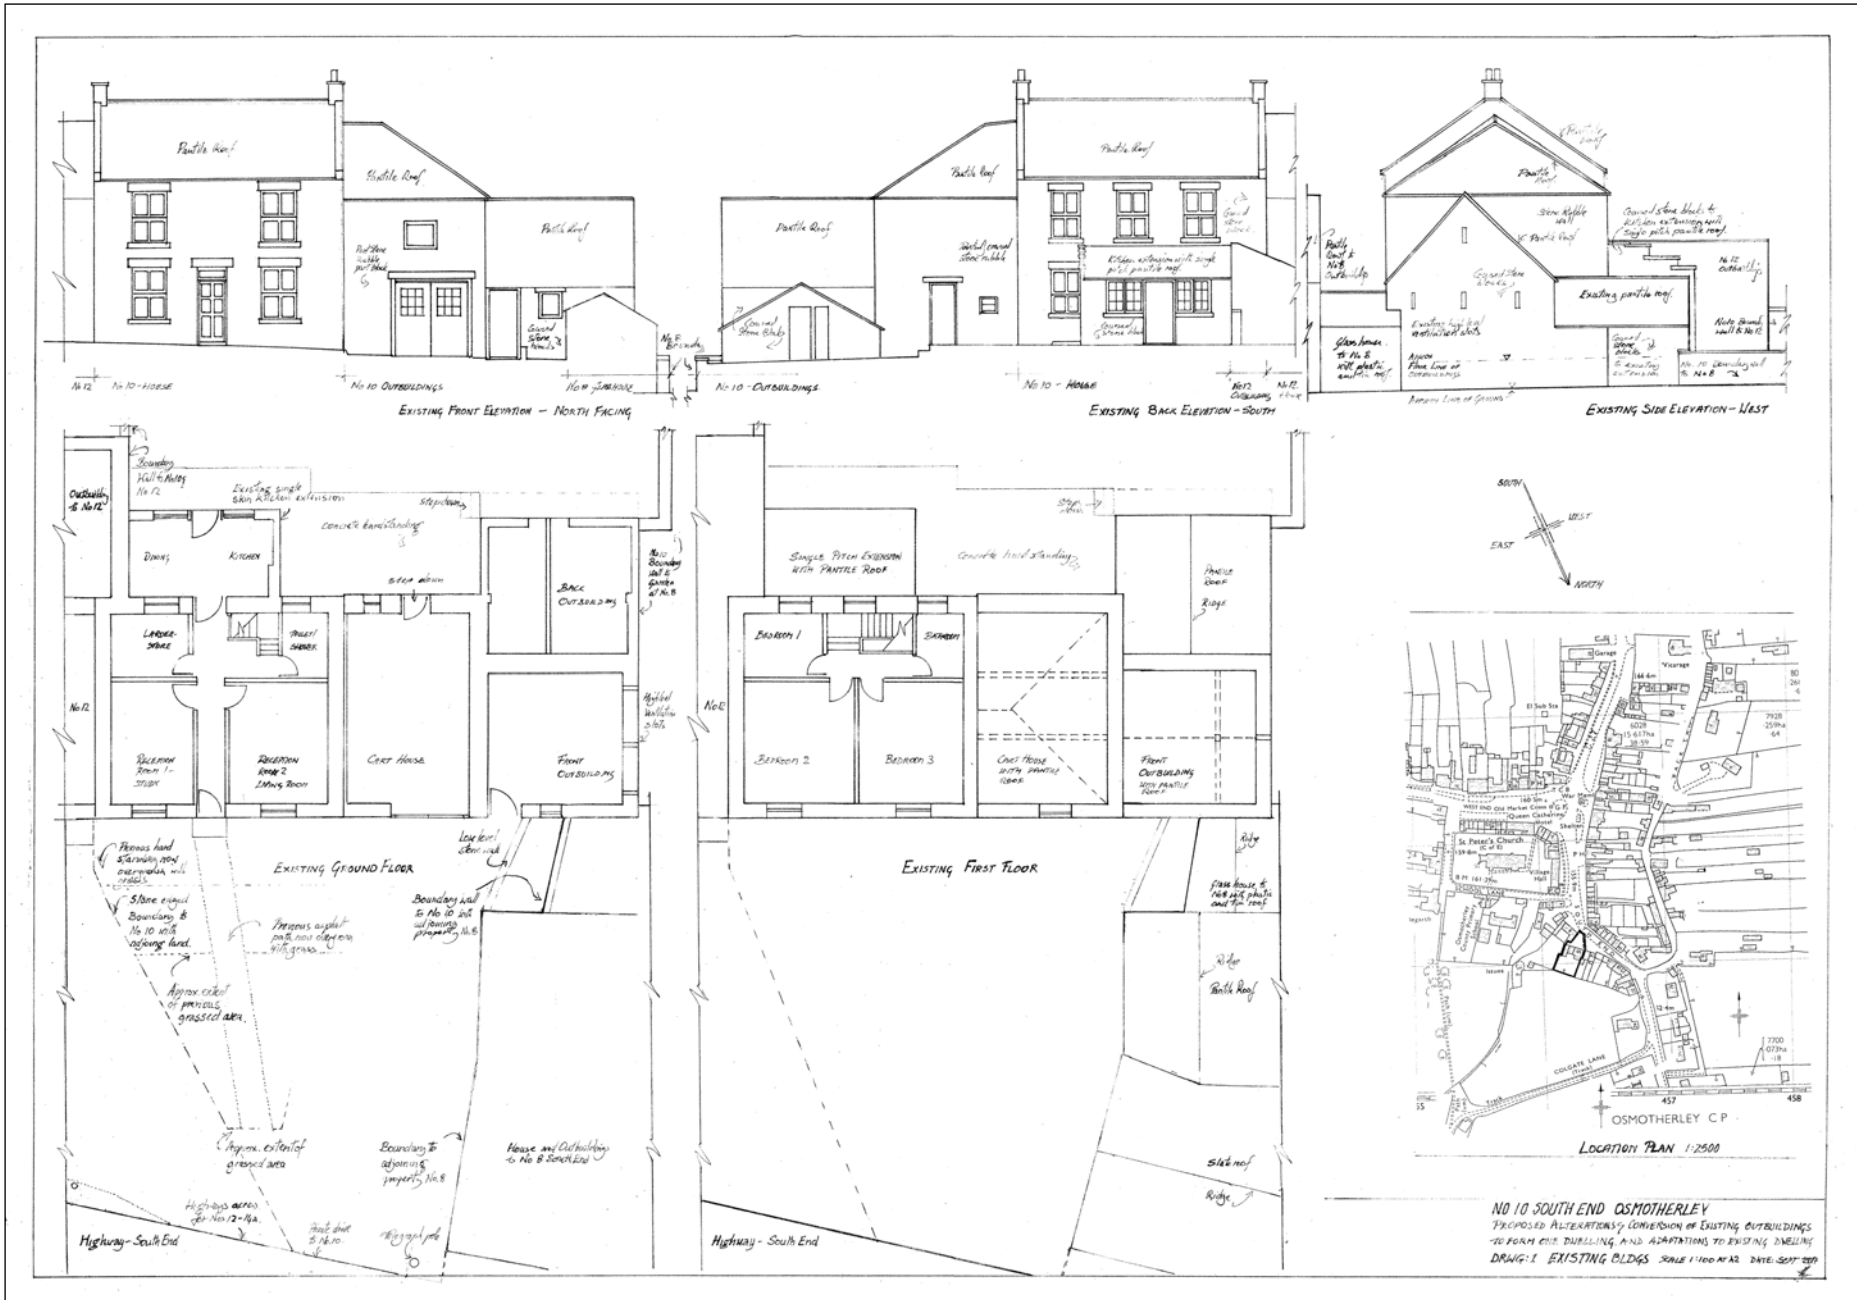
APPENDIX A

The outbuildings are all duo pitch pantile covered roofs with loose rafters, purlins and trusses as indicated on the existing plan Drawing No. 1 in Appendix A.
