# **JK ARBORICULTURE**

## **Arboricultural Survey & Implication Study**

### **Hillside Farm, Littlebeck, Whitby**

February 2018

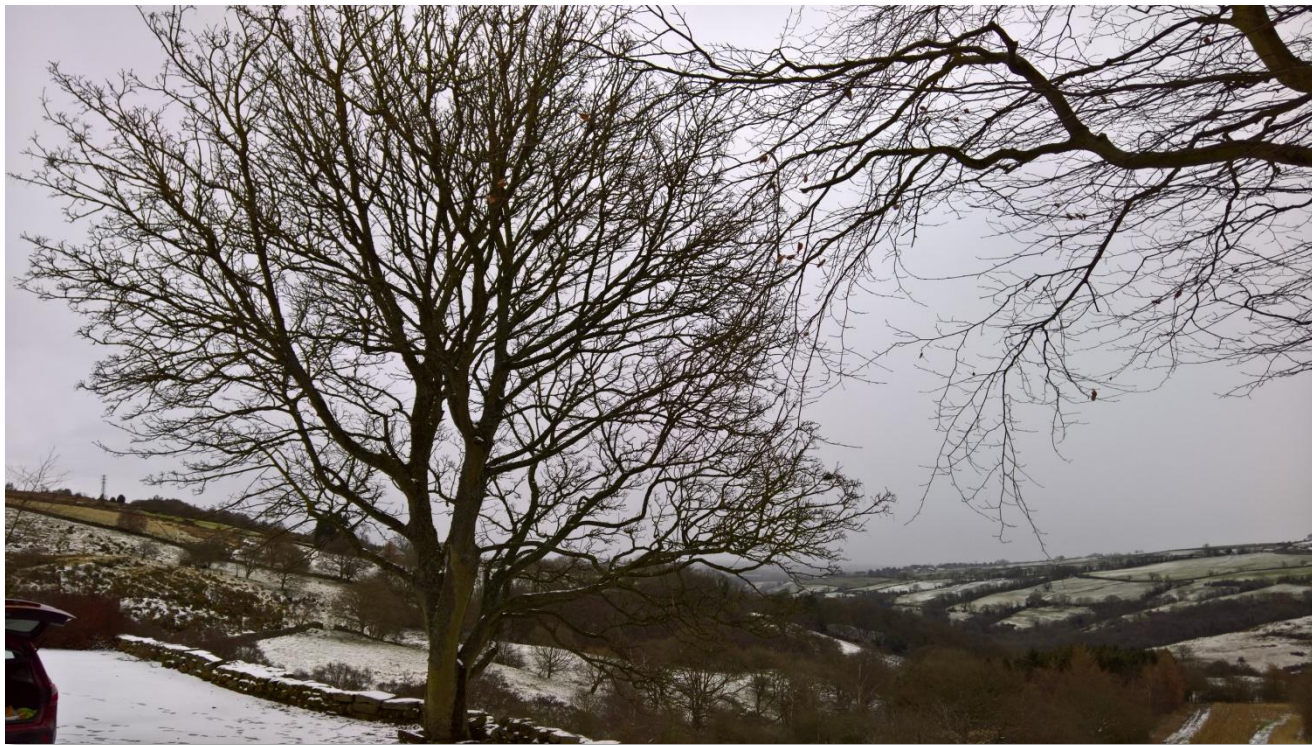
T1 Sycamore

A maturing fairly symmetrical tree in good condition somewhat stunted by its exposed location. Growing at the south eastern end of the forecourt almost adjacent to the low dry- stone wall.

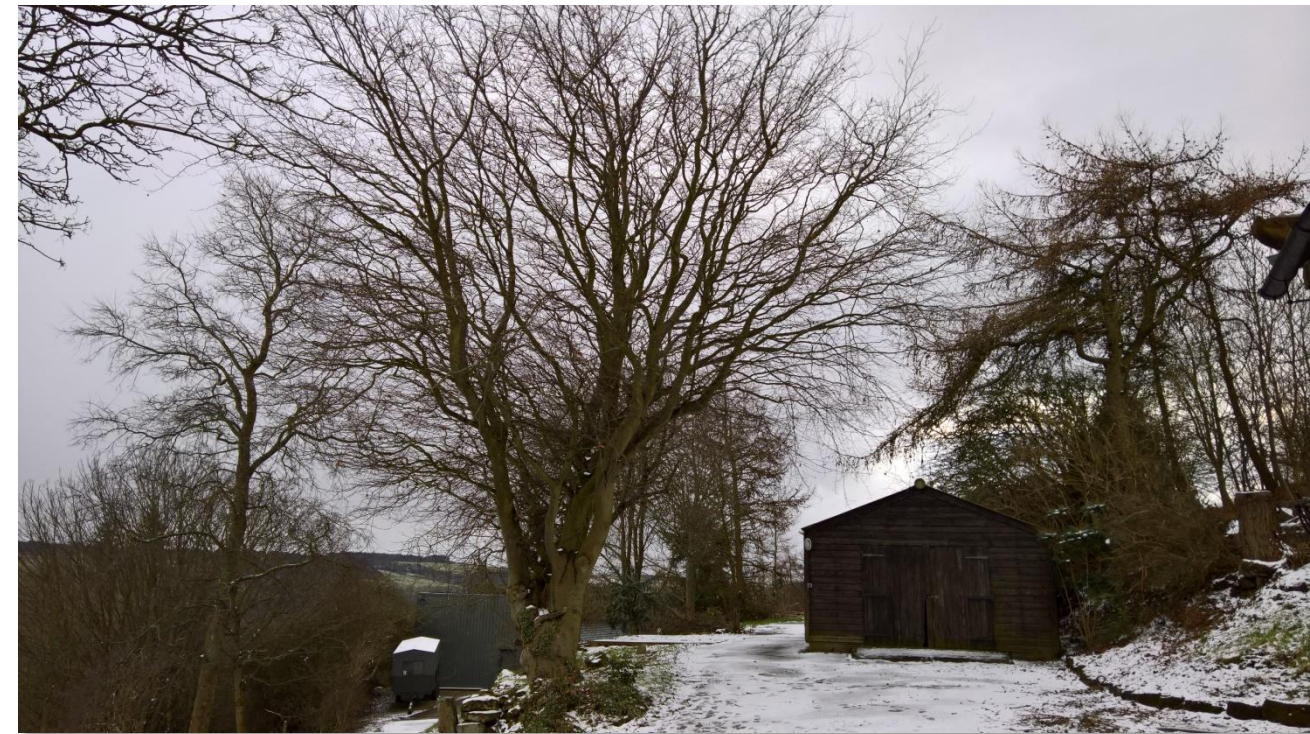
T2 Copper Beech

A maturing tree in fair condition having a multi-stemmed congested crown emerging from a short main trunk. Evidence of the removal of three main boughs several years ago where large wounds have partially healed. Growing on the edge of the elevated area adjacent to the access to the farm. May be the remnant of a former hedge on the site.

Piping for the new heating system from the converted shed to the south west of this tree could potentially run through the outer edge of the RPA for this tree.

Ensure that the alignment of the piping runs outside of the limit of the RPA.

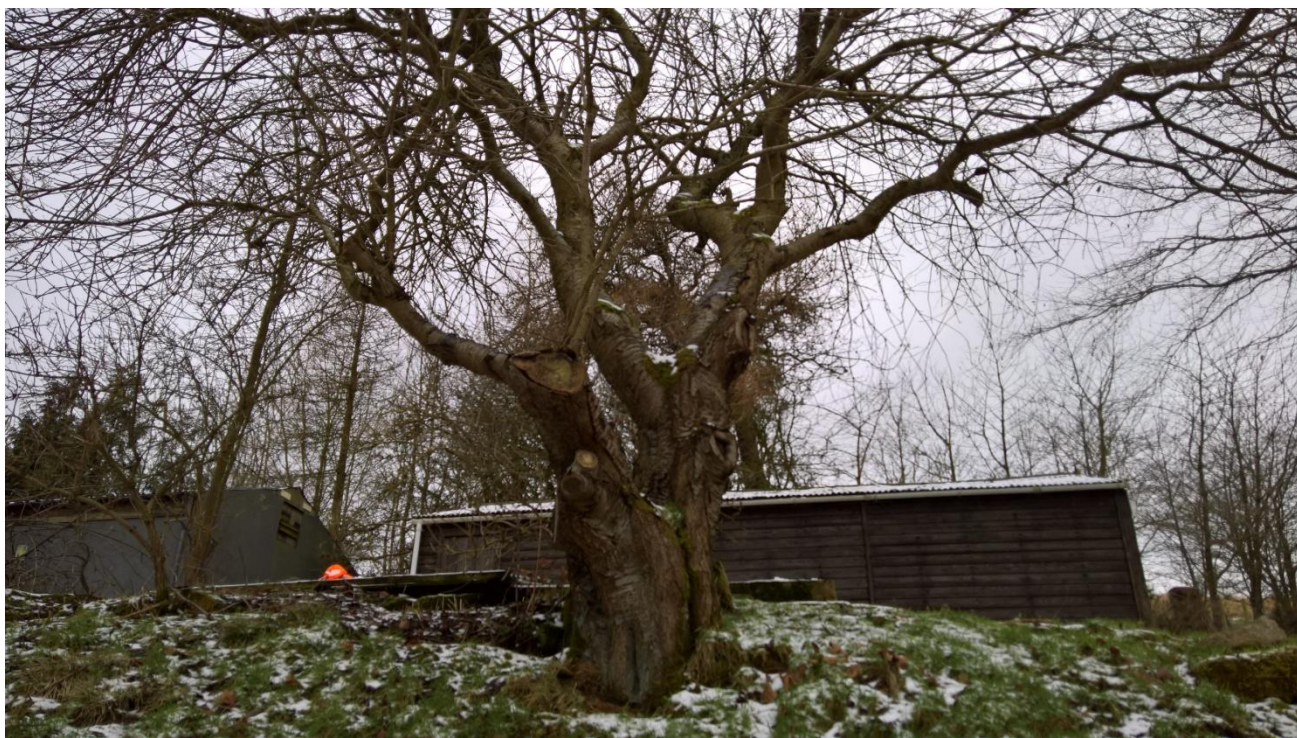
T3 Cherry

An over-mature tree in only fair structural condition growing on sloping land and to the south east of T2. The tree is formed by two main co-joined trunks. This tree has been heavily pruned in the past severing large limbs resulting in large scars where decay has set in.

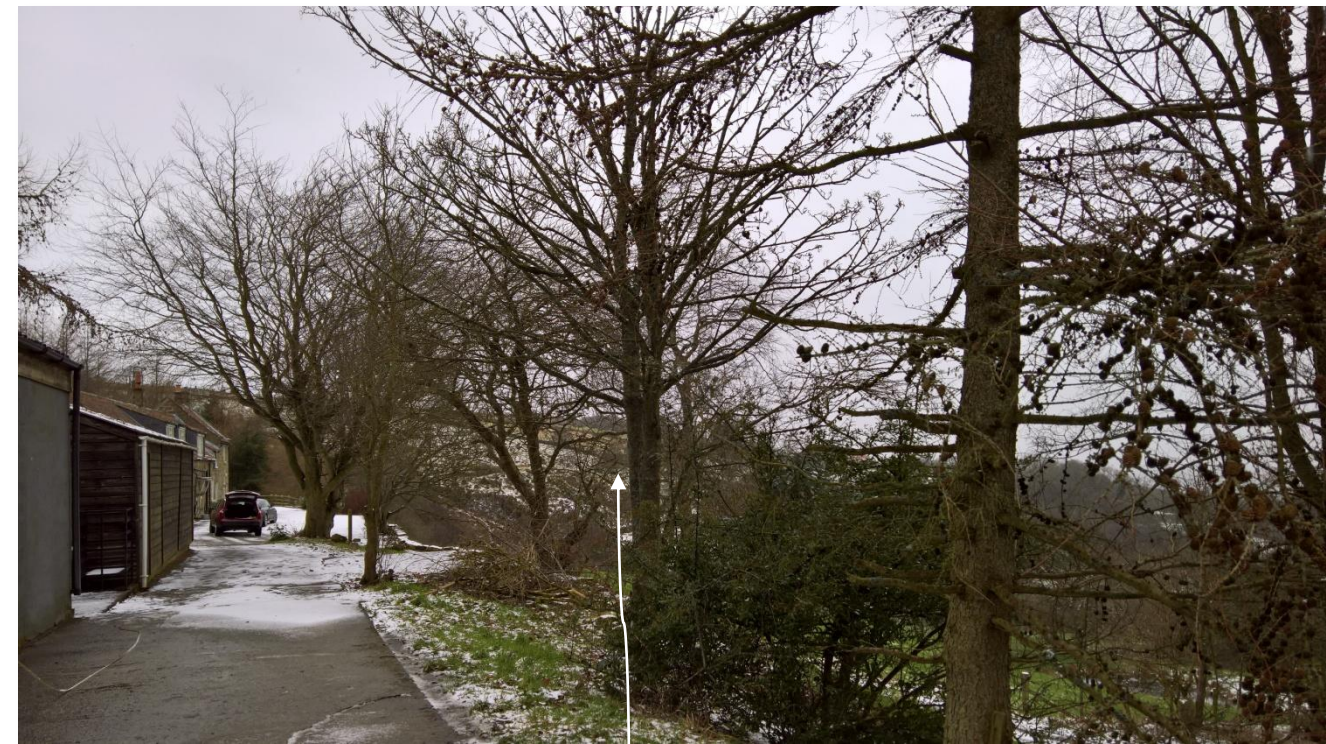
T4 Sycamore

A medium sized semi-mature tree growing along the same alignment and to the south east of T3 and formed by two co-dominant stems. A narrow crown in good condition.

T4 will only be required to be fenced along the alignment of grassed area as its RPA is within the grassed area it is growing in. The proposed alignment for protective fencing is annotated on the survey plan at Appendix 3

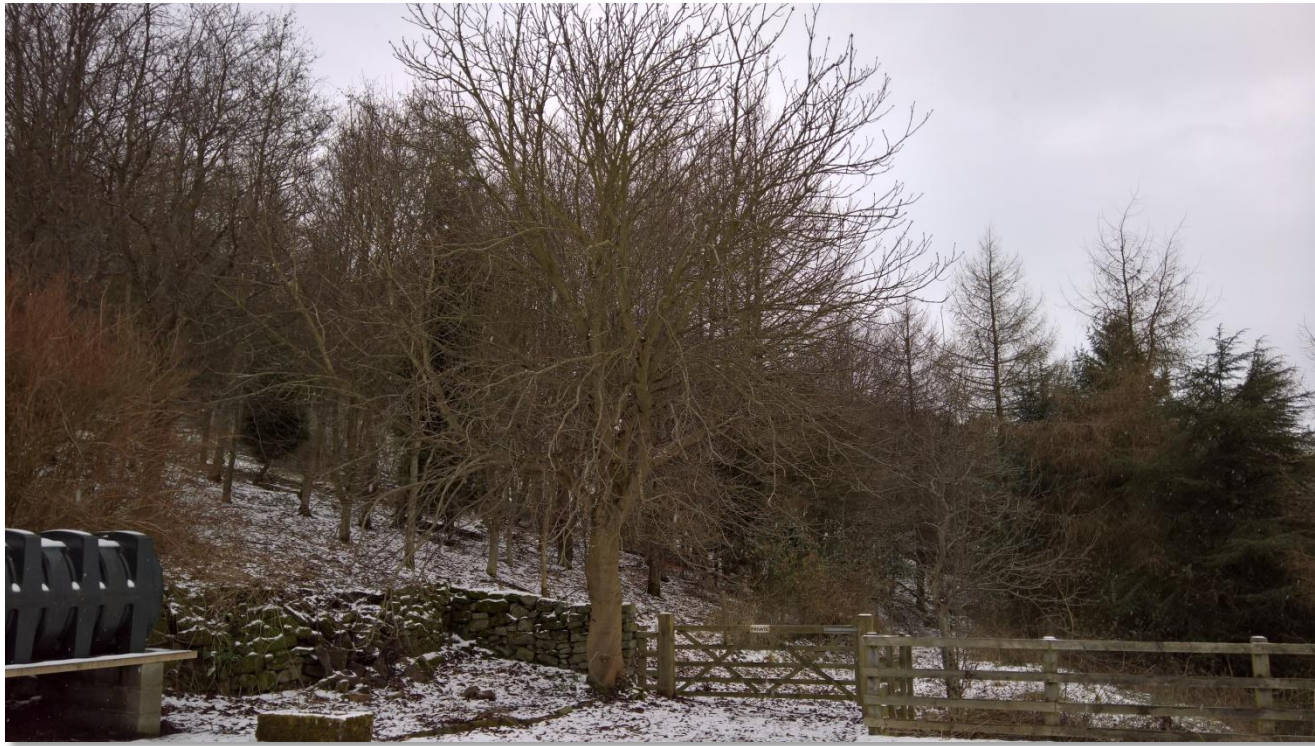
**T5 Horse Chestnut and plantation beyond**

A semi - mature tree growing at the north western end of the site. Congested crown but in a healthy condition. Some cracking of the bark at the base of the crown possibly due to twisting under wind stresses.

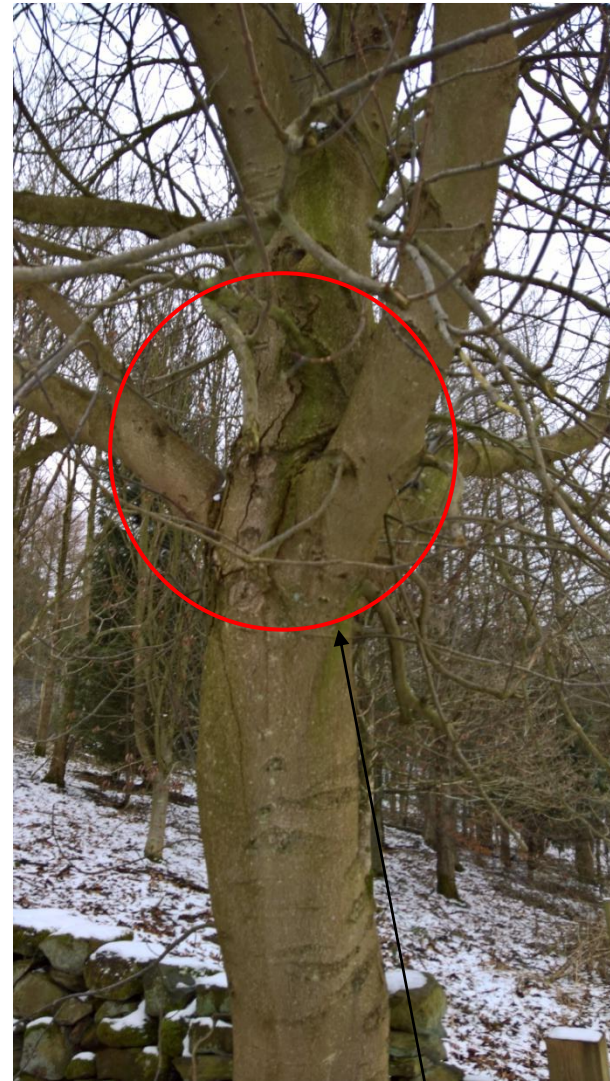
**Minor cracking in bark at base of crown**
