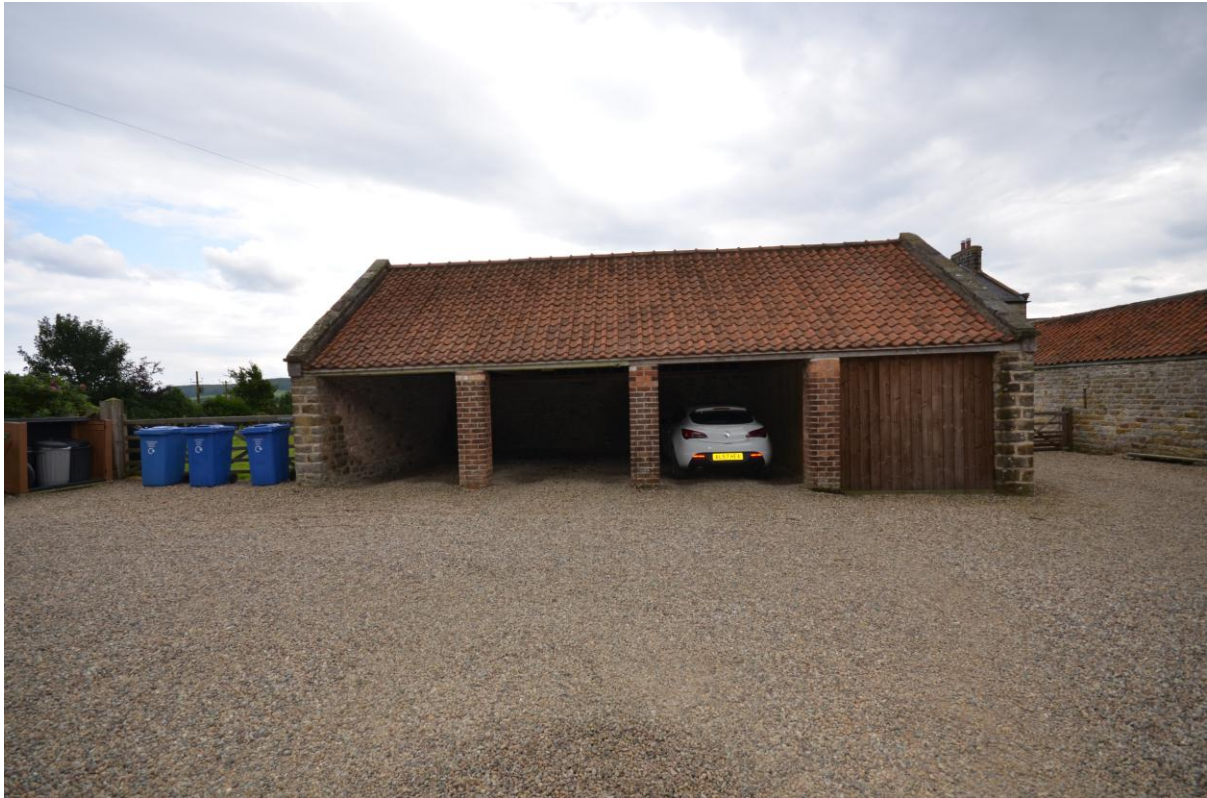
1. North elevation of Rowan Barn. This building has been re-roofed and refurbished in the last few years.
2. North elevation of Rowan Barn.

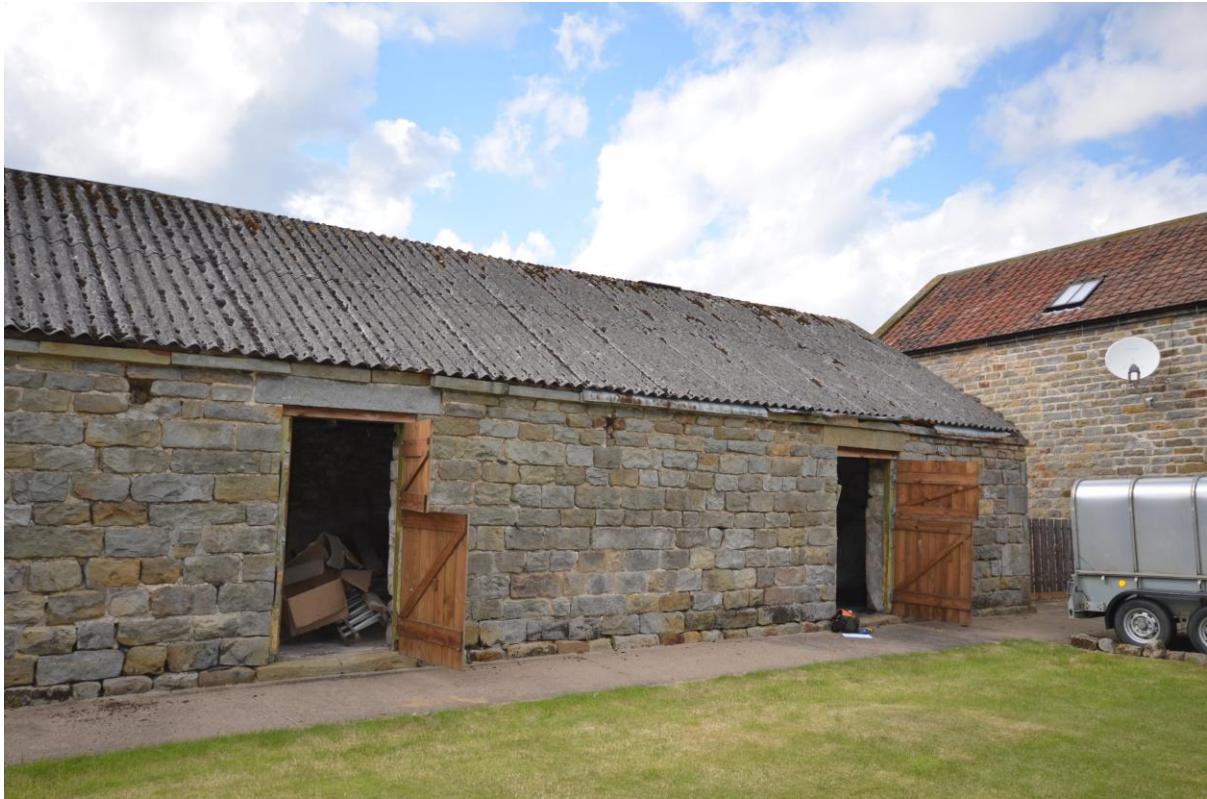
3. East elevation of Mulberry Barn, an asbestos roof was fitted probably in the 1960's.
4. West elevation of Mulberry Barn with an asbestos roof and a pantiled lean-to.

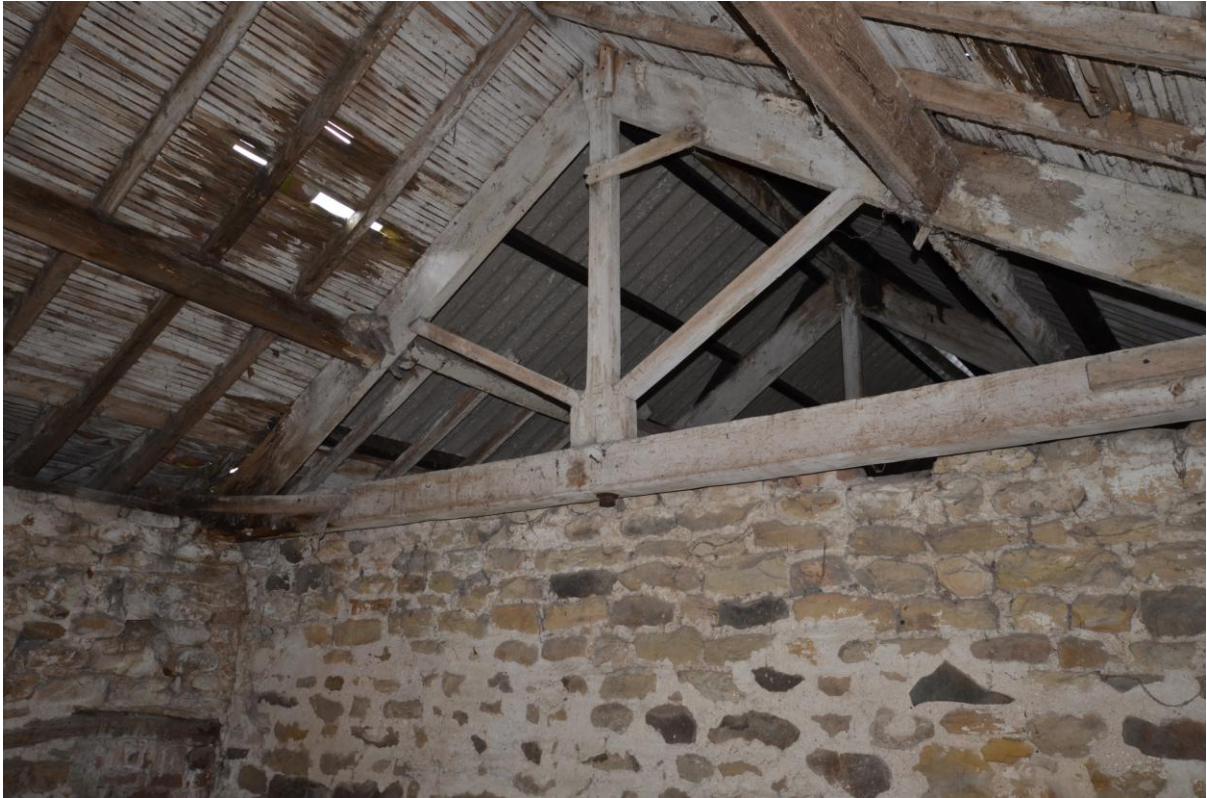
5. Internal view at the junction between Mulberry Barn and Hornbeam Barn showing the existing king post trusses which are generally in sound condition although there is evidence of damp penetration.
6. General view across the courtyard to Hornbeam Barn and Mulberry Barn.

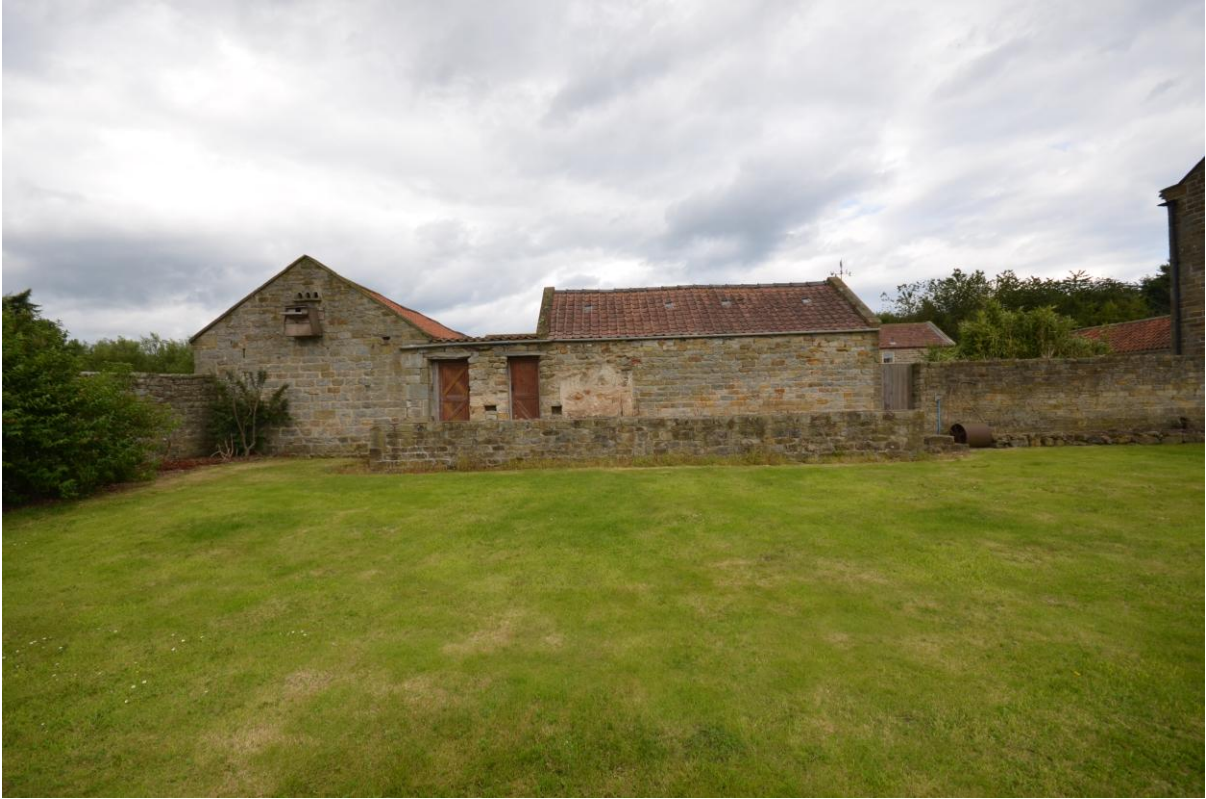
9. South elevation of Hornbeam Barn, a greenhouse has been removed in the past leaving a plinth wall.
