VISUAL STRUCTURAL SURVEY

**RAITHWAITE HALL
RAITHWAITE HALL ESTATE
SANDESEND ROAD WHITBY**

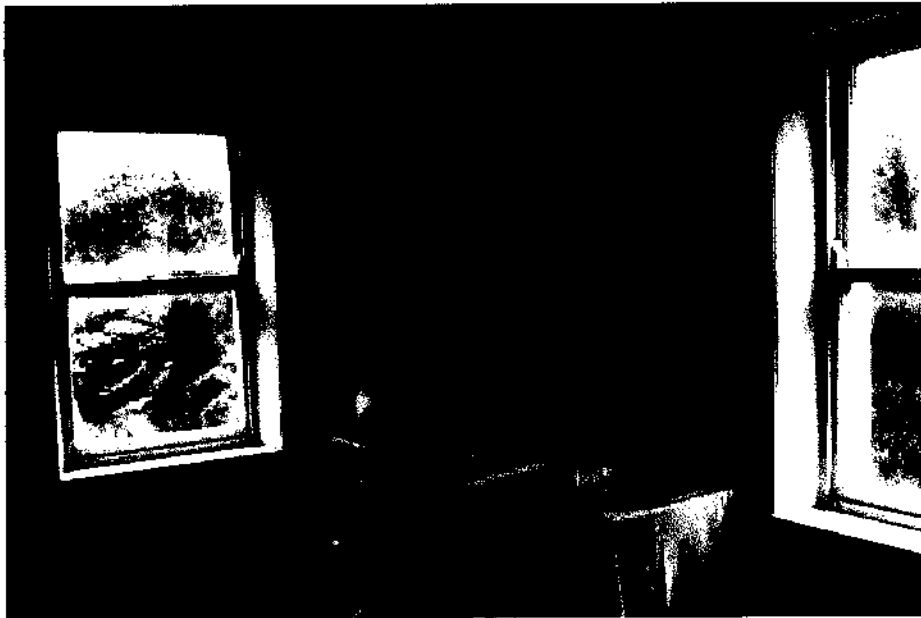
14. Damp to south elevation at 2nd floor level
