PROPOSED CONVERSION

OF OUTBUILDINGS

LADYSMITH FARM

Re: Proposed Conversion of Outbuildings
Ladysmith Farm, Stoupe Brow, Ravenscar

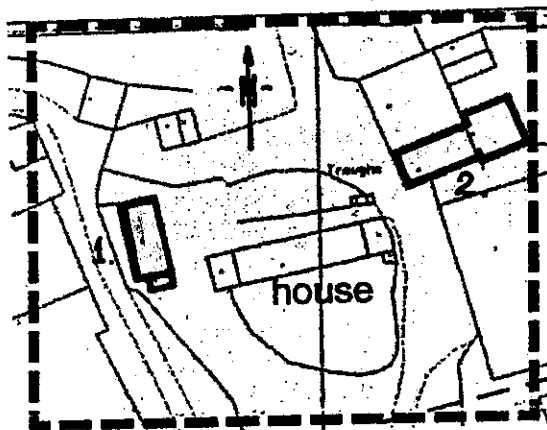
As requested, I carried out an inspection of the outbuildings, identified below, on the 12th November 2009 to assess the structural condition of the buildings
