Bat Building Assessment

Hearn Head House Farm,
Troutsdale
North Yorkshire

Report Reference: CL611/005/001

Prepared by
Clear Environmental Consultants Limited
June 2010

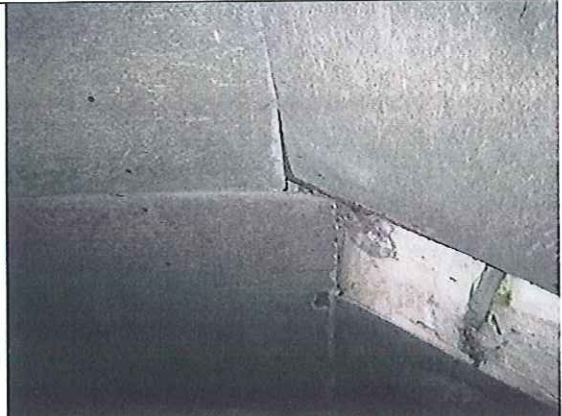
B2b was a single storey, stone built building with a pitched clay tiled roof with roof lights and gable ends. A small roof void and chipboard underboarding was present. No access was available into the roof void. Potential bat access points were present in the form of slipped roof tiles and missing mortar. No evidence of bat occupation was recorded during the survey. Swallows were recorded nesting within B2b.

Photo 7: B2b interior showing underboarding

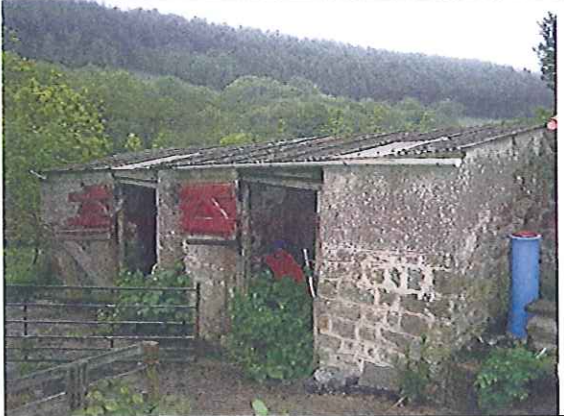
Photo 8: B3 exterior

B3 was a single storey, stone built building with a flat corrugated asbestos roof with roof lights. No roof void was present and the wooden beams were exposed. Potential bat access points included the open doors. No evidence of bats was observed in association with the building and bat roosting potential was considered to be low.

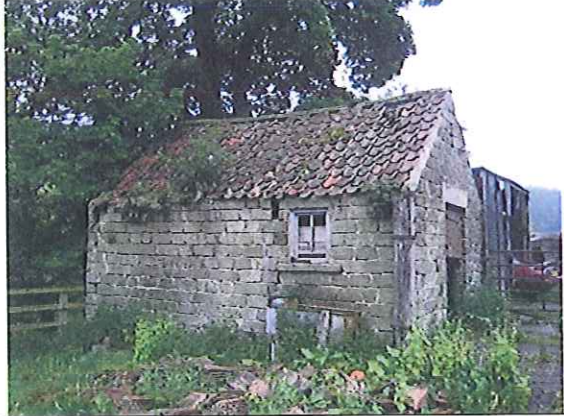
Photo 10: B4a exterior

B4a was a single storey, stone built building with a pitched clay tiled roof and gable ends. No roof void was present. Wooden sarking was recorded between the roof tiles and wooden beams. Partially boarded windows with no glass were present. Potential access points consisted of gaps between the tiles and through the boarded window. No evidence of bats using this building was recorded. Swallows were recorded nesting within the building.

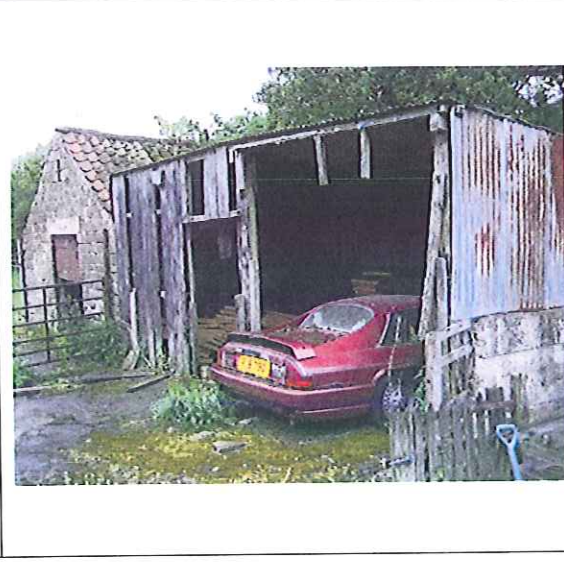
Photo 12: B4b

B4b was a single storey flat roofed building of breeze block, wood and corrugated metal construction with a single pitched corrugated asbestos roof. Large gaps were present within the walls, with the front wall largely open. Bat roosting potential was considered to be low and no evidence of bat occupation was recorded.

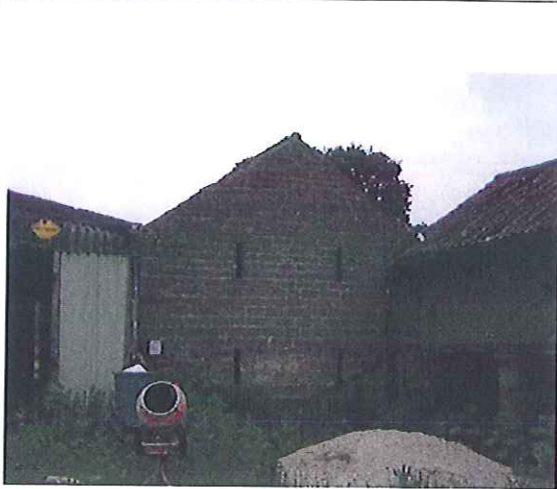
Photo 13: B5 exterior

B5 was a single storey stone built barn used as a gym and motorcycle storage room with a pitched clay tiled roof and gable ends. Lead flashing was present where B1 joined with B5. Internally the building was open to the roof with no roof void present. Underfelting was present. Potential access points were present through open windows, and missing ridge tiles. No evidence of bats using this building was recorded although the building was considered to have moderate bat roosting potential.

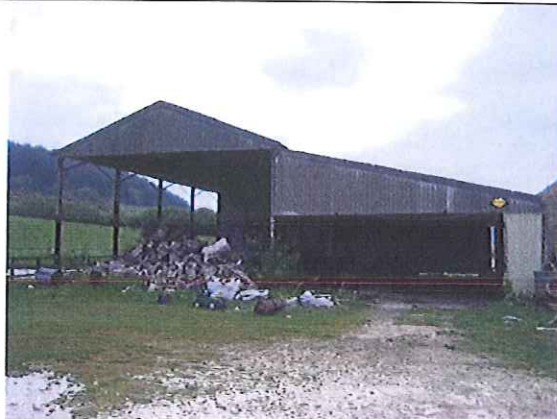
Photo 15: B6

B6 comprised a large corrugated asbestos and metal barn, with a pitched asbestos roof. Metal beams were present internally. Two walls were open. No evidence was found in association with B6. This building is considered highly unlikely to support roosting bats.

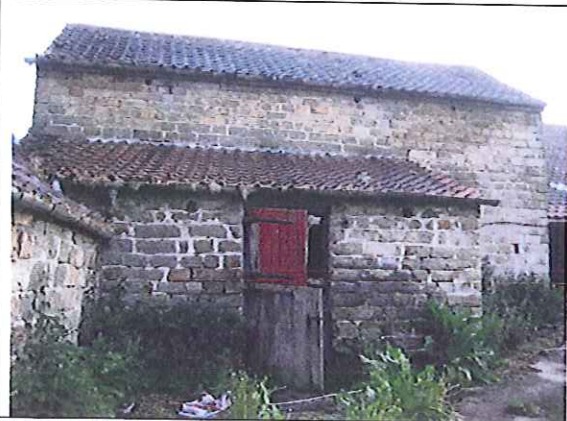
Photo 16: B7 exterior

B7 was a single storey, stone built building with a single pitched clay tiled roof. Lead flashing was present where the ridge adjoined the rear of B1. Internally, wooden sarking was present, with a roof void absent. Heavy cobwebbing was present. Potential bat access points included gaps under the tiles and in the sarking, holes in the mortar and holes in the walls with pipes. No evidence of bat occupation was recorded and the building was considered to have low-moderate bat roosting potential.

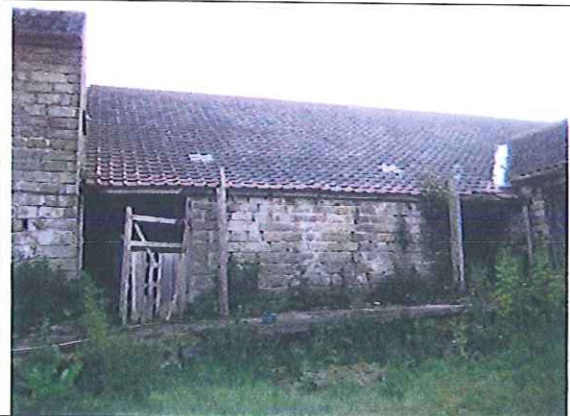
Photo 18: B8 exterior

B8 was a single storey stone built building with a single pitch clay tiled roof with very small roof lights which adjoins B5. Lead flashing was present. No roof void was present and the tiles had underfelting. Potential bat access points were present through the open doors and gaps in the mortar. No evidence of bat occupation was recorded and the building was considered to have low-moderate bat roosting potential.

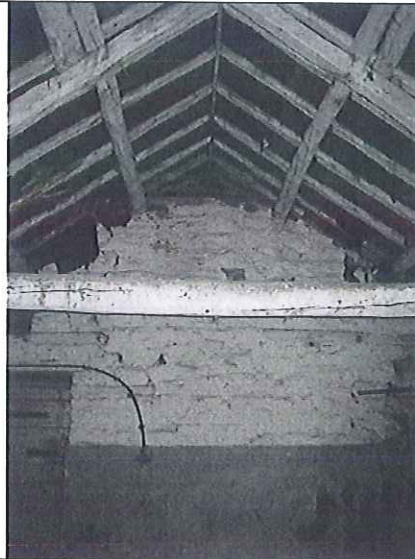
Photo 20: B9 interior

B9 was a single storey stone built building with a pitched clay tiled roof with one gable end and lead flashing. No roof void was present although the tiles had underfelting which was peeling away in places. Wooden beams were present. Potential bat access points comprised missing tiles, gaps around the door lintel and holes in the underfelt. Approximately 10 bat droppings were recorded on a wall. The building was considered to have high bat roosting potential.

The external and internal features of the buildings were surveyed and evidence of roosting bats found. Due to the nature and condition of the buildings, it was considered that there were suitable roosting opportunities for bats. It is recommended that two emergence (dusk) surveys and one roost (dawn) survey, are undertaken on the buildings to assess the levels of activity.

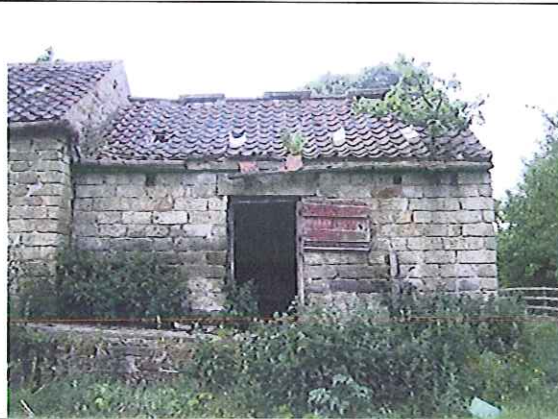
Photo 22: B9a exterior

B9a was a single storey stone built building with a pitched clay tiled roof with gable ends. No roof void was present and the tiles had wooden sarking. Potential access points were present in the form of open windows, holes from old roof beams, slipped tiles, holes in the mortar, open doors and holes in the wall formed by a former pigeon coop. No

evidence of bat occupation was recorded and the building was considered to have moderate bat roosting potential.
