NYM / 2010 / 0 9 3 1 / FL

**INSPECTION OF A BARN AT
HIGH BARNS, WHITBY LAITHES,
HAWSKER, WHITBY**

MR. & MRS. COLE

**BY R. O. BIRDSALL M.Sc., M.I.C.E.
CHARTERED ENGINEER**

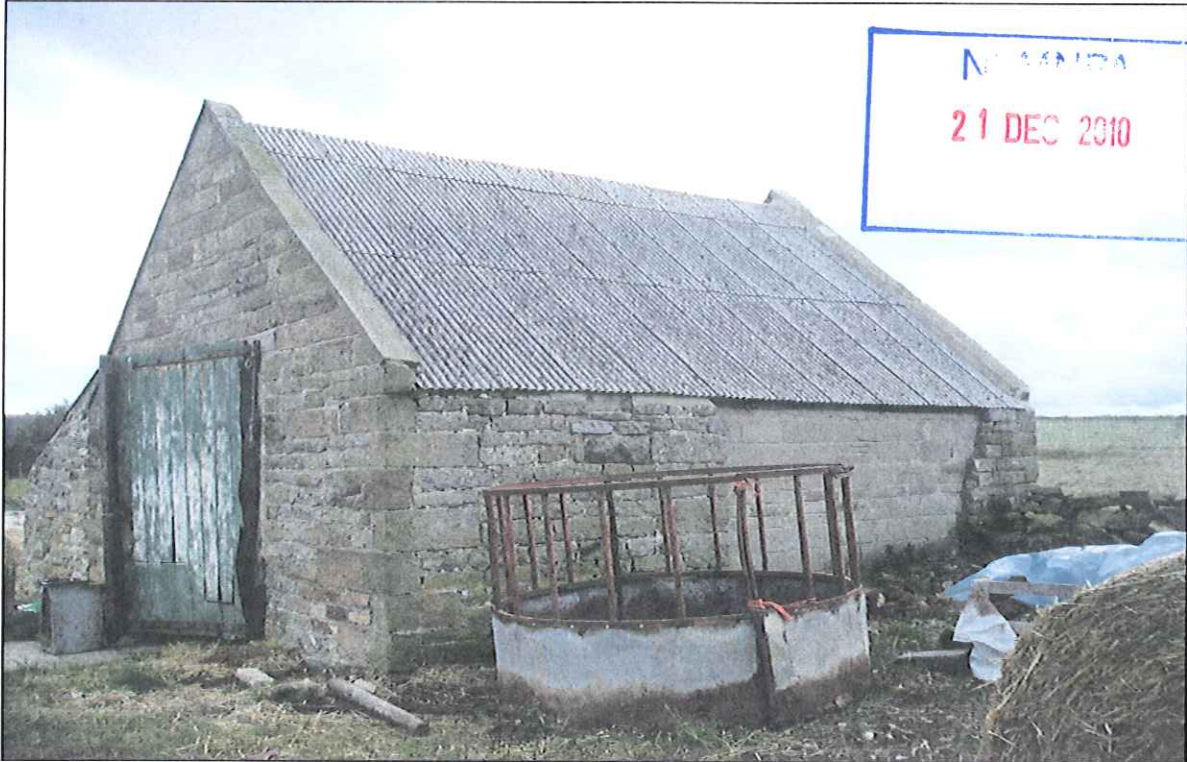
PHOTOGRAPH 1
HIGH BARN, WHITBY LAITHES, HAWSKER, WHITBY

- 2.3 The main side elevation (north west facing) can be seen in photograph 1. The stonework is in reasonable condition.
- 2.4 The other side elevation (south east facing) can be seen in photograph 3. The stonework on this elevation is of poorer quality than the main building.

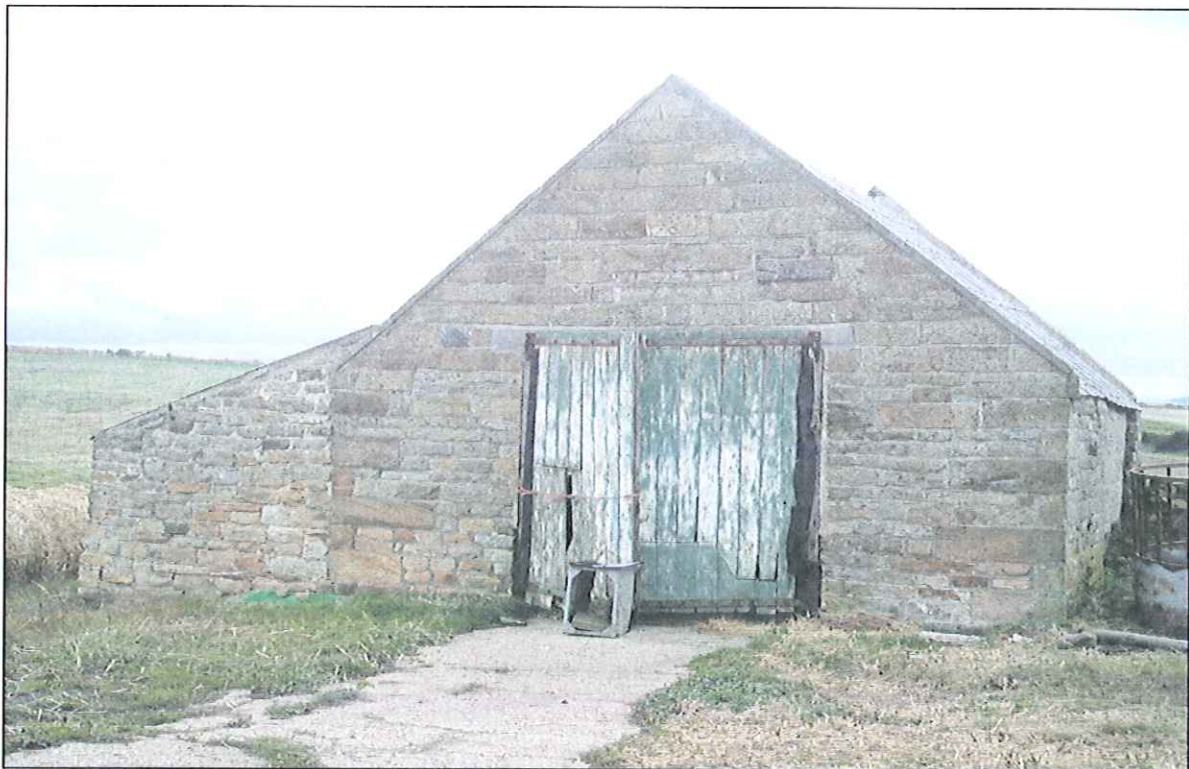
PHOTOGRAPH 2
HIGH BARN, WHITBY LAITHES, HAWSKER, WHITBY

- 2.1 The front (north east facing) elevation can be seen in photograph 2. It can be seen that the property consists of a main building with a high pitch roof and an extension to the east with a low pitch roof. The stonework on the main building is in reasonable condition. The stonework on the extension is poorer quality and not bonded to the main building, see photograph 3.

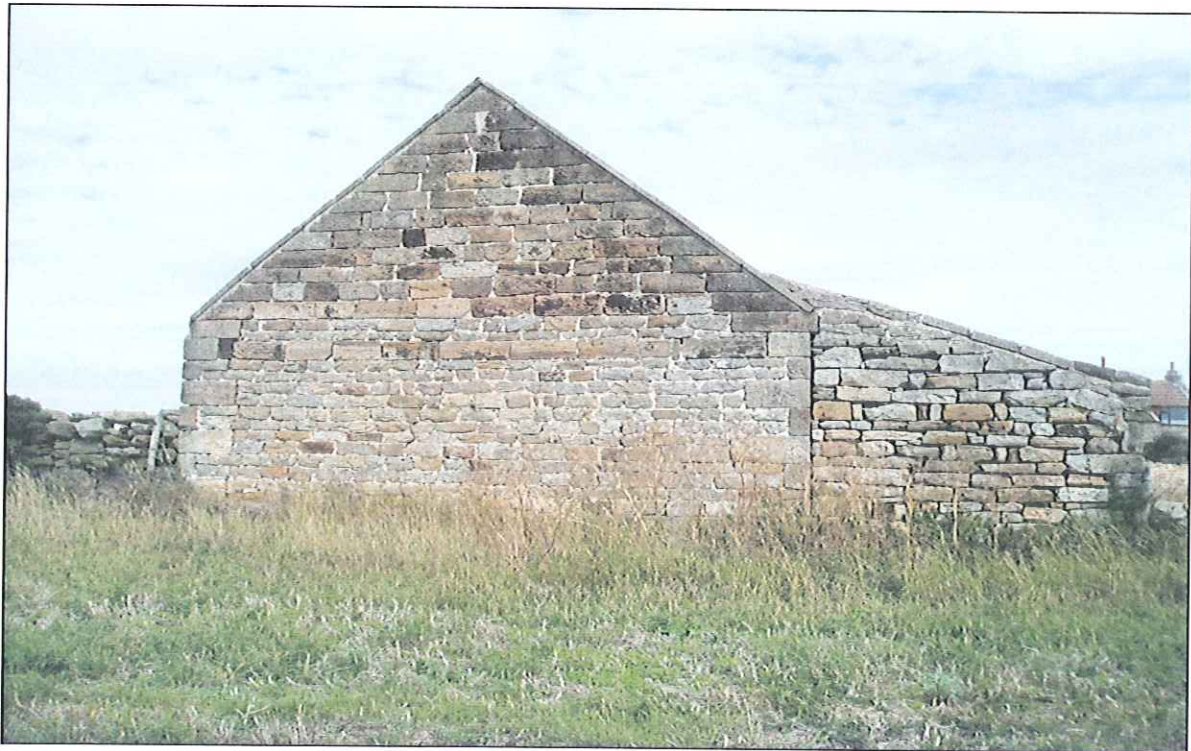
PHOTOGRAPH 4
HIGH BARNS, WHITBY LAITHES, HAWSKER, WHITBY

- 2.2 The rear (south west facing) elevation can be seen in photograph 4. The stonework on the main building is in reasonable condition. The stonework on the extension is poorer quality and the mortar joints have weathered. There is no bonding of stonework between the main building and the extension.

- 3.4 The new blockwork walls should be founded on a new raft floor slab which should be constructed using reinforced concrete on compacted hardcore.
- 3.5 Any cracking in the stonework joints should be carefully repaired. Some of the stonework in the existing extension will need to be locally rebuilt and the remainder re-pointed.
