PROPOSED CONVERSION
OF OUTBUILDINGS
MOORGATE LEES FARM
HAWSKER
WHITBY
FOR
MRS A L ROSWALD

Ref: MA10/32

Re: Outbuildings, Moorgate Lees Farm, Hawsker, Whitby

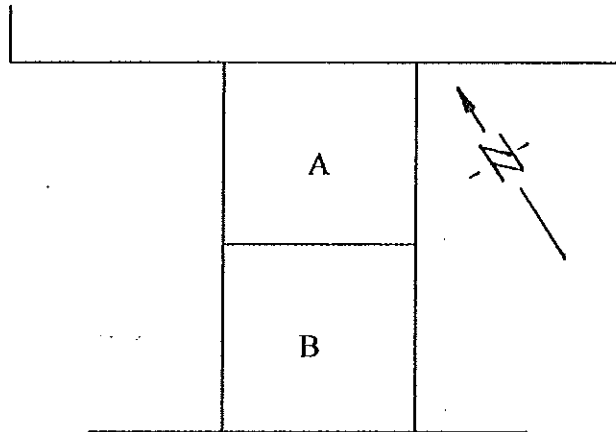
As requested, I carried out an inspection at the above property on the 30th March 2010 restricting my attention to the outbuildings A and B, as marked on sketch below.
