Condition Report

Dalby Beck, Low Dalby, Pickering.

Introduction

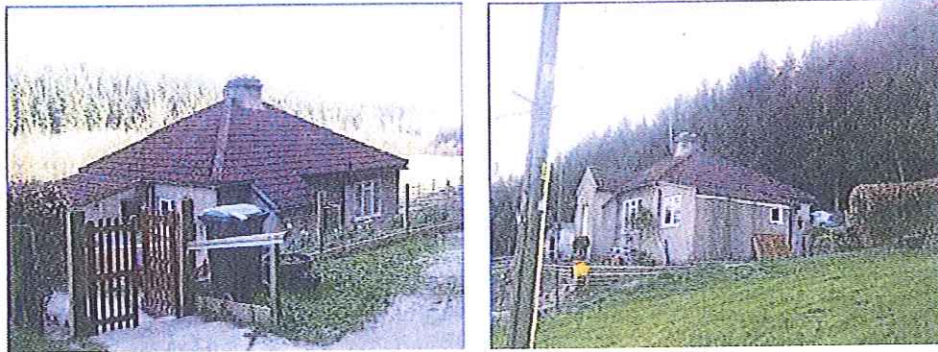
1.1 As previously mentioned the property is a prefabricated concrete detached bungalow built on a sloping site onto infill materials unknown.

1.2 It appears that the building has been constructed off a ground bearing concrete slab that has suffered significantly from water erosion and possible slippage of the land adjacent has occurred.

- 1. Underpinning of Foundations. Estimated cost £6,000 to £10,000.**
 It is my expert opinion that the external walls would require underpinning along the east, north and south sides to ensure no further settlement or slippage of the property down the incline of the hill.

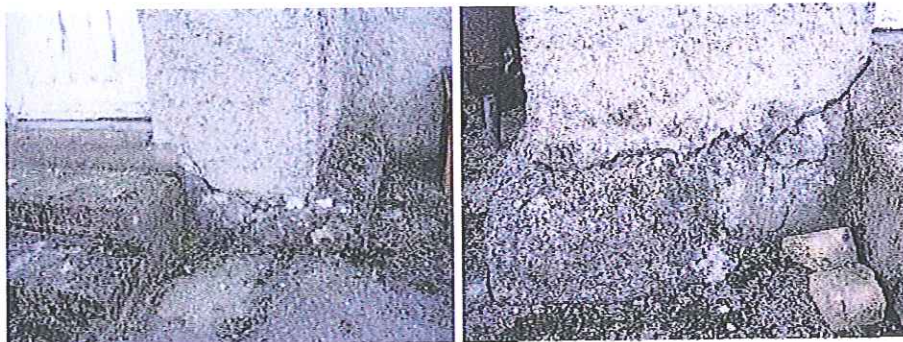
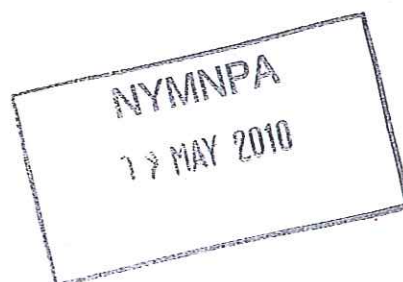
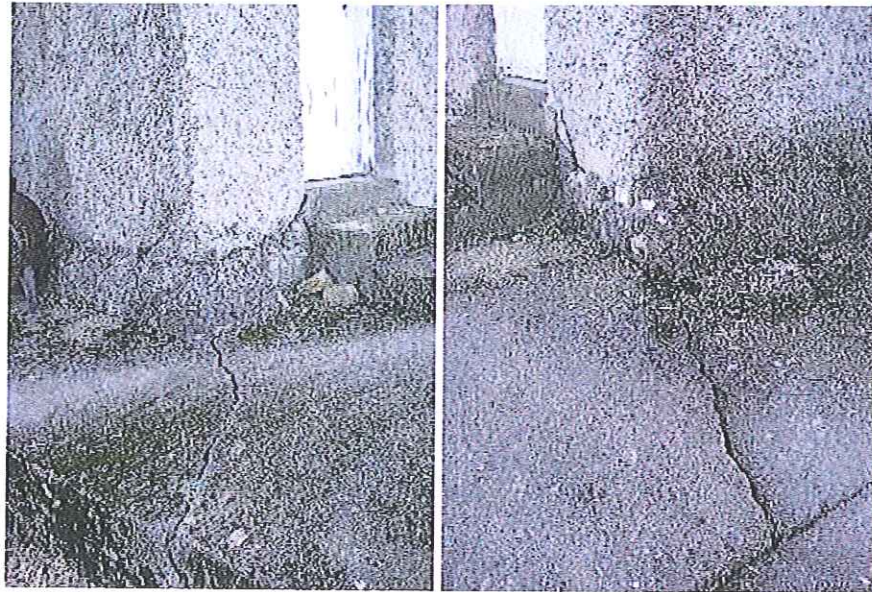
1.4 The east facing wall had clearly suffered from long term water erosion of earth beneath the structure resulting in numerous settlement cracks around the front porch structure.

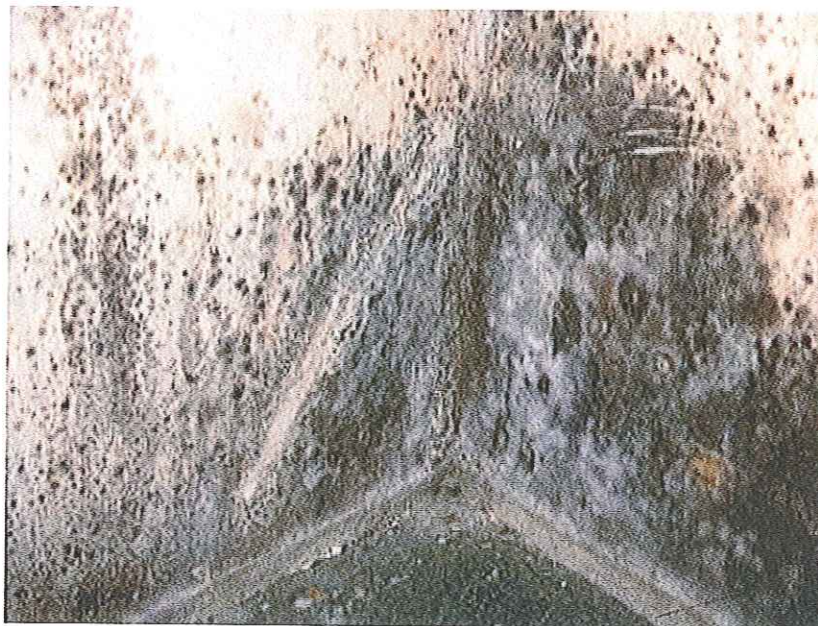
1.5 In many places throughout the property there is a damp smell, black mould growth and other microbial is apparent on walls particularly at wall abutments and junctions. This is consistent with moisture ingress and a lack of natural ventilation to the property. In the cupboards and wardrobes stored boxes and items of clothing have also signs of mould growth upon them.

- 6. Internal Finishes. Estimated cost £3,750**
 The internal plaster finishes have been significantly damaged by moisture ingress and in many places mold growth is apparent. It is my expert opinion that all internal finishes should be removed, a vapour check incorporated into the construction to reduce interstitial condensation and all walls re-finished with a minimum 12.5mm thick dry lining board with taped filled and sanded joints ready for redecoration.

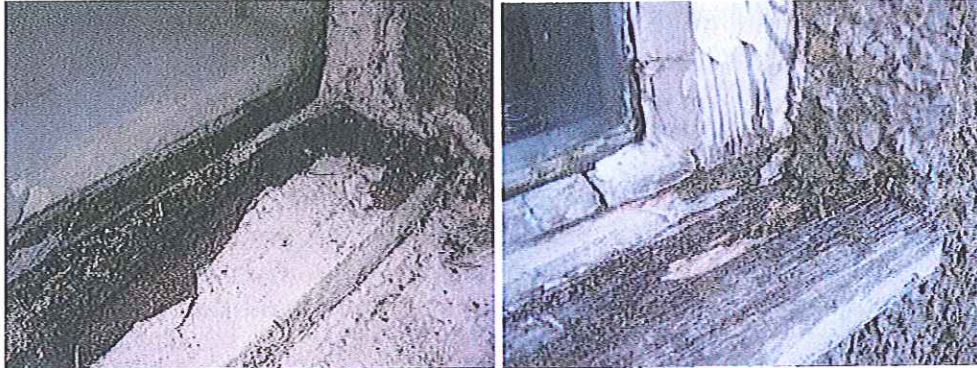
1.6 The windows and doors are painted timber with single glazed panes. They are in a very poor state of repair with the majority of window frames showing signs of decay due to moisture ingress.

- 4. New External Windows and Doors. Estimated cost £8,000.**
 The existing timber windows are in a poor state of repair and being single glazed would not meet current building regulation requirements. It is therefore essential that the windows and doors be fully replaced with insulating double glazed timber windows.

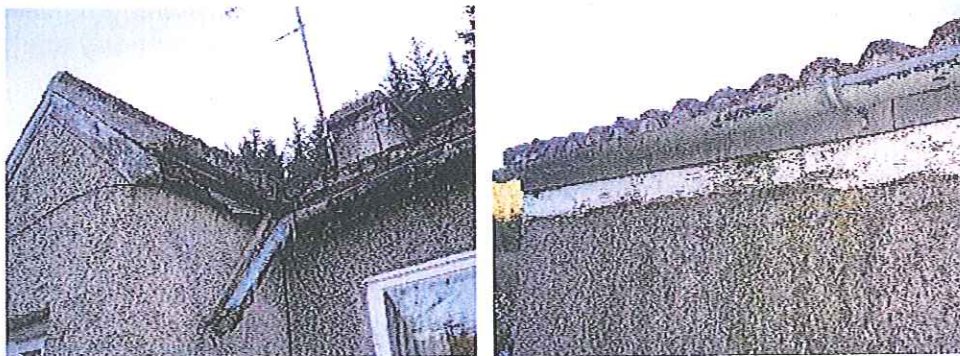
1.7 The roof is of a hipped construction of timber with sarking board, roofing felt and double roman concrete roof tiles. The roof was found to be in an acceptable level of repair with only a few minor cracked tiles but requires complete replacement of flashings around the chimney penetration.

1.8 The timber fascias around the property would require complete replacement as they were rotten and falling away. The ends of the trusses where the fascias had been fixed also appear to have signs of rotting and would require significant repair before new fascias could be fixed. The gutter and rainwater downpipes would require replacement in many cases or removal, cleaning down and re-fixing in other areas to deal with broken brackets and apparent leaks which looks to be the cause of many areas of water ingress into the building.
