STRUCTURAL REPORT
OLD COASTGUARD LOOKOUT BUILDING
ROBIN HOODS BAY
FOR
MRS SALLY STRAWS

6 April 2011

Re: Old Coastguard Lookout Building, Robin Hoods Bay

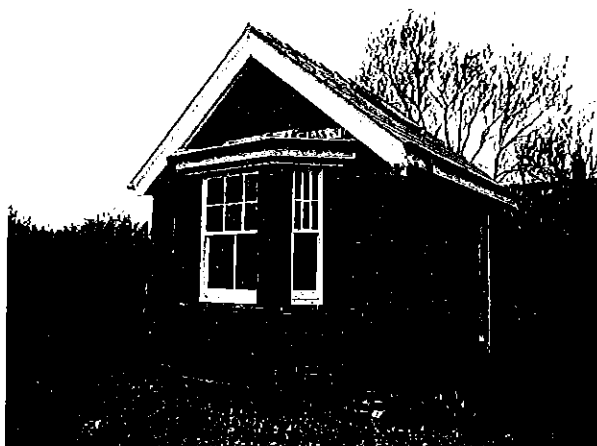
The single storey building has a small footprint, purpose built for the Coastguard Service, with cavity brick walls, a slate covered roof, and is situated on a high level plateau hill top.

All walls are plumb and there are no apparent indications of any cracking or movement. The brickwork is in good condition and only minor re-pointing is required.

The slate covered roof has a true profile and the building is considered structurally sound.
