**INSPECTION OF A BARN AT  
HIGH BARNES, WHITBY LAITHES,  
HAWSKER, WHITBY**

**MR. & MRS. COLE**

**BY R. O. BIRDSALL M.Sc., M.I.C.E.  
CHARTERED ENGINEER**

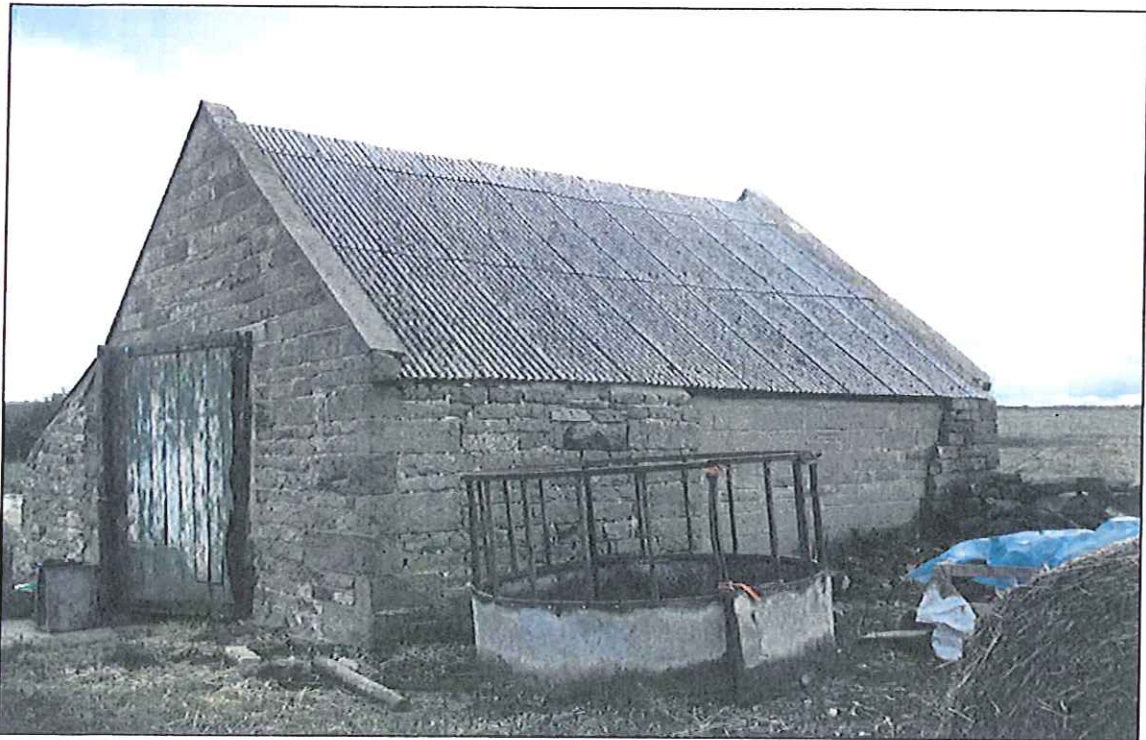
**PHOTOGRAPH 1**  
**HIGH BARNS, WHITBY LAITHES, HAWSKER, WHITBY**

- 2.3 The main side elevation (north west facing) can be seen in photograph 1. The stonework is in reasonable condition.
- 2.4 The other side elevation (south east facing) can be seen in photograph 3. The stonework on this elevation is of poorer quality than the main building.

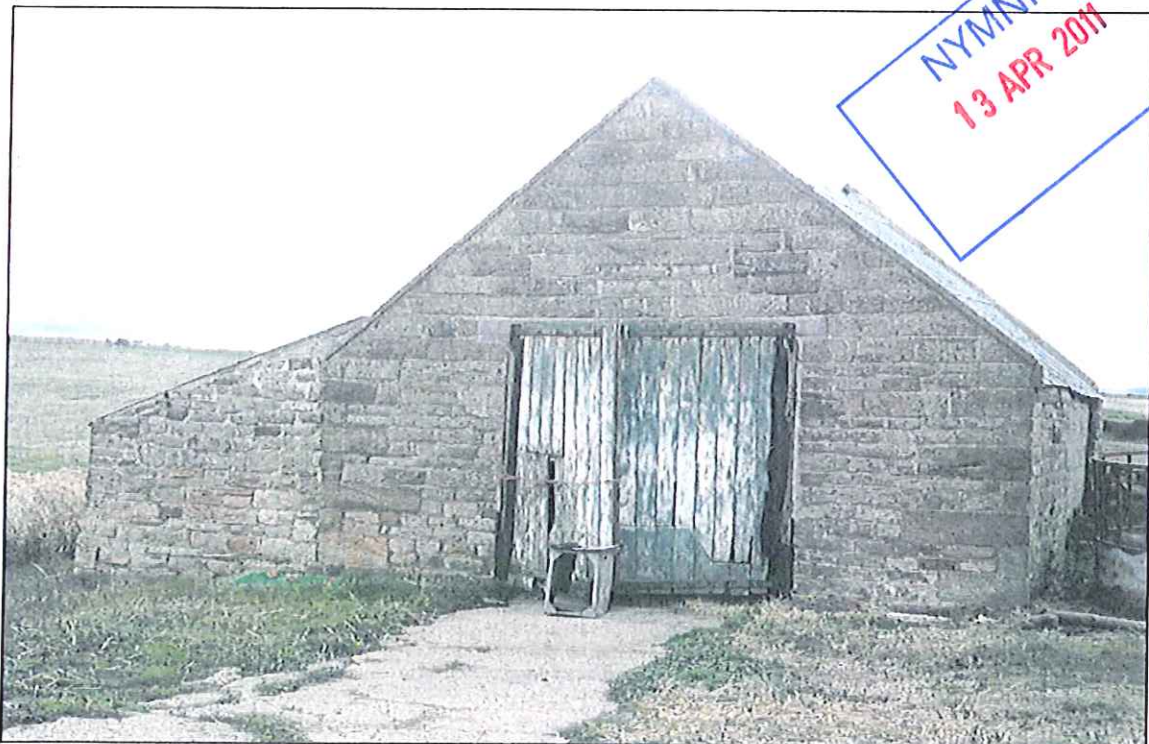
**PHOTOGRAPH 2**  
**HIGH BARNS, WHITBY LAITHES, HAWSKER, WHITBY**

- 2.1 The front (north east facing) elevation can be seen in photograph 2. It can be seen that the property consists of a main building with a high pitch roof and an extension to the east with a low pitch roof. The stonework on the main building is in reasonable condition. The stonework on the extension is poorer quality and not bonded to the main building, see photograph 3.

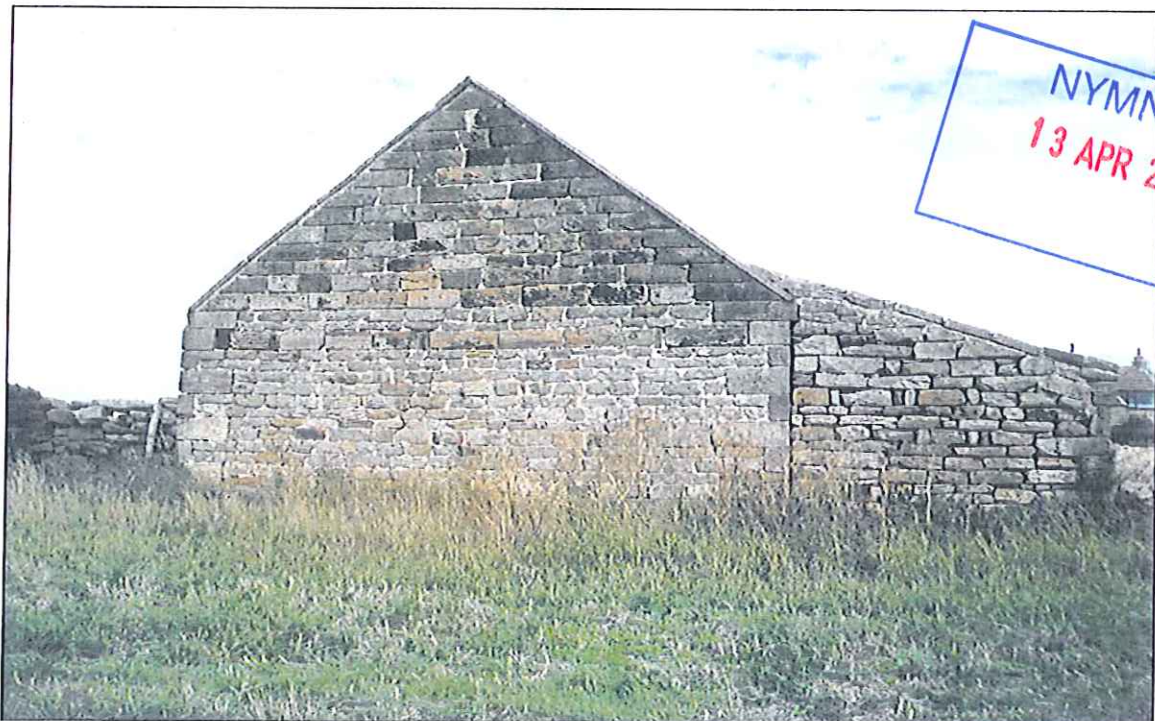
**PHOTOGRAPH 4**  
**HIGH BARN, WHITBY LAITHES, HAWSKER, WHITBY**

- 2.2 The rear (south west facing) elevation can be seen in photograph 4. The stonework on the main building is in reasonable condition. The stonework on the extension is poorer quality and the mortar joints have weathered. There is no bonding of stonework between the main building and the extension.

- 3.4 The new blockwork walls should be founded on a new raft floor slab which should be constructed using reinforced concrete on compacted hardcore.
- 3.5 Any cracking in the stonework joints should be carefully repaired. Some of the stonework in the existing extension will need to be locally rebuilt and the remainder re-pointed.
