**INSPECTION OF EXISTING GARAGE AT  
HIGH BARNs, WHITBY LAITHES,  
HAWSKER, WHITBY**

**MR. & MRS. COLE**

**BY R. O. BIRDSALL M.Sc., M.I.C.E.  
CHARTERED ENGINEER**

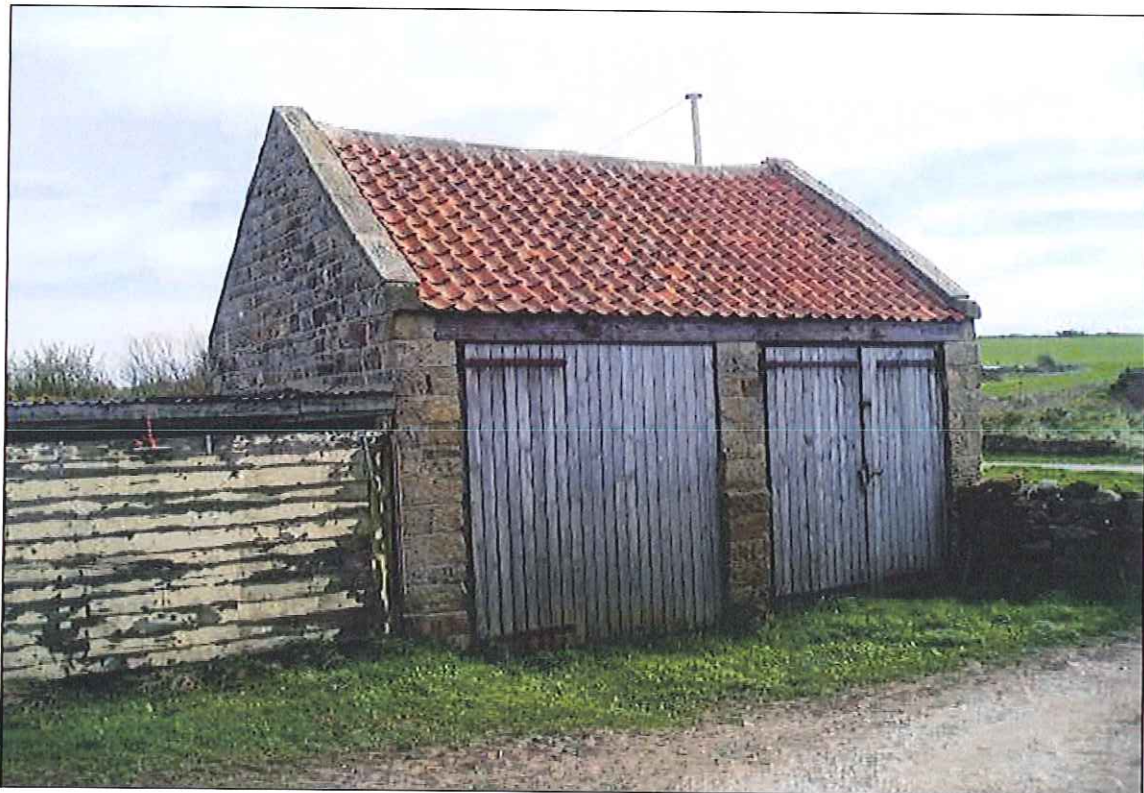
**PHOTOGRAPH 1**  
**EXISTING GARAGE, HIGH BARNS, WHITBY LAITHES**

- 2.1 The front (north west facing) elevation can be seen in photograph 1. The sandstone piers are in good condition. The lintels over the doors consist of timber.
- 2.2 The south west facing gable wall can be seen in photograph 2. The sandstone walling is in good condition but the stone lintel over the door does not have any bearing, see photograph 3.
- 2.3 The rear (south east facing) elevation can be seen in photographs 4 and 5. The wall is slightly out of level but otherwise in good condition. A previous window opening has been filled in with stone at some point in the past, see photograph 6.
- 2.4 The north east facing gable wall can be seen in photograph 7. The wall is in good condition except for some cracking near the eastern corner, see photograph 8.

- 3.6 All exposed timber embedded in the wall should be carefully removed and replaced with sandstone.
- 3.7 The timber lintels should generally be replaced with stone on hidden steel lintels.
- 3.8 All aspects of the conversion should comply with current Building Regulations.
