**TREE SURVEY AND RECOMMENDATIONS IN ACCORDANCE WITH
BS.5837:2005 "TREES IN RELATION TO CONSTRUCTION –
RECOMMENDATIONS"**

"Crestbank", Robin Hood's Bay.

This report provides information in accordance with BS.5837:2005 "Trees in relation to construction – Recommendations" for proposed development at "Crestbank", Robin Hood's Bay, North Yorkshire.

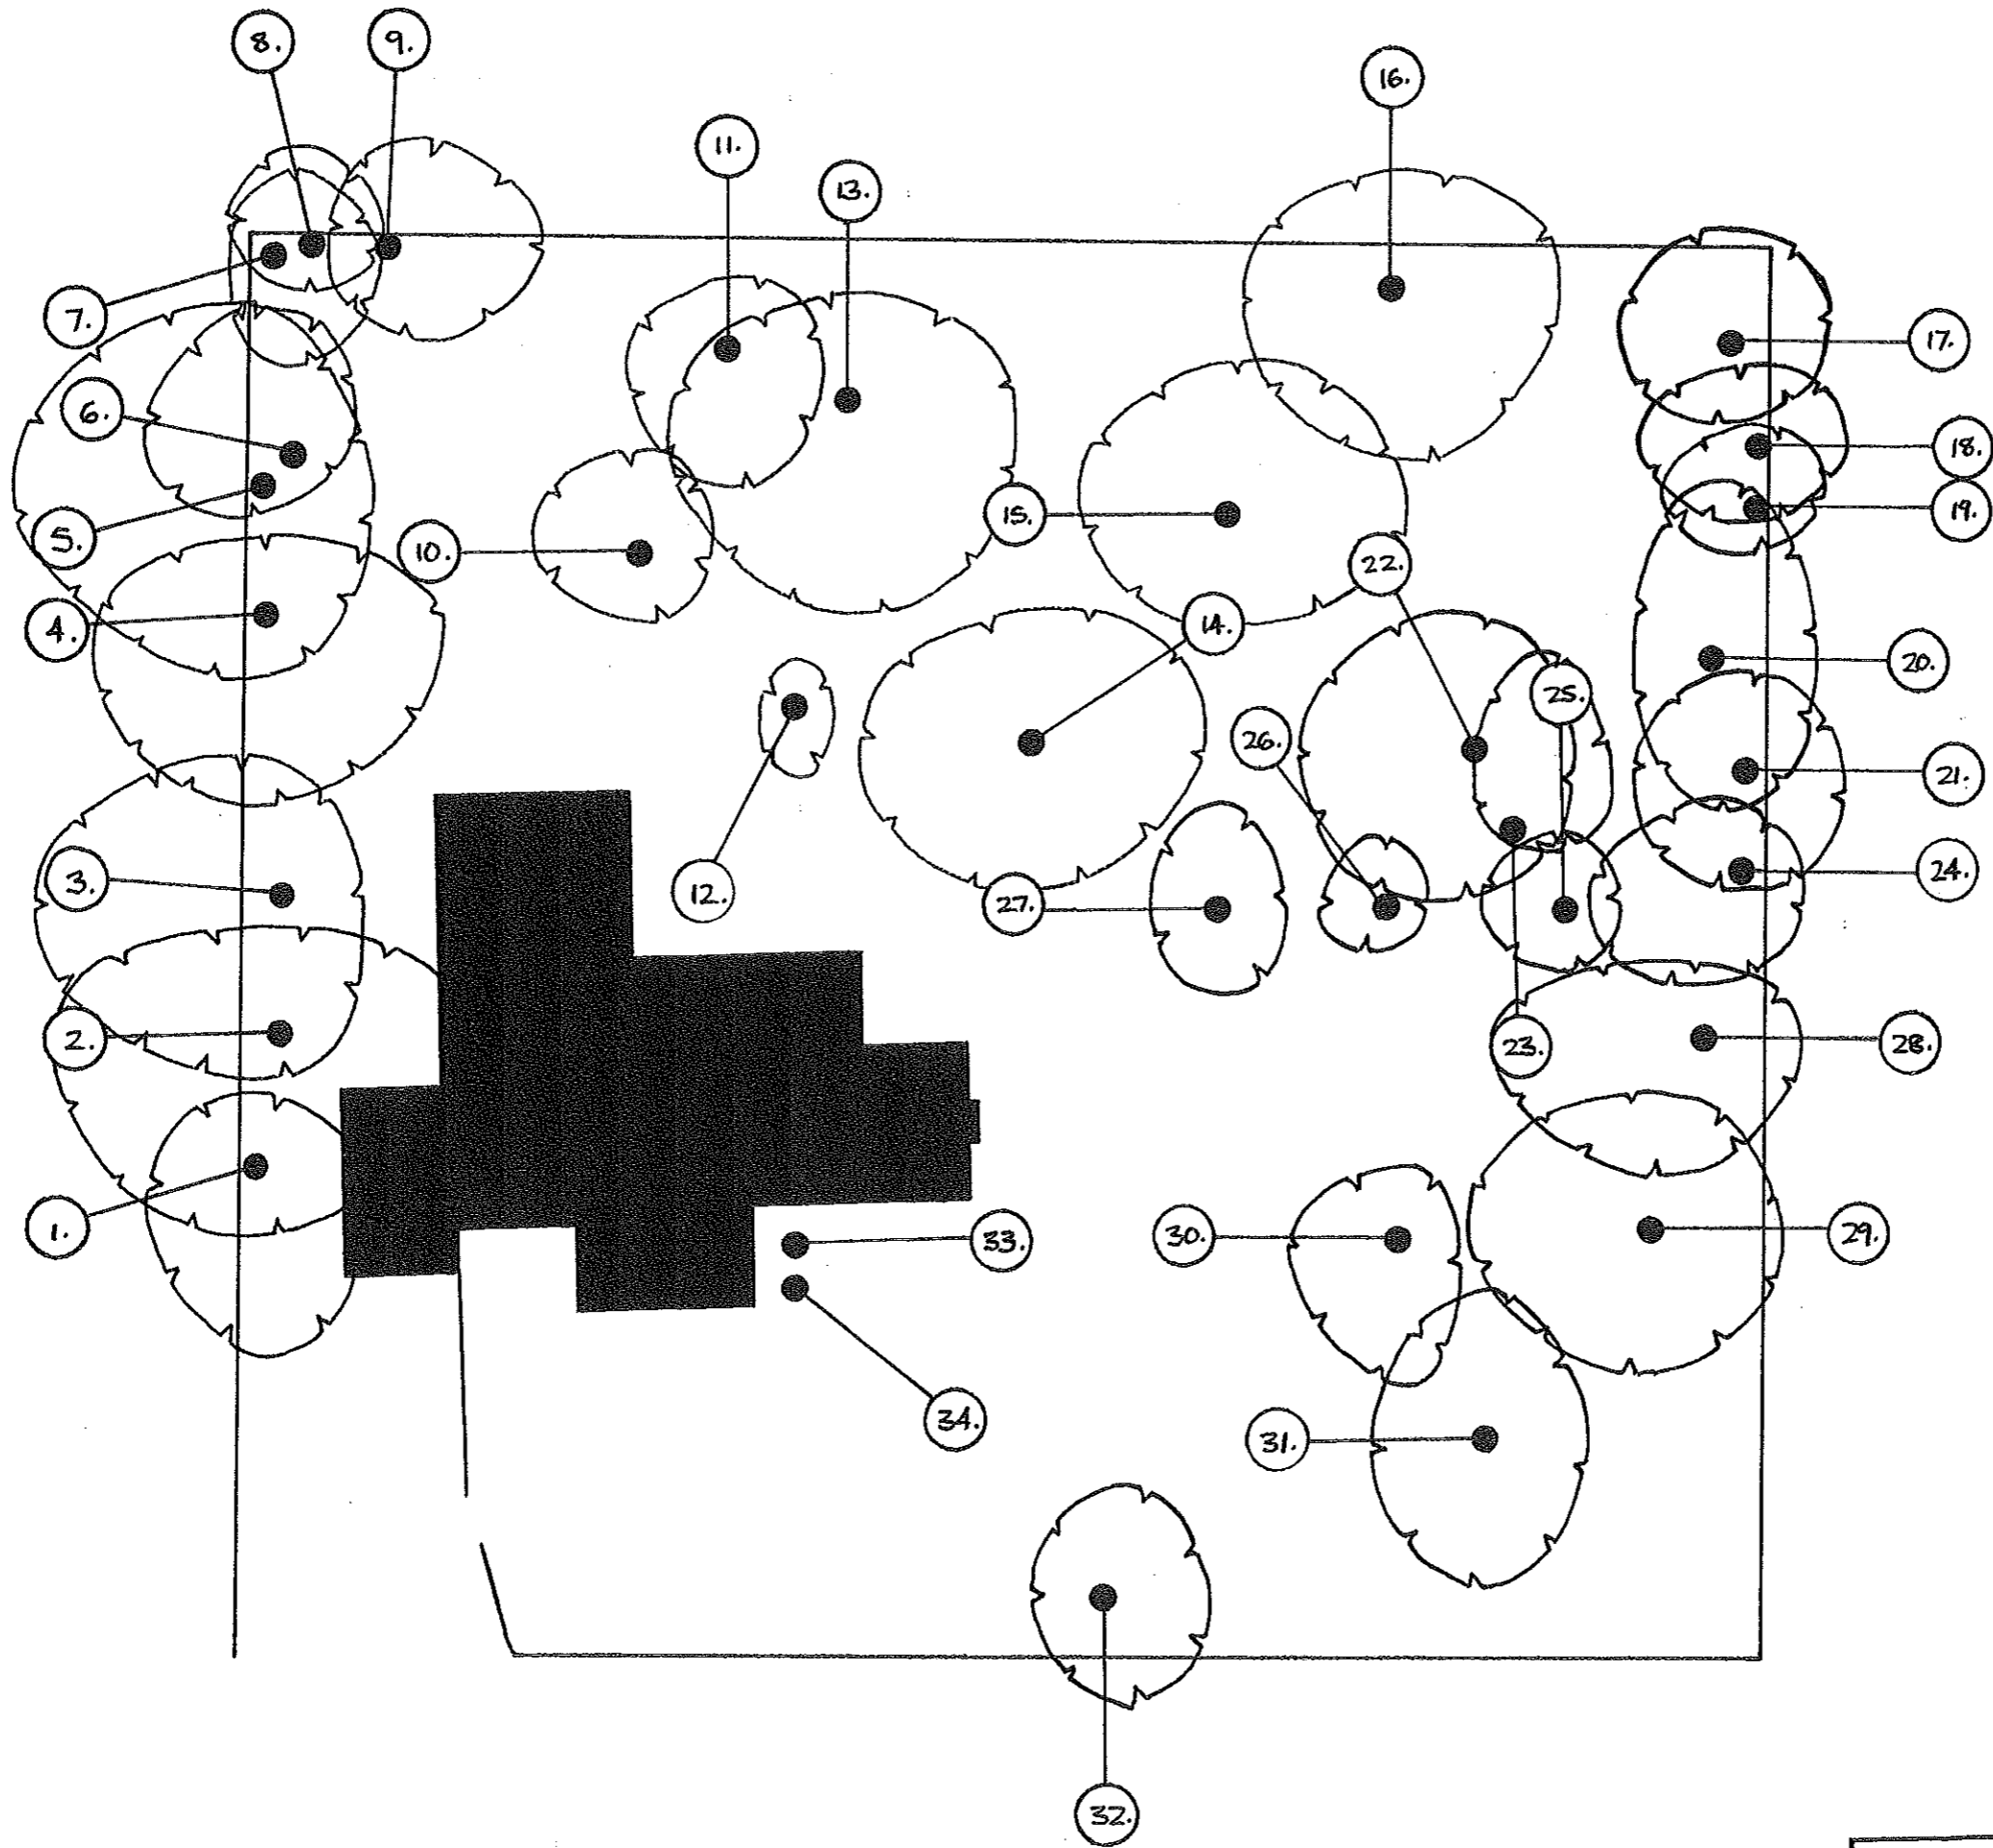
Existing Tree Survey Plan

Of the 34 individual trees on the site that were assessed, nineteen are of a condition to warrant category C, or above, ratings.

Tree 3 is a fairly young Oak. There is a dead branch detached and hanging within the canopy of this tree.

Tree 8 is a Holly that is growing in a very restricted space between two utility poles. This tree will not achieve its full potential and should be removed to avoid possible service disruption in the future. This Holly should be removed.

Tree 9 is an old Ash stump with fairly extensive and heavy regrowth coming from a decaying and likely to collapse base. This stump and regrowth should be removed.

Tree 13 is a Cherry with a considerable lean. The rootplate is lifting and there is evidence of root decay fungi at the base of the stem. This tree should be removed.

Tree 20 is a fairly young Sycamore which has a large decay scar from ground level to a height of approximately 2.5m up the stem. This tree can be retained for the time being but the condition of the scar should be monitored.

Tree 22 is a Cherry which is of poor structural condition with basal decay evident. This tree should be removed.

Tree 23 is a poor quality mature Apple displaying root decay and a significant lean and should be removed.

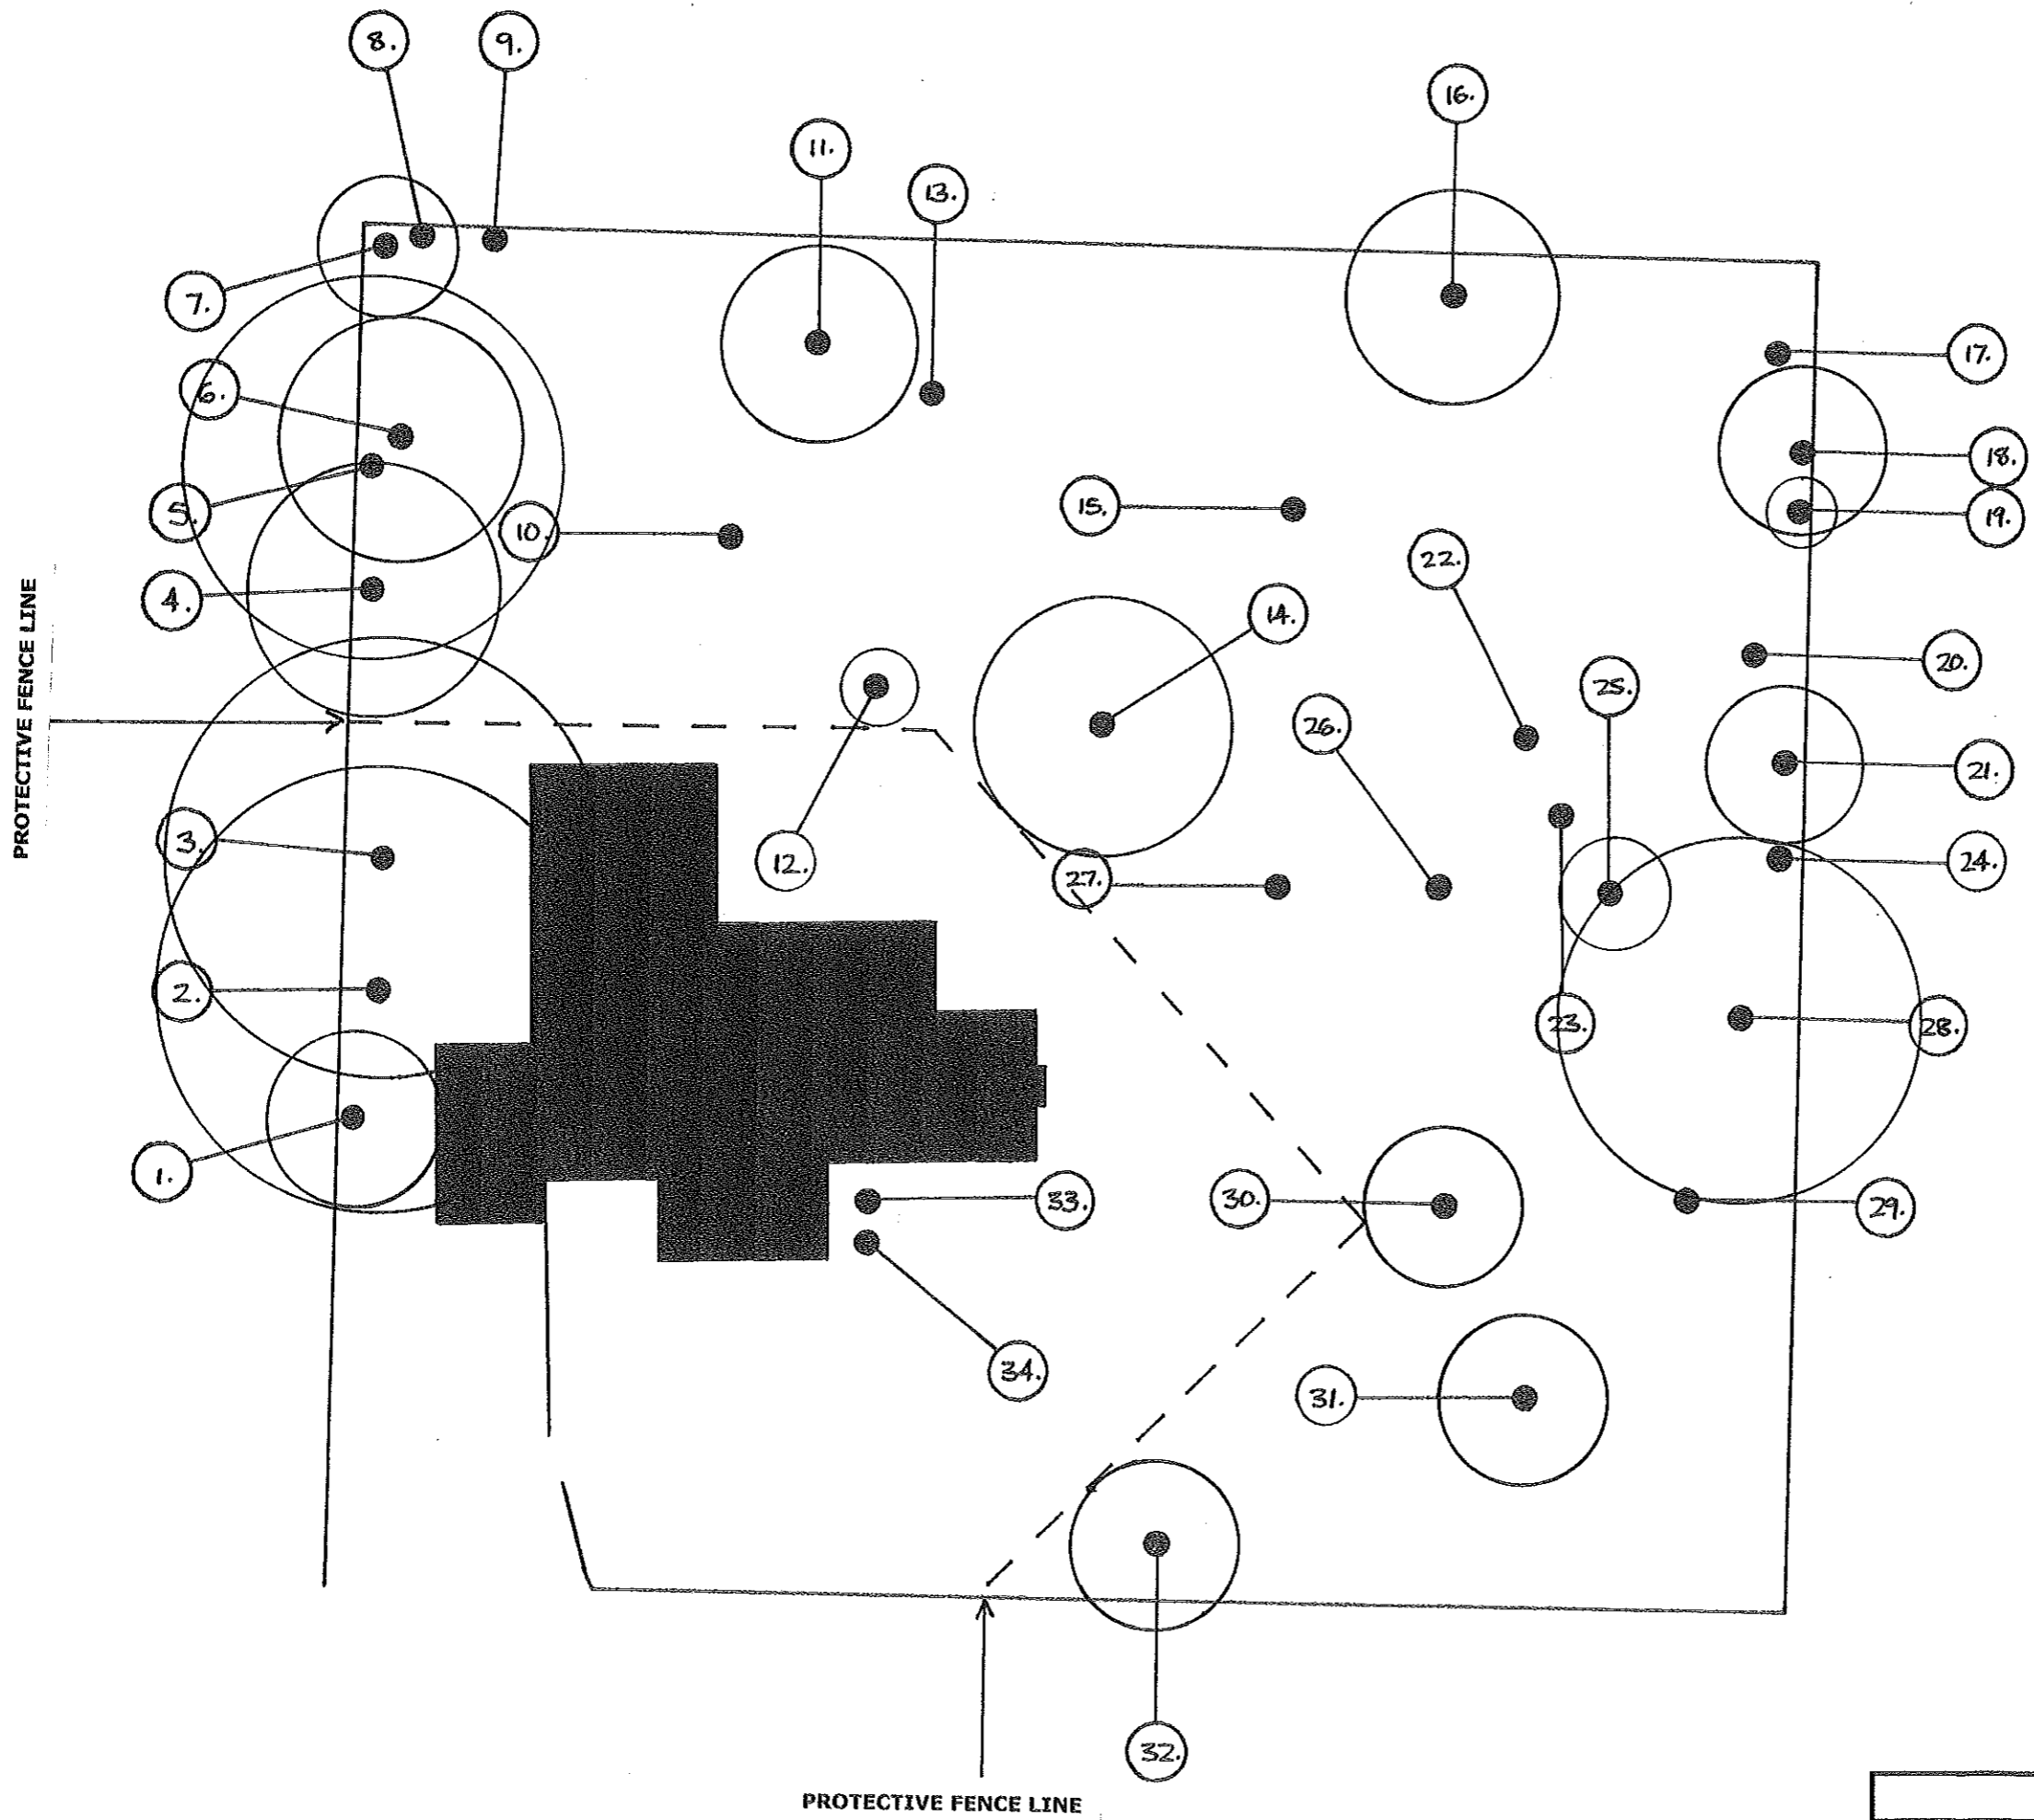
The retained trees identified within this document are not in positions to constitute a constraint to development if care is taken and the contents of this document adhered to.

The RPA shown on the Tree Constraints Plan can be deformed to allow the development on this side of the property, but the area of the RPA must remain the same.

Fencing needs to be erected in accordance with the Tree Constraints Plan. The fence should comprise a vertical and horizontal framework supporting weldmesh, chainlink fencing or similar. This should be continuous and immovable. All weather notices should be attached to the fencing clearly marked with the following: "Construction Exclusion Zone – Protected Trees – Keep Out".
