PRELIMINARY ARBORICULTURAL ASSESSMENT

**Proposed development
comprising the provision of six
Family Style Camping Pods at the
Falcon Inn
Whitby Road, Cloughton,
Scarborough**

**for
Mr Ray Owen**

February 2005

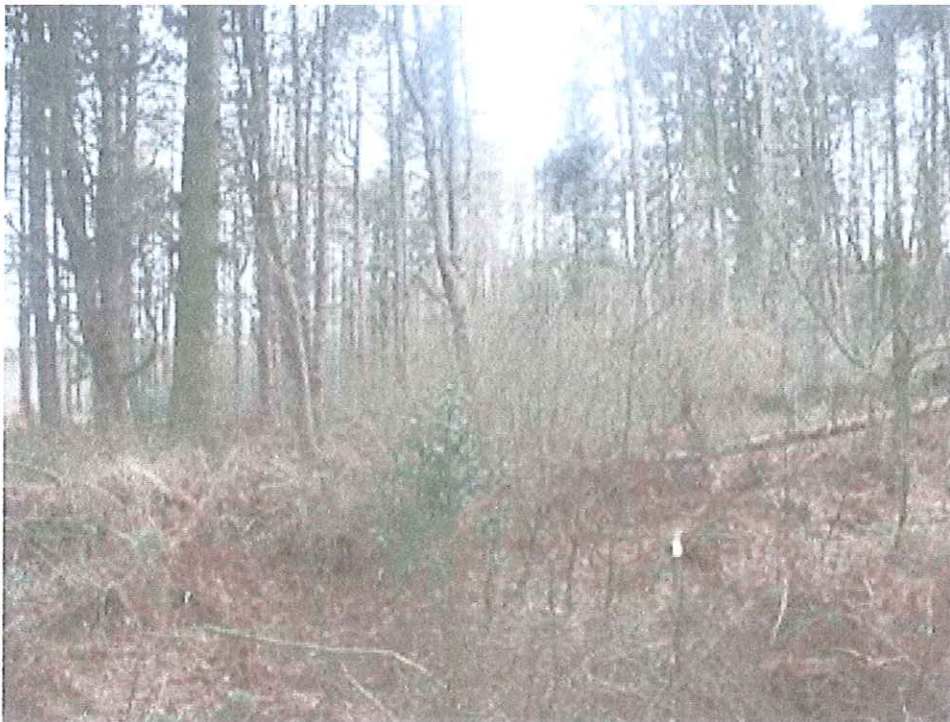
Fig 2

It is evident that management has not been consistent over the production period; there is some thinning in the centre (either managed or through natural losses) but not at the perimeters. Where the trees have not been thinned, growth is etiolated - taller and thinner than would be expected with a properly managed plantation.

General view of the plantation

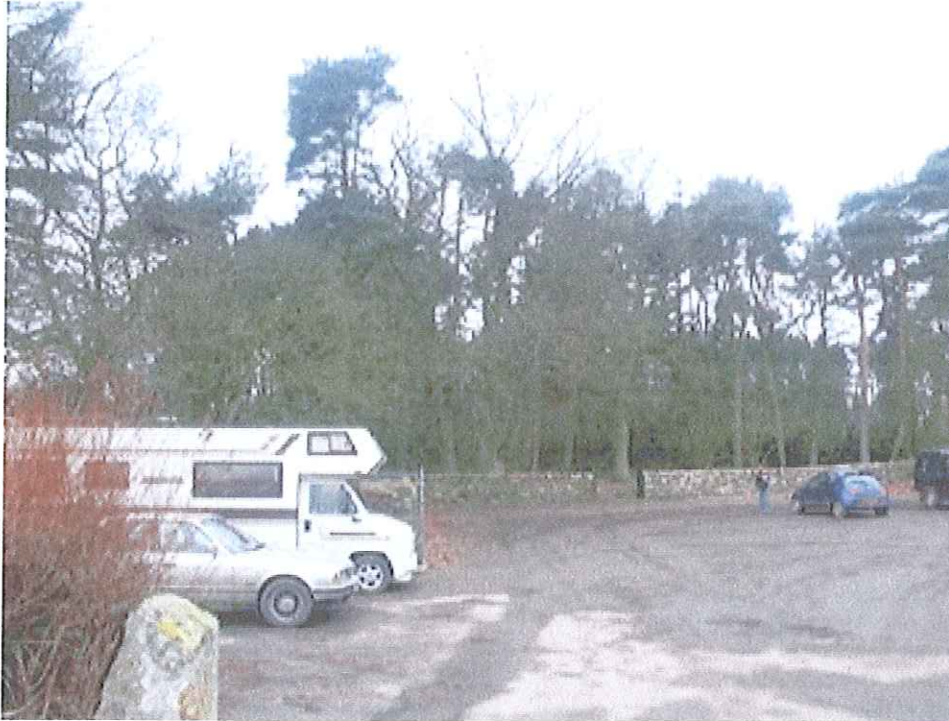
Fig 3

There is no evidence of ongoing forestry activity other than the replanting. There appears to be no sporting use. The site perimeter is unfenced and there is a gateway from the Falcon Hotel car park. This and foot-worn trails in the plantation, suggest that informal public access has been established on the site.

Public access from the Falcon Hotel car park

This plantation is highly unstable and as a matter of urgency requires action to prevent public access on grounds of health and safety.

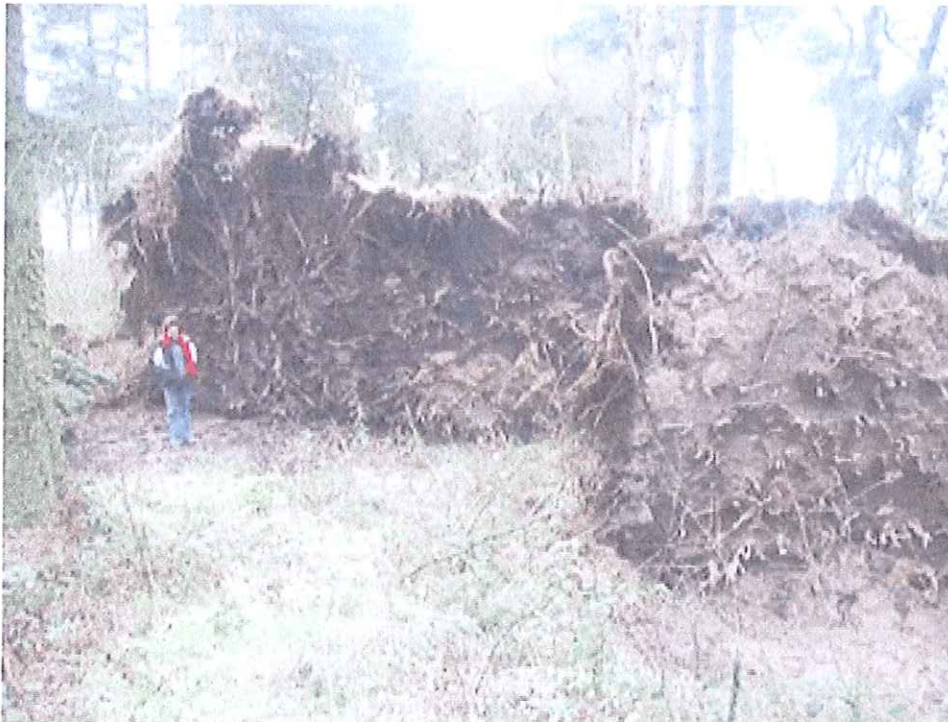
Fig 4

There are a large number of mature trees, which have recently fallen. The falling pattern is uniform to the southeast and forms a clear line of damage extending from the north west to south east corner of the site

Initial examination of the fallen trees indicates that both larch and pine are affected and that the trees were healthy at the time of falling. There is also some evidence of snapping of bowl at approximately 3m.

Examination of the root plate shows rooting to be extensive and interlinked. It is also extremely shallow – only 100-200mm. Clay loam adheres to the roots and a heavy clay sub-soil is evident at the root horizon. There is no penetration of roots into the sub soil.

As the trees are 40-50 years old and are apparently healthy, losses cannot be attributed to disease or senility. Sudden catastrophic failure coincided with high winds and the uniform direction of drop and the loss of mainly strong mature trees with heavy canopy indicate windthrow as the cause of the damage.

Uprooted trees showing shallow root system

A management plan be drawn up to identify trees subject to wind throw and those which may have sufficient wind tolerance to remain viable.

In line with an agreed management plan, felling and replanting of the central vulnerable areas is recommended, along with selective felling and replanting of the perimeter planting to remove weak, damaged trees and to increase diversity and visual quality.

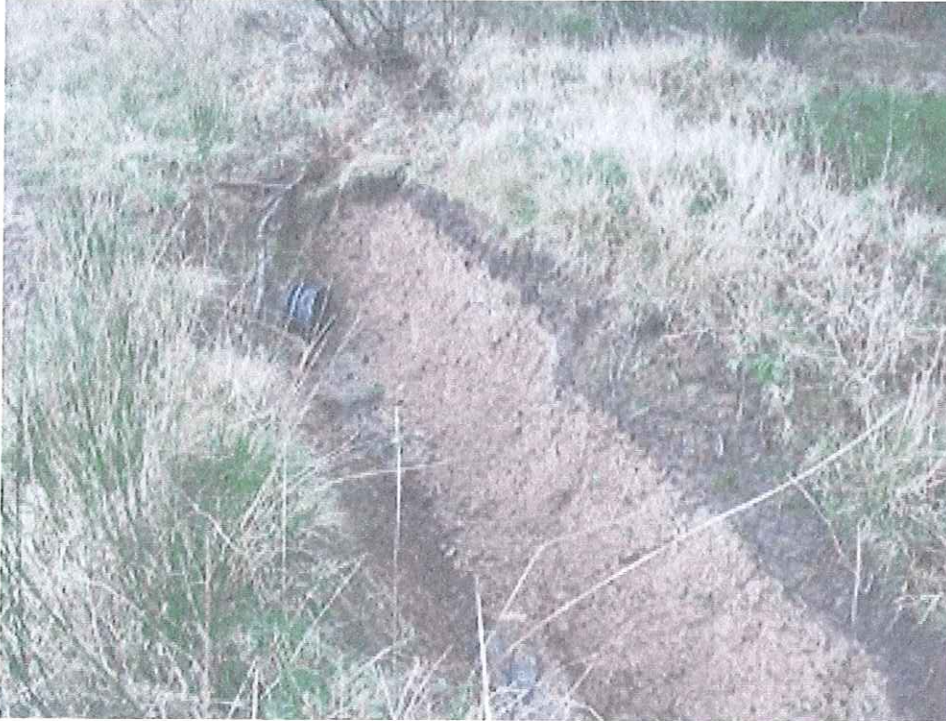
Fig 5

A newly excavated drainage trench on the adjacent plantation clearly shows the organic rich clay soil to extend to only to a depth of 100-200mm, below which there is a distinct and abrupt change to heavy waterlogged mineral clay. There is no mixing of the soil horizons, which indicate the site was not ripped prior to planting.

Drainage trench showing shallow soil horizons

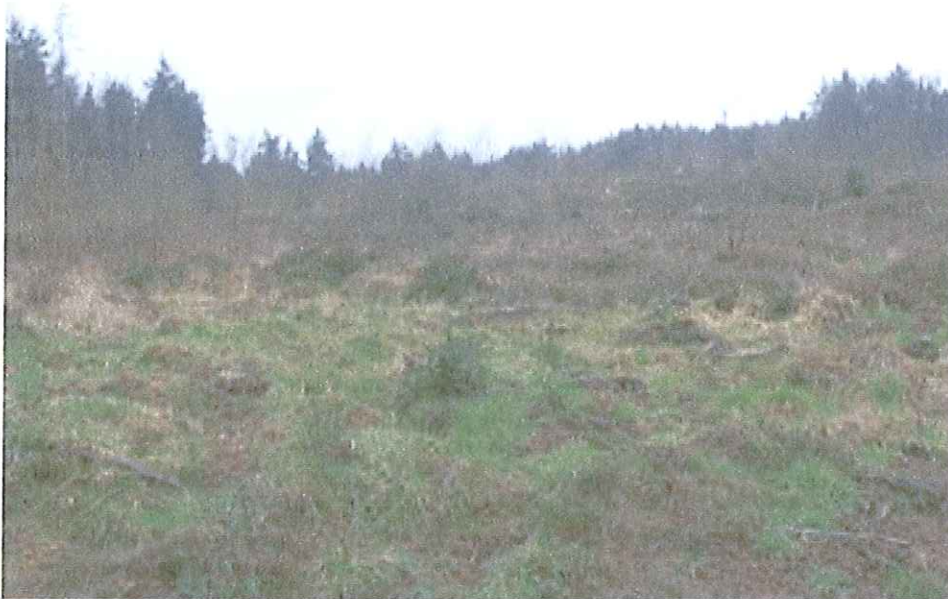
Fig 6

This woodland has until recently remained stable; however the block felling of the Forestry Commission land to the north and west of the site has created an opening for wind from a direction the trees in the centre of the plantation have not previously experienced. Having grown sheltered from northerly winds the stand has developed little rooting resistance to prevent overturning.

The altered wind pattern leaves the Falcon Plantation exposed. The effect of this is particularly severe at ground level since winds, which would previously have been slowed and filtered by the adjacent woodland, are now unchecked.

Northerly winds which would previously have been lifted above the canopy by the barrier of adjacent woodland, now fall back to ground level, further increasing the intensity of the forces experienced by the Falcon Plantation.

The remaining Forestry Commission woodland blocks now serve to funnel winds towards the site. Therefore the plantation now experiences highly concentrated wind strengths at ground level from a direction which was previously sheltered.

Area of clear felling to the north and west of the plantation
