Ref: MA12/74

**Re: Cliff Farm, Iburndale, Sleights, Whitby**

As requested I carried out an inspection of the outbuildings at the above property on the 8<sup>th</sup> August 2012, to assess the existing structural condition of the units and their suitability for conversion

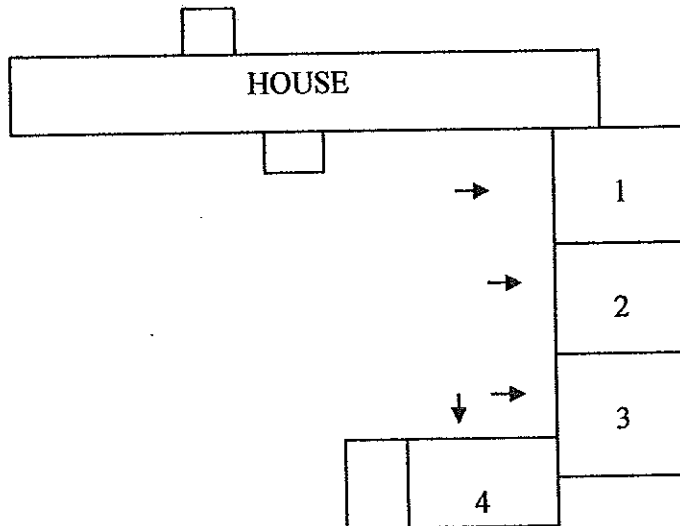
Front Elevations as viewed from courtyard →
