Spa Pods – Raithwaite Hall Tree survey and Arboricultural assessment August 2012

# NYM / 2012 / 0 4 4 2 / F L

## TREE SURVEY

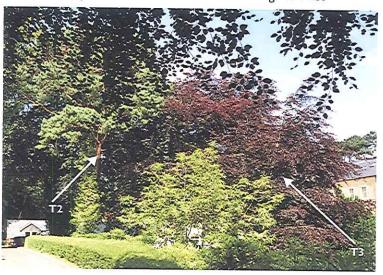
All of the trees within the study area T1-T5 (Figures 1, 2 and 3) are of a high quality (category A). They are located on a steep vegetated bank, adjacent to the main Hall buildings. Most of the trees (T1, T2, T3 and T5) are mature and have been allowed to generally develop a healthy and uninhibited spread however there is some leaning to the south west by T1 and to the north east by T3. T4 is early mature shrubby tree and located at the bottom of the bank next to the river.

These trees should be retained where possible and development should not take place within their root protection areas (RPAs), unless measures are taken to avoid damage to the roots. It would therefore be recommended that to avoid potential damage to the root system of the trees, the following measures are considered for works within the RPAs;

- The proposed access route should be of boardwalk style to minimise the need for foundation construction.
- Trenching for services should be avoided
- Excavations for foundations should be avoided
- Excavations to create terraces should be avoided
- Machinery should not be introduces beneath tree canopies where this could result in damage to limbs
