PRELIMINARY ARBORICULTURAL ASSESSMENT

**Proposed development
comprising the provision of six
chalets at the Falcon Inn
Whitby Road, Cloughton**

**for
Mr Ray Owen**

February 2005

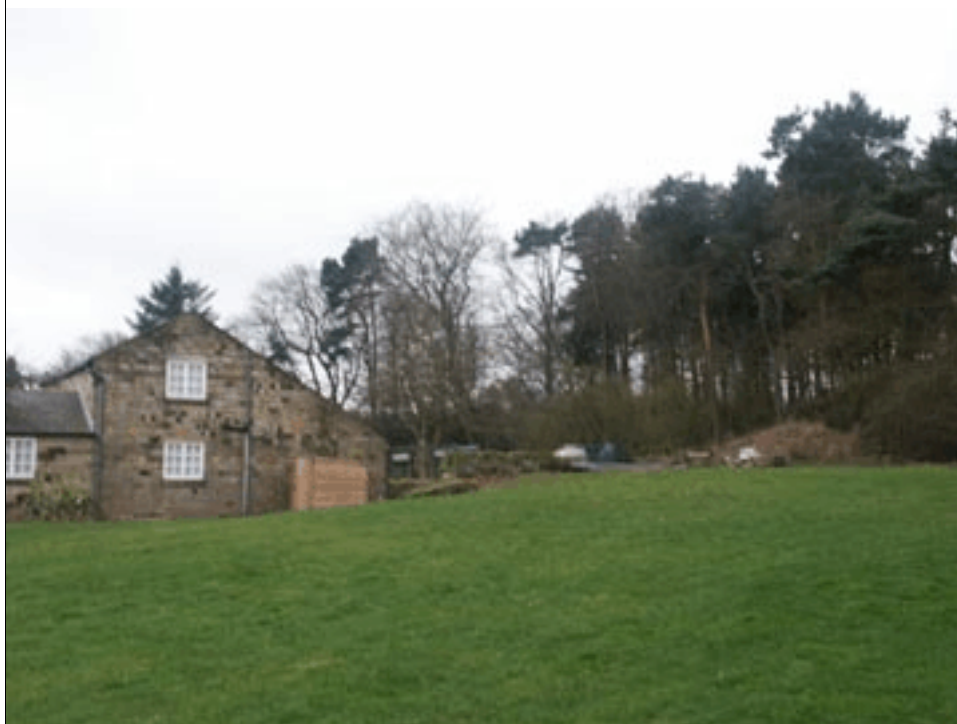
Fig 1 Hotel in relation to the plantation

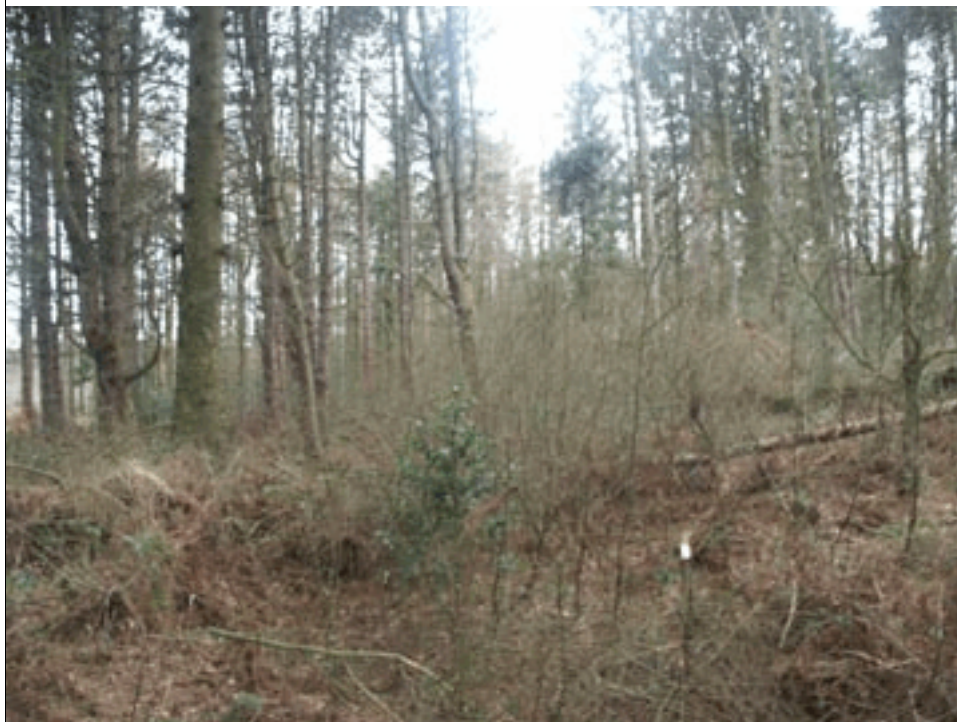
It is evident that management has not been consistent over the production period; there is some thinning in the centre (either managed or through natural losses) but not at the perimeters. Where the trees have not been thinned, growth is etiolated - taller and thinner than would be expected with a properly managed plantation.

Fig 2 General view of the plantation

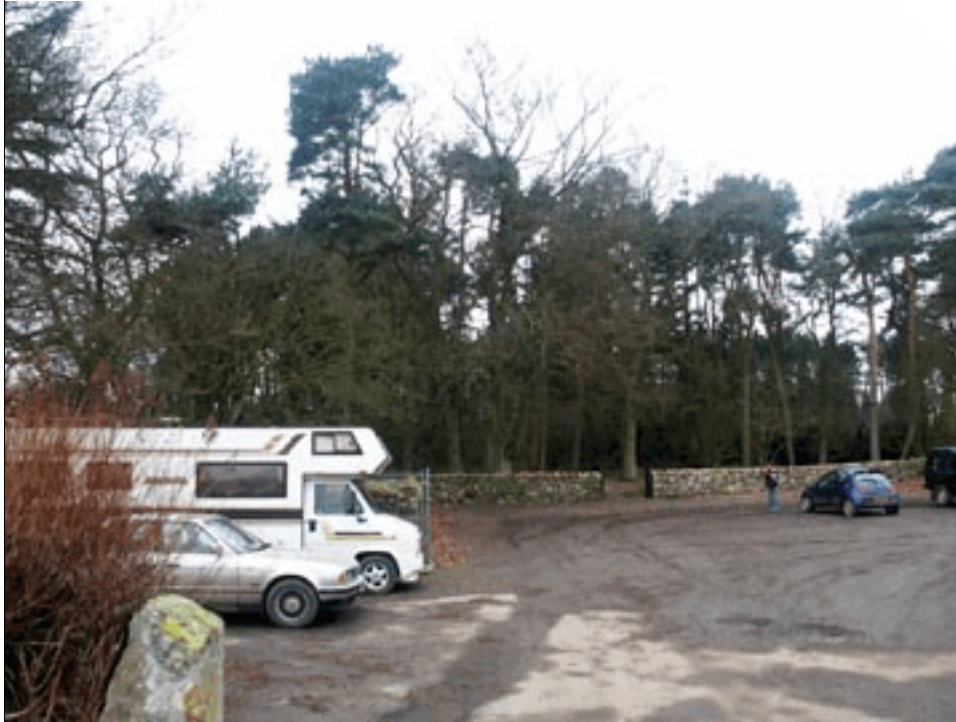
There is no evidence of ongoing forestry activity other than the replanting. There appears to be no sporting use. The site perimeter is unfenced and there is a gateway from the Falcon Hotel car park. This and foot-worn trails in the plantation, suggest that informal public access has been established on the site.

Fig 3 Public access to plantation from the Falcon Hotel car park

This plantation is highly unstable and as a matter of urgency requires action to prevent public access on grounds of health and safety.

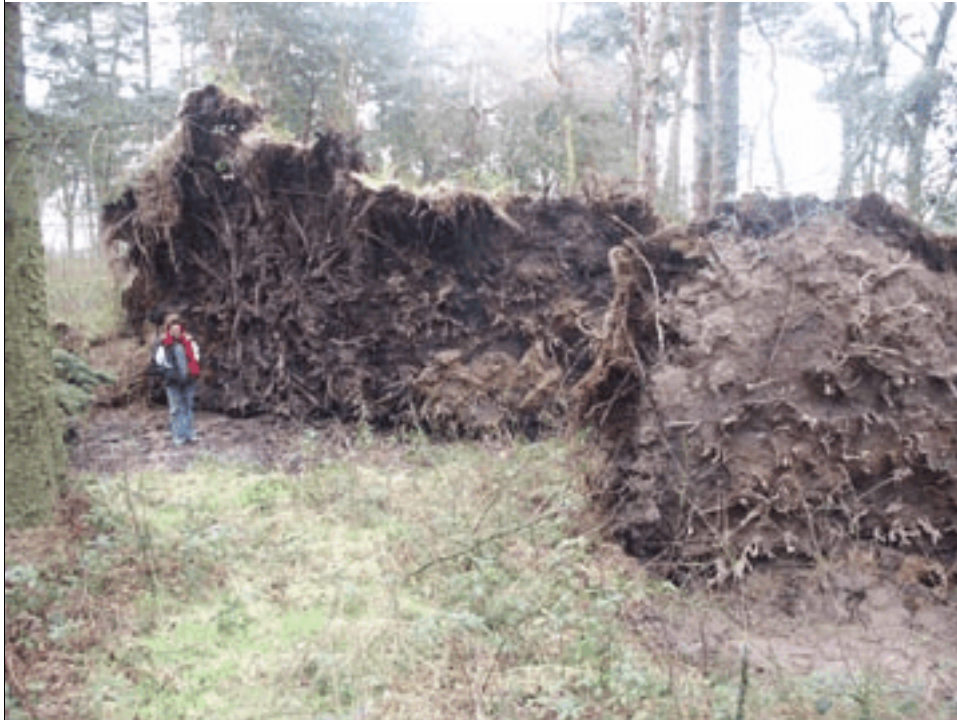
There are a large number of mature trees, which have recently fallen. The falling pattern is uniform to the southeast and forms a clear line of damage extending from the north west to south east corner of the site

Initial examination of the fallen trees indicates that both larch and pine are affected and that the trees were healthy at the time of falling. There is also some evidence of snapping of bowl at approximately 3m.

Examination of the root plate shows rooting to be extensive and interlinked. It is also extremely shallow – only 100-200mm. Clay loam adheres to the roots and a heavy clay sub-soil is evident at the root horizon. There is no penetration of roots into the sub soil.

Sudden catastrophic failure coincided with high winds and the uniform direction of drop and the loss of mainly strong mature trees with heavy canopy indicate windthrow as the cause of the damage.

Fig 4 Uprooted trees showing shallow root system

A management plan be drawn up to identify trees subject to wind throw and those which may have sufficient wind tolerance to remain viable.

In line with an agreed management plan, felling and replanting of the central vulnerable areas is recommended, along with selective felling and replanting of the perimeter planting to remove weak, damaged trees and to increase diversity and visual quality.

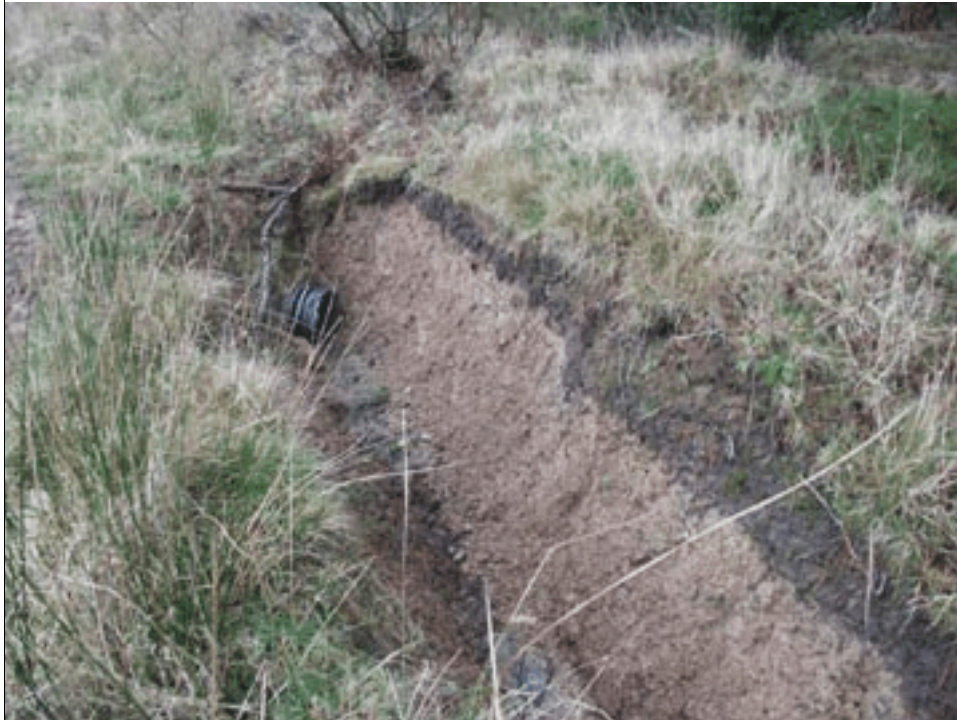
A newly excavated drainage trench on the adjacent plantation clearly shows the organic rich clay soil to extend to only to a depth of 100-200mm, below which there is a distinct and abrupt change to heavy waterlogged mineral clay. There is no mixing of the soil horizons, which indicate the site was not ripped prior to planting.

Fig 5 Drainage trench showing shallow soil horizons

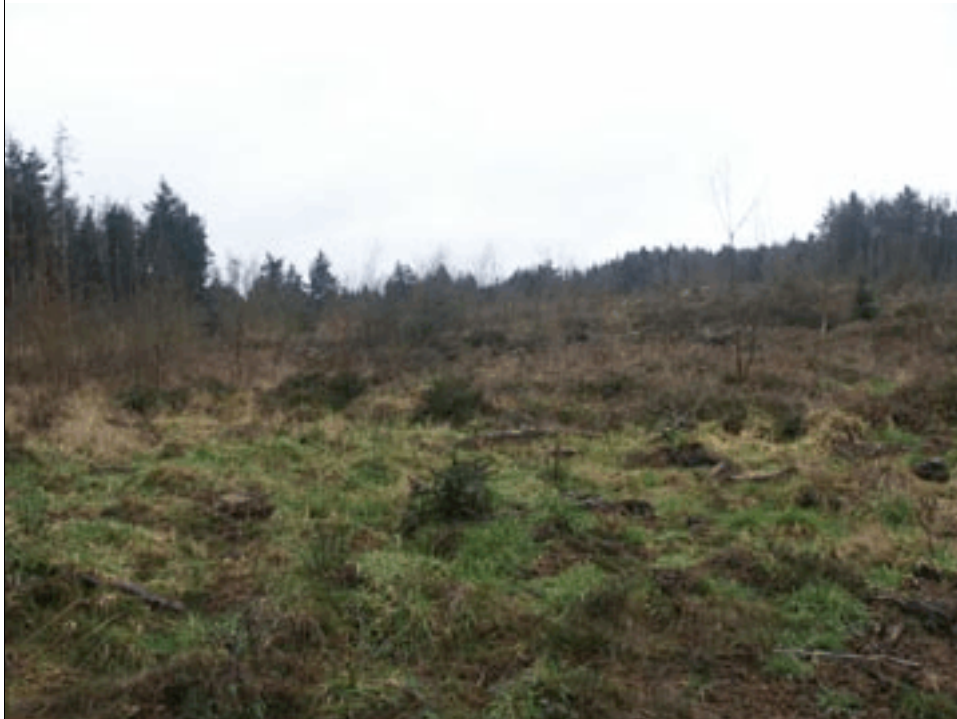
This woodland has until recently remained stable; however the block felling of the Forestry Commission land to the north and west of the site has created an opening for wind from a direction the trees in the centre of the plantation have not previously experienced. Having grown sheltered from northerly winds the stand has developed little rooting resistance to prevent overturning.

The altered wind pattern leaves the Falcon Plantation exposed. The effect of this is particularly severe at ground level since winds, which would previously have been slowed and filtered by the adjacent woodland, are now unchecked.

Northerly winds which would previously have been lifted above the canopy by the barrier of adjacent woodland, now fall back to ground level, further increasing the intensity of the forces experienced by the Falcon Plantation.

The remaining Forestry Commission woodland blocks now serve to funnel winds towards the site. Therefore the plantation now experiences highly concentrated wind strengths at ground level from a direction which was previously sheltered.

Fig 6 Area of clear felling to the north and west of the plantation
